Bridge Inspection Report

00338
SH 14 Marion
over
CROOKED CREEK

Structure Number: 00338

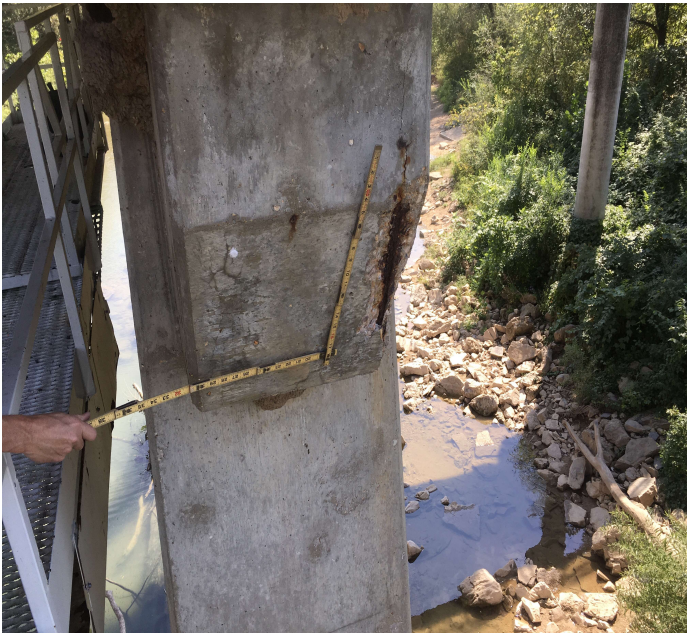
Underside of pier #1 spalled with rebar exposed.

PHOTO 1 Description Spall with exposed rebar at the right cap haunch of pier #3.

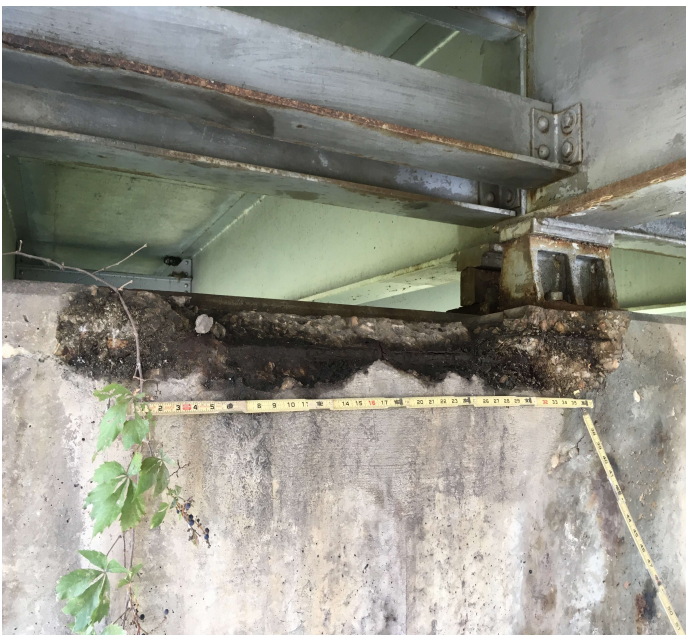
PHOTO 1 Description

Pier #1 has a spall with rebar exposed on the back side of the cap and a large 3' spall with rebar exposed in the top edge of the cap in bay #4.

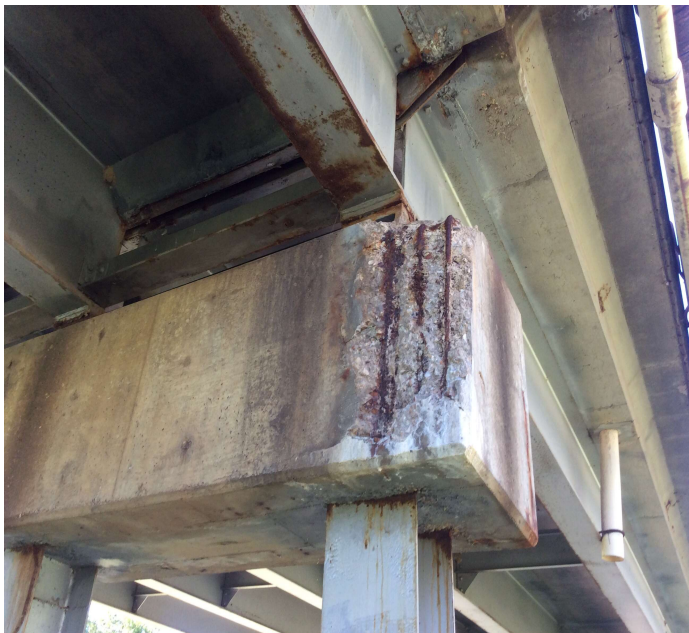
Bent #3 right cap end has a spall with rebar exposed.

PHOTO 1 Description Spall with rebar exposed at left cap end of bent #3
