Bridge Inspection Report

02157

US 71 Benton 1

LITTLE SUGAR CREEK

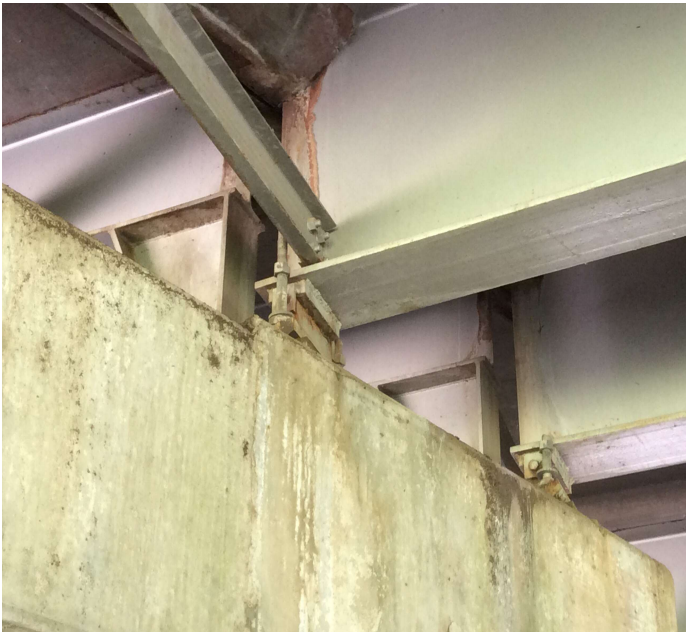
Span #4 girders #9, #10, #11 at end threaded bearing pin nut isn't fully threaded.

PHOTO 1 Description Typical anchor bolts with excessive projection.

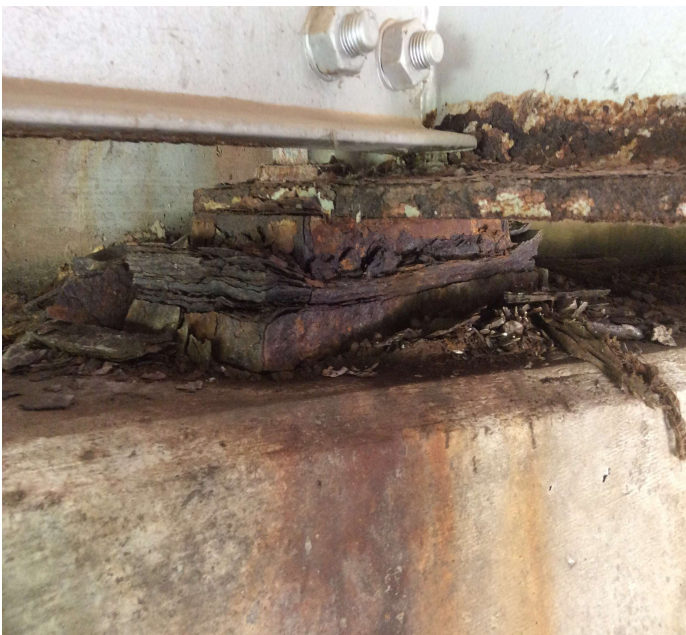
Abutment #1 and #2 caps have debris heavily corroded bearings.

PHOTO 1 Description Typical view of bearings at Abutment 2 SB lanes

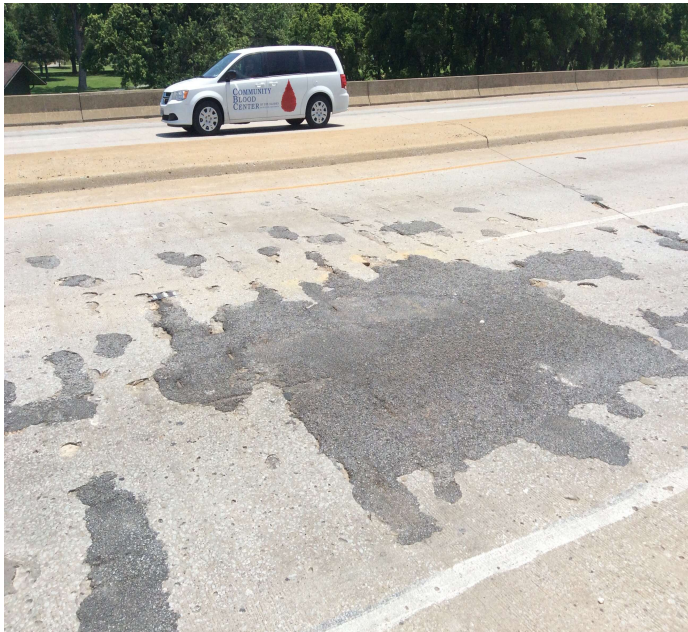
Deck span #2,#3 south bound lanes and spans #4 thru #6 north bound lanes numerous spalls with rebar exposed.

PHOTO 1 Description Area with spalling, patching and steel exposed in SB lanes adjacent bent 2 in span 3

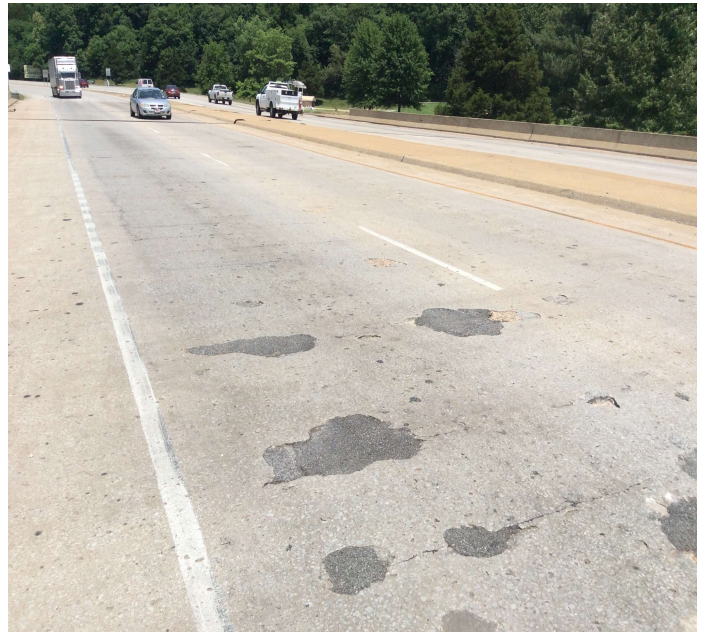
PHOTO 2 Description General view of SB lanes span 3 looking north.

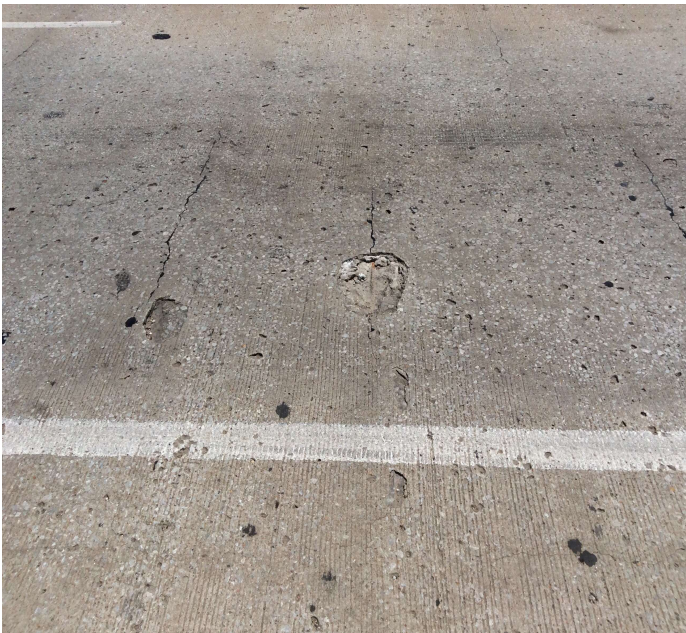
PHOTO 3 Description Span 2 SB lanes left lane spalling with steel exposed approximately 7' from bent 1 road iron.

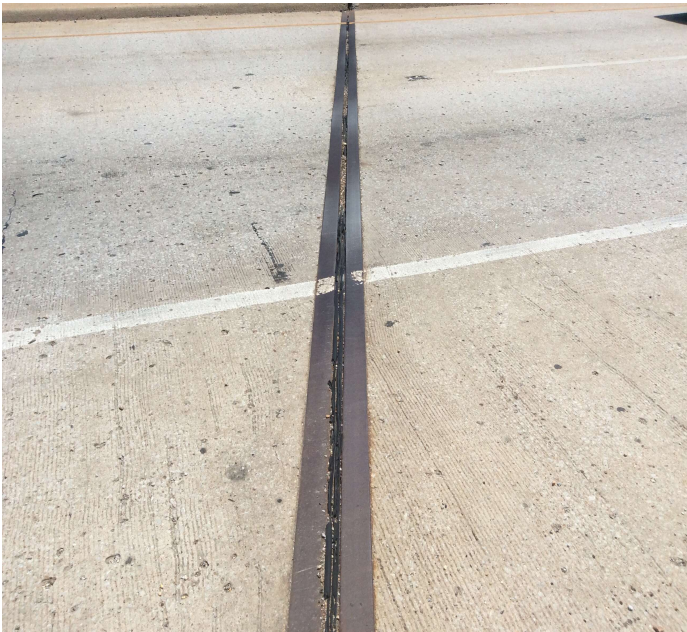
Excessive leakage, torn and moved from original position allowing free flow of water in some locations.

PHOTO 1 Description Bent 1 SB lanes joint material.

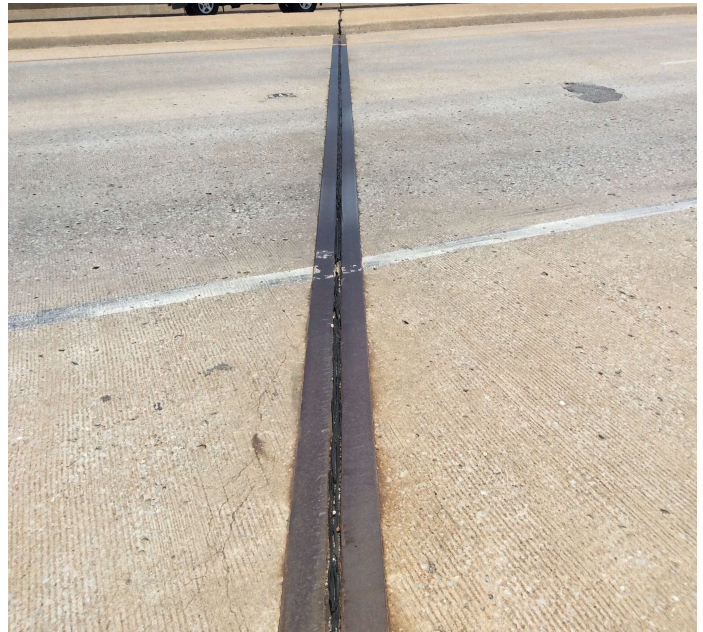
PHOTO 2 Description SB lanes bent 5 joint material

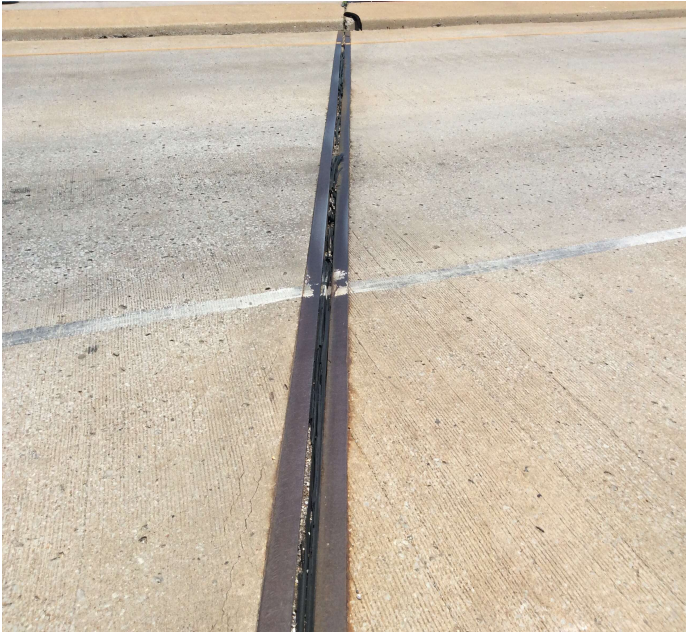
PHOTO 3 Description Bent 4 SB lanes joint material

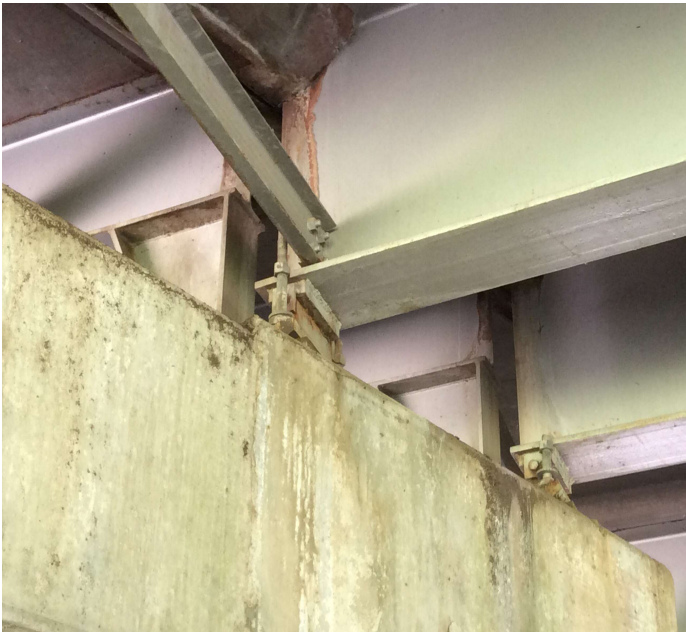
Piers #1, #3, #4 and #5
Numerous anchor bolts have excessive projection

PHOTO 1 Description Typical anchor bolts with excessive projection.

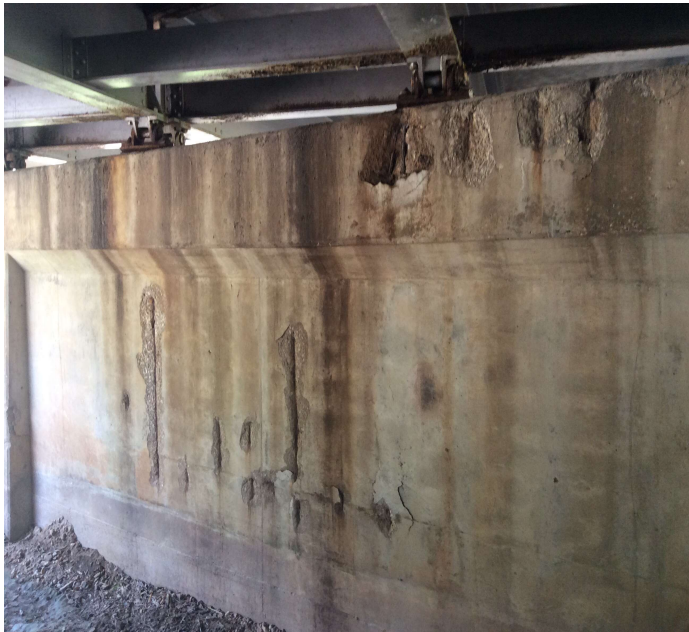
Pier #2, columns #4,#6 and right end of concrete cap has spalls, deterioration and rebar exposed , and Pier #4,5 left end of concrete cap has deterioration and cracking with leaching.

PHOTO 1 Description NB lanes bent 5 ahead side spalling to pier wall and cap with steel exposed.

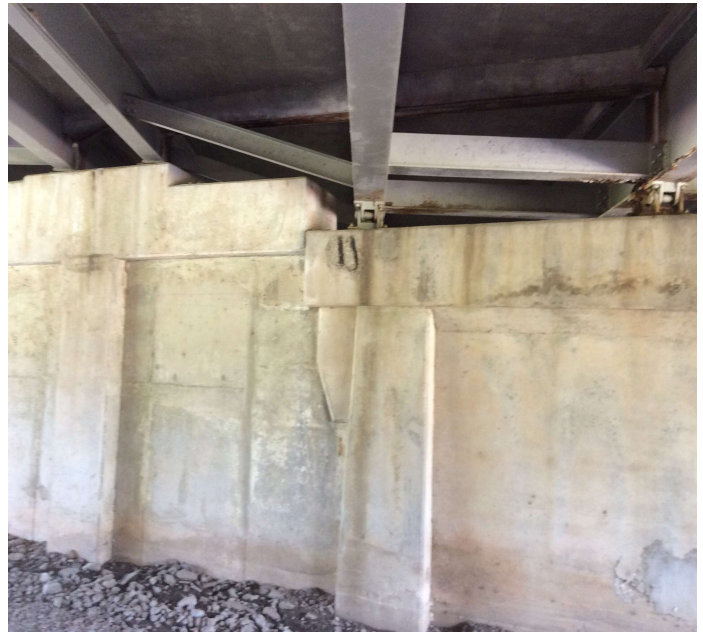
PHOTO 2 Description NB lanes bent 5 behind side spalling with steel exposed above column 4.

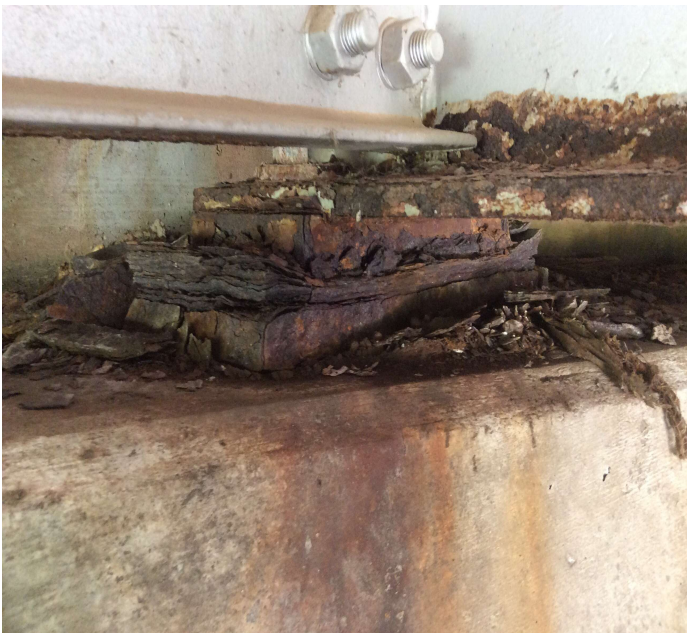
Steel superstructure under deck expansion joints- Rust and corrosion

PHOTO 1 Description Typical view of bearings at Abutment 2
SB lanes

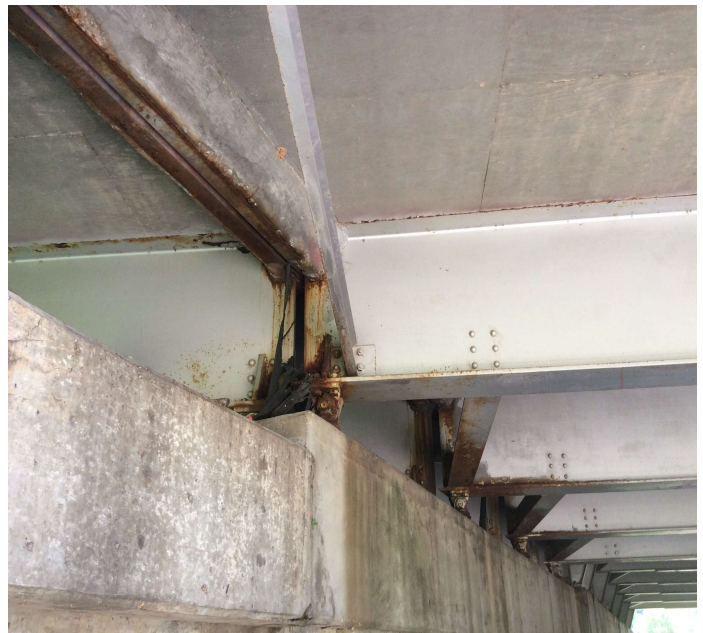
PHOTO 2 Description NB lanes span 5 bent 4 end of beam
corrosion.

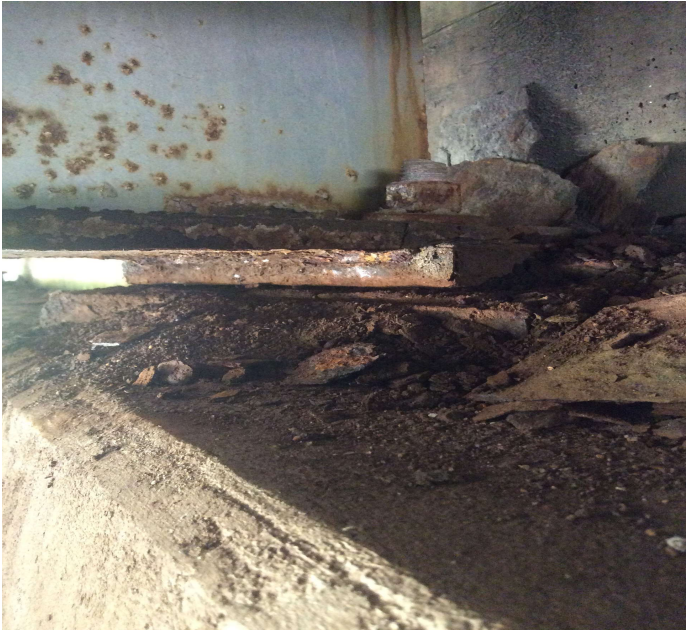
PHOTO 3 Description Abutment 2 bearing 2 is free floating and is moving when under load.

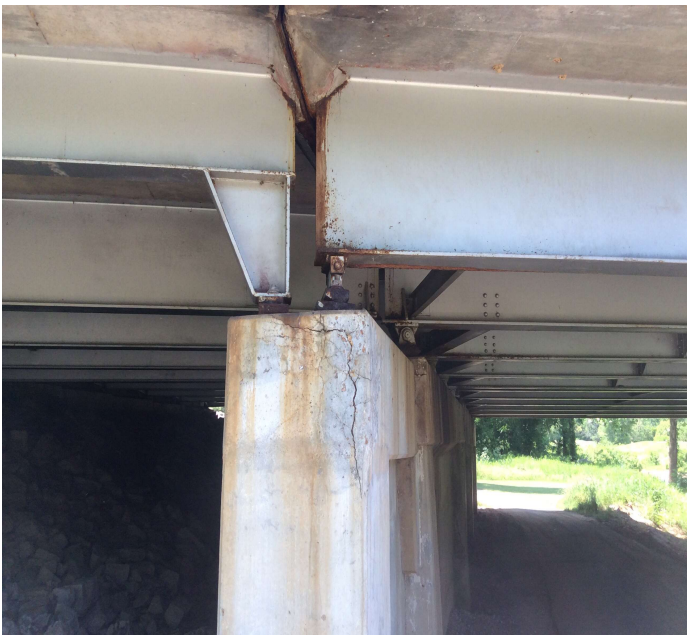
Pier #1 cap- Minor spalls and cracking

PHOTO 1 Description NB lanes Bent 1 right column 6
cracking with delaminated areas.

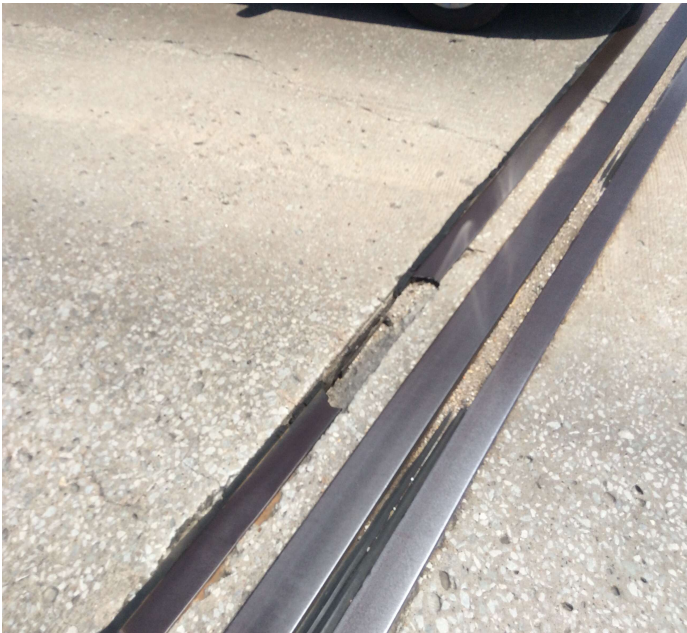
Abutment #2 southbound lanes backwall road iron- Portion missing and loose.

PHOTO 1 Description SB lanes abutment 2 road iron Missing.
