Bridge Inspection Report

02158
US 71 Benton 1
over
PINION CR

Structure Number: 02158

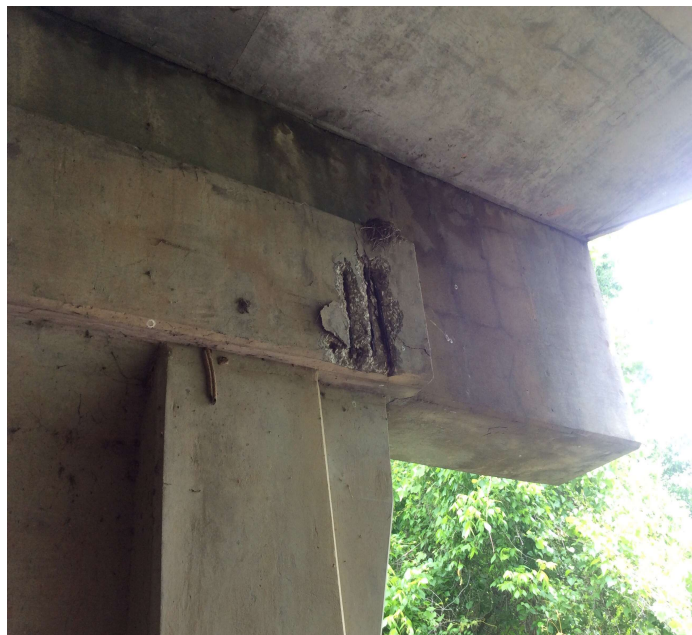
Bents #1, #2

Spalls with rebar exposed on caps and columns.

PHOTO 1 Description Spall with rebar exposed at ahead side of bent #2 upper right corner.

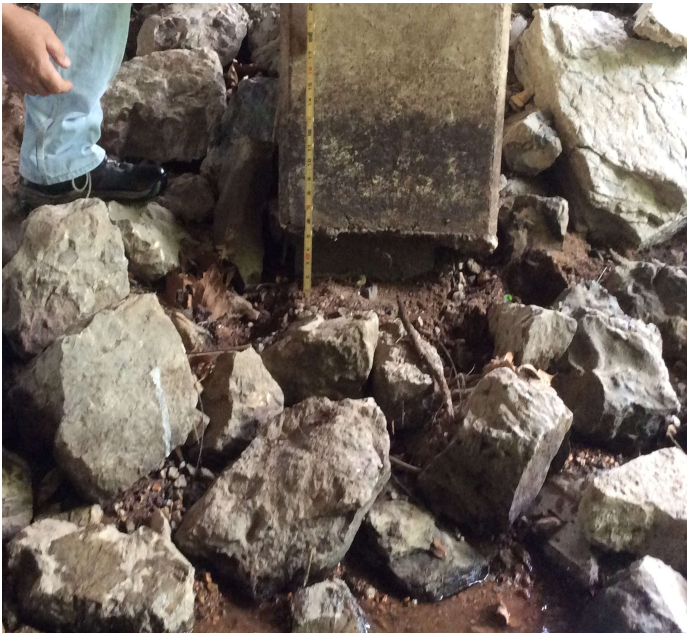
PHOTO 1 Description

5" of steel pile exposed at column 2 of bent #1 at ground level.

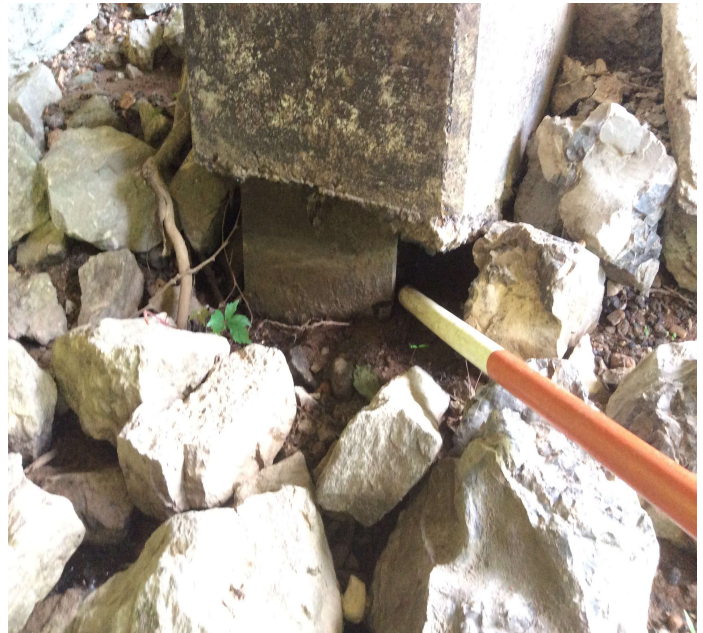
PHOTO 2 Description Bent 1 column 2 ahead side steel piling visible.

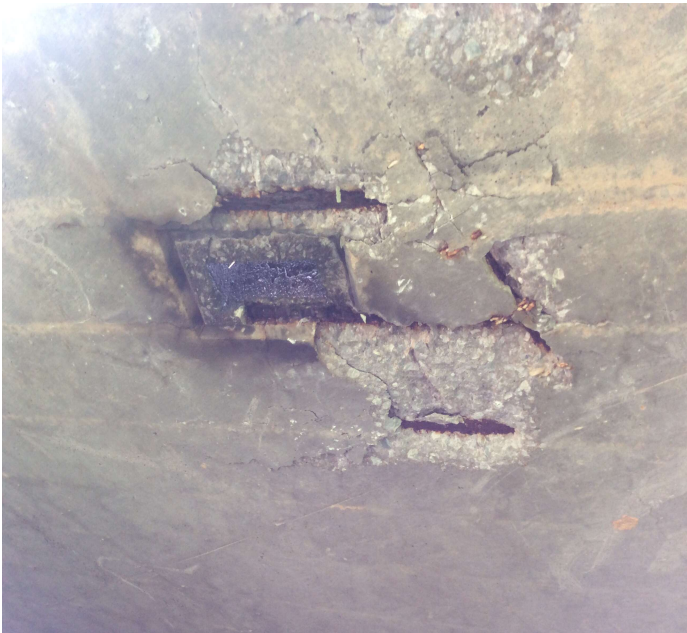
PHOTO 1 Description

Spalls with rebar exposed at left drain areas in span #3.

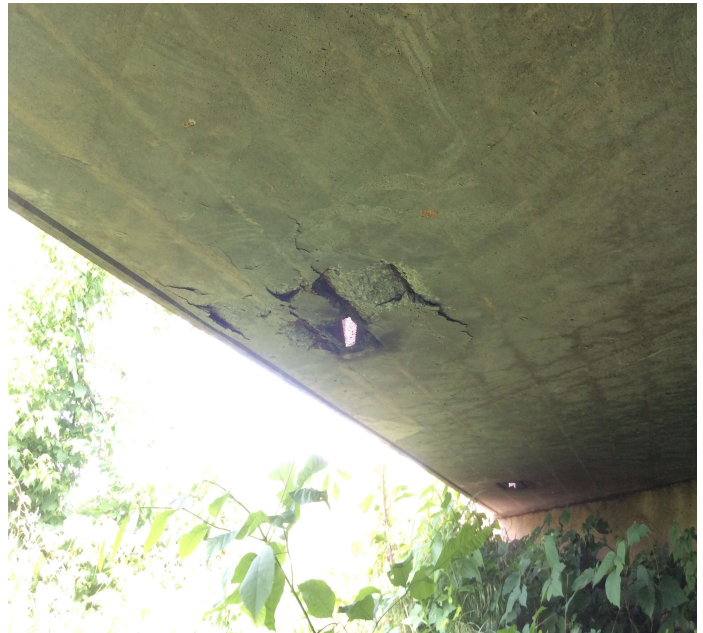
PHOTO 2 Description Span 3 left spalling around deck drains typical
