Bridge Inspection Report

02469

US 62/412 Marion

CROOKED CR & MO NA RR

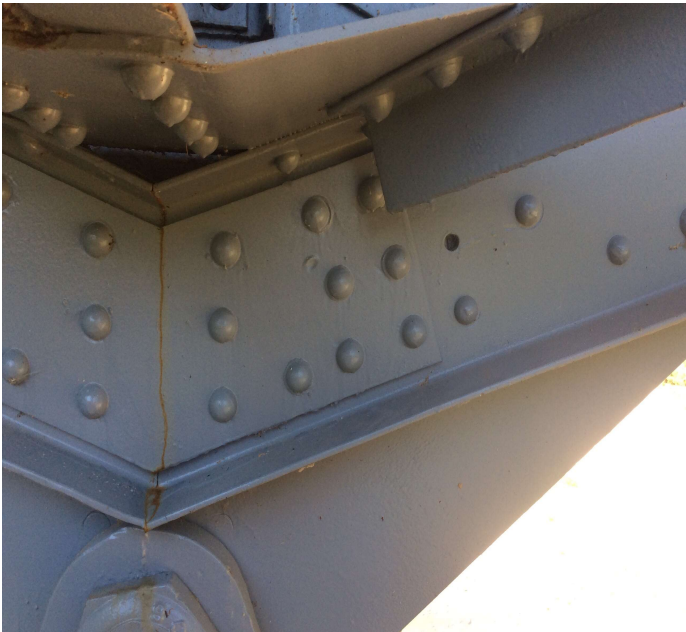
Left truss -bottom chord PP L15 right truss connection has a rivet sheared off. A sheared rivet was noted in the interior top chord connection between L2 and L3 left truss.

PHOTO 1 Description Rivet sheared off at the interior bottom chord connection at L 15 right truss.

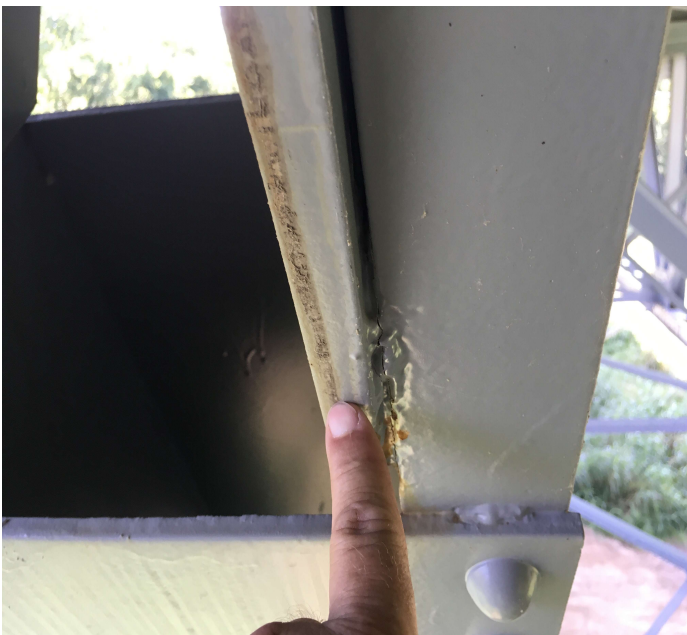
PHOTO 1 Description

L26 has a tack weld crack at batten plate lower left and lower right connection that has not propagated into the base metal. Cracked tack welds like this one exist through out the structure.

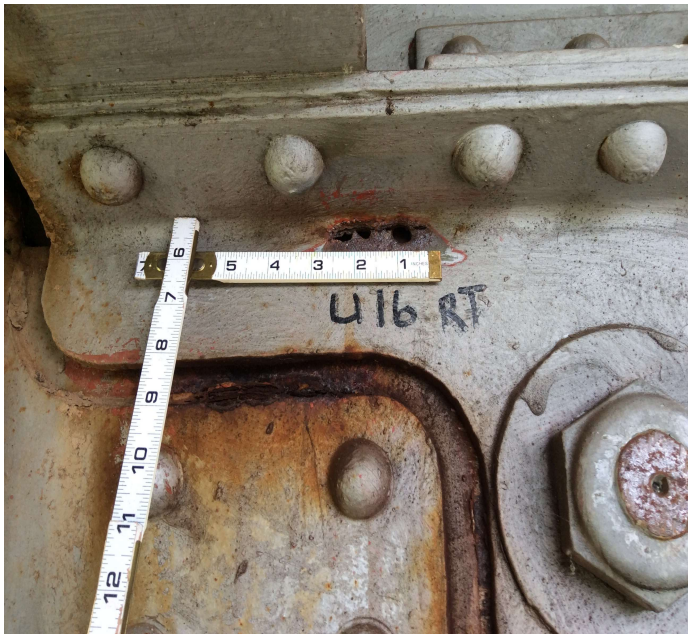
Top chord: U-16 right truss 2 3/4" hole rusted through web section, this area of the truss is at zero moment.

PHOTO 1 Description U-16 right holes rusted through web section.

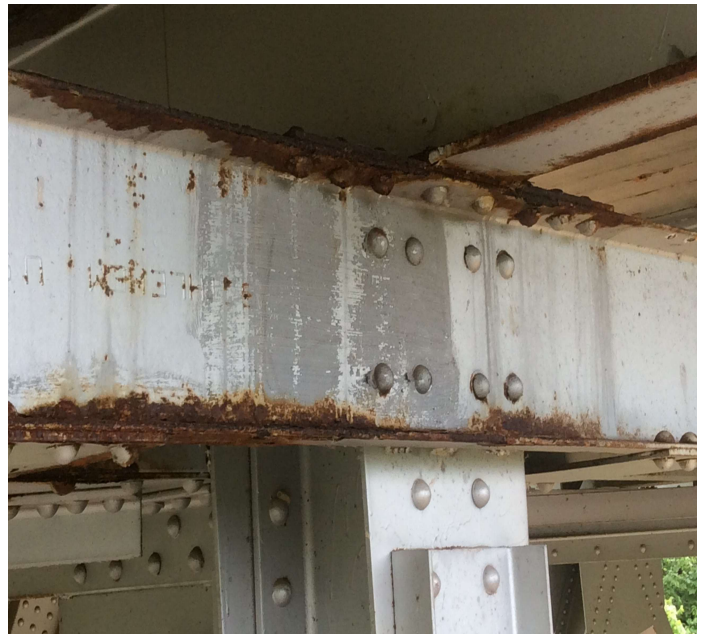
PHOTO 2 Description U-29 right active corrosion to top cord with flaking rust.

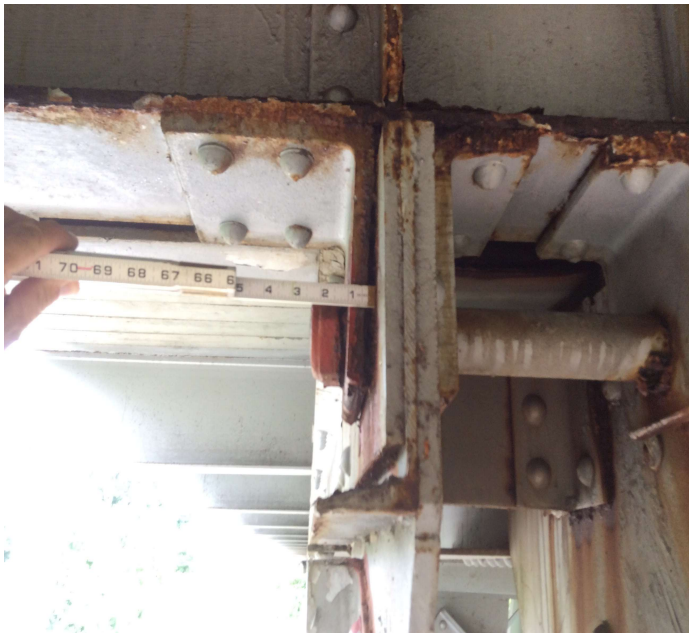
PHOTO 3 Description U-42 right pack rust minor out of plane bending to pin and pin connection.

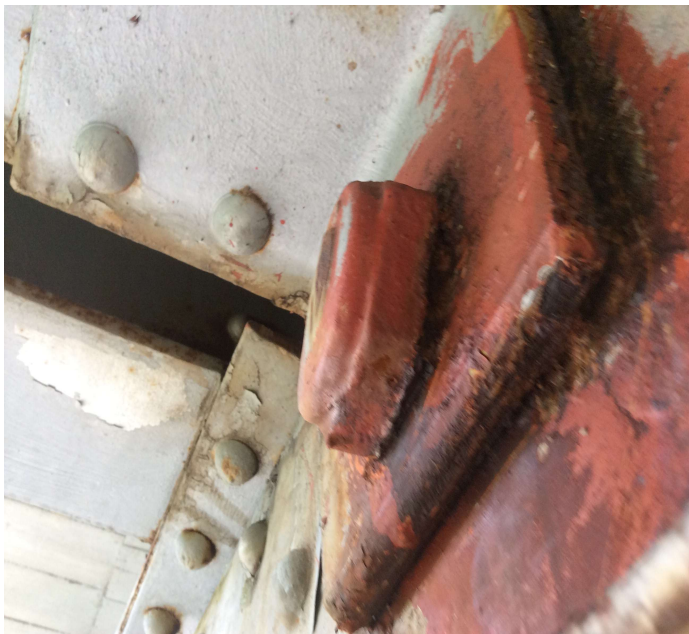
PHOTO 4 Description U-42 right pin has out of plane bending.

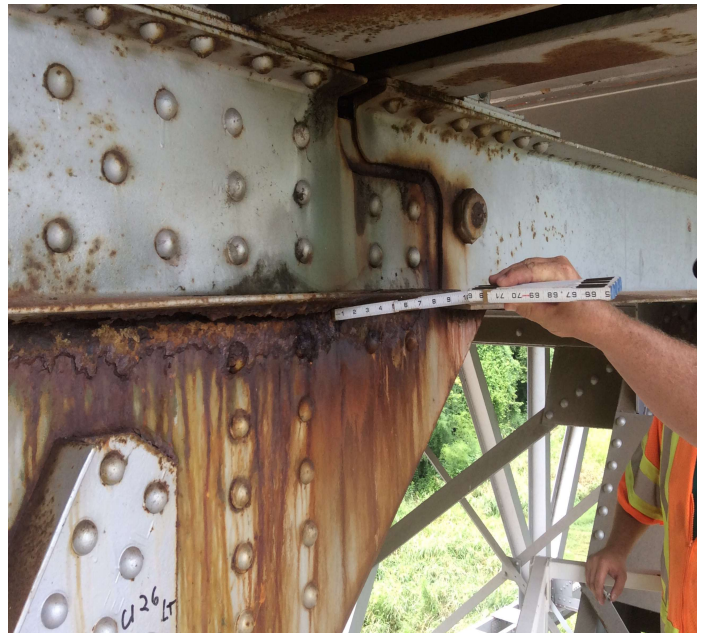
PHOTO 5 Description U-26 left pack rust with measurable section loss top cord and gusset plate.

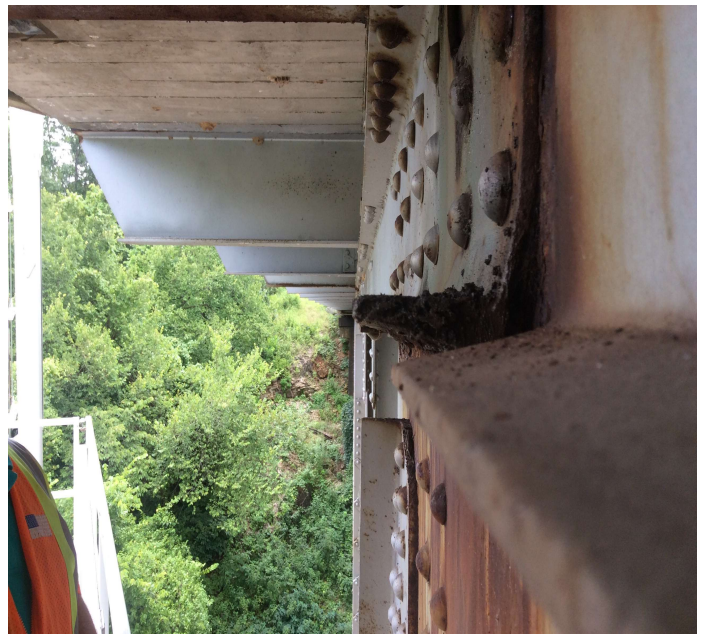
PHOTO 6 Description U-26 left top cord pack rust with out of plane bending.

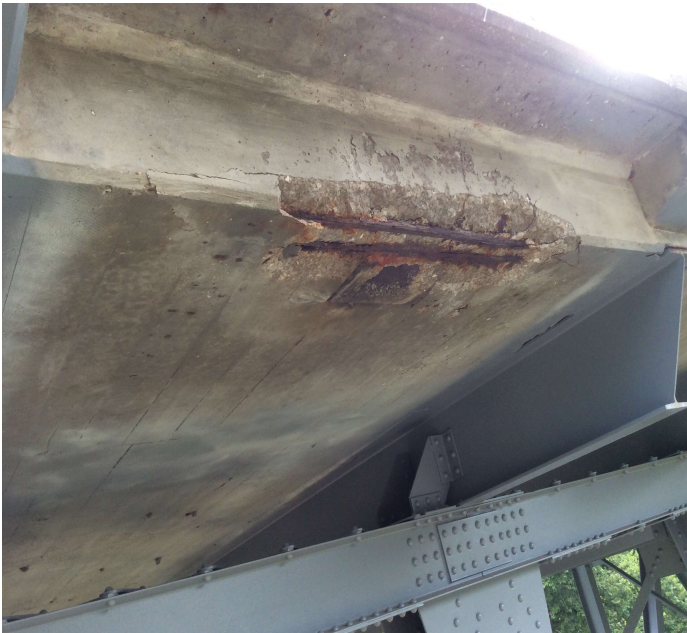
PHOTO 1 Description

Spalls with rebar exposed at all drain areas along both sides of structure

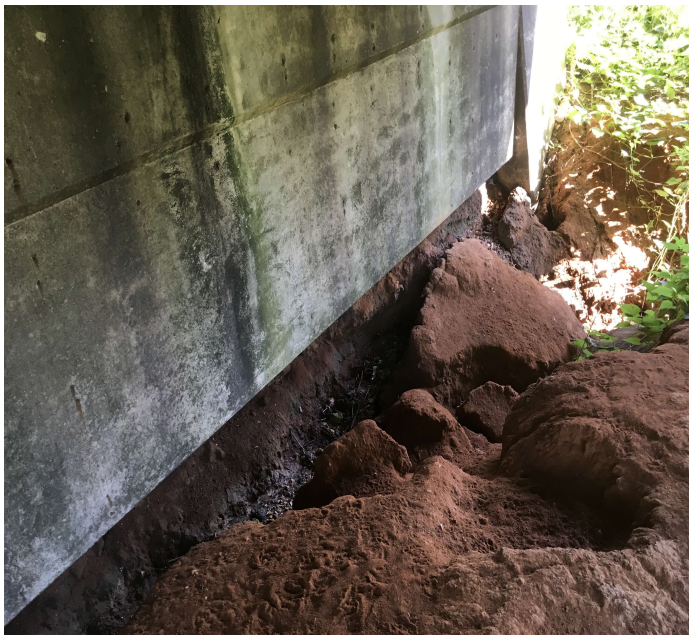
The abutment #1 and #2 embankment slopes have erosion that has cut ditches down the face of the slopes.

PHOTO 1 Description Embankment erosion at abutment #1 that extends under the web wall of the abutment.

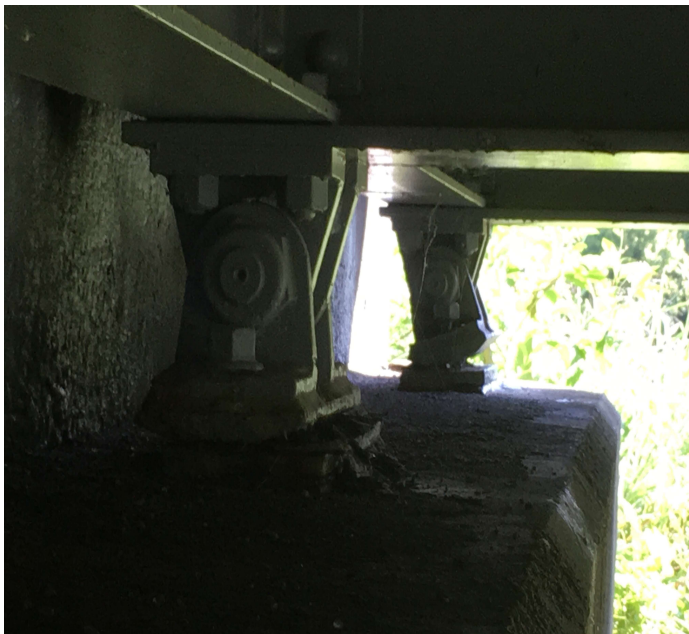
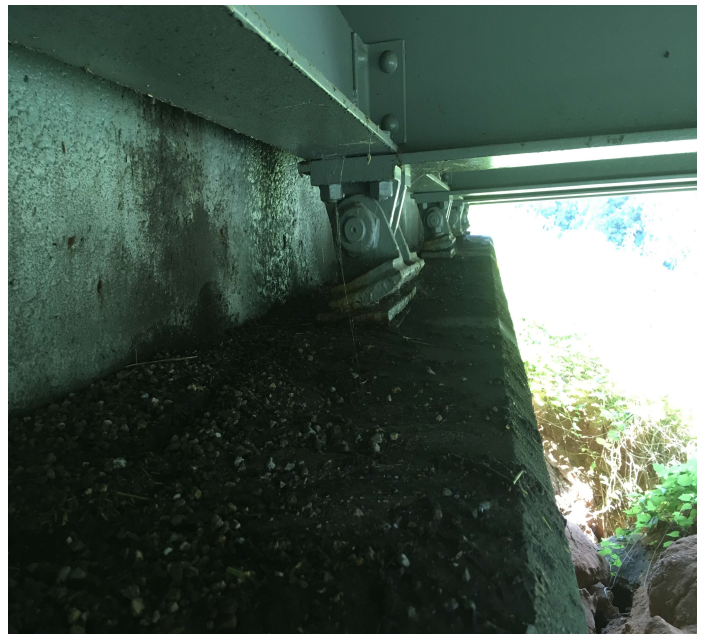
Abutment #1 moveable bearings- bearings #1,3,4,5 are tilted excessively toward the back wall. Bearing #2 is not tilted at all. All 5 bearings have corrosion with pitting and flaking rust in the rocker areas. Many of the anchor bolts are missing at this location.

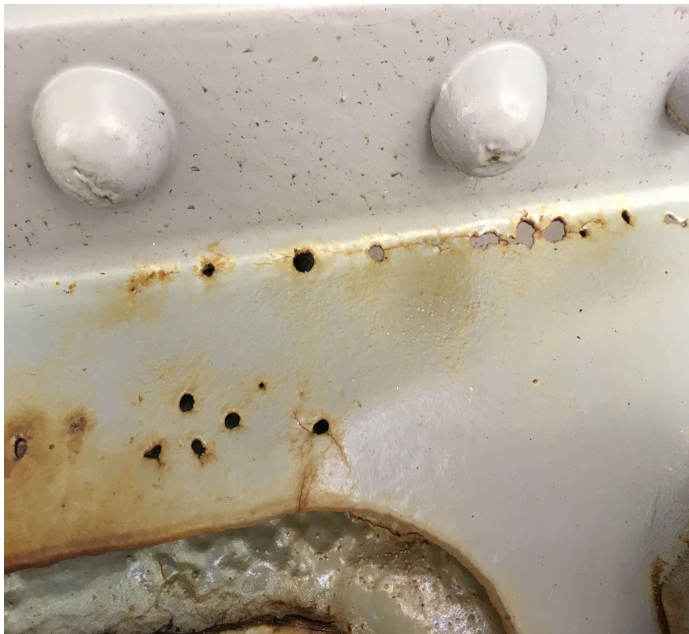
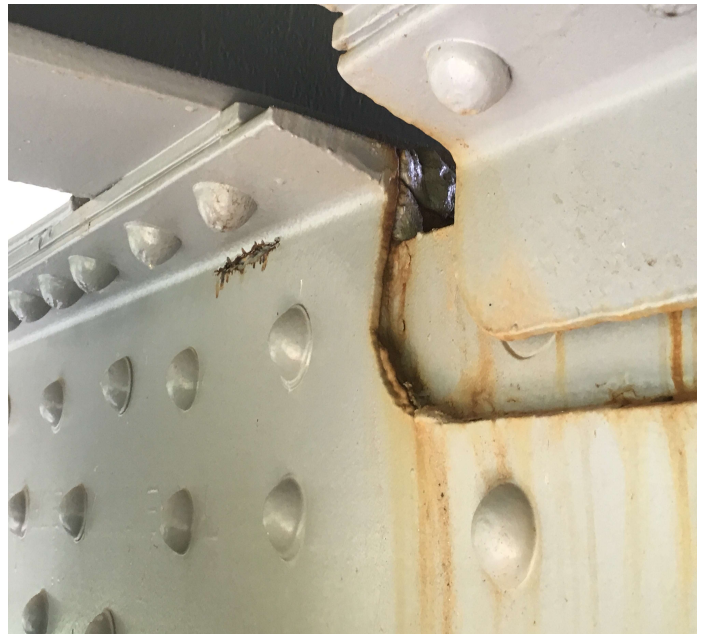
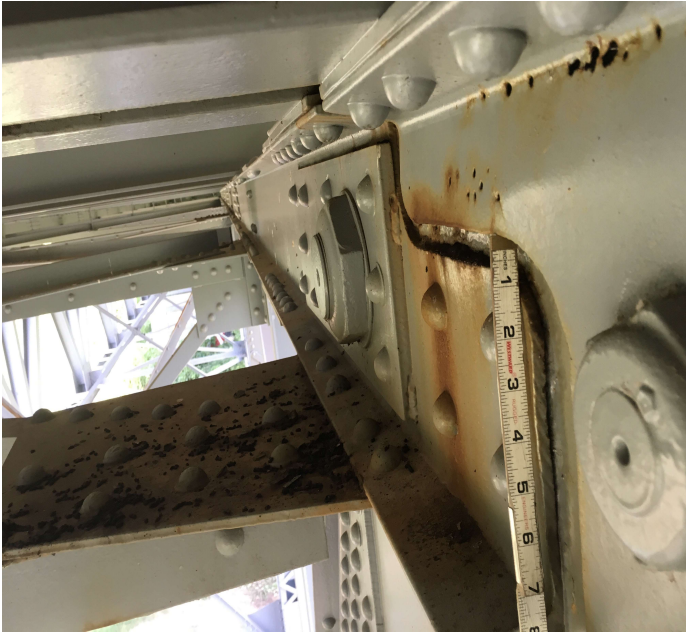
The pinned connection on the top chord at U16 on the left and right truss has rust holes in the web section.
The pinned connection on the top chord at U26 on the left and right truss has rust holes in the web section.
These are zero load locations.
