Bridge Inspection Report

03345

**U.S. 412 Madison
over
WAR EAGLE CREEK**

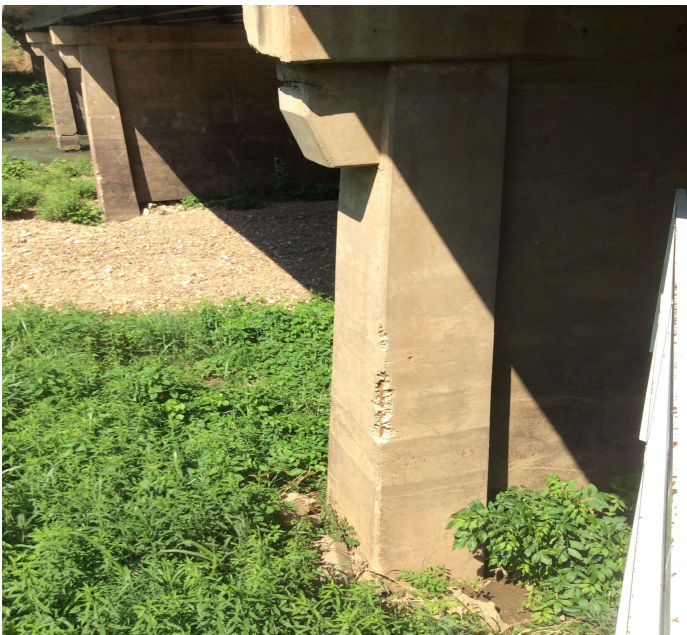
Pier # 5 left column & pier # 6 right column - Cracking & deterioration.

PHOTO 1 Description Bent 5 column 2 right side steel exposed.

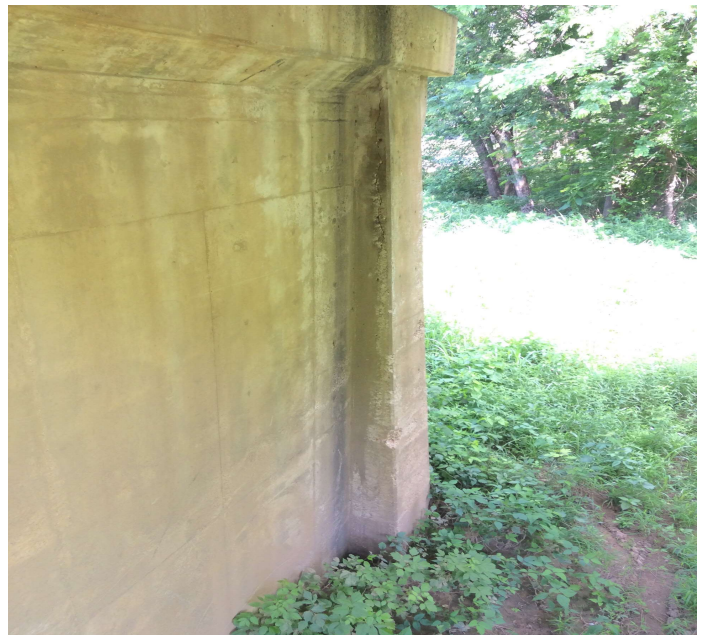
PHOTO 2 Description Bent 2 column 1 ahead side vertical cracking.

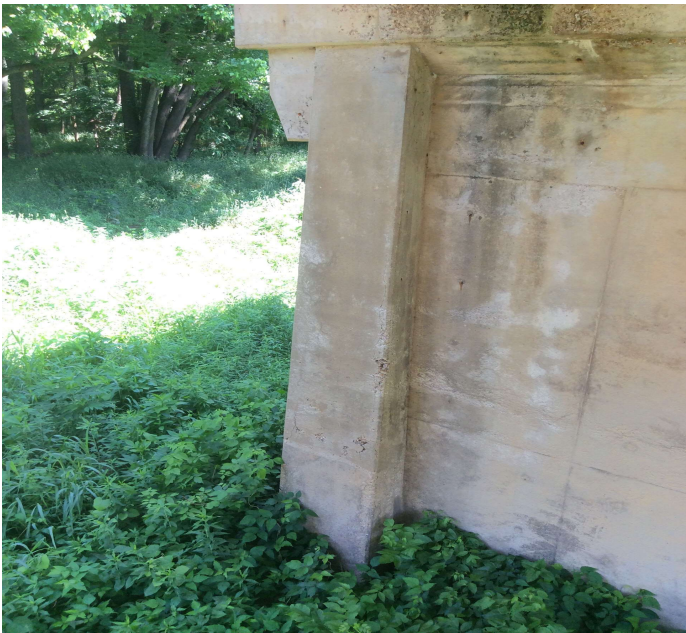
PHOTO 3 Description Bent 5 column 1 behind side sampling and cracking.

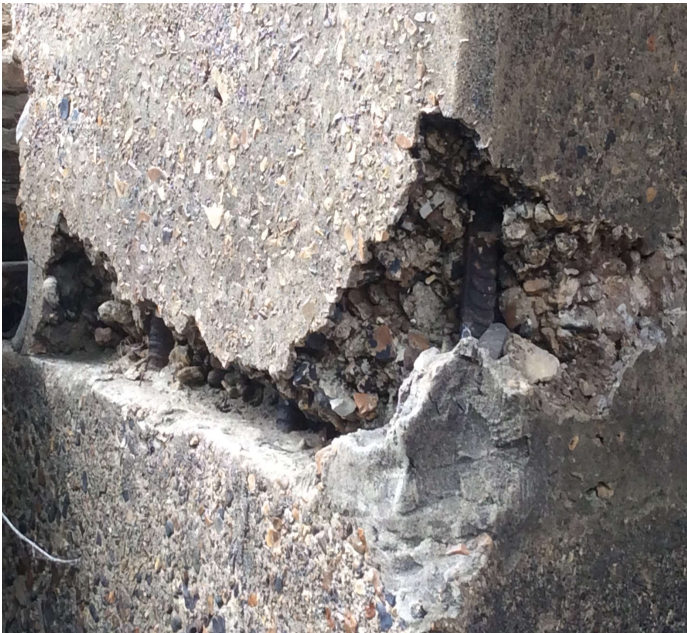
Pier # 3 left & right columns ; Pier # 5 right column - Spalls, delamination, cracking & deterioration

PHOTO 1 Description Bent 3 ahead side of right column 2 steel exposed.

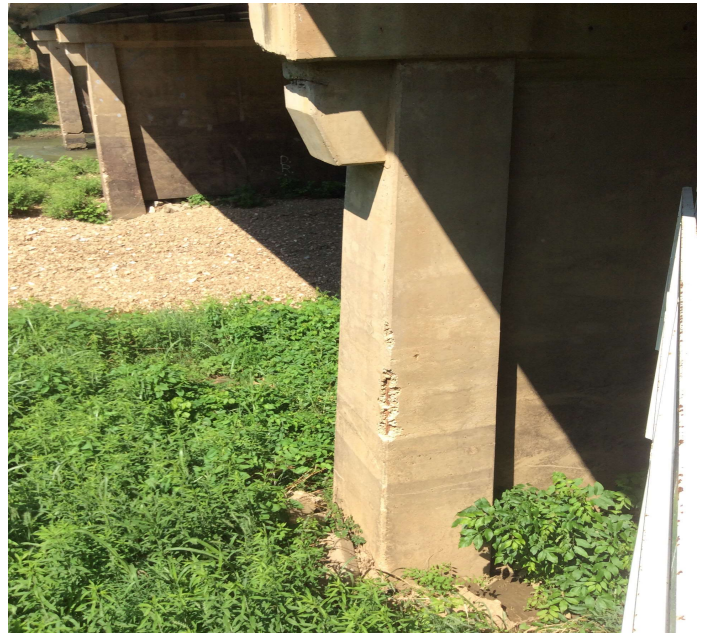
PHOTO 2 Description Bent 5 column 2 right side steel exposed.

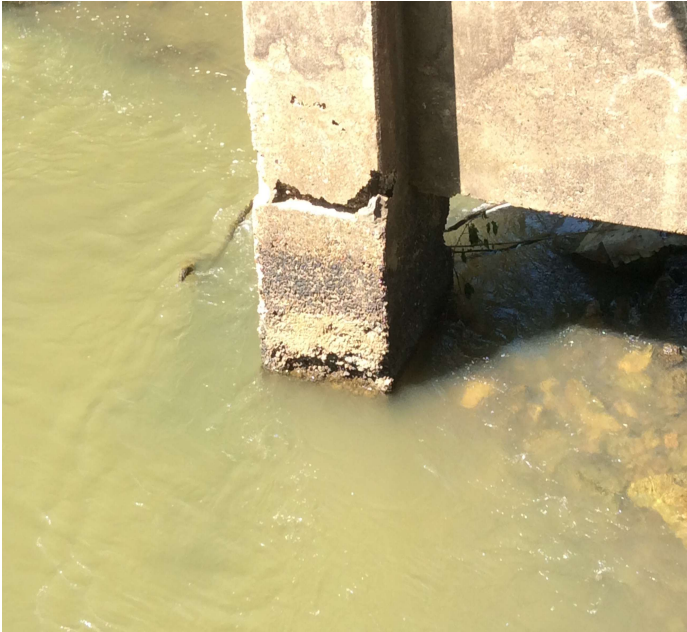
PHOTO 3 Description Bent 3 column 2 ahead side side large areas of spalling with steel exposed.

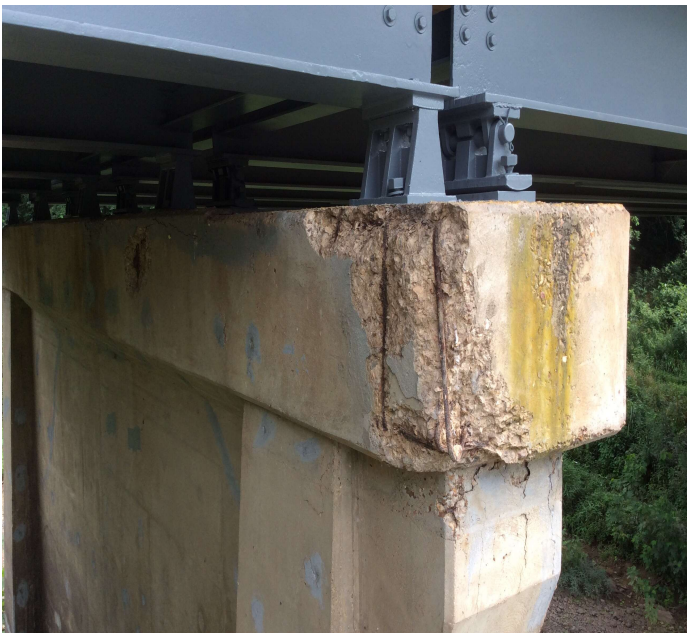
Pier # 4 concrete cap _ Spalls with rebar exposed, delamination & cracking.

PHOTO 1 Description Exposed rebar to right end of bent 4.

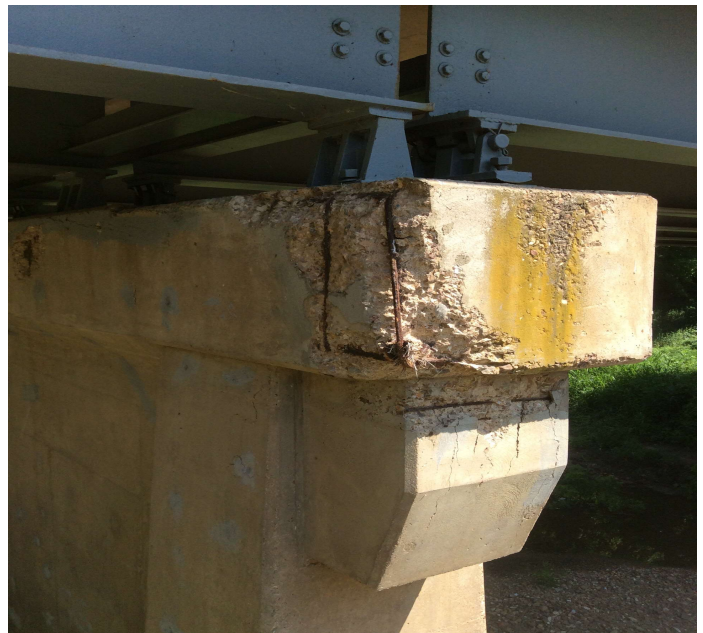
PHOTO 2 Description Bent 4 cap right has spalling with steel exposed.

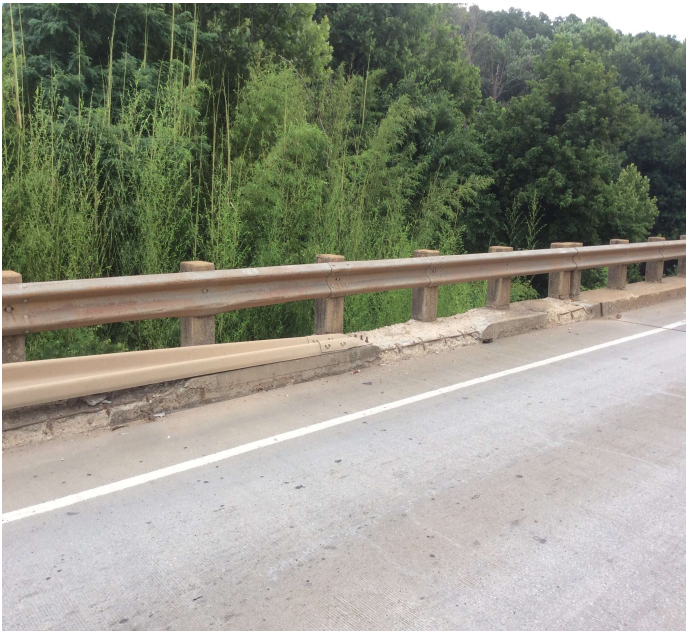
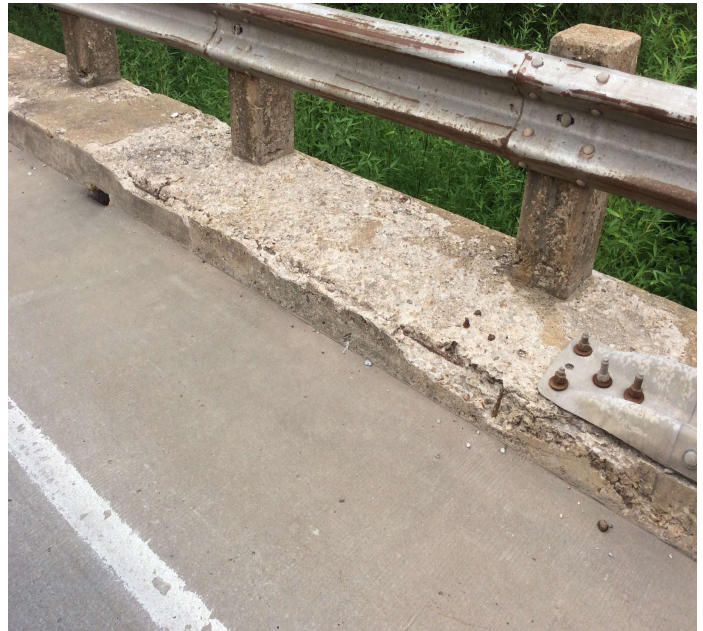
Deck curb throughout - Spalls with rebar exposed.

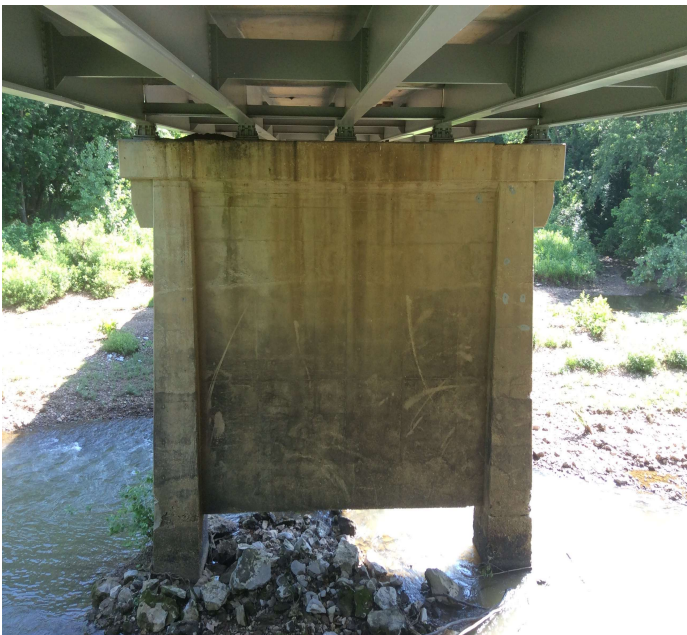
Piers # 1 & # 2 - Scour
