Bridge Inspection Report

05330
US 65 Boone
over
CROOKED CREEK

Structure Number: 05330

Facility Carried: US 65 Boone

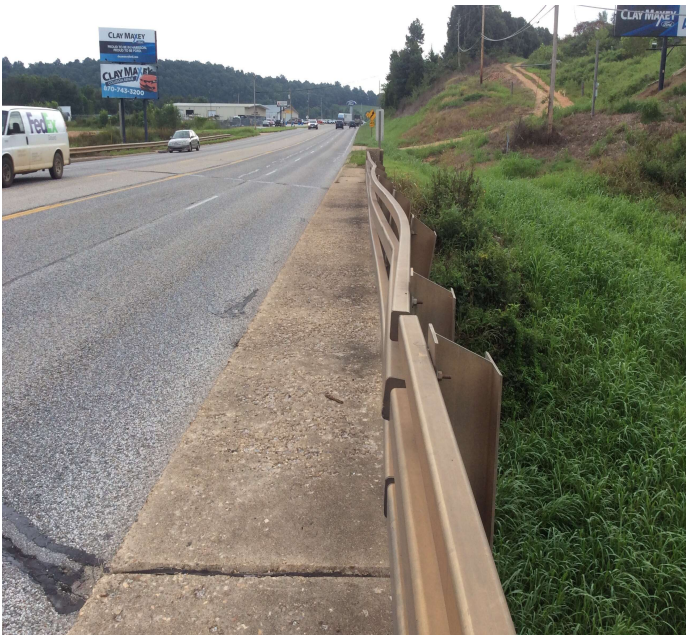
PHOTO 1 Description

The right side bridge rail at span #6 has vehicle damage for 27'.

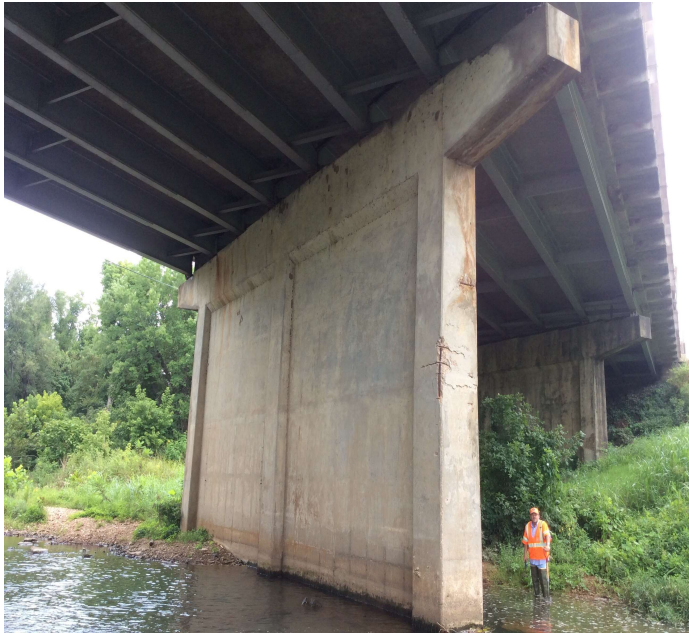
PHOTO 1 Description

Bent #1 cap- has delamination.

Bent #2 cap- has exposed rebar.

Bent #3 cap- has delamination.

Bent #4 cap- has delamination and a spall with exposed rebar.

Bent #5 cap has delamination.

Bent #1 column #2- has a spall with exposed rebar.

Bent #3 column #1 has a delamination.

Bent #4 column #1 has delamination, column #3 has 2 spalls with exposed rebar.

Bent #5 column #1 and #2 have delamination.

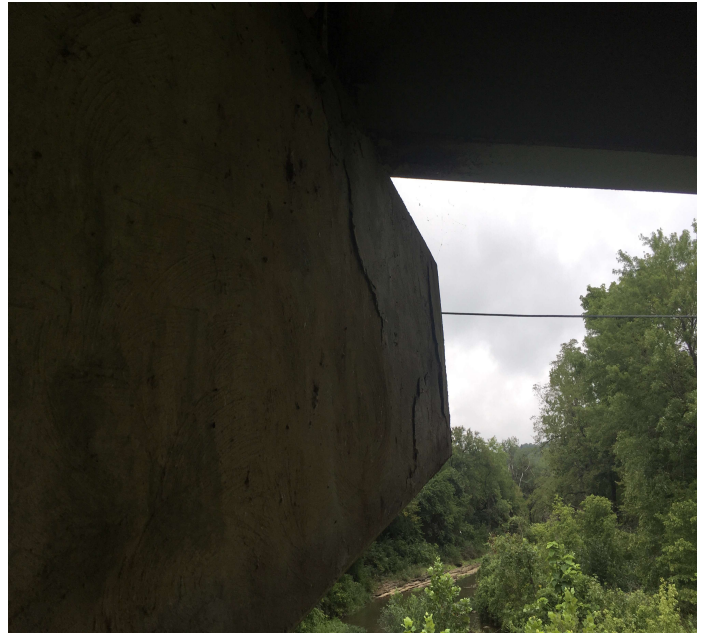
PHOTO 2 Description Large delaminations on the span #5 side of the bent #4 cap. Typical of the left and right sides.

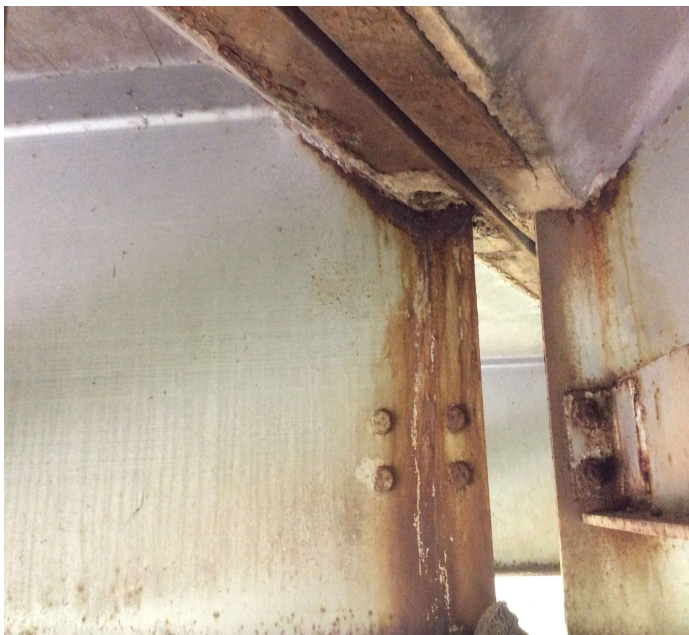
PHOTO 1 Description

The beam ends over the bents have varying lengths of corrosion with minor section loss. The bearings also have corrosion in most locations.

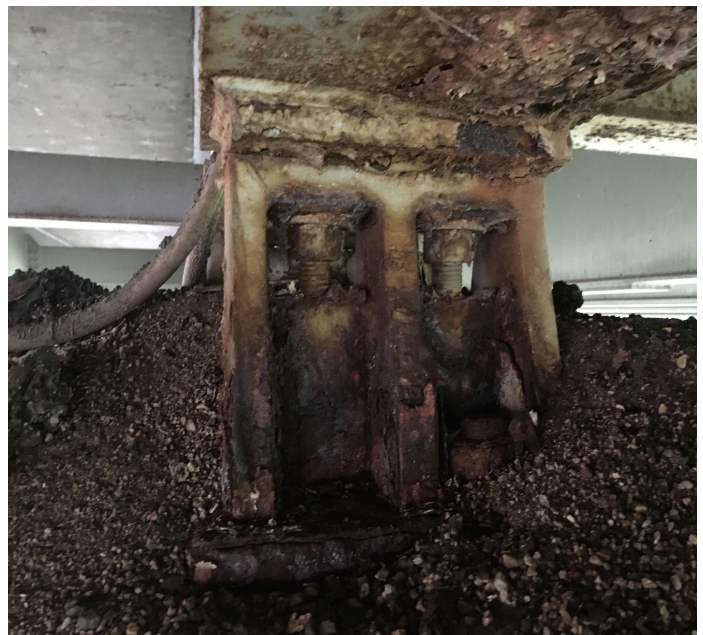
PHOTO 2 Description Fixed bearing condition at bent #2. Typical of bearings # 4-6.

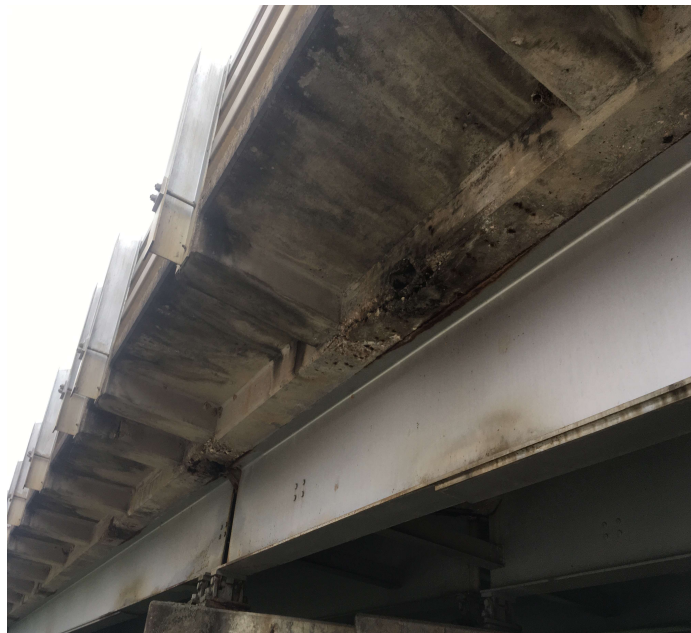
The drain areas and deck overhangs have several locations that are spalled with rebar exposed.

PHOTO 1 Description Drain area condition. Showing spalling and delamination some with rebar exposed. Typical of many locations.

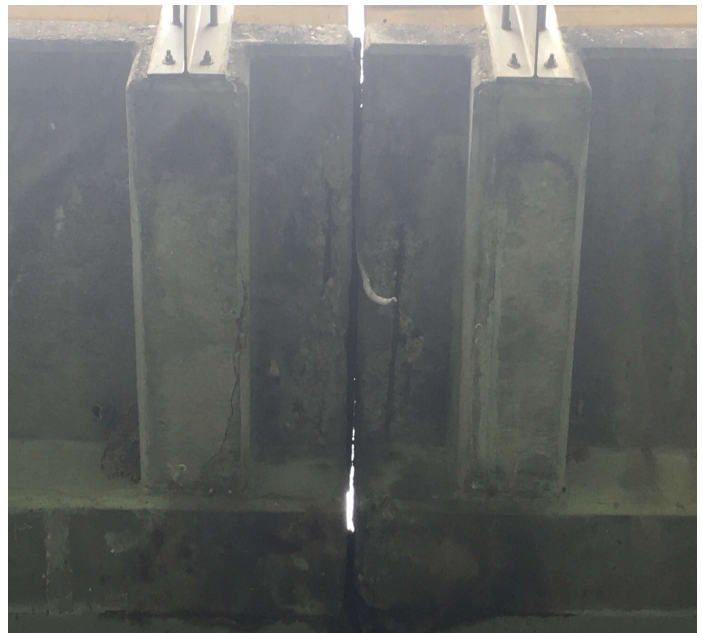
PHOTO 2 Description Shallow rebar exposed on the underside on the right concrete bridge rail in spans #5,6.

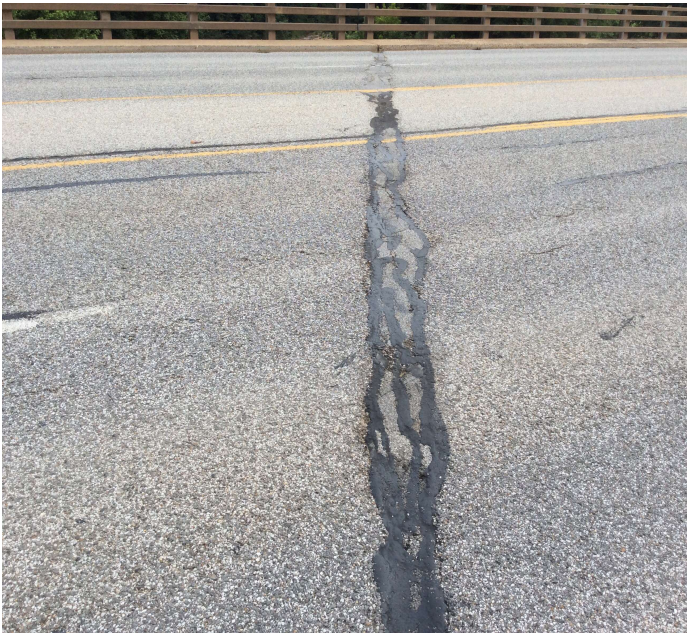
PHOTO 1 Description

The compression joints over bents #2 & #5 have areas of the seal missing, allowing free flow of water and debris.

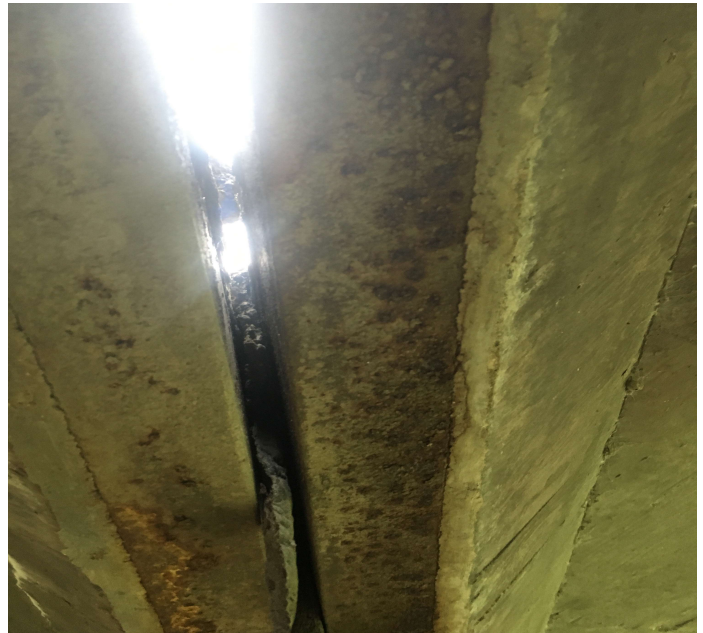
PHOTO 2 Description Areas of Missing joint seal over bent #5 allowing free flow of water.

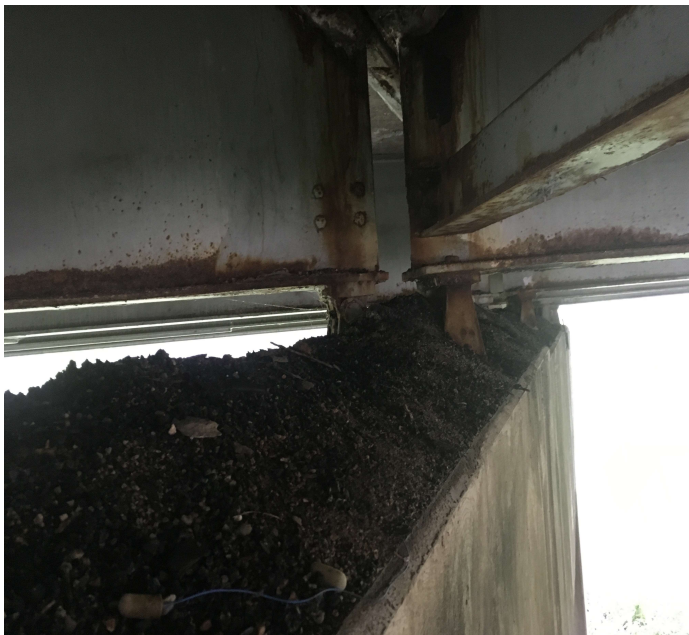
The bent caps at bents #2,5 have heavy debris build up that is promoting corrosion on the bearings.

PHOTO 1 Description Heavy Debris build up on the bent #2 cap.

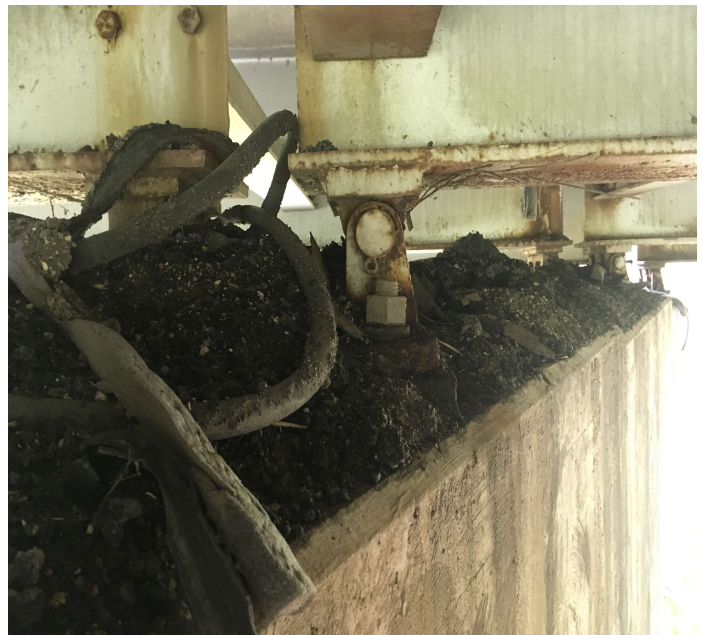
PHOTO 2 Description Heavy build up on the bent #5 cap.
