# Bridge Inspection Report

**A2771**  
**US 412 Carroll**  
**over**  
**OSAGE CREEK**

Structure Number: A2771

Facility Carried: US 412 Carroll

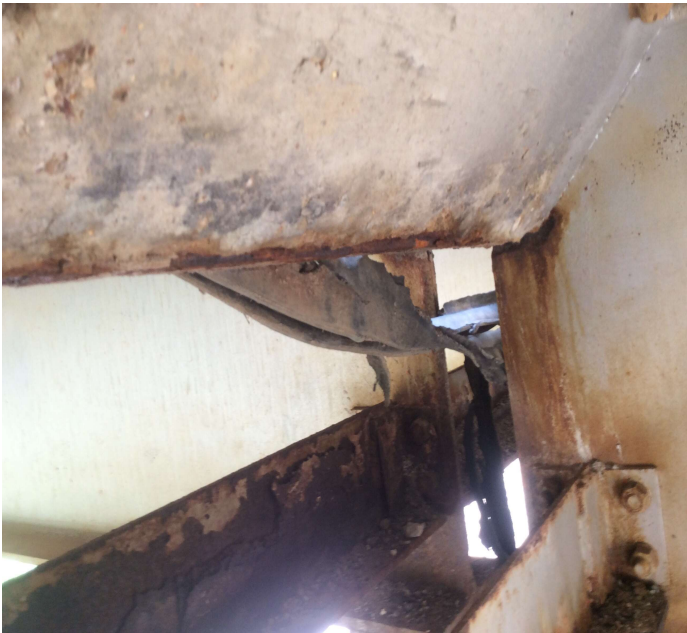
All deck joints are torn or dislodged with large sections missing, allowing water and debris onto pier caps.

PHOTO 1      Description      Dislodged joint seal typical of all locations.

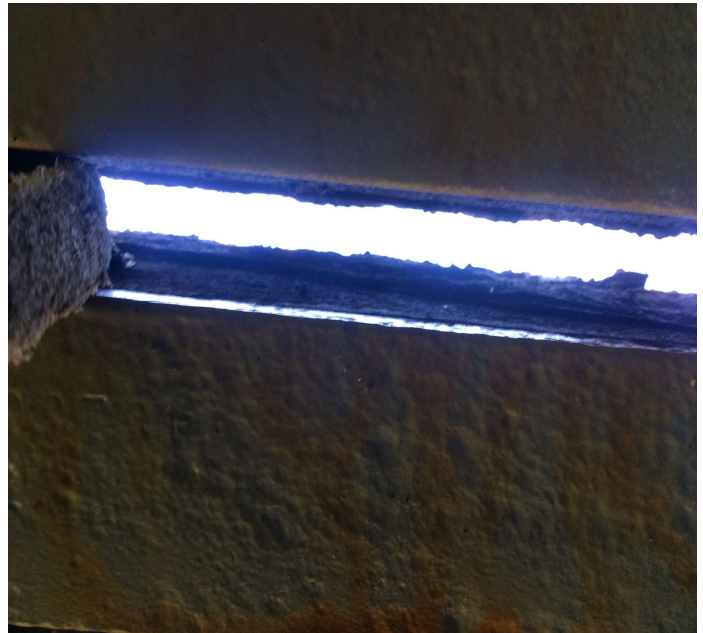
PHOTO 2      Description      18" of cs4 joint seal leakage in bay 3 over pier #5.

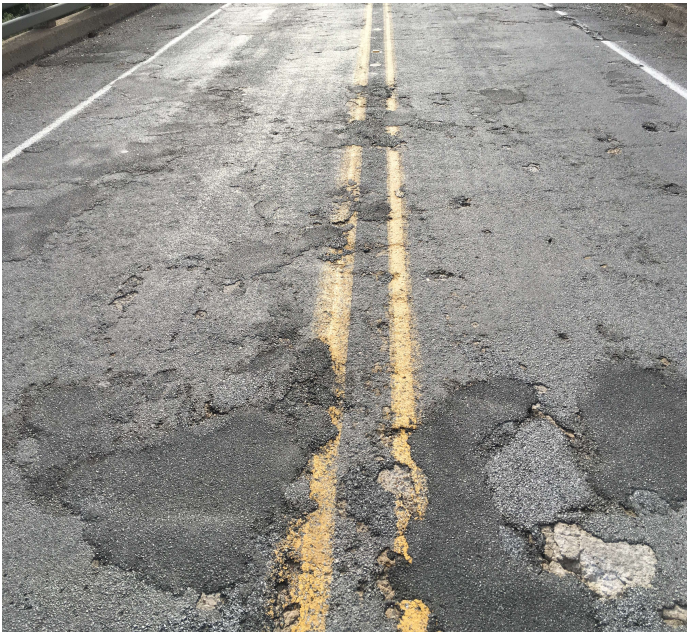
PHOTO 1 Description

All deck spans have deep delaminations with areas of pot holes in the driving surface.  
The undersurface of the deck has areas of full depth contamination.

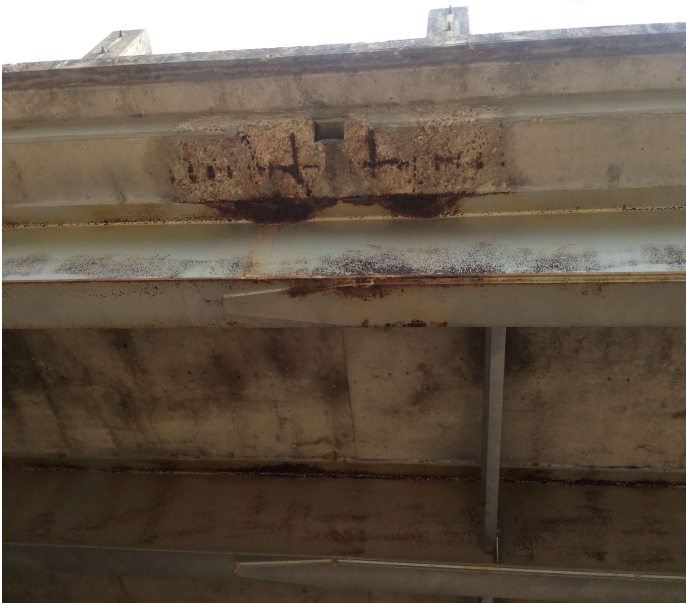
Numerous deck drain areas along the left and right side overhangs have spalling with rebar exposed

PHOTO 1      Description      Typical drain spalled area

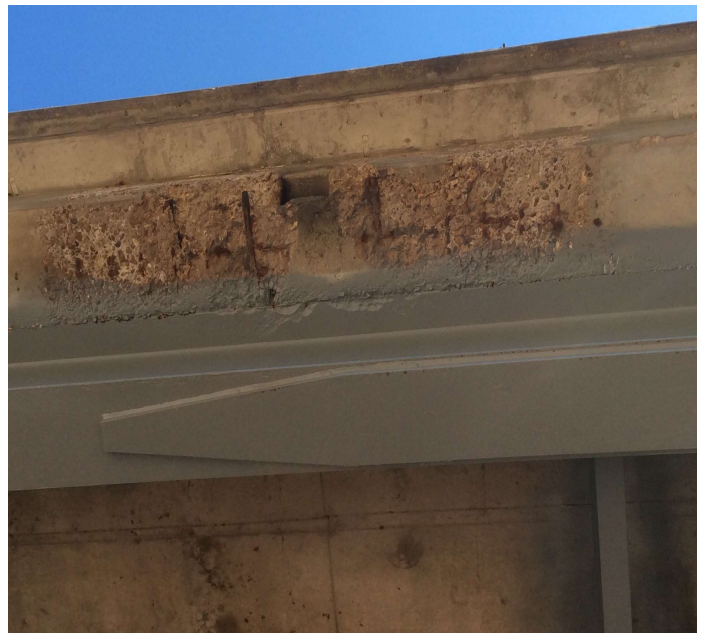
PHOTO 2      Description      Typical of several locations along the left and right side of structure.
