Asset #M0547(Routine, Underwater type 2)

Madison Co. SH 23 over CREEK

Location: 0.53 MI NO OF FRANKLIN CO

Team Lead: Nathan Rowland Inspection Date: 11/02/2023

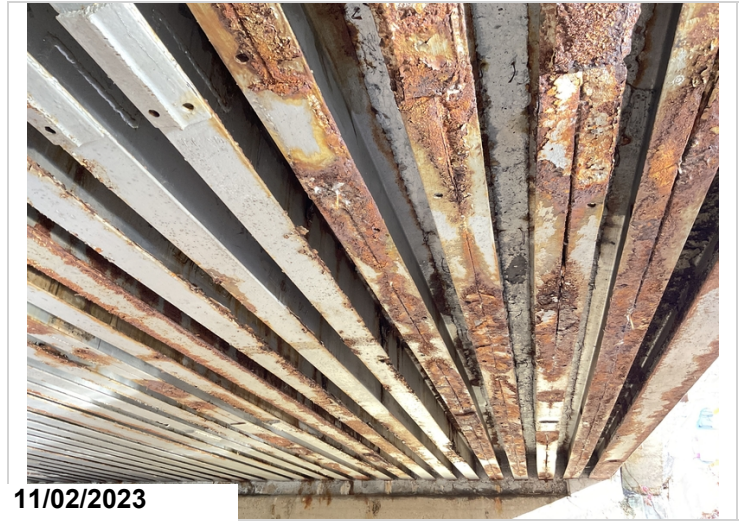
Flaking rust and section loss to girders on east side of bridge

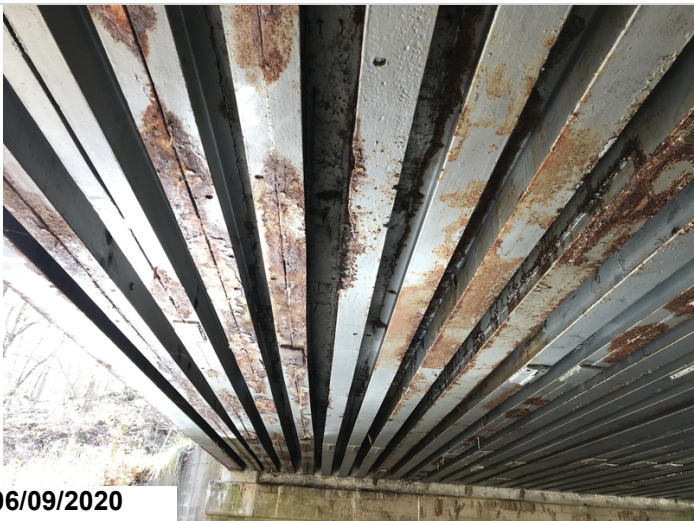
View of active corrosion to girders typical for right side of structure

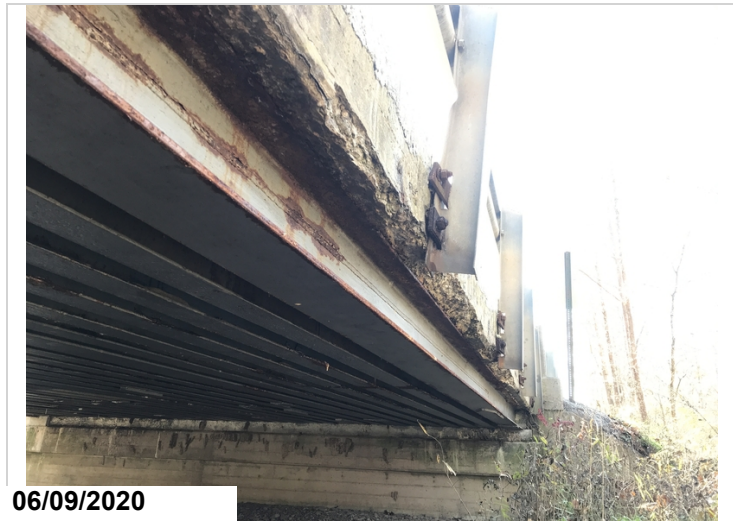
Left side of deck in overhang area spalling that exposes the top flange of girder.

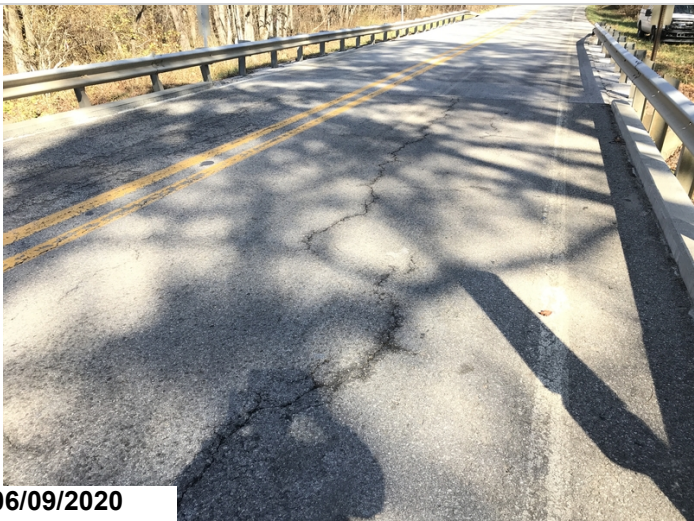
Cracking in the north bound lanes wearing surface

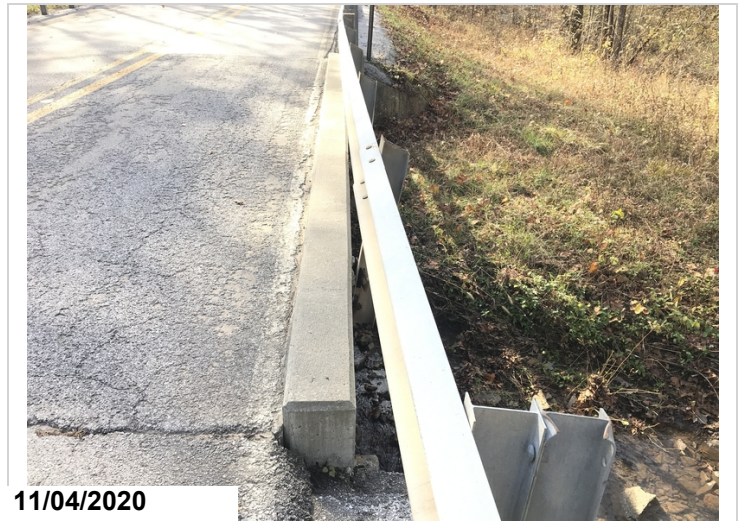
Railing left adjacent abutment #2 minor collision damage.

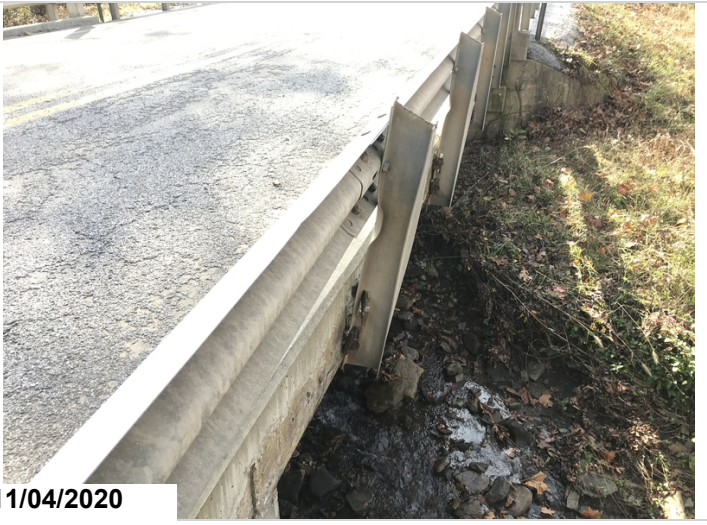
Railing left adjacent abutment #2 minor collision damage.

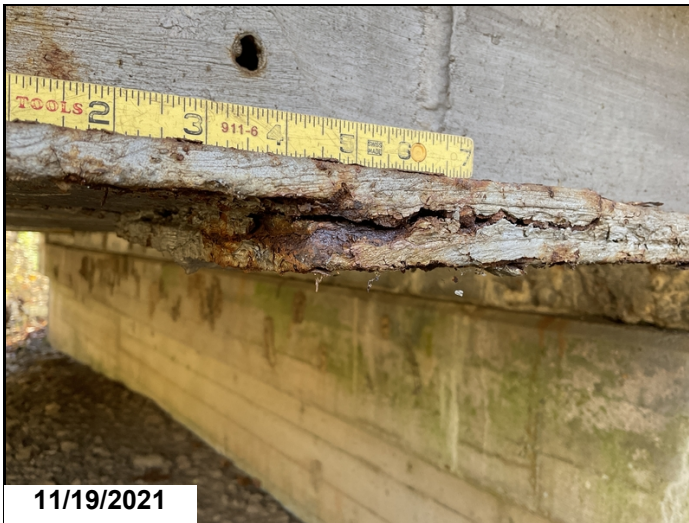
Pack rust is separating the bottom flange splice plate welds on beam #1 near abutment #1.

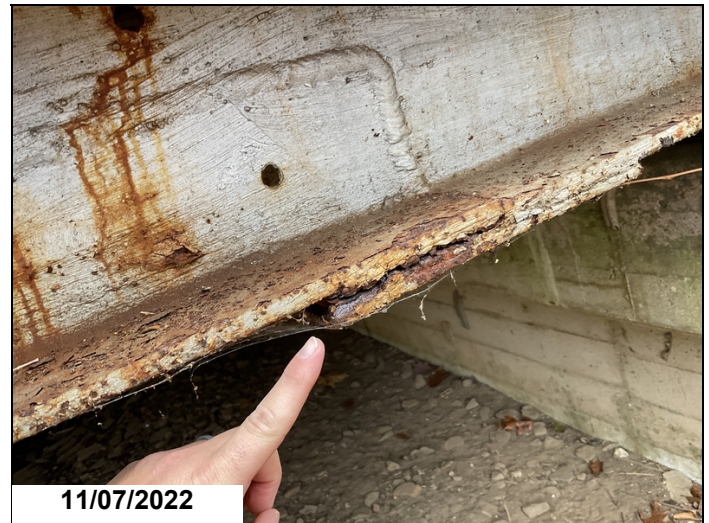
Girder #1 adjacent abutment #1 splice cover plate has separated from bottom flange on the t-splice side. Welds have deteriorated causing packrust.

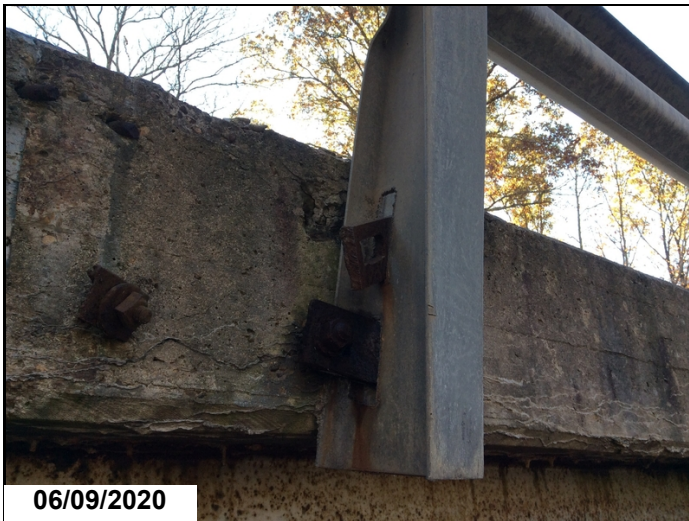
Bridge railing - The bridge railing on the left side at end has loose anchorage.

Bent 2 left - bridge rail anchorage is loose.

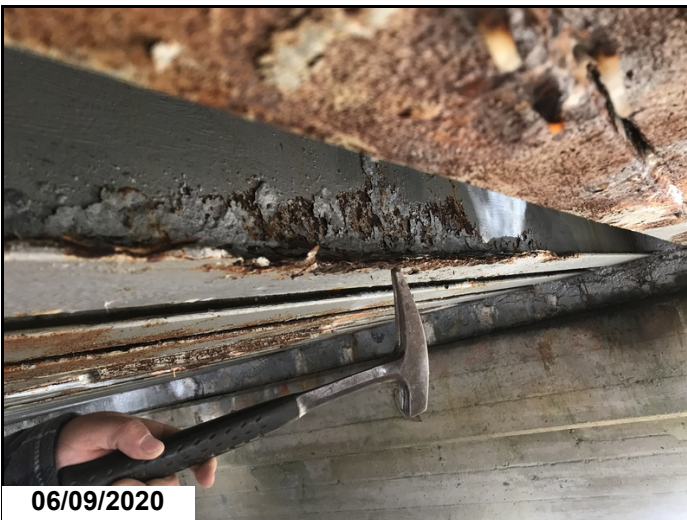
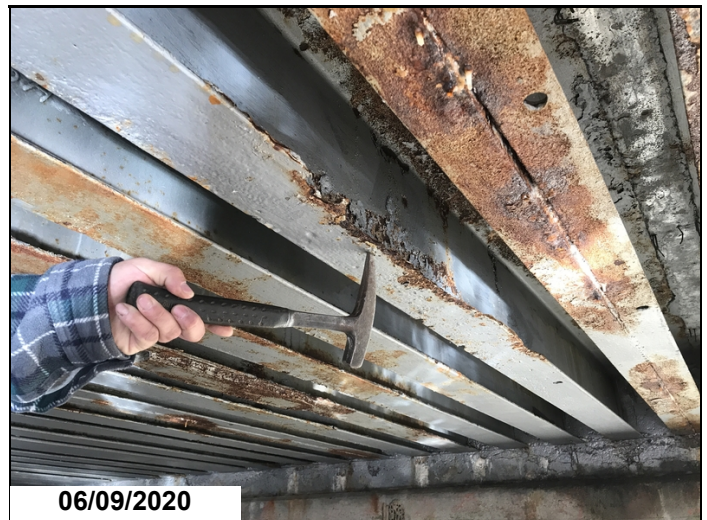
Superstructure - Girder #28 has significant section loss to the bottom flange in several locations. The most notable is an area of section loss that has reduced the width of the bottom flange up to 1" in an area approximately 2' long located approximately 6' from abutment #2. Beams #2,3,4,5 and 26,27 also have section loss down to knife edge on the bottom flange in some locations. The superstructure has a failing paint system with moderate pitting to the bottom flanges in several locations.

Girder #28 has section loss that has reduced the width of bottom flange up to 1" in an area approximately 2' long and in a few other random locations.

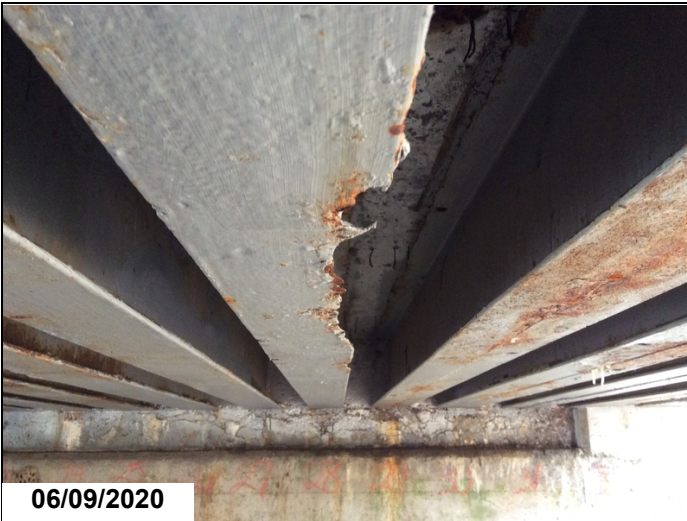
Girder #28-Section loss to bottom flange.

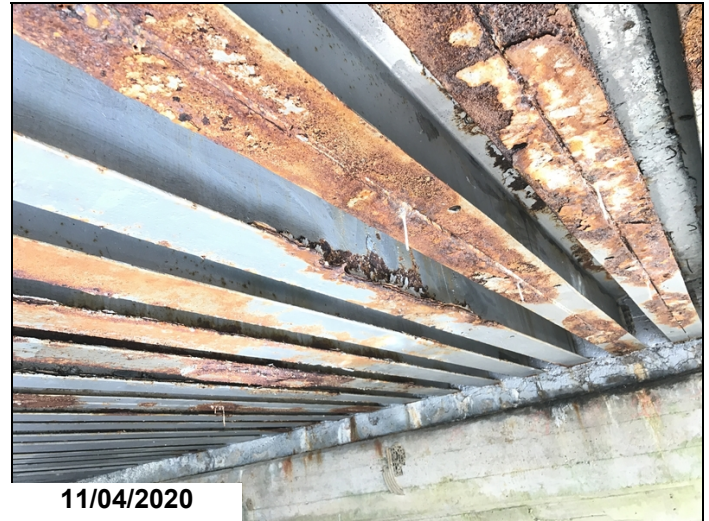
Girder #28 has significant section loss to the bottom flange

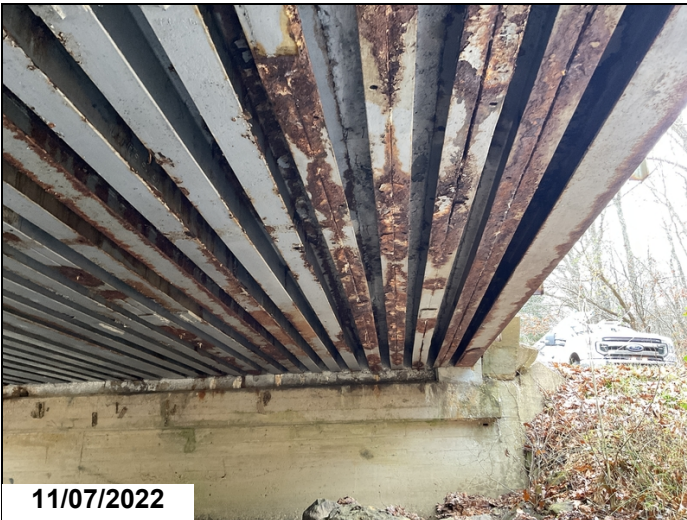
View of girders with flaking rust
