Route:59 Section:01 Log:8.67

Bridge #01100(Routine)
SH 59 Benton 2 over SPAVINAW CREEK
Location: 1.90 MI S JCT OF SH 72

Team Lead: Nathan Rowland Inspection Date: March 02, 2020

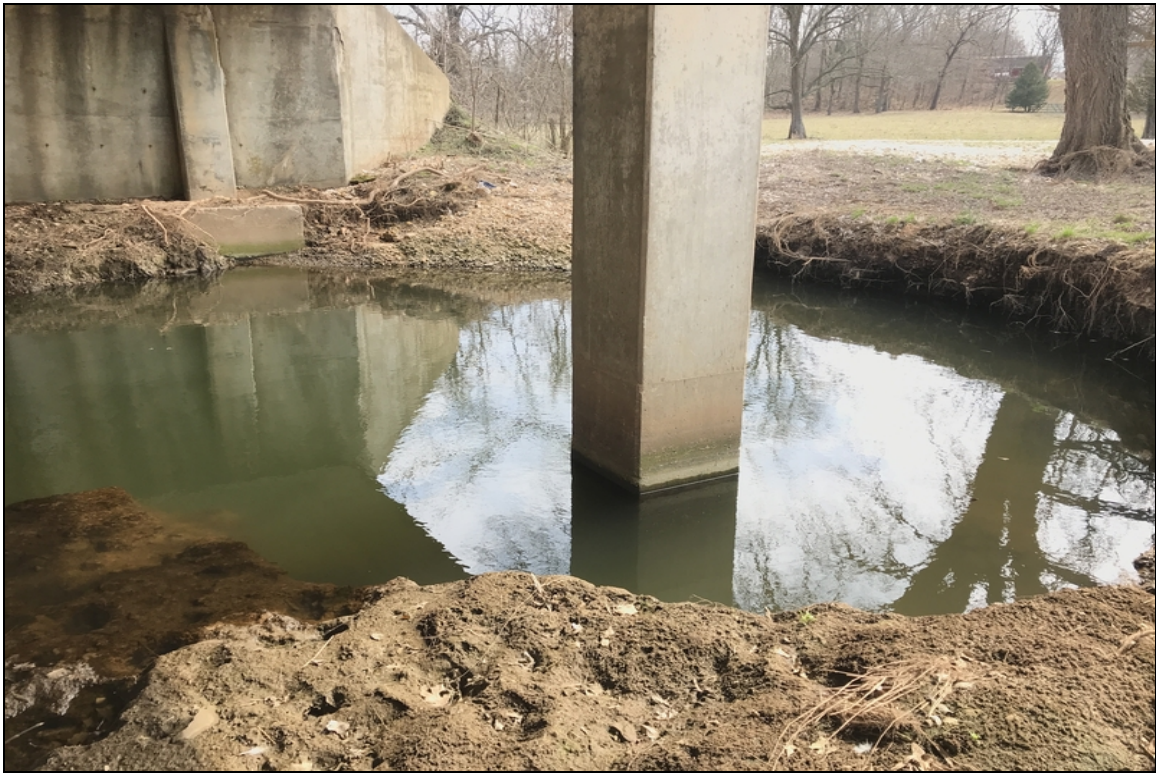
Channel at bent #10 right has a localized scour since last inspection due to high water event.

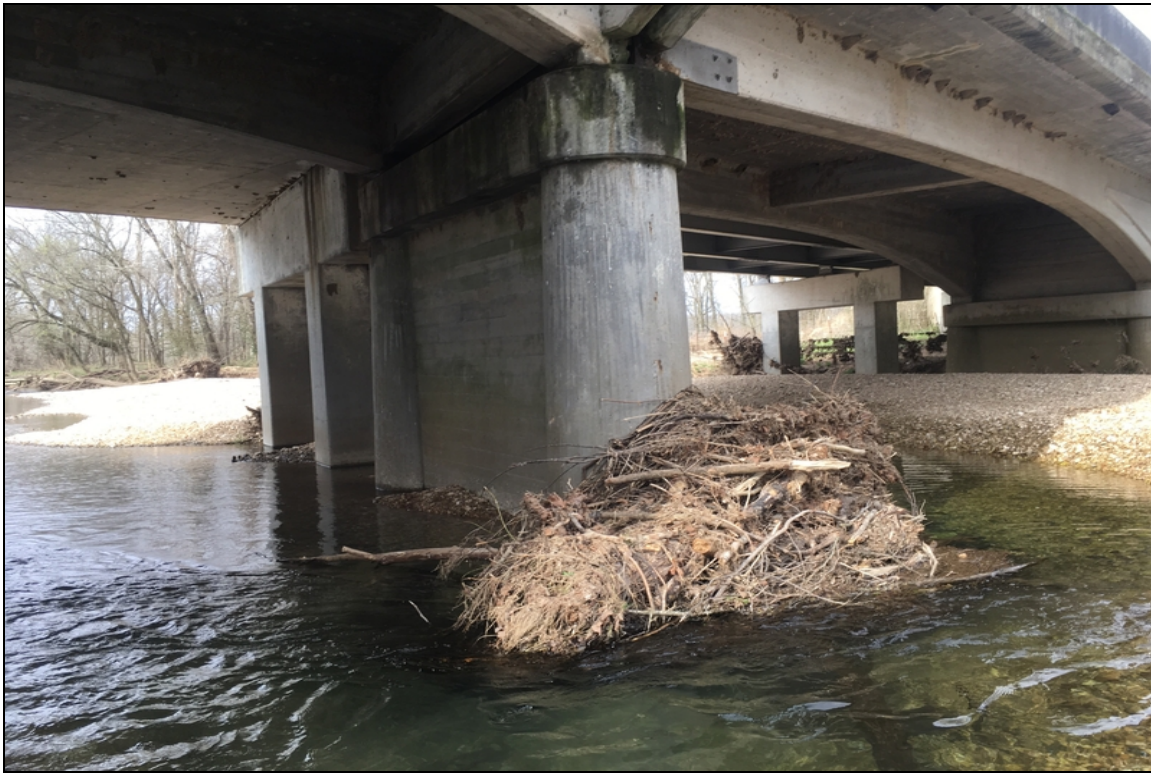
Pier 2 has drift accumulation

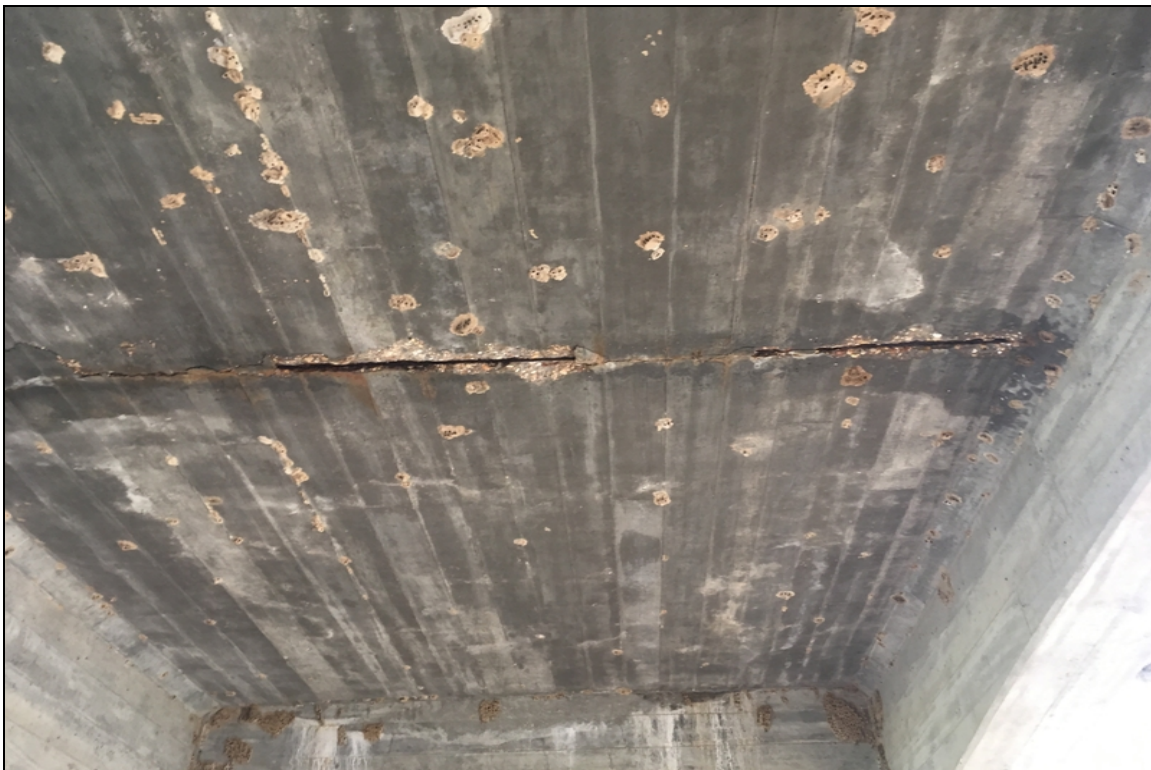
Spalling with exposed reinforcing steel in span 9

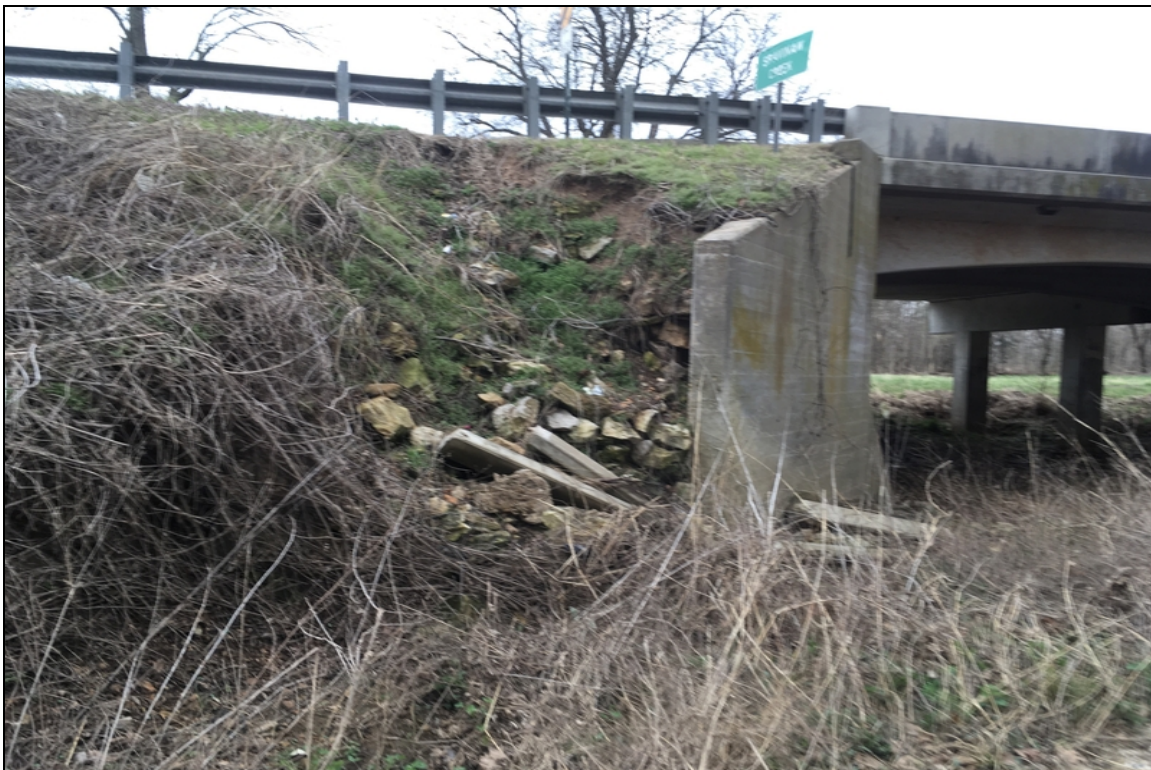
Erosion behind left wing wall at Abutment 2

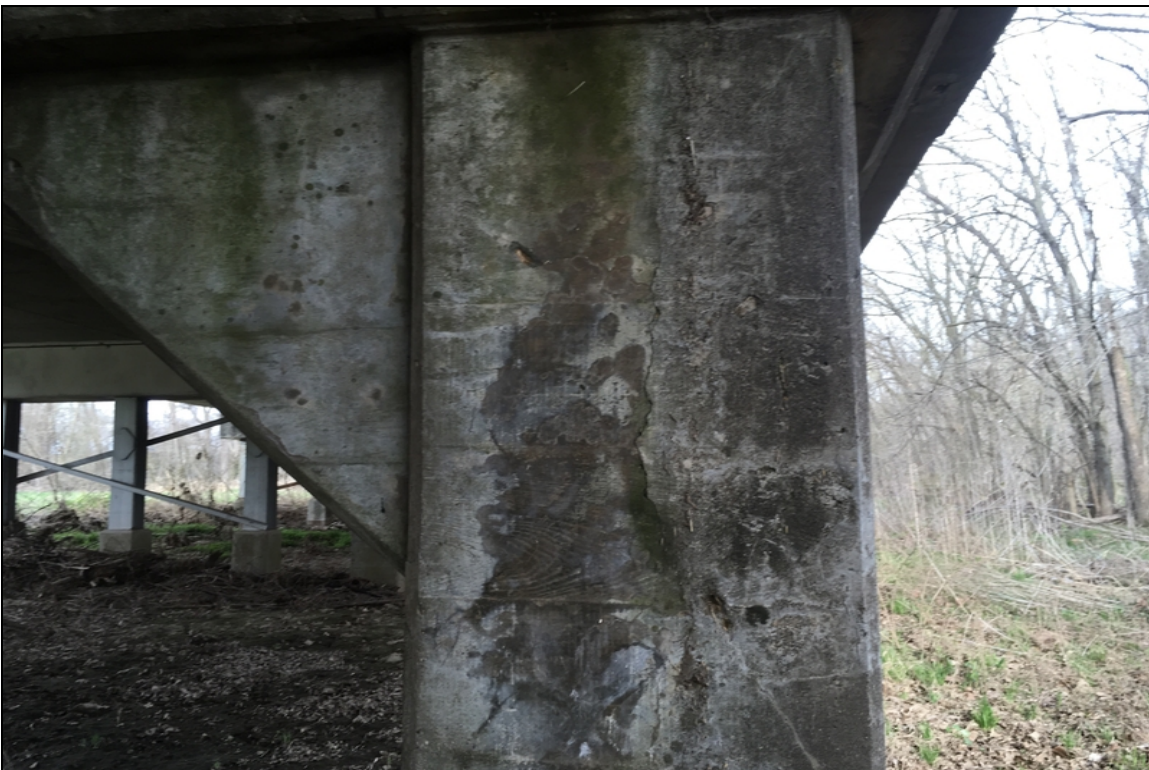
Typical cracking in the columns

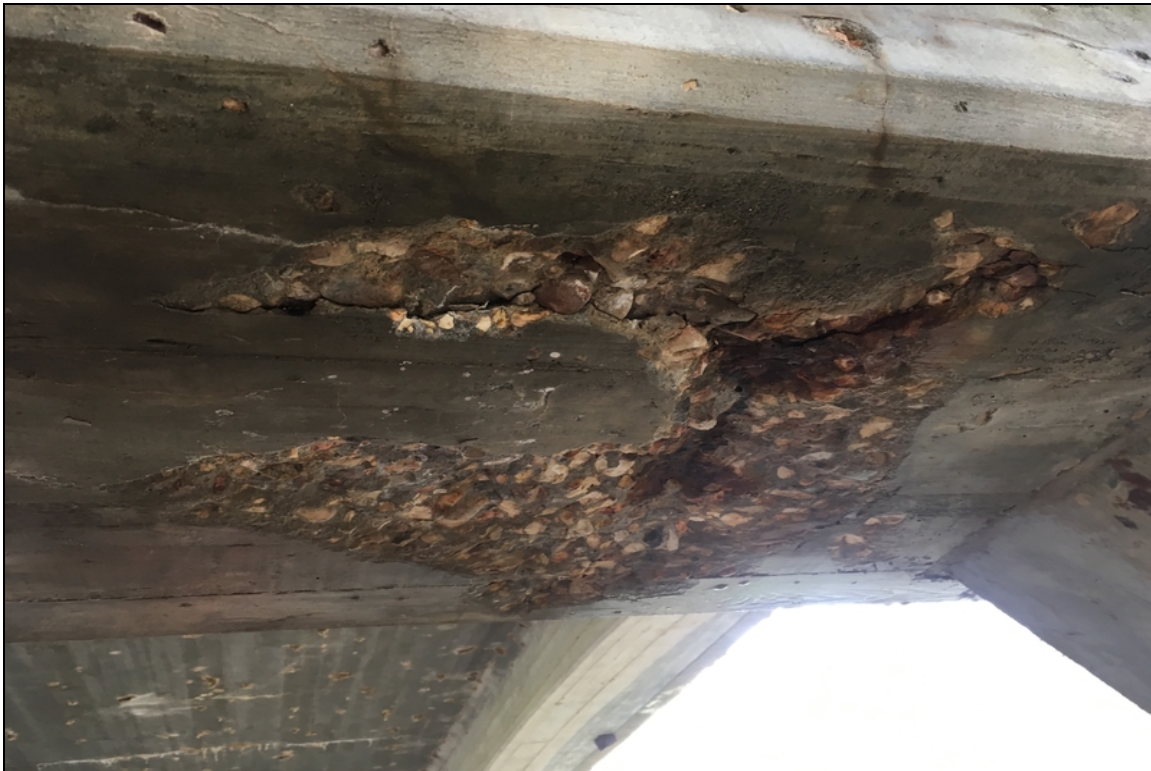
Bent 7 has exposed reinforcing steel on the under surface of cap

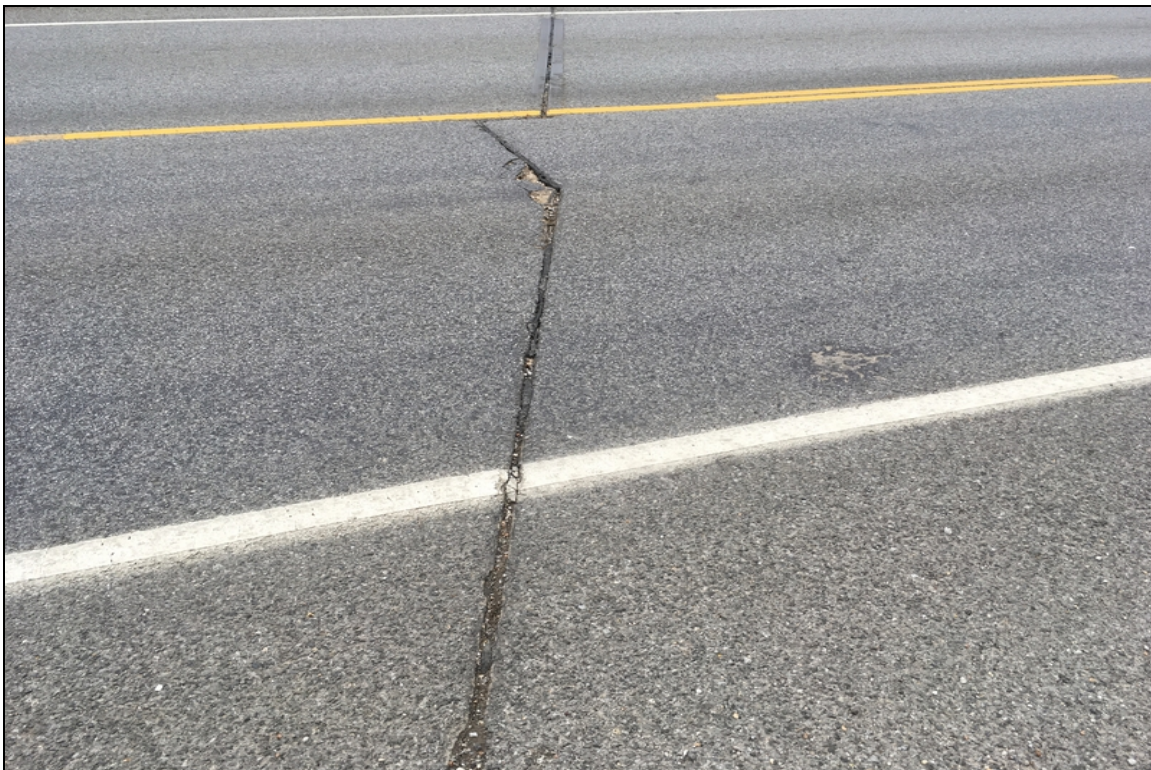
Adhesion failure

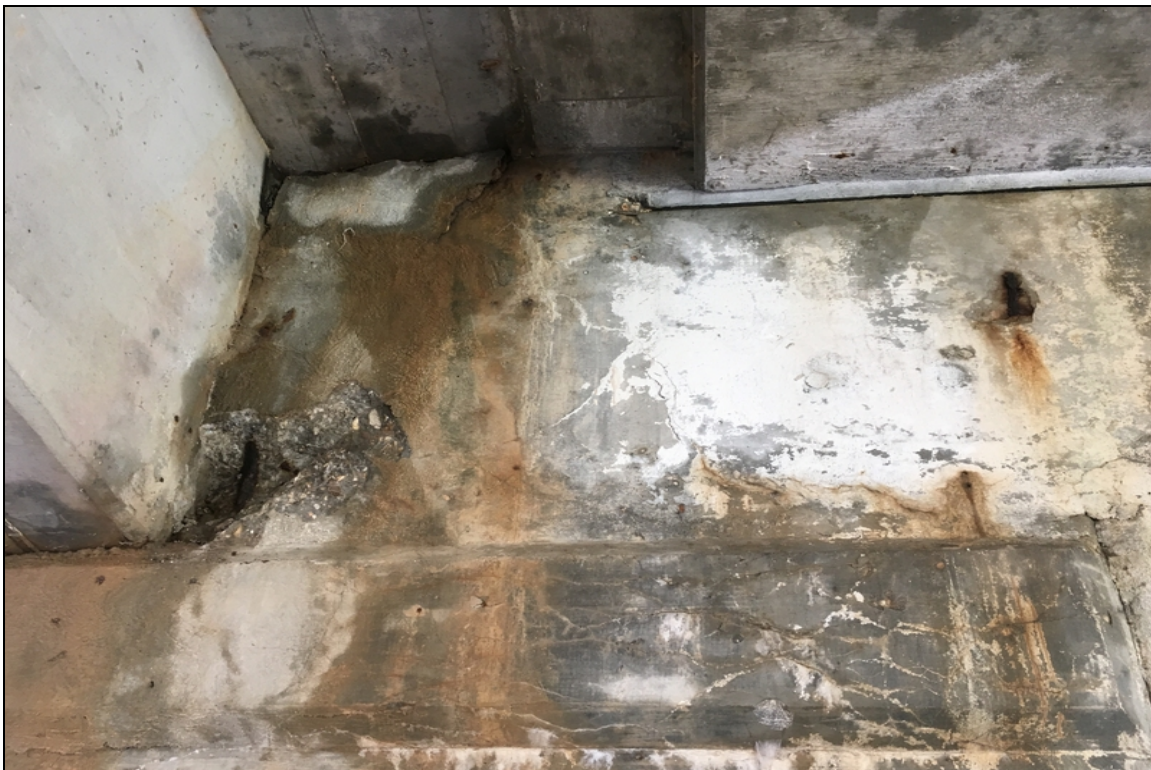
Centerline of abutment 2 breastwall has spalling with exposed reinforcing steel with initial section loss.

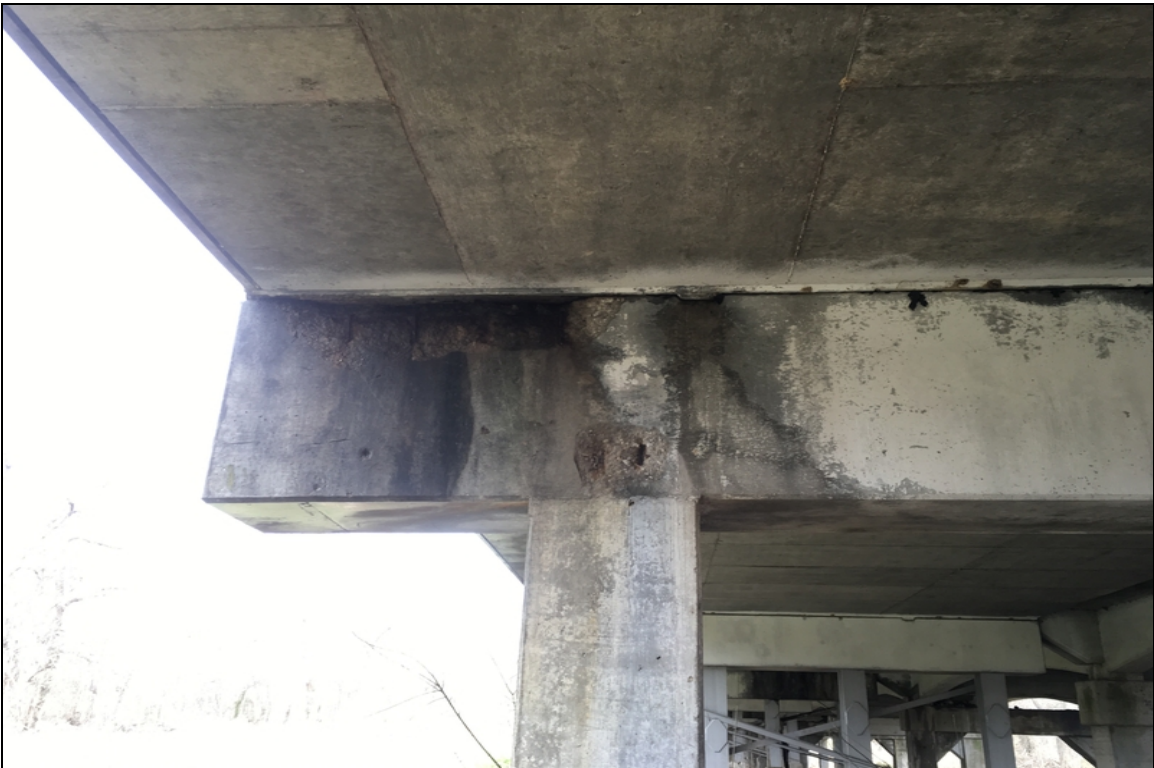
Bent 9 has spalling with exposed reinforcing steel

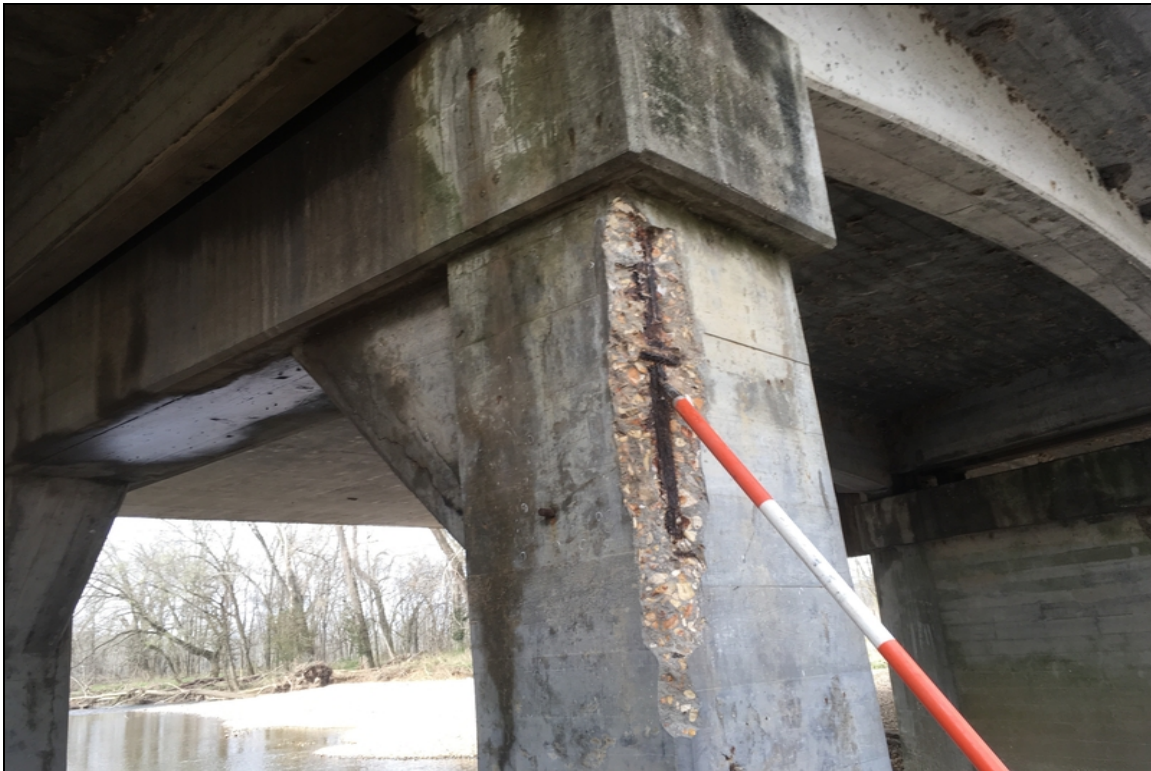
Bent 3 Column 1 has Spalling with exposed reinforcing steel

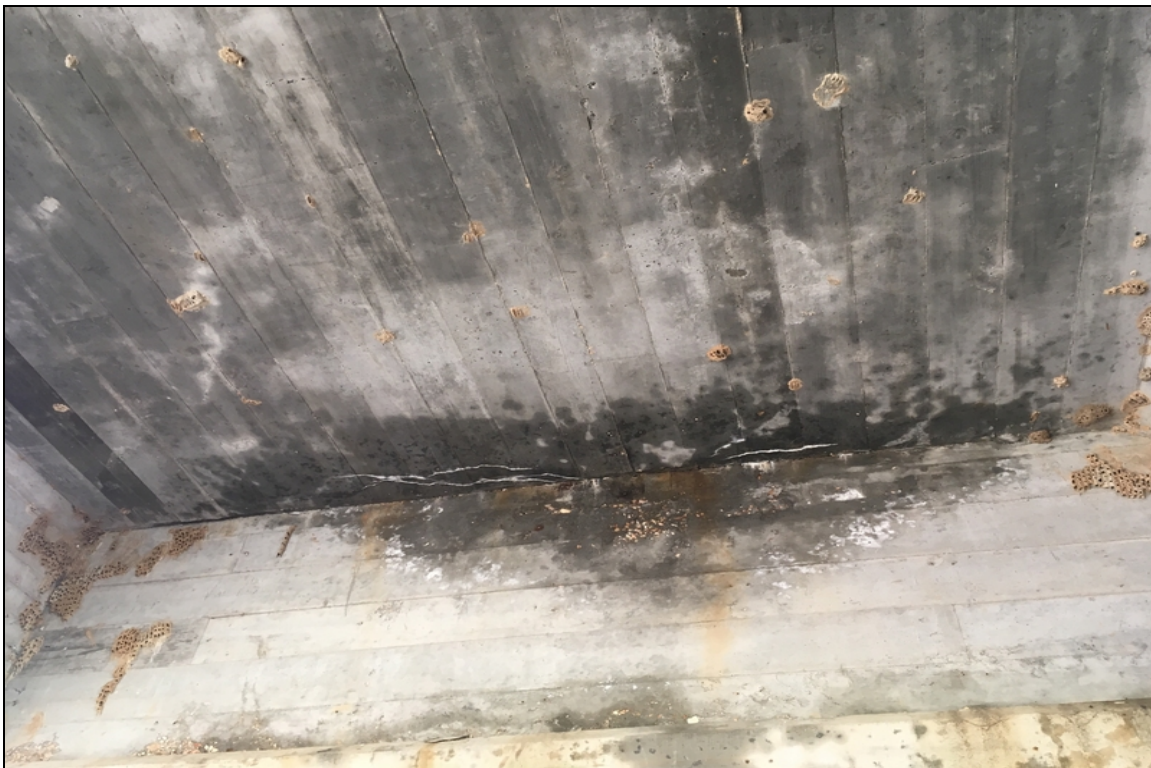
Span 10 has cracking with efflorescence

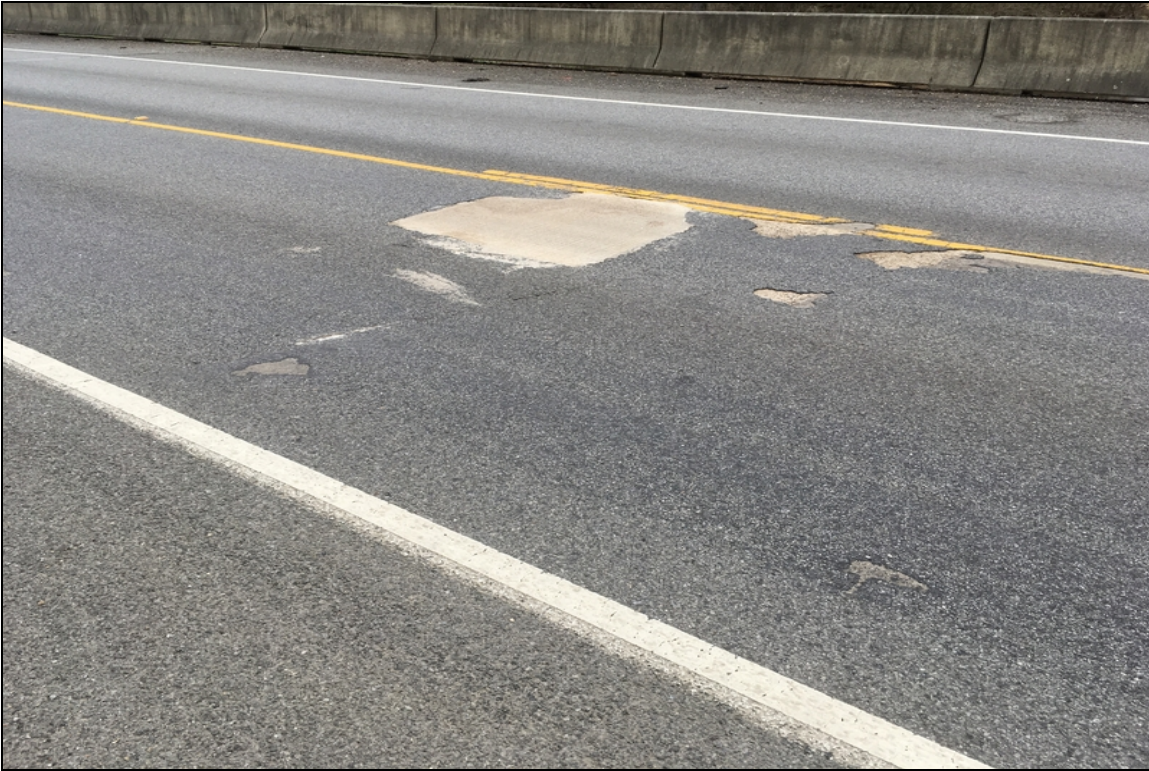
Span 1 patched areas

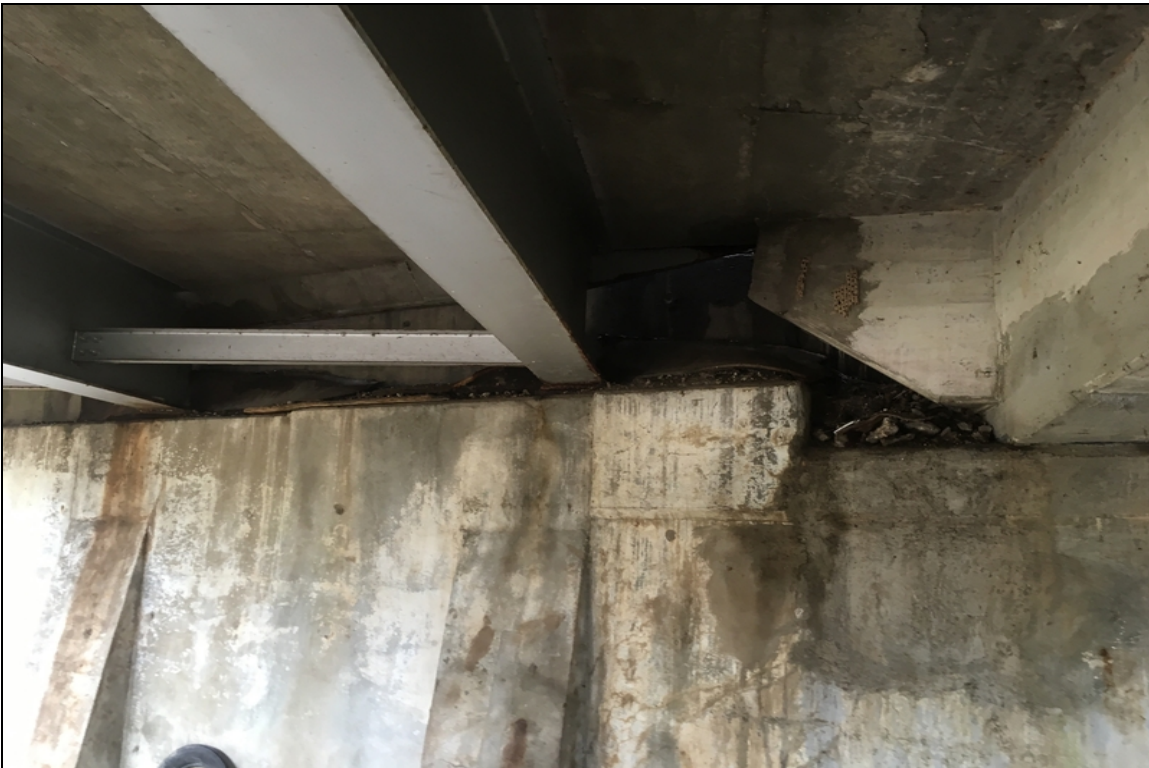
Debris accumulation on abutment 1

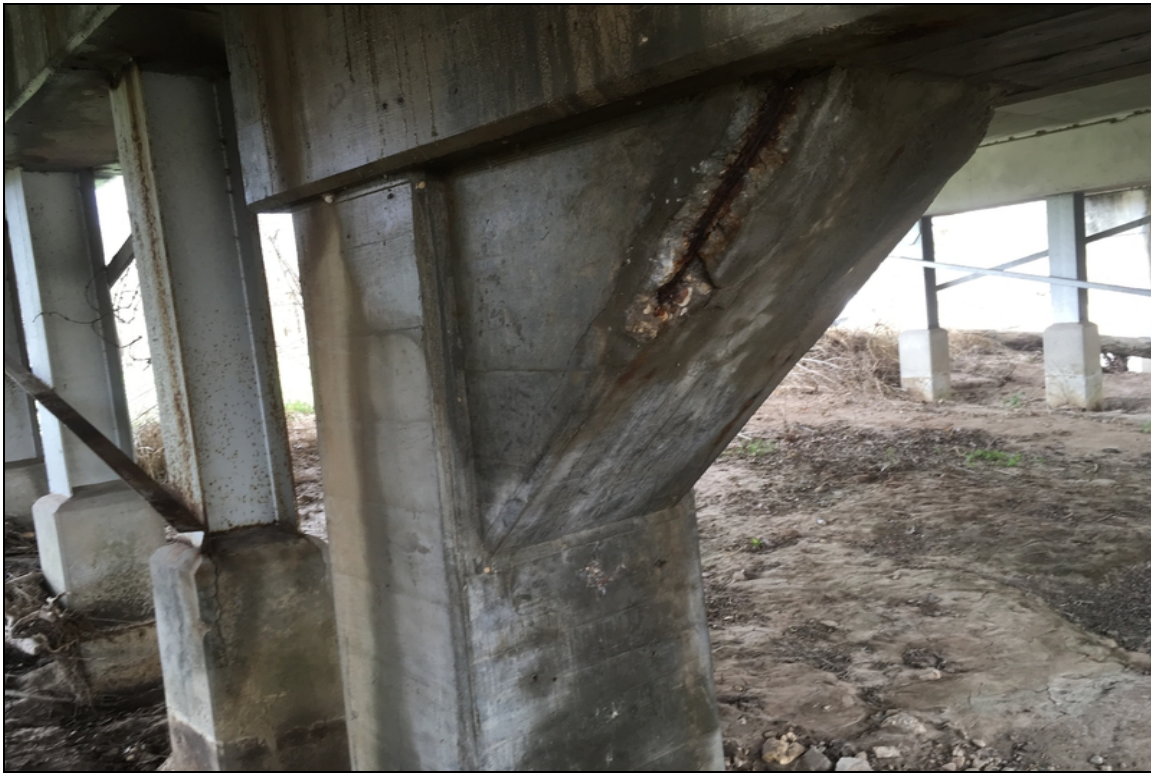
Haunches have exposed reinforcing steel

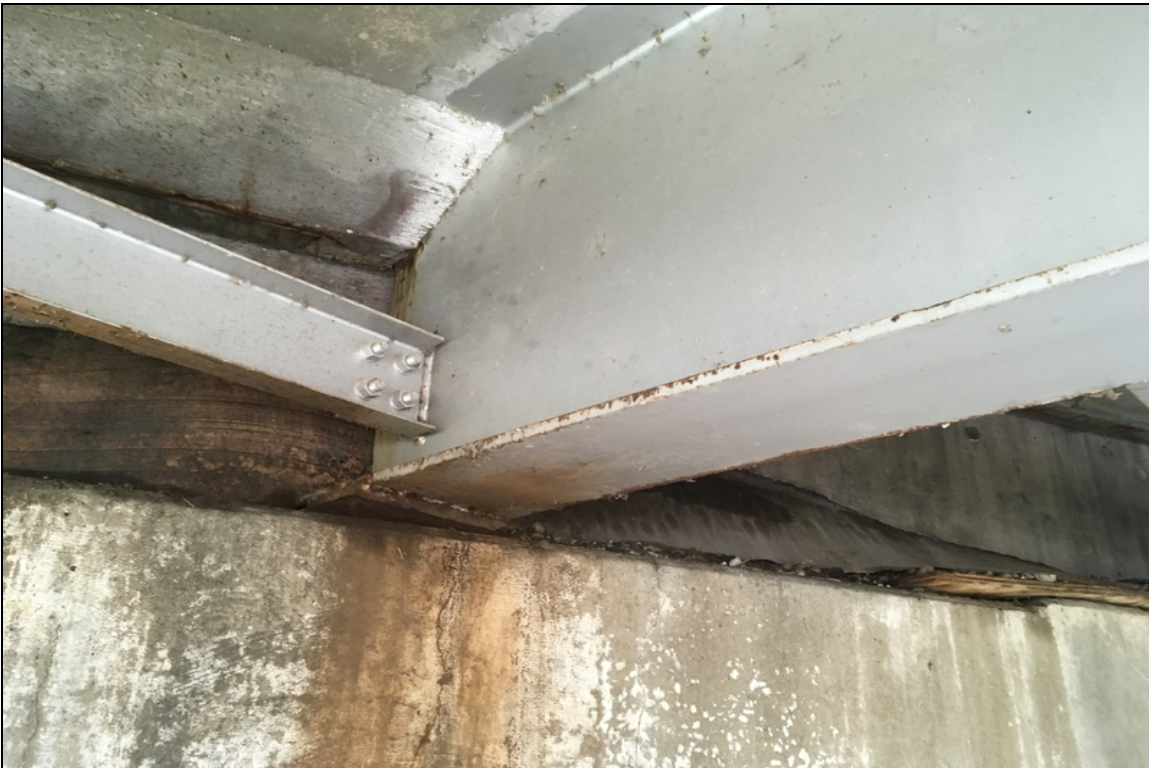
Beam ends have paint failure with active corrosion

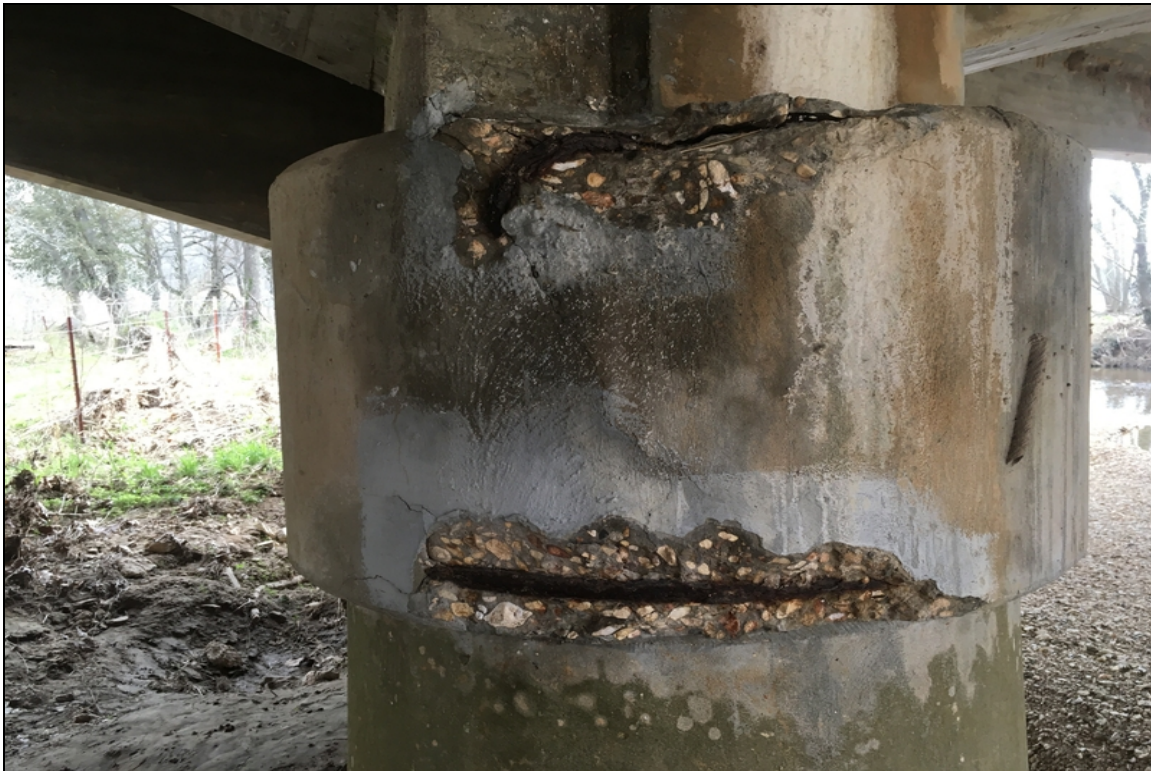
Bent 2 Column 2 has Spalling with exposed reinforcing steel

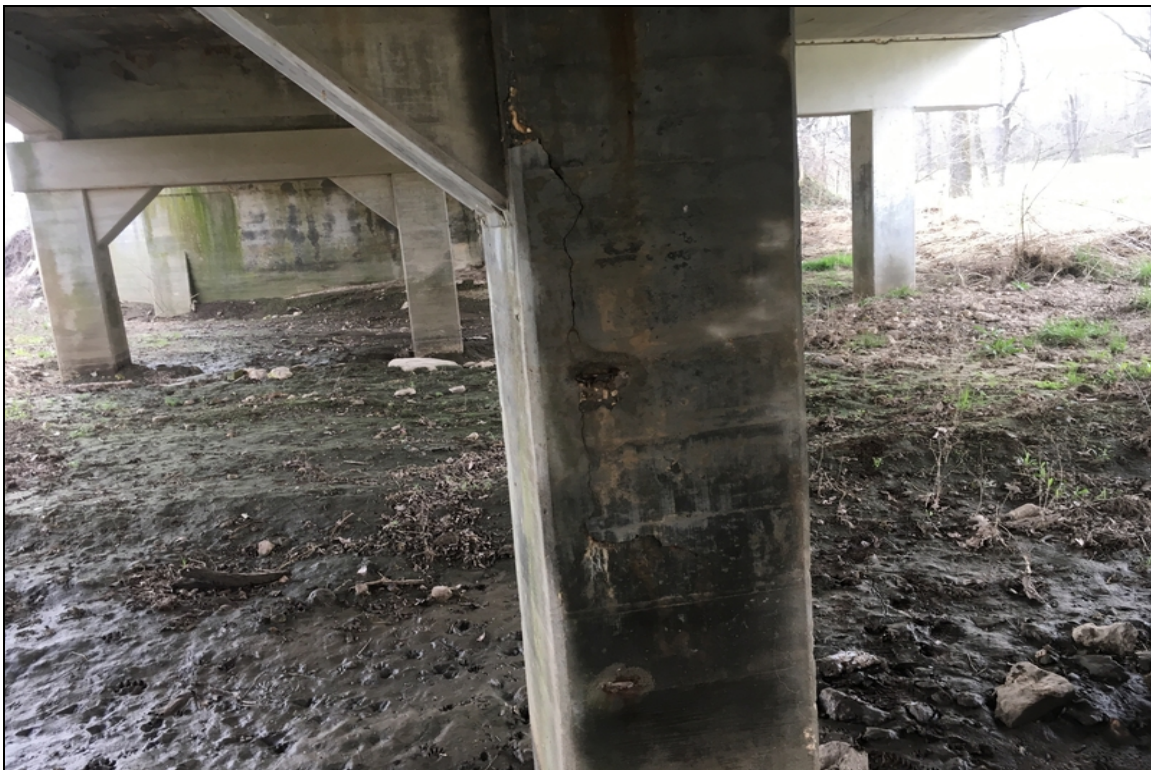
Bent 9 column 2 have spalling with exposed reinforcing steel.

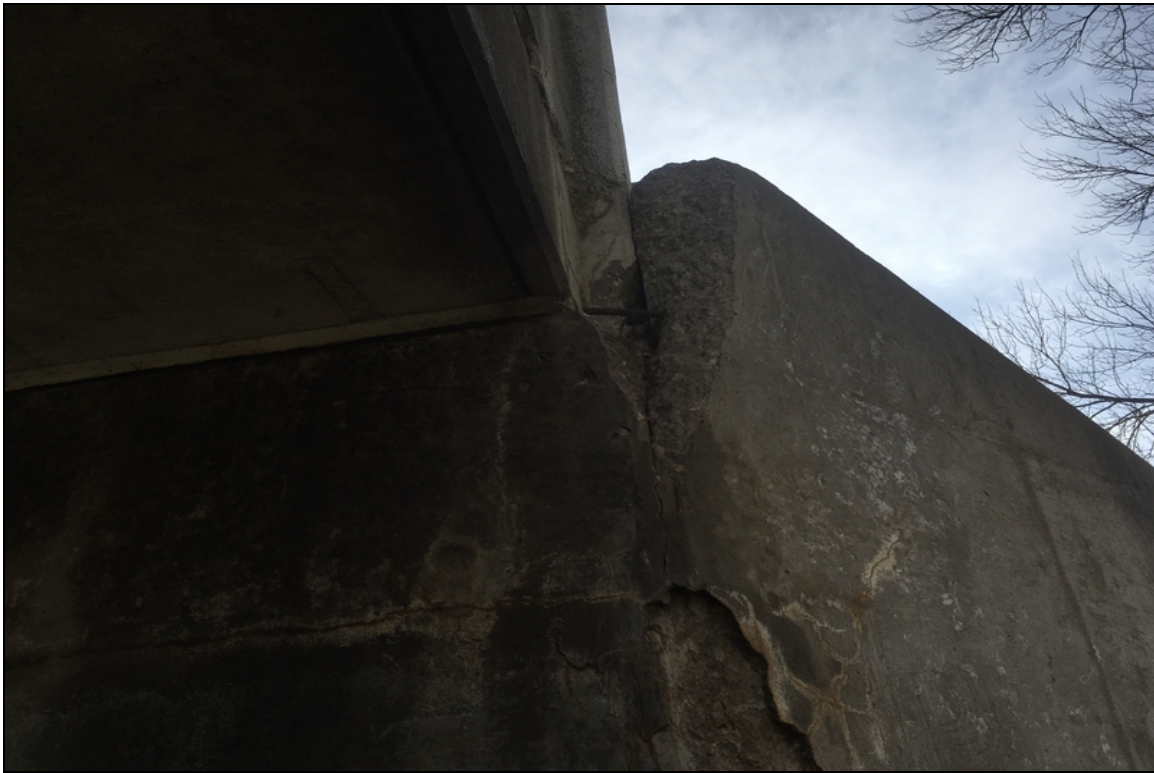
Abutment 2 right wingwall juncture has spalling that exposes the reinforcing steel with initial section loss.

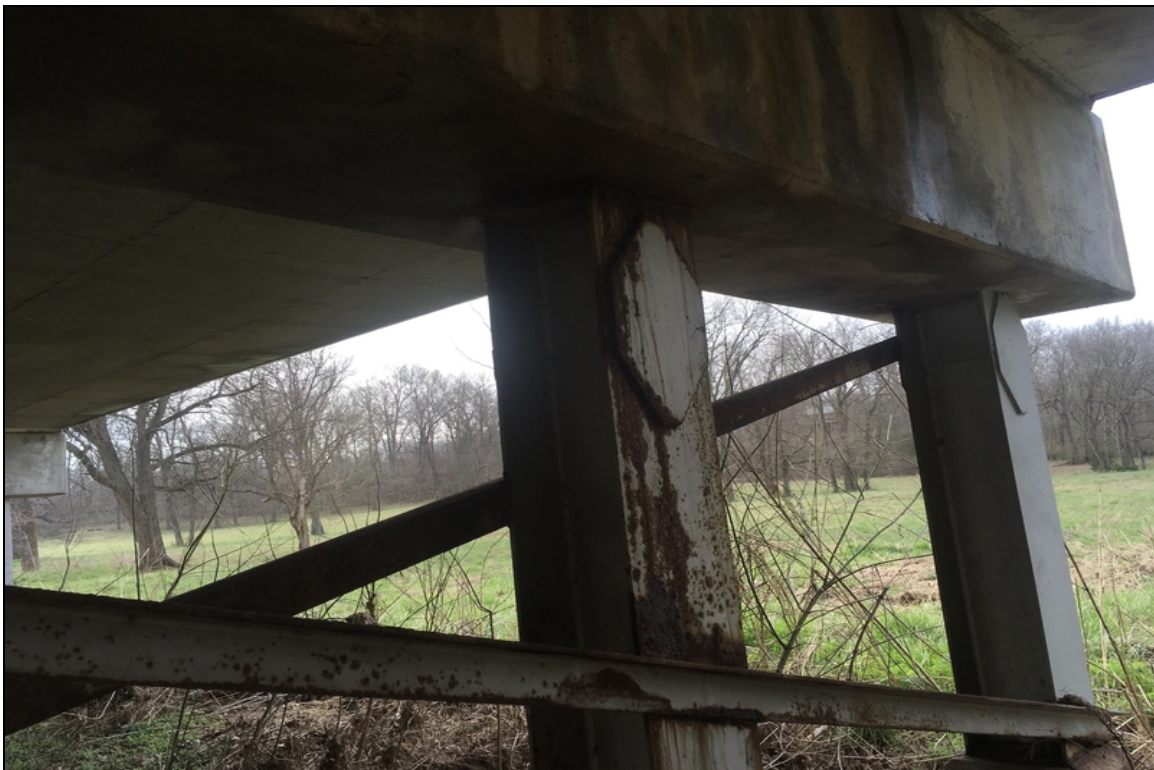
Steel piles have Active corrosion with Section loss

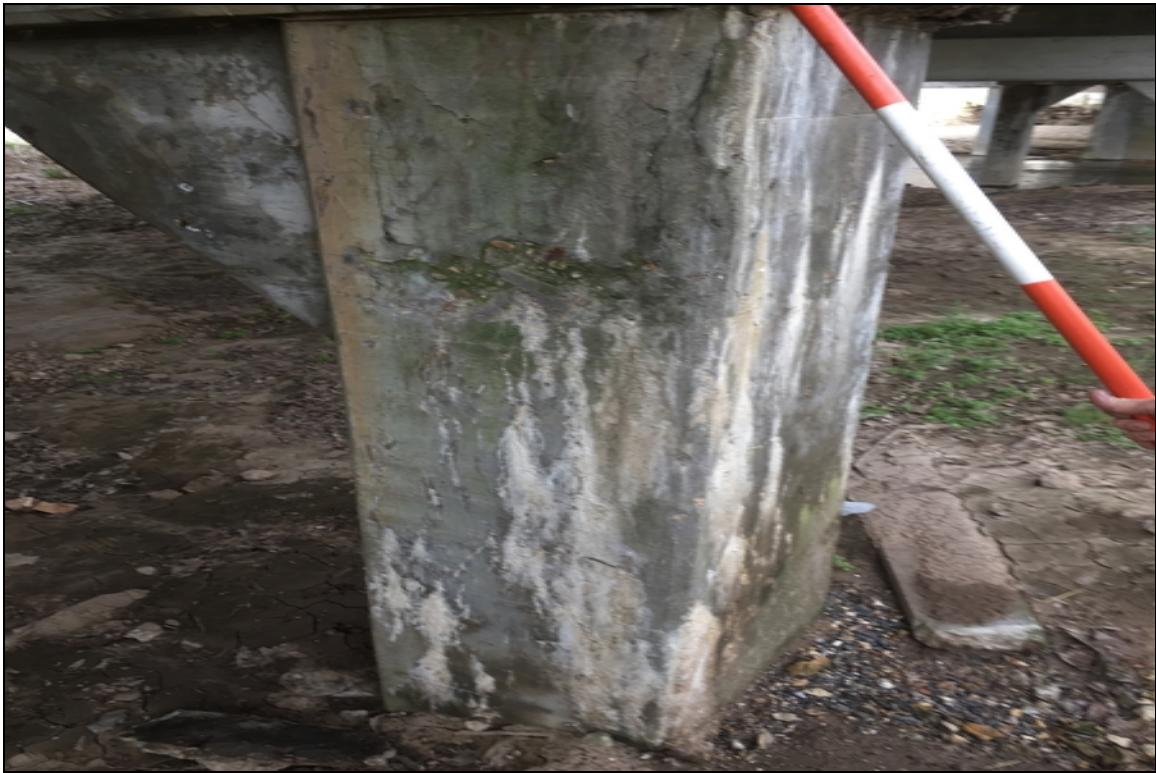
Bent 5 column 1 have cracking with efflorescence

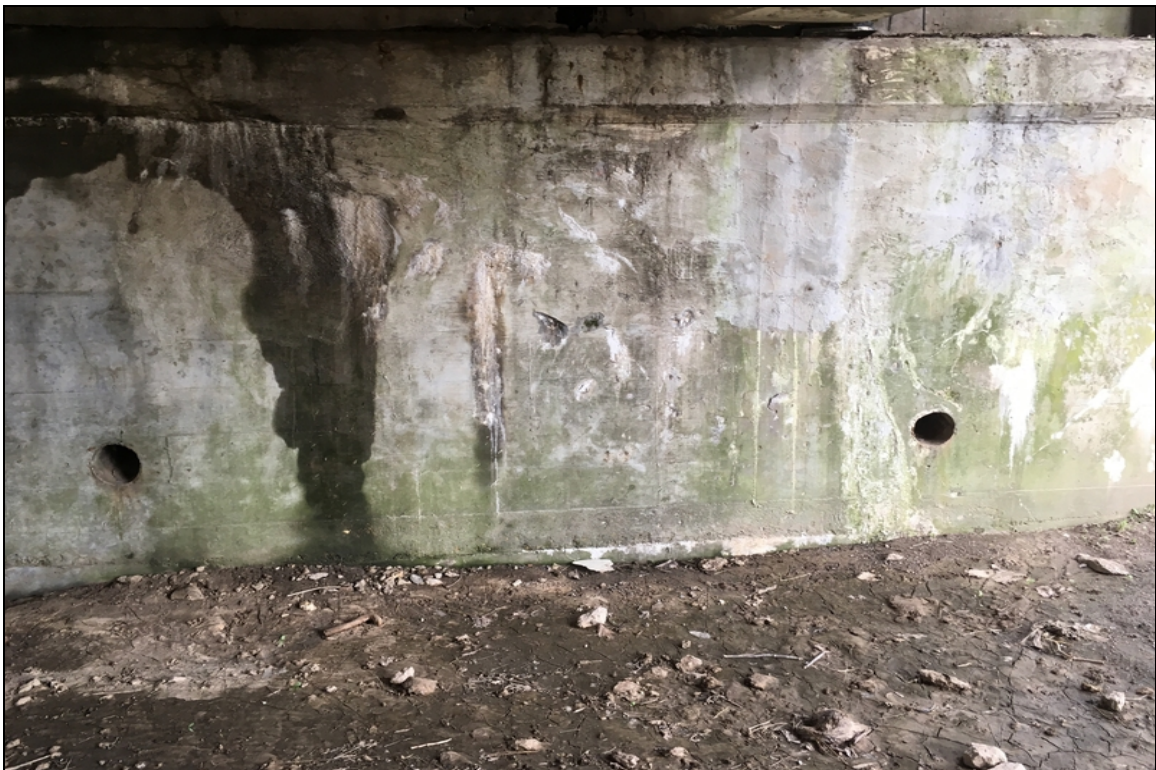
Abutment 1 has efflorescence build up

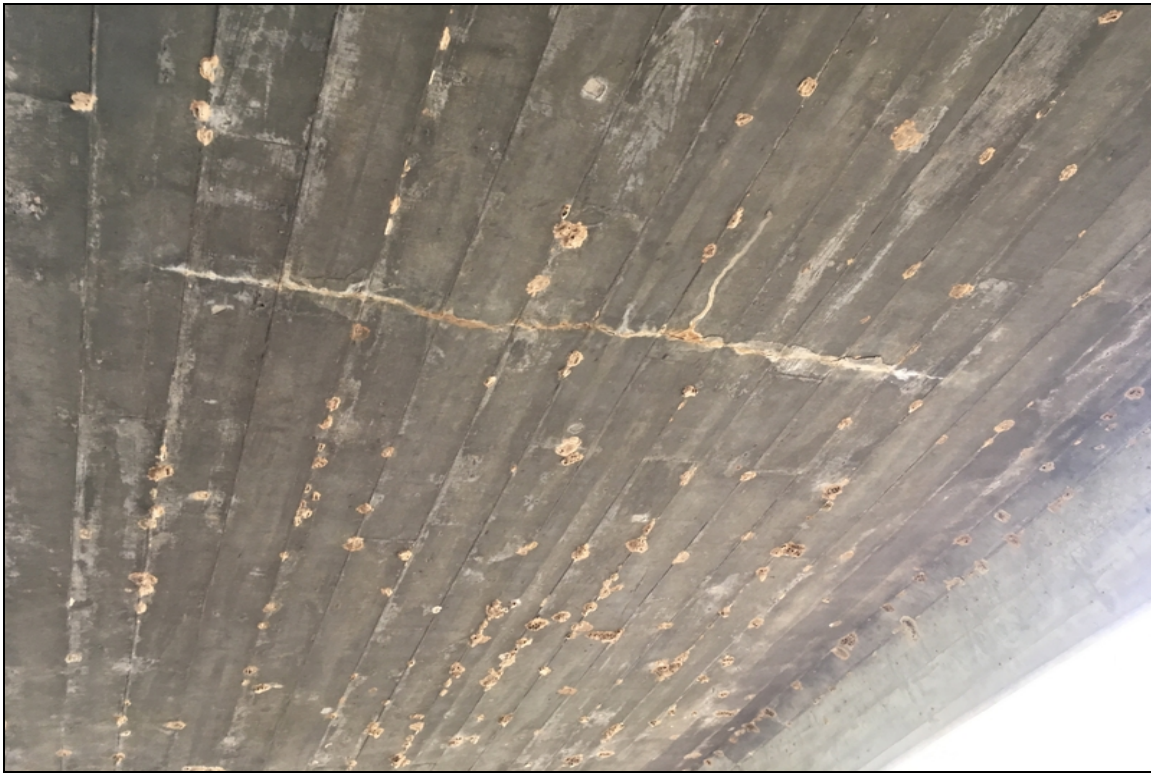
Span 7 has transverse cracking with efflorescence

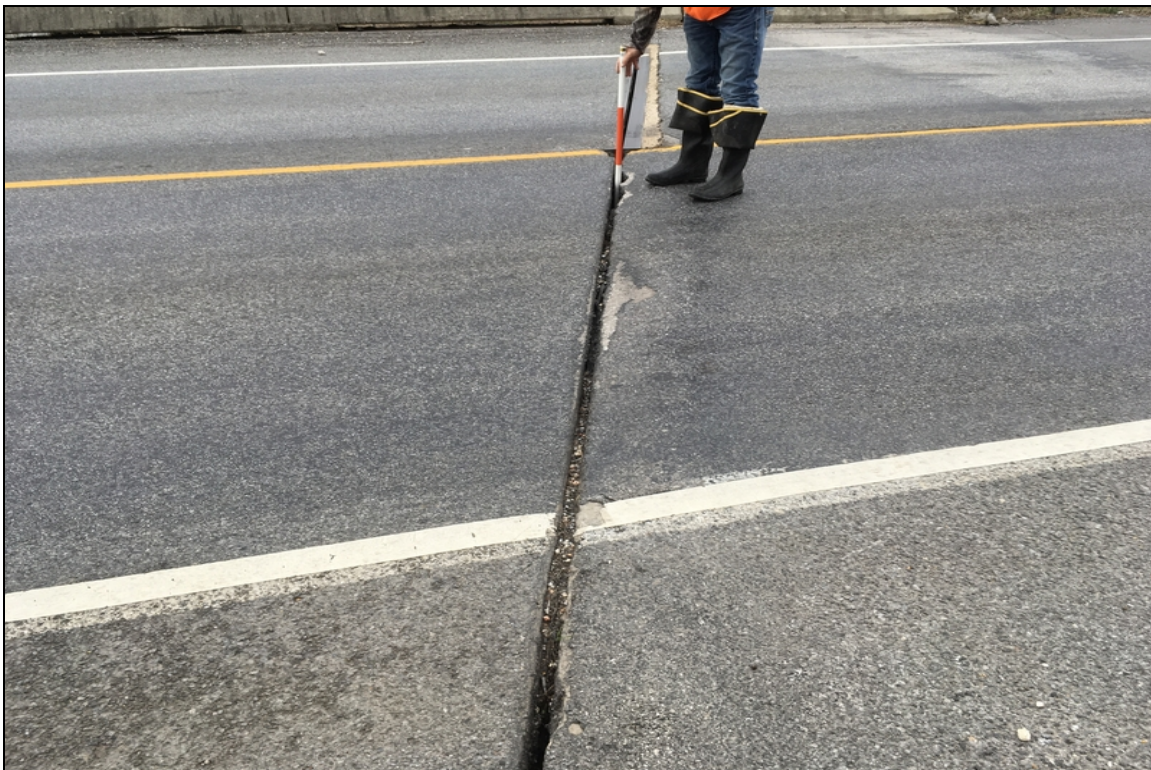
Abutment 1 pourable joint Seal is missing allowing dirt and debris on top of bridge seat

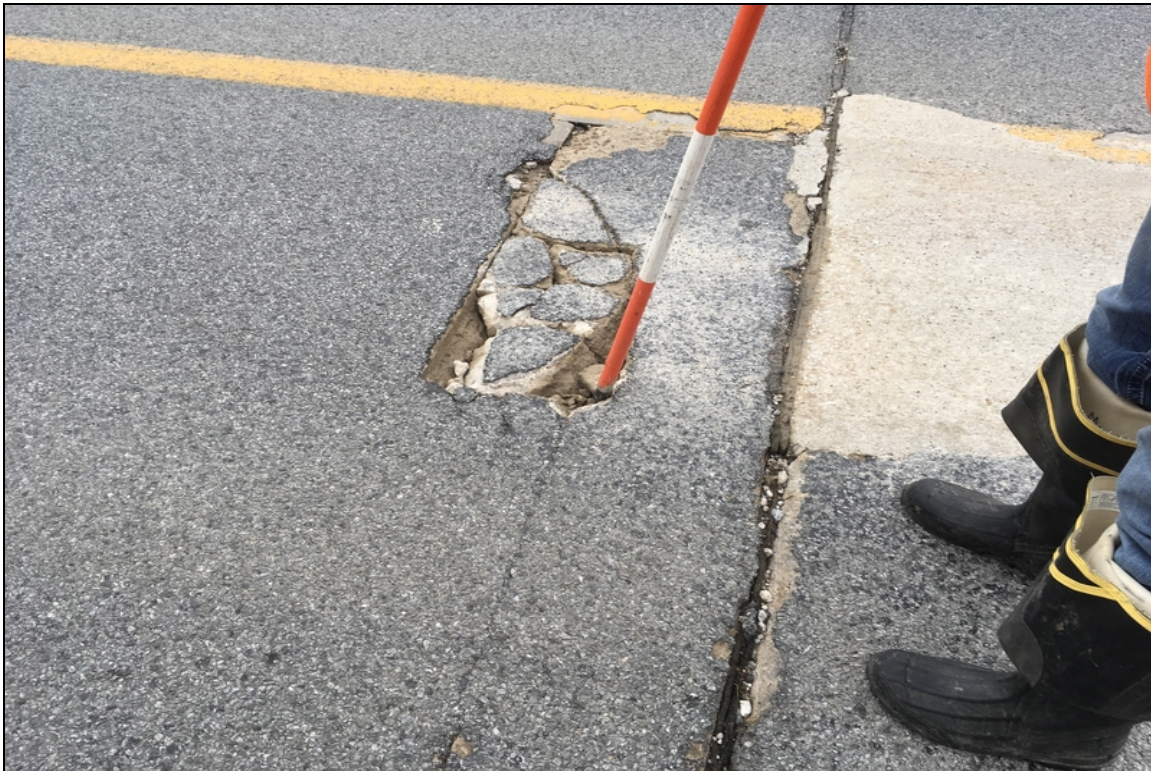
Failed patched area in the approach spans

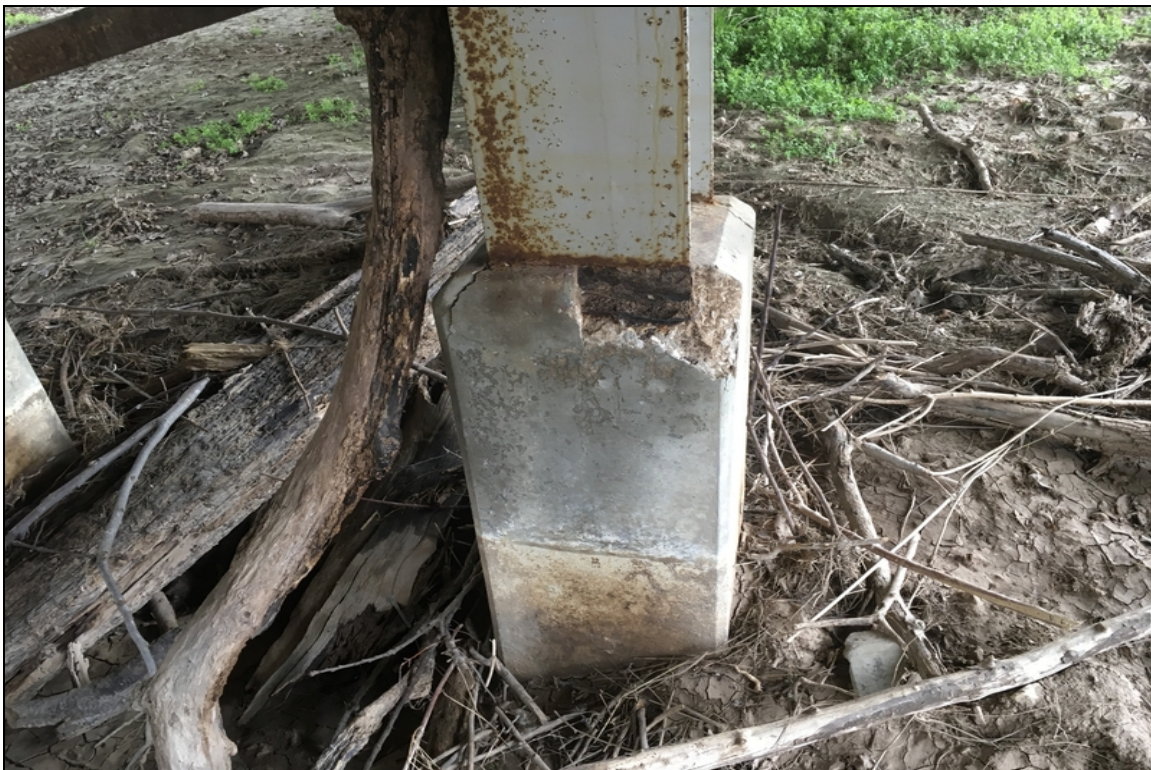
The reinforced concrete is Spalling and cracking at the base of the steel piles
