Route:59 Section:01 Log:8.67

Bridge #01100(Routine)
SH 59 Benton 2 over SPAVINAW CREEK
Location: 1.90 MI S JCT OF SH 72

Team Lead: Nathan Rowland Inspection Date: March 02, 2020

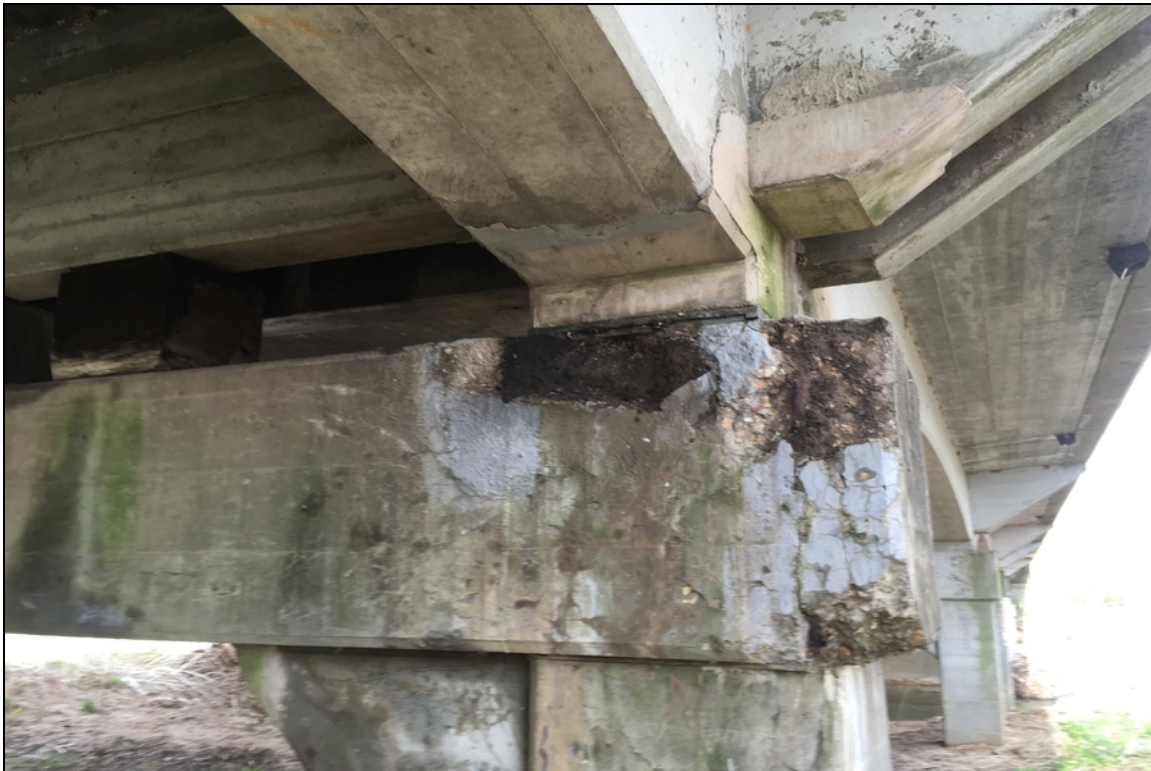
Bent 5 has Spalling with exposed reinforcing steel

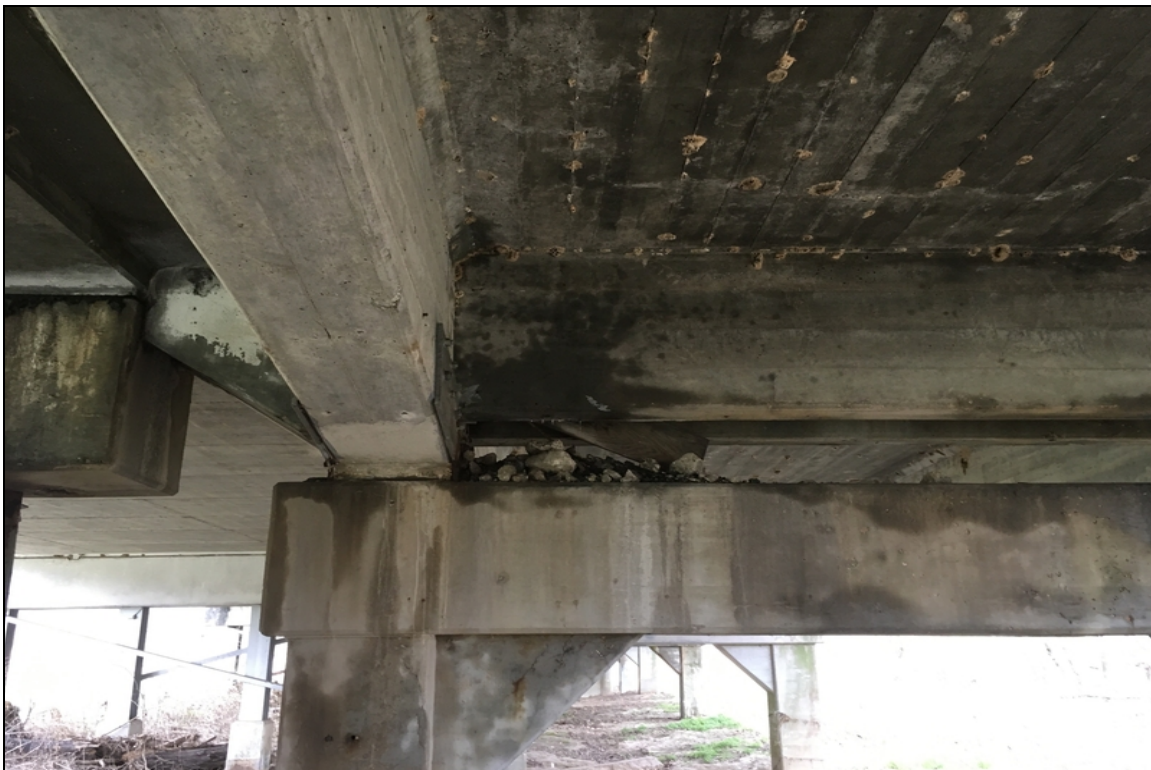
Bent 7 Cap has dirt and debris accumulation

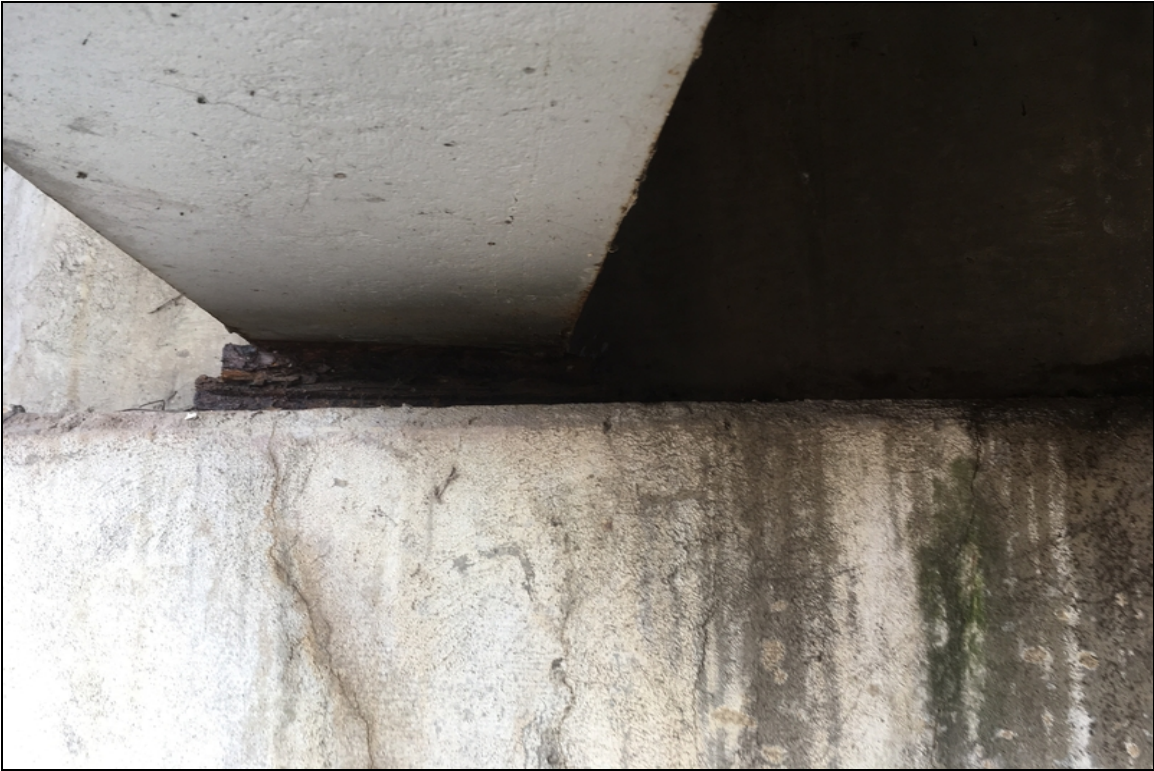
Bearings have Active corrosion with flaking rust

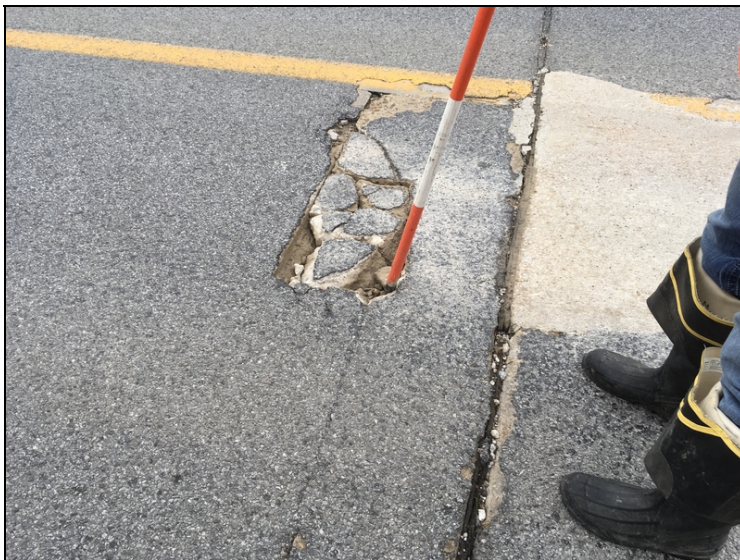
The driving surface of the deck has an area with concrete deterioration that is located in the wheel path and The has loose concrete in the spall. B priority for safety.

Span #8 Failed patched area in the approach span.

Maintenance forces have repaired this area since last inspection WNR 03/02/2020.

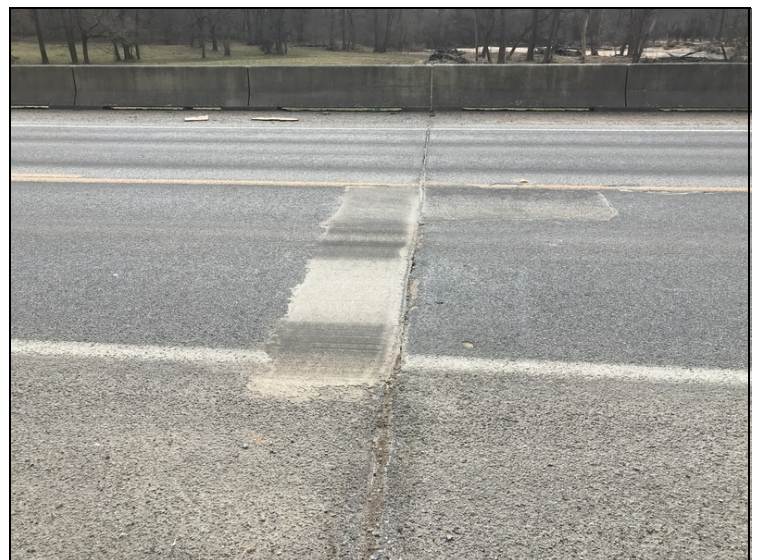
Span #8 Failed patched area in the approach span has been repaired since las inspection.

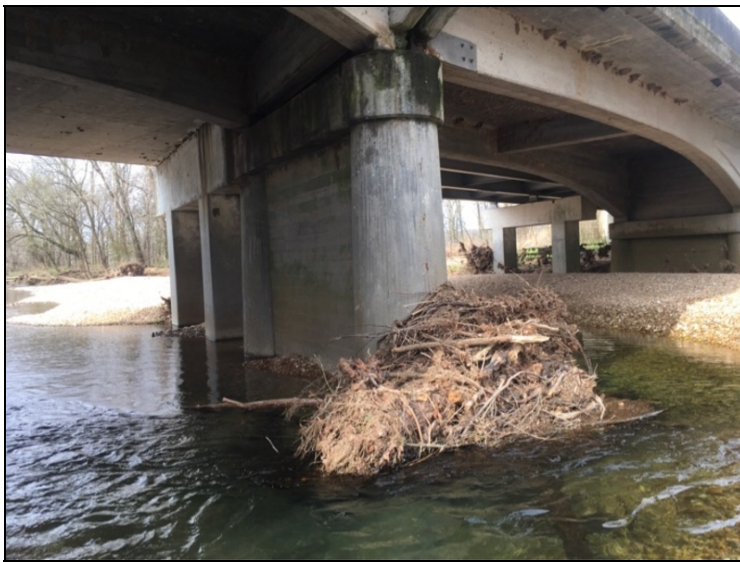
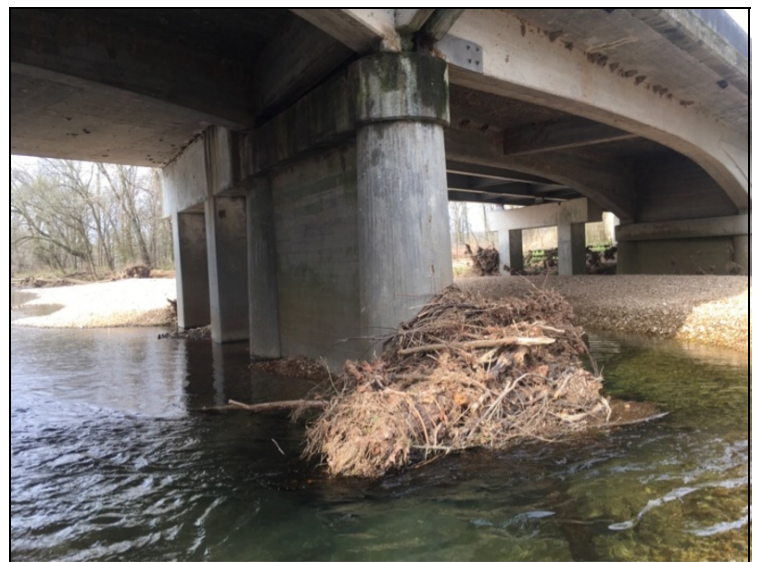
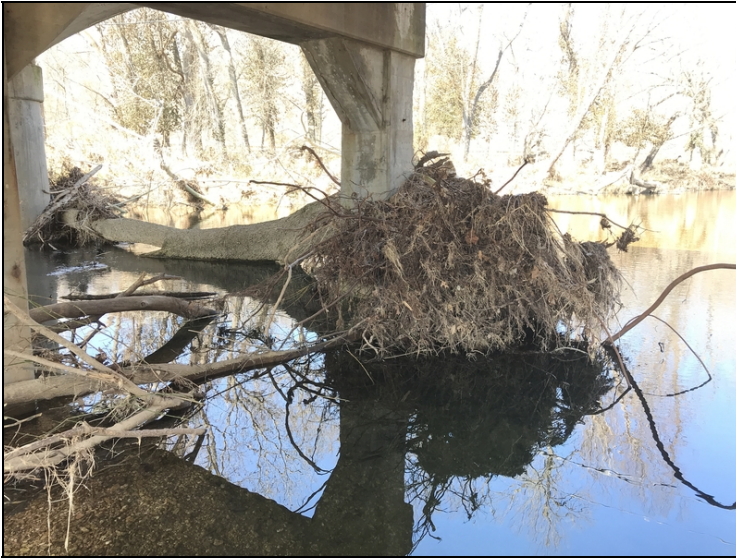
Bents #2 and #3 have Large trees and drift accumulation causing localized scour.

Minor drift accumulation at bent 2.

Pier 2 has drift accumulation

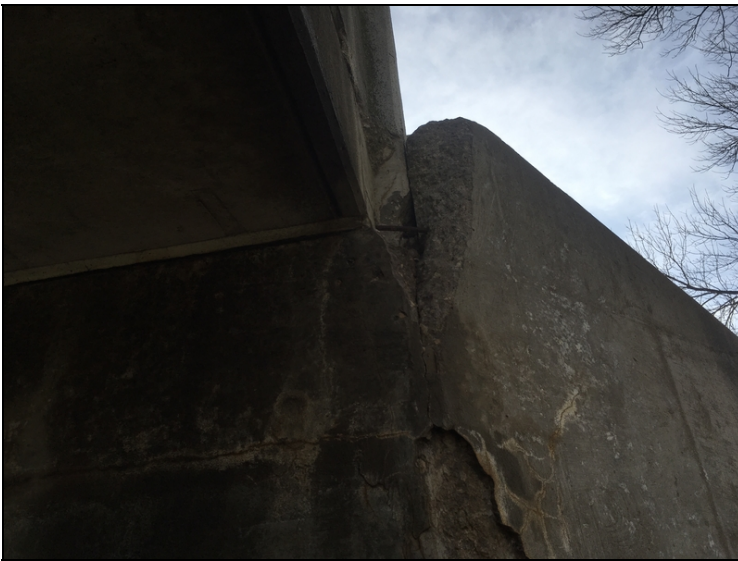
Spall with rebar exposed at abutment #2 upper right corner at wing wall connection. Rebar exposed in deck soffit in spans #2,7,9

Abutment 2 right wingwall juncture has spalling that exposes the reinforcing steel with initial section loss.

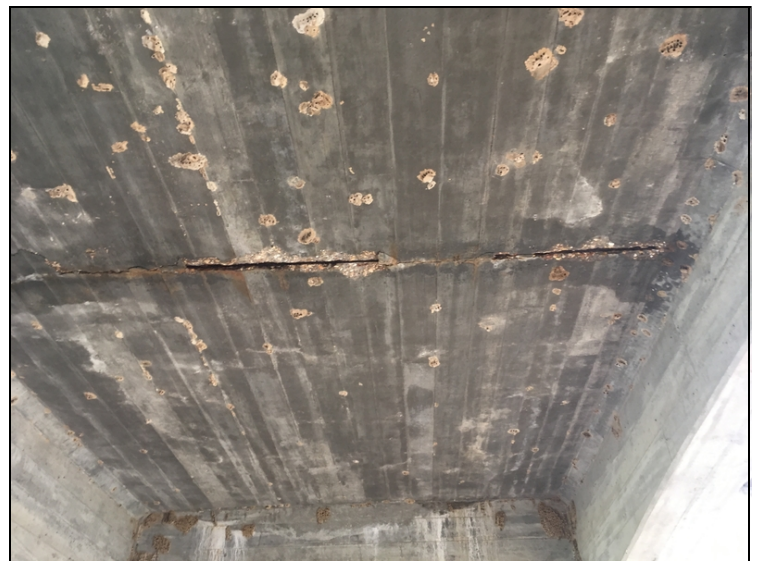
Spalling with exposed reinforcing steel in spans #2, 7, and 9.

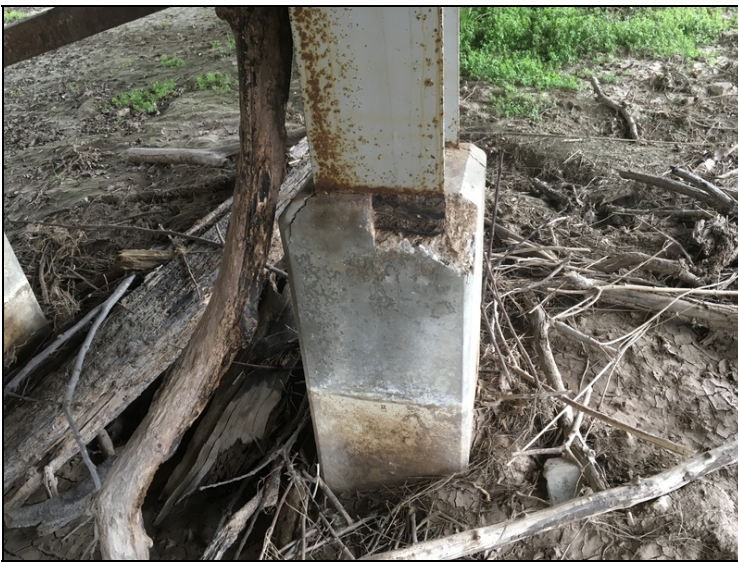
Bents #5,7 steel columns #1 thru #4 at top of concrete encasement- cracking. also mild section loss to steel piling
no apparent noteworthy changes to steel piles since last inspection.

The reinforced concrete is spalling and cracking at the base of the steel piles

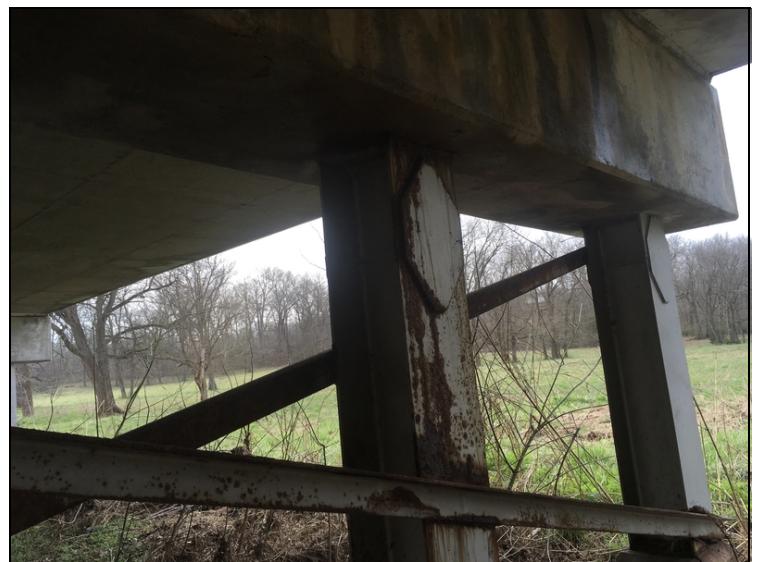
Steel piles have active corrosion with section loss

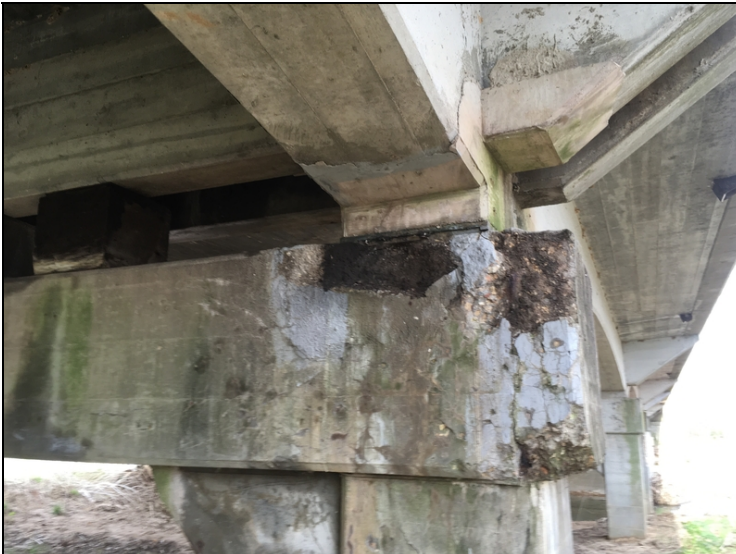
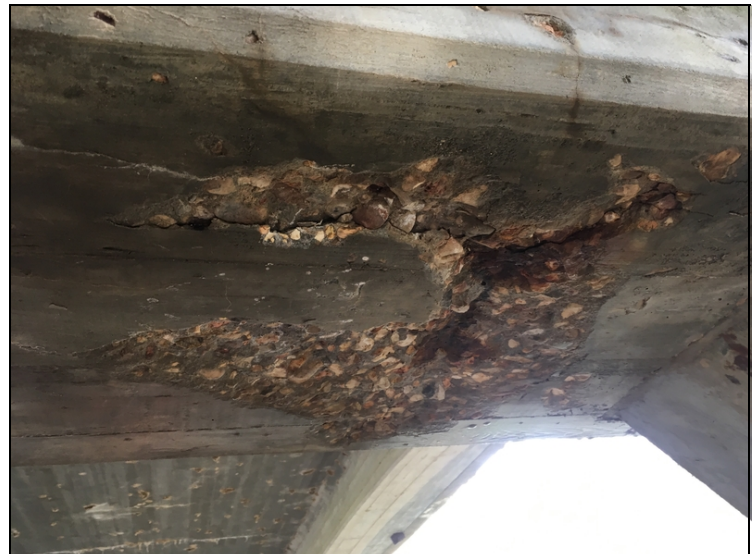
Bents #1, 2, 3, 5, 6, 7, & 9 has concrete delaminations and spalling that exposes the reinforcing steel with measurable section loss. Bent 5 left cap spall has now propagated under bearing areas. (see photo 4).

Bents #1, 2, 3, 5, 6, 7, & 9 has concrete delaminations and spalling that exposes the reinforcing steel with measurable section loss.

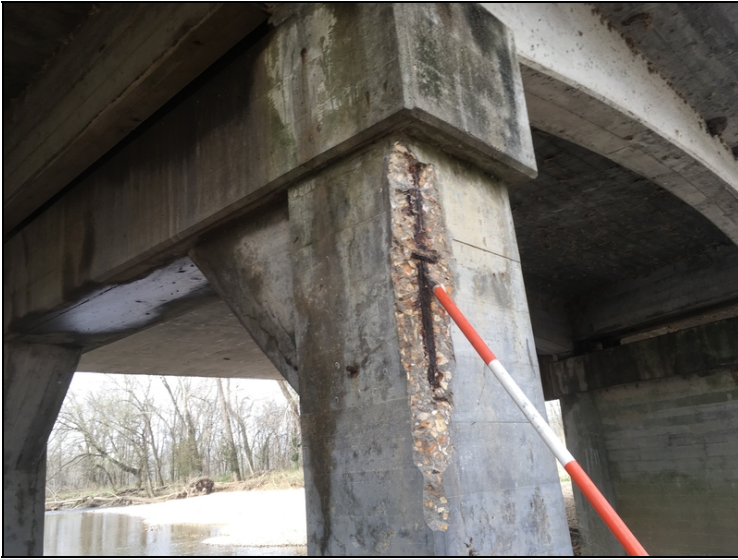
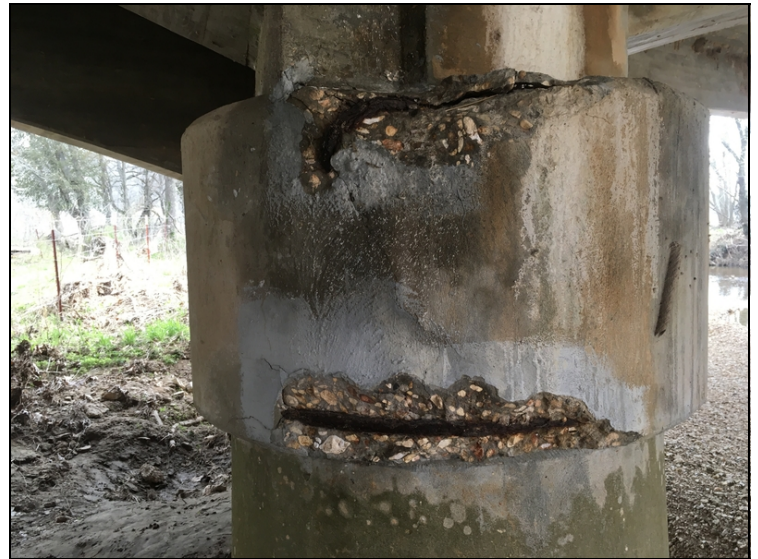
Bent 9 (column 2), bent 2 (column 2), bent 3 (column 1), has concrete delaminations and spalling that is exposing the reinforcing steel with measurable section loss.

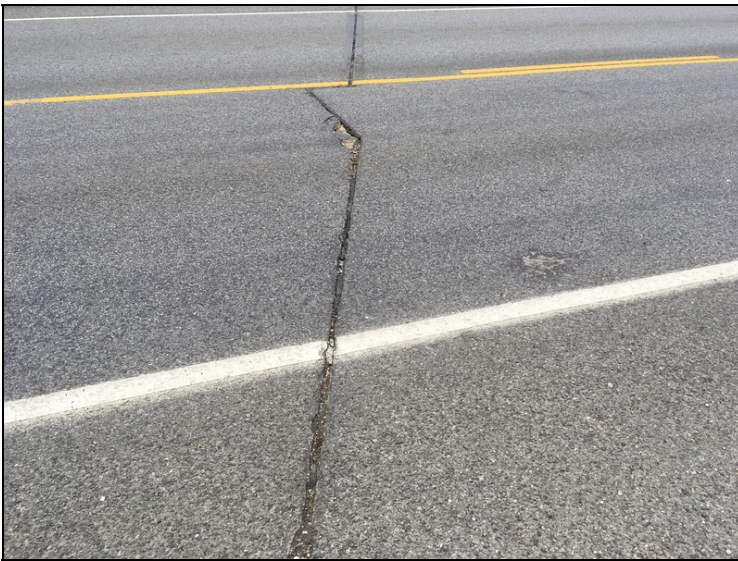
Deck joint at abutment #1-
Joint filler missing allowing free flow of water.
Pourable and compression joint seals have heavy adhesion failure that is allowing water and debris to accumulate on to the caps at all of the intermediate bents and abutments.

Adhesion failure

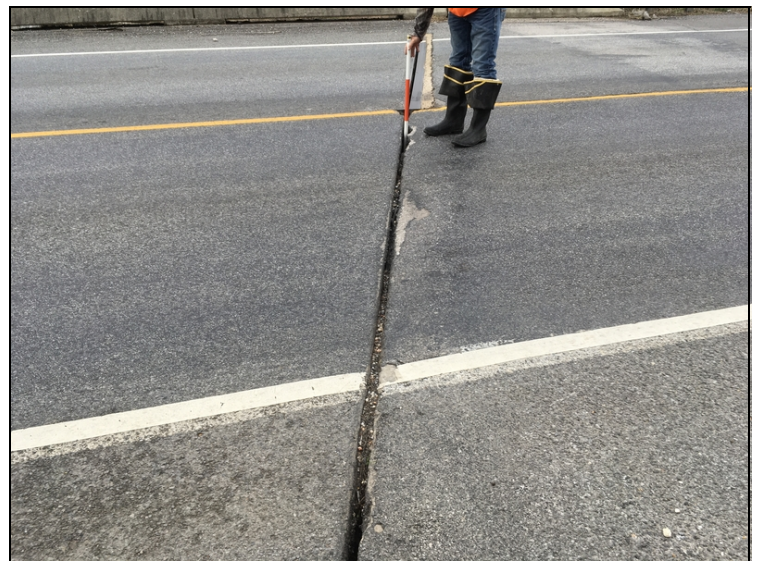
Abutment 1 pourable joint Seal is missing allowing dirt and debris on top of bridge seat
