Bridge #06995(Routine)

SH 59 Benton 2 over CHALYBEATE CREEK

Team Lead: Benjamin Smith Inspection Date: January 27, 2020

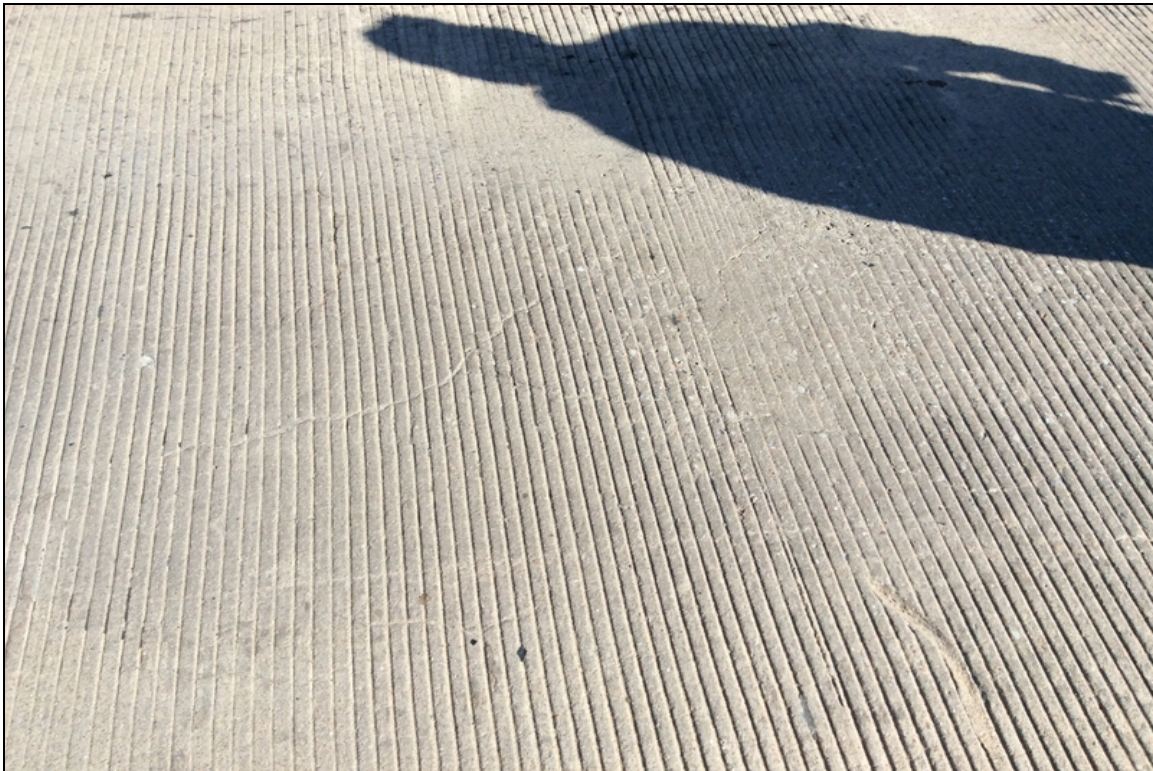
(12)							
01/27/2020:							
-The driving surface of the deck has numerous sealable cracks in all spans. The deck has full length longitudinal cracks in several locations with areas of heavy mapcracking. The cracks have been sealed in a few locations.							
-The gutters in span #1 have moderate dirt and debris accumulation near abutment #1.							
Undersurface - has sip forms.							
Span 1- has 9 total feet of cs2 efflorescence in the overhangs.							
Span 2- has 23 total feet of cs2 efflorescence in the overhangs.							
Span 3- has 10 total feet of cs2 efflorescence in the overhangs.							
107	Steel Open Girder/Beam	LF	1080	639	432	9	0
1000	Corrosion	LF	441	0	432	9	0
515	Steel Protective Coating	SF	11178	10710	432	18	18
3430	Oxide Film Degradation Color/Texture Adherence (Steel Protective Coatings)	SF	468	0	432	18	18

Cracking span 1 right side near mid span.

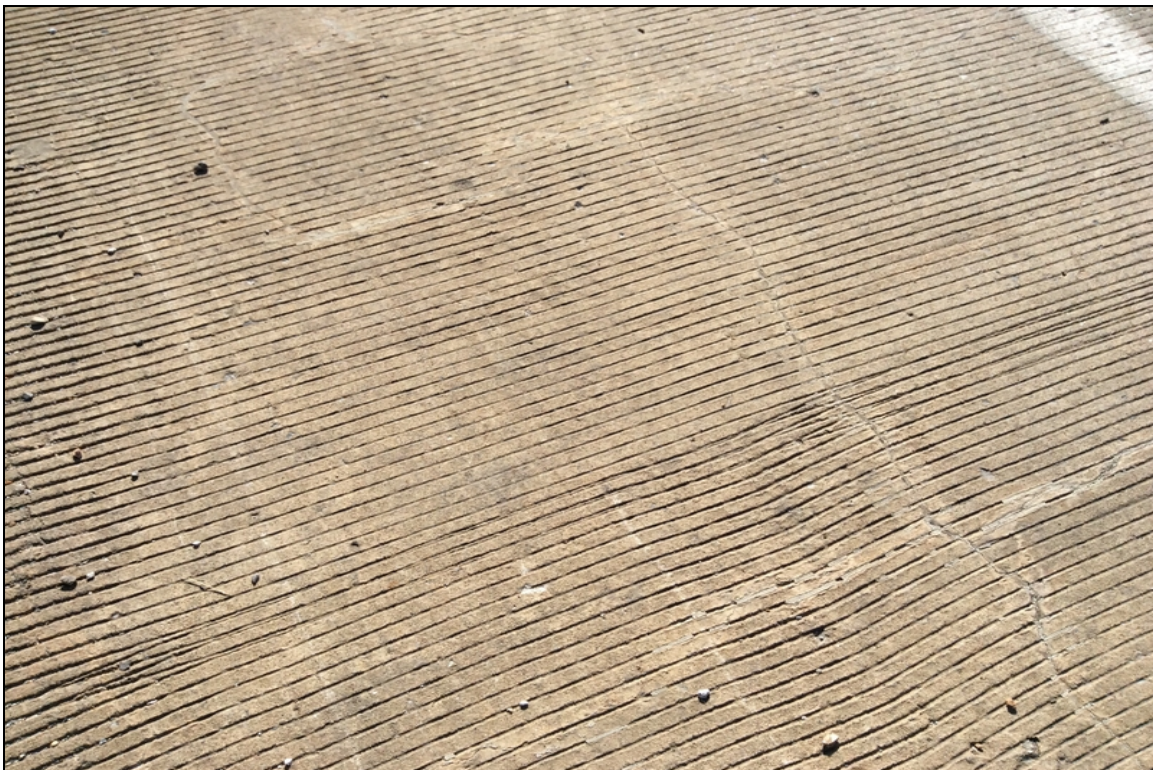
Cracking in deck span 2 near bent 1.

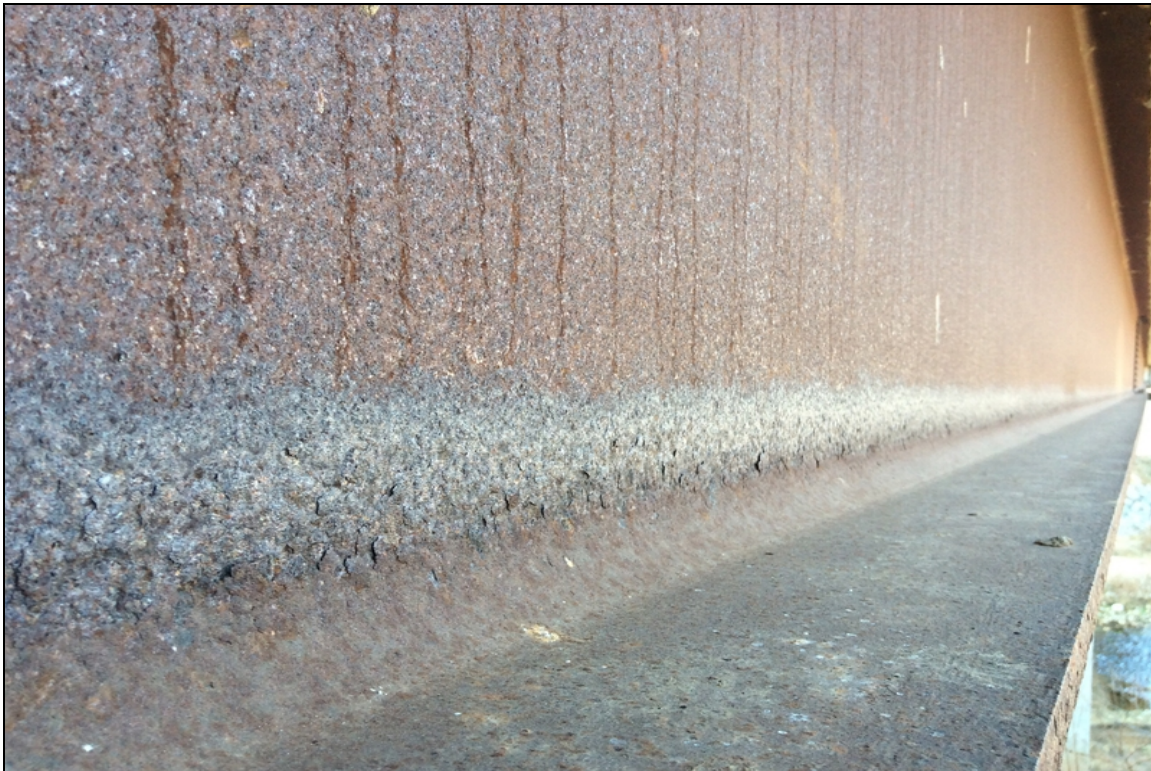
(107)							
01/27/2020 - The ends of some of the girders over the abutments have corrosion in locations with flaking rust to the weathering steel protective coating where the expansion joint seals leak onto the Substructure and Superstructure.							
Span #1- Beams #1,4,5 have 5 total feet of cs 3 corrosion at the beam ends over abutment 1. The lower portion of the external web on beams #1,5 have cs 2 corrosion.							
Span #2- The lower portion of the external web on beams #1,5 have cs 2 corrosion.							
Span #3- Beams #1,4 have 4 total feet cs 3 corrosion at the beam ends over abutment 2. The lower portion of the external web on beams #1,5 have cs 2 corrosion.							
205	Reinforced Concrete Column	EA	6	5	1	0	0
1080	Delamination/Spall/Patched Area	EA	1	0	1	0	0

Girder #1-Abnormal weathering to exterior side.

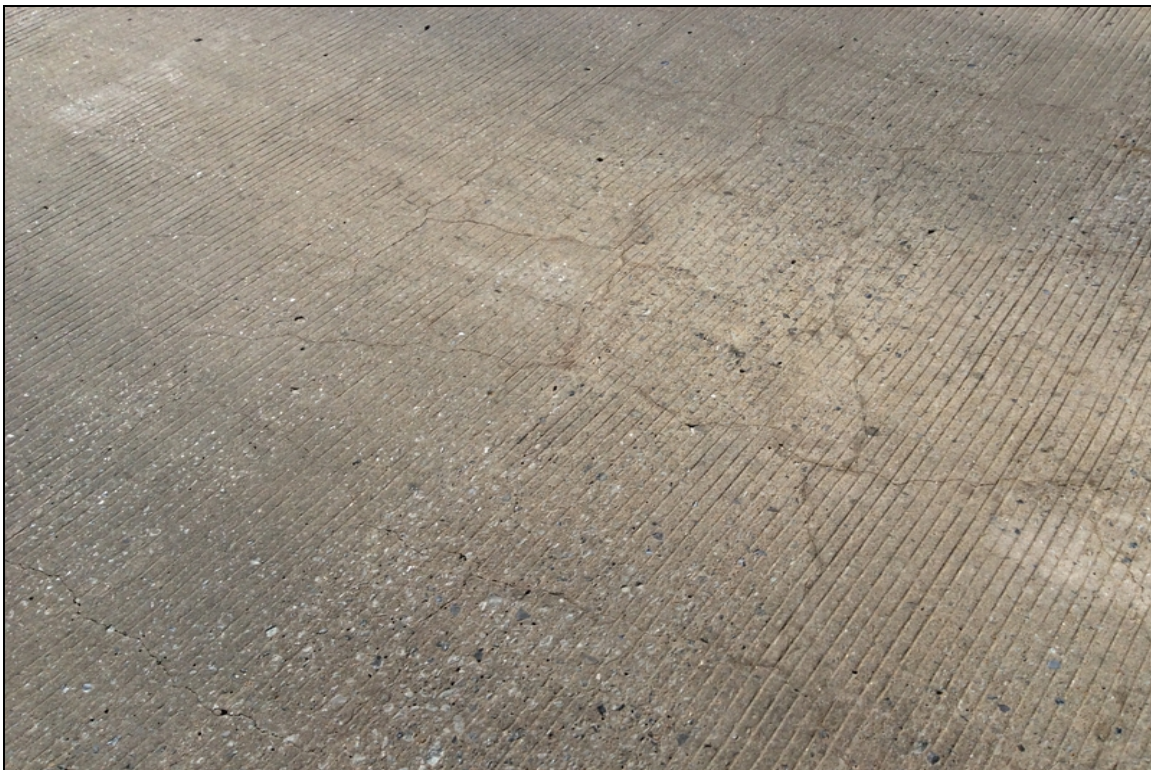
Map cracking in span 3 Left side center of north bound lane.

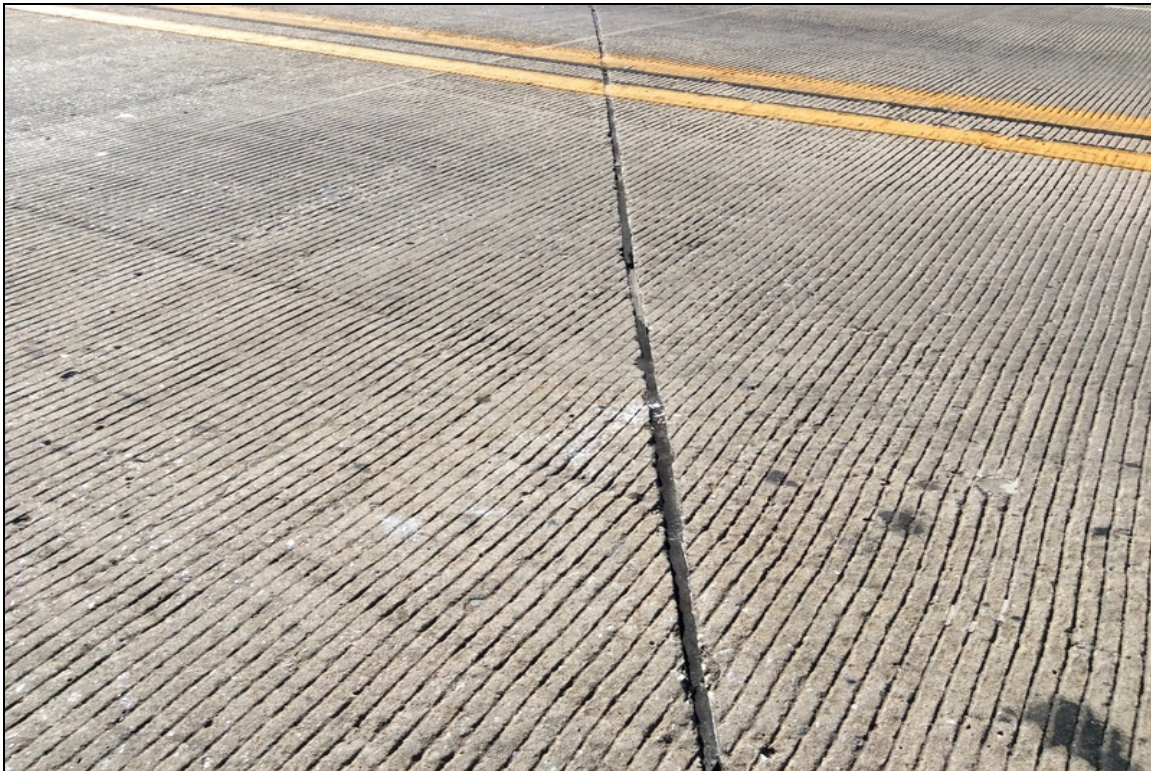
Bent 2 joint seal missing.

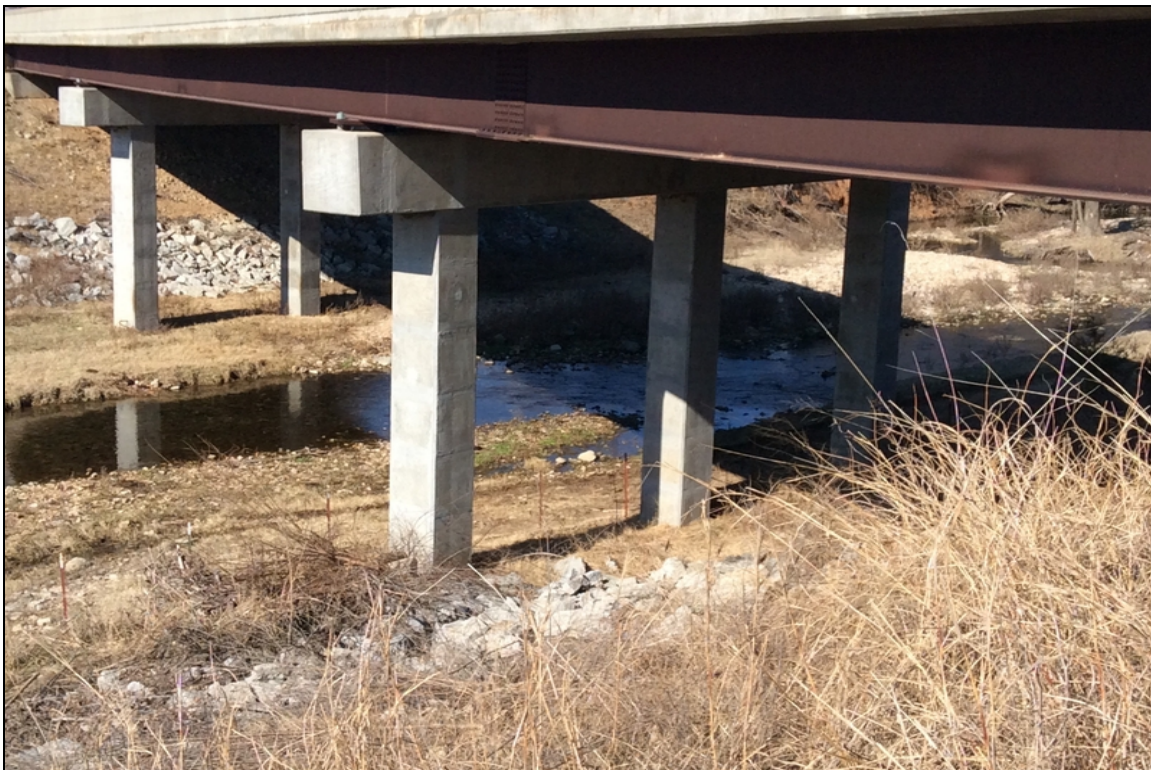
Substructure footings have cover.

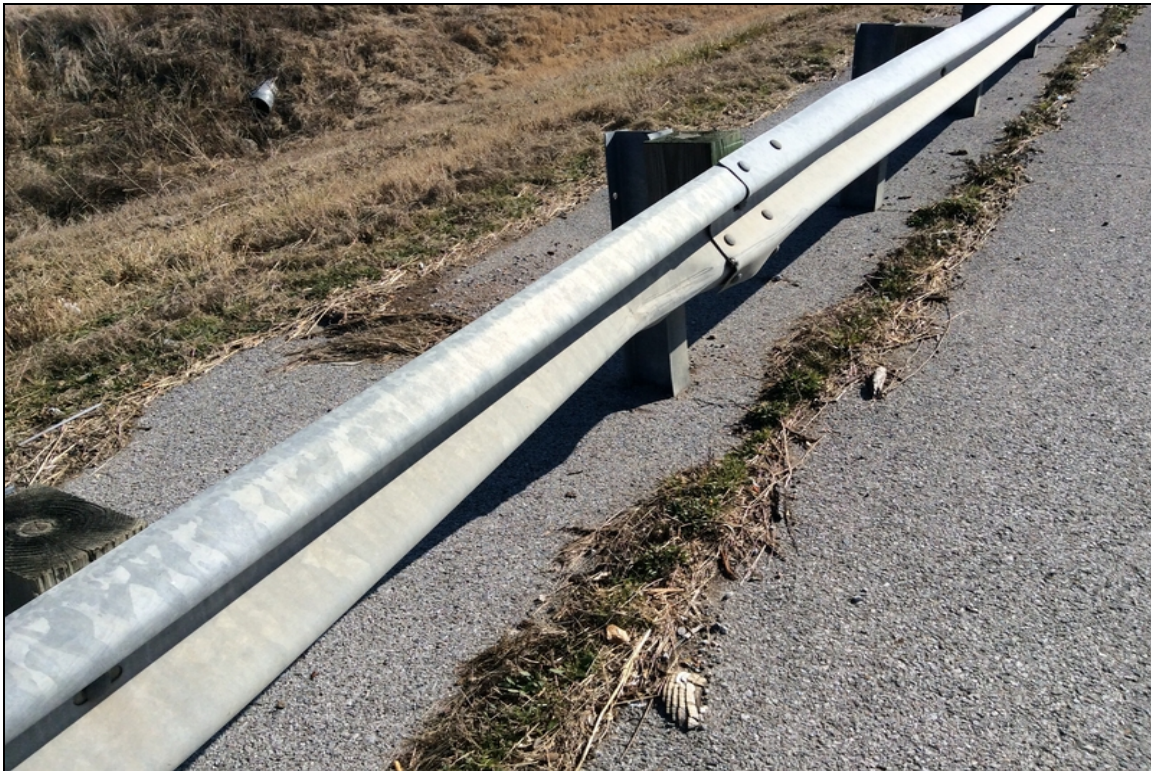
Collision damage at guardrail approximately 40 feet from bridge end. Southeast railing.

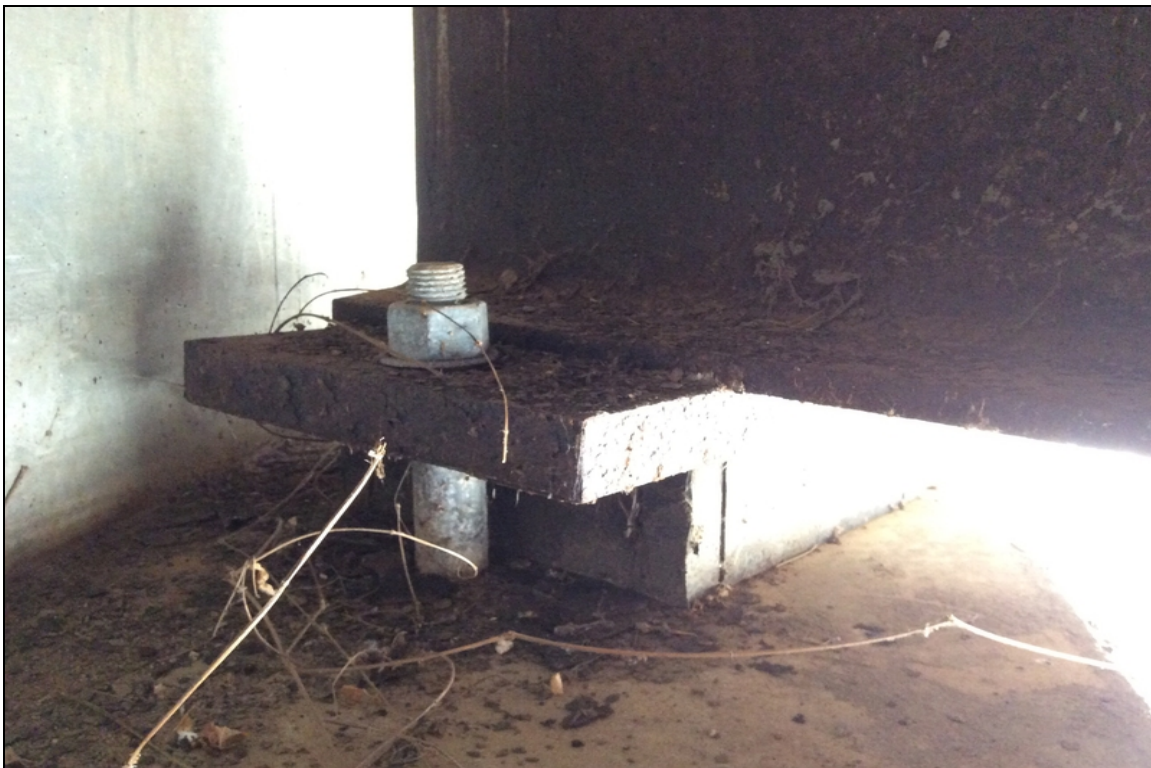
Abutment #2, bearing #4-Abnormal weathering.

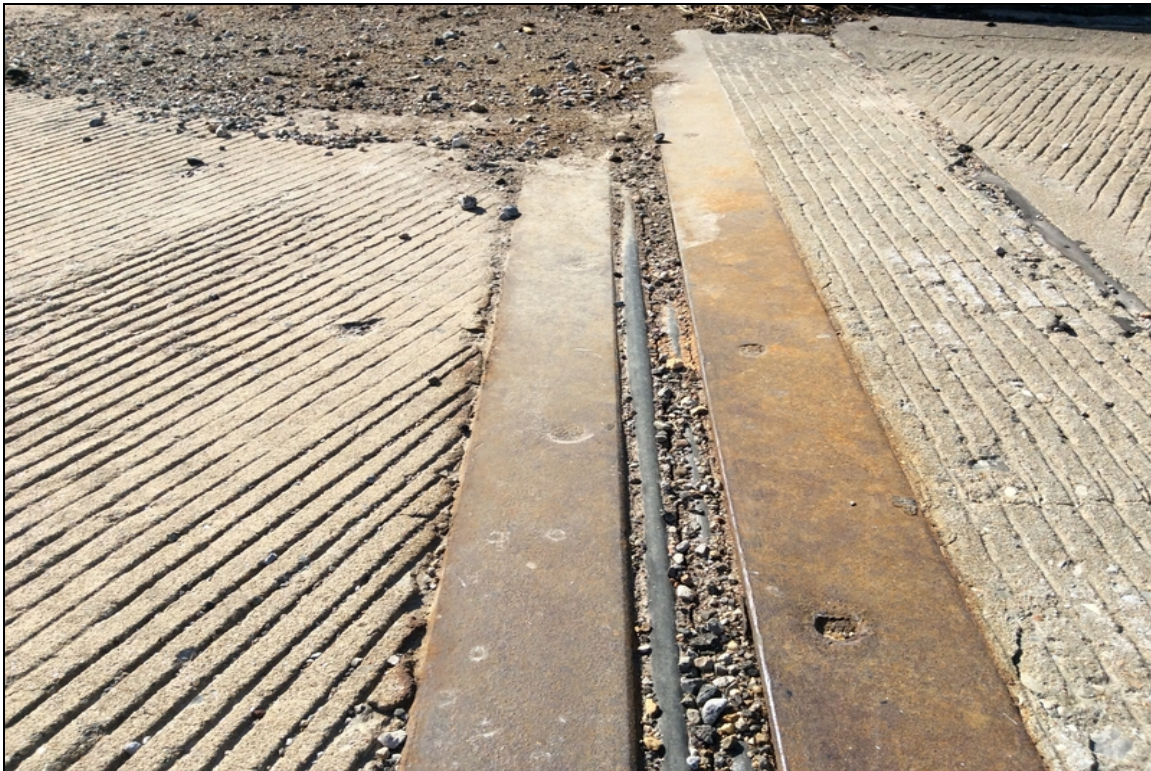
Abutment #1-Debris impact in compression joint.

Expansion joints - The compression joint seals have heavy debris impactation in the gutters. The seals leak water in locations allowing water to leak onto the Superstructure causing corrosion and abnormal weathering to the steel protective coating of the girder ends and bearing devices over abutments.

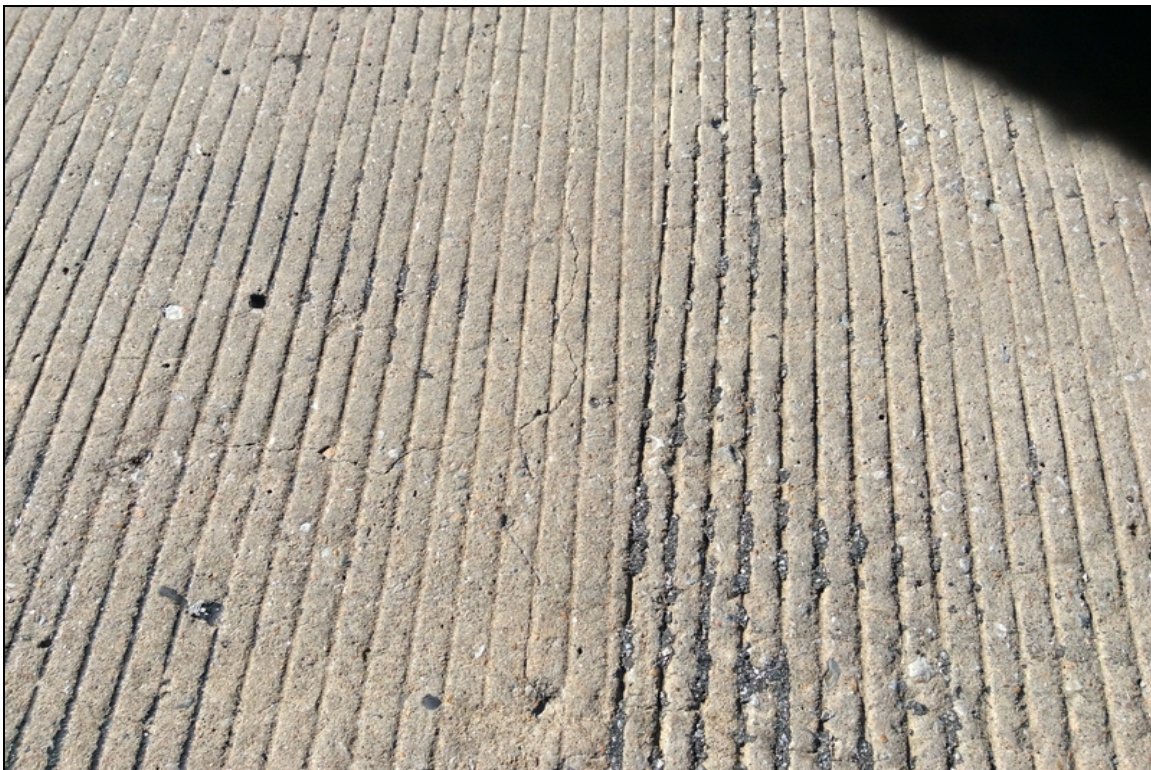
Cracking in span 1 Left side near abutment 1.

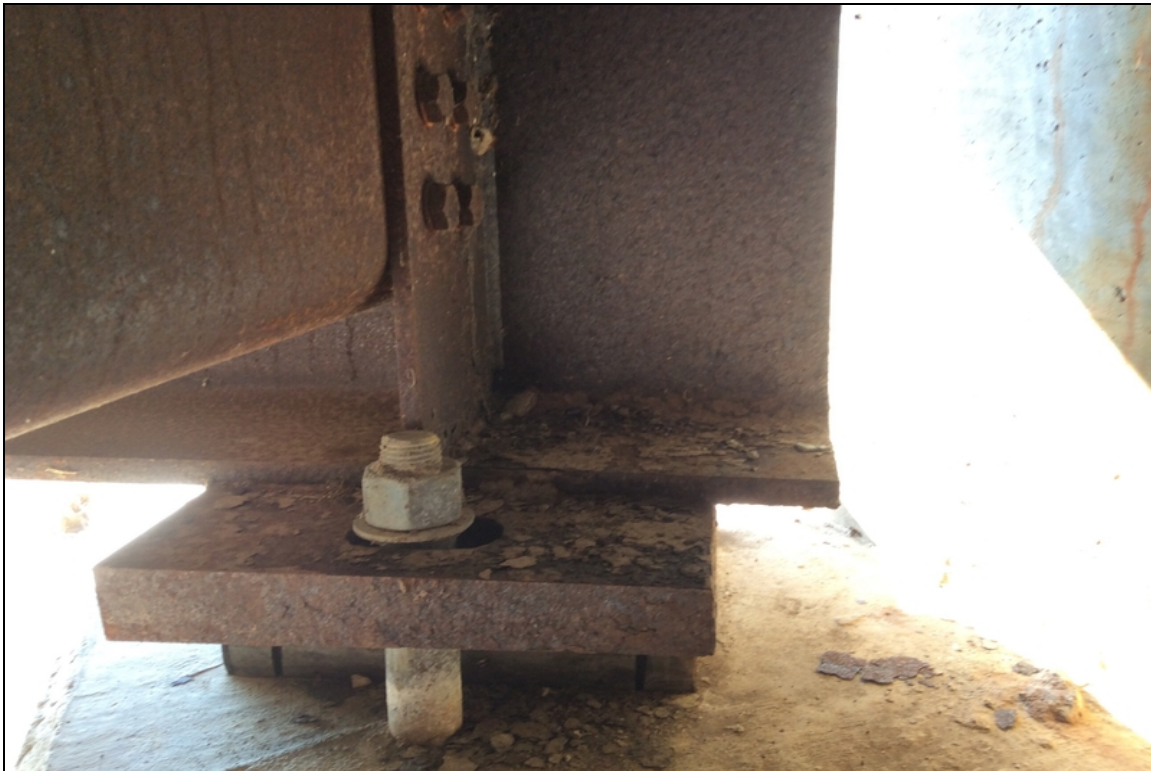
Corrosion with flaking rust

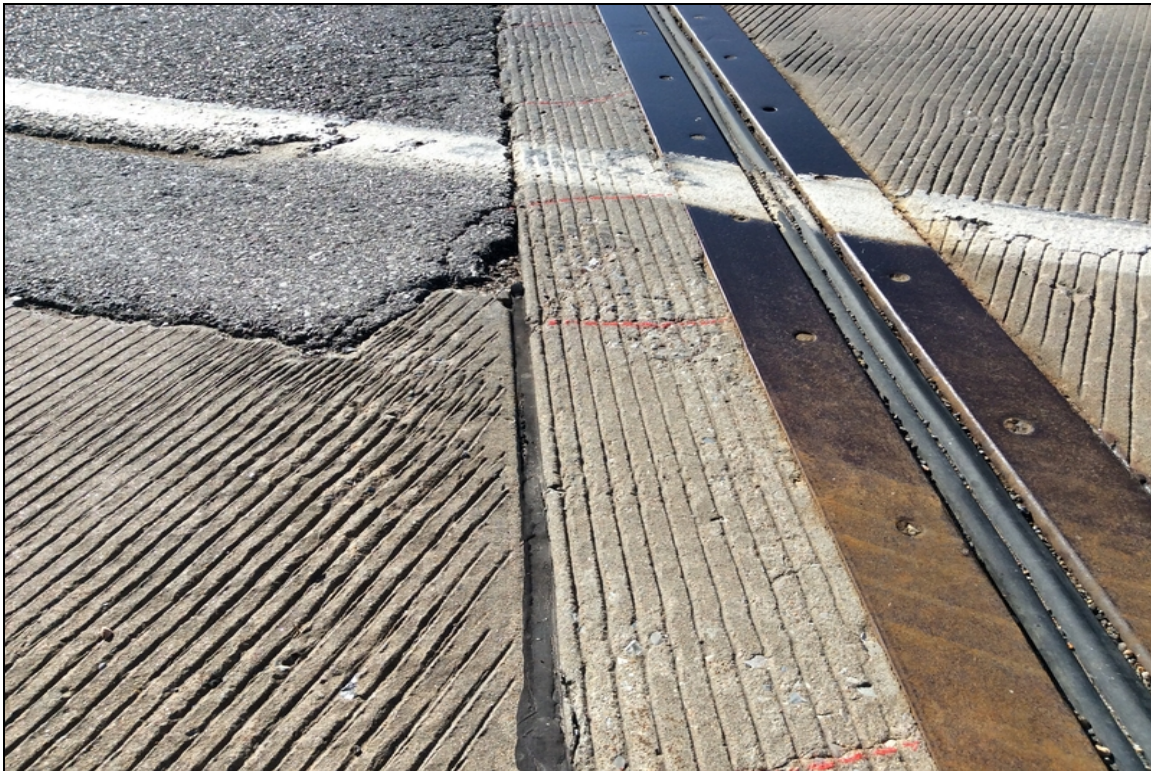
Transverse cracking in the backwall.

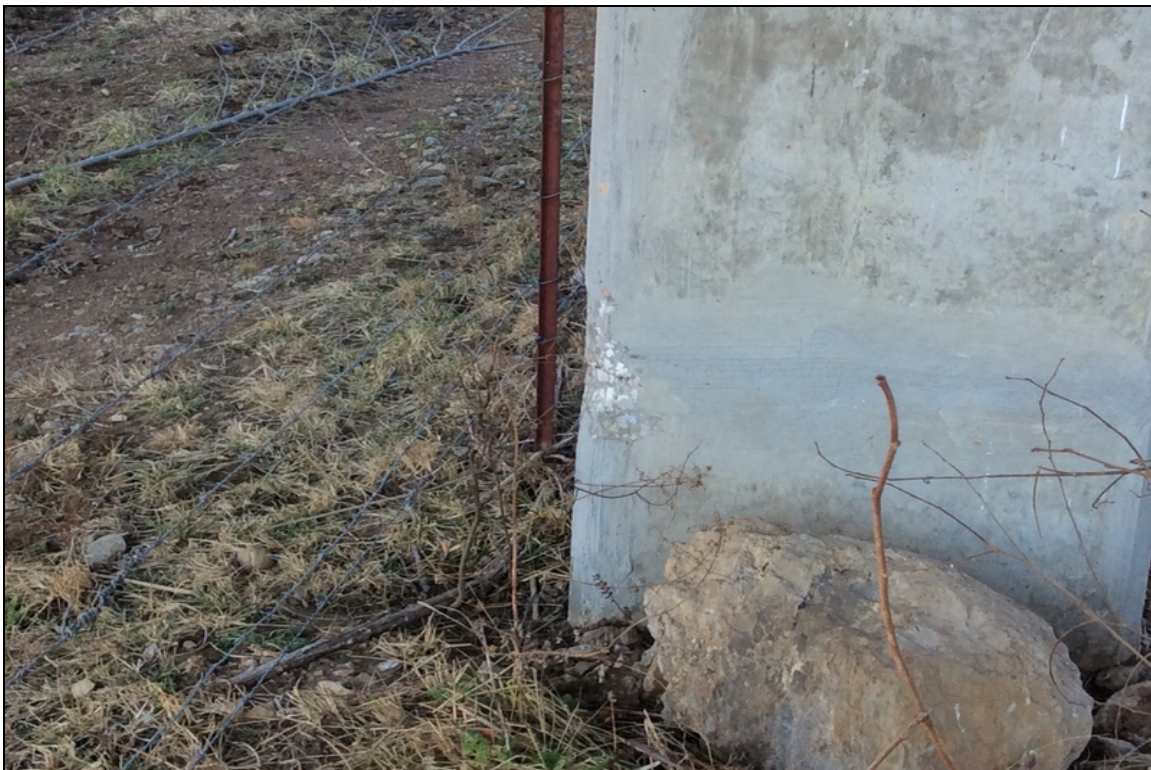
(205)							
-Bent 1- no deficiencies noted.							
-Bent #2, column #1 has a shallow softball sized shallow spall with no exposed reinforcing steel near base of column on the span 2 side.							
-All footings have cover at this inspection.							
215	Reinforced Concrete Abutment	LF	96	51	45	0	0
1120	Efflorescence/Rust Staining	LF	7	0	7	0	0
1130	Cracking (RC and Other)	LF	38	0	38	0	0

Bent 2 column 1 softball sized shallow spall

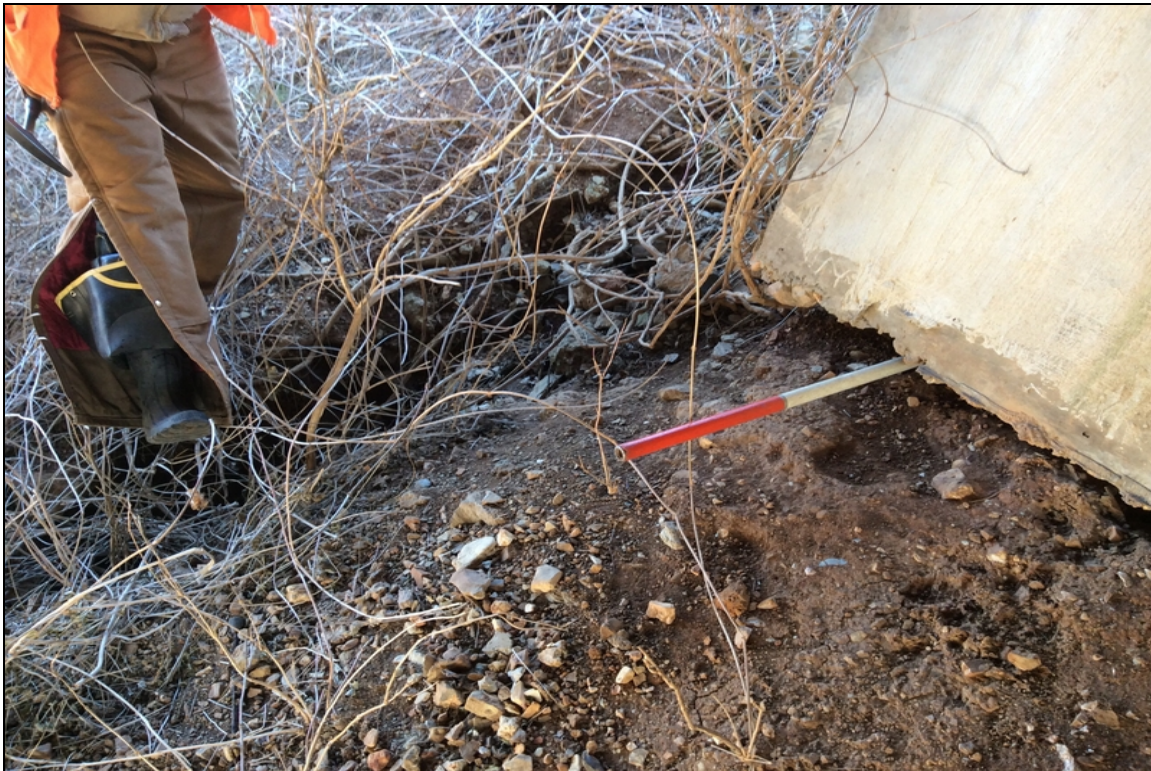
Abutment 2 Left side has minor earth settlement.

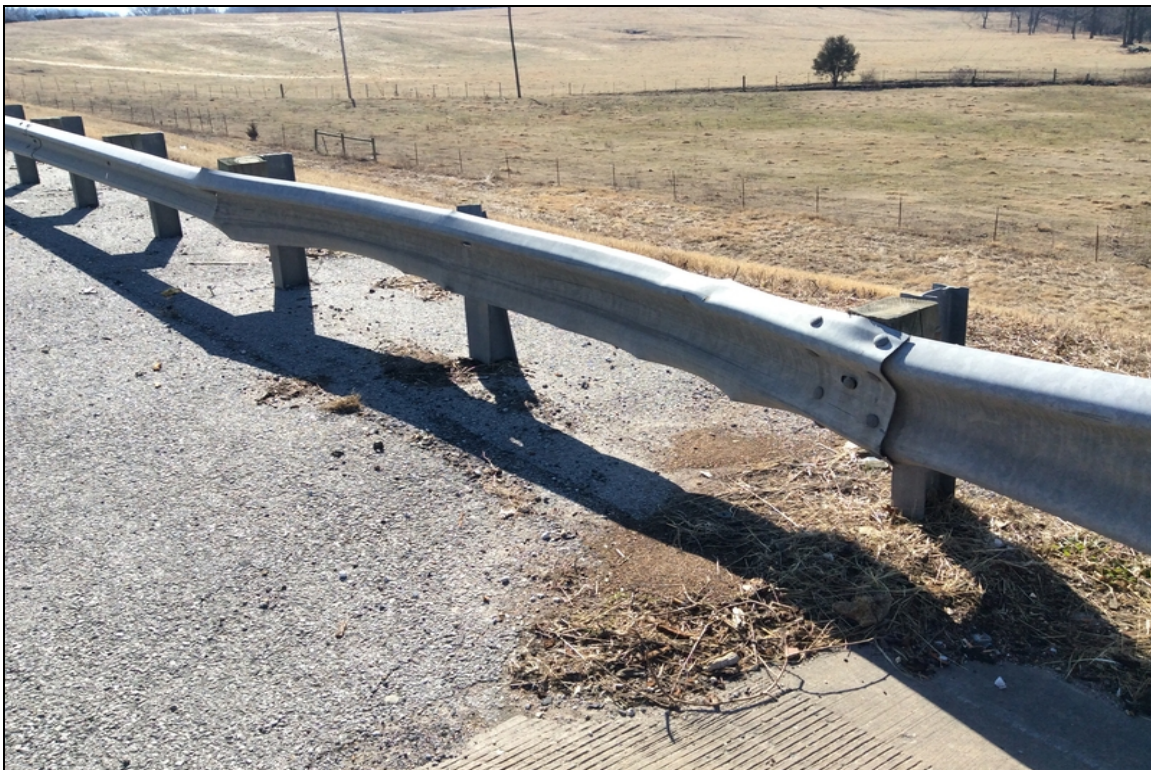
Collision damage at guardrail approximately 20 feet from bridge end. Southwest railing.

South approach railing - The Southwest railing has collision damage that has broken the railing loose from one post and caused out-of-plane bending in a section of the railing that has created a "pocket" in the railing.

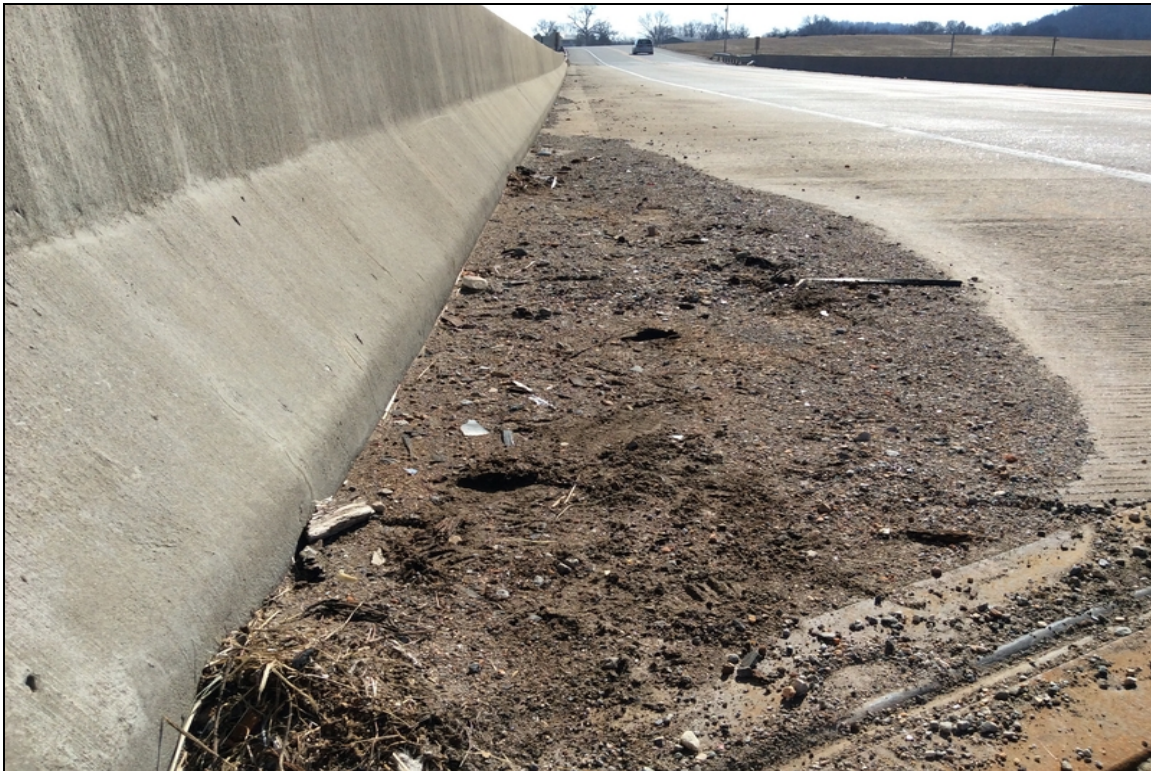
The gutters in span #1 have dirt and debris accumulation near abutment #1.

Deck - The gutters on the right and left sides of span #1 have moderate dirt and debris accumulation near North bridge end.

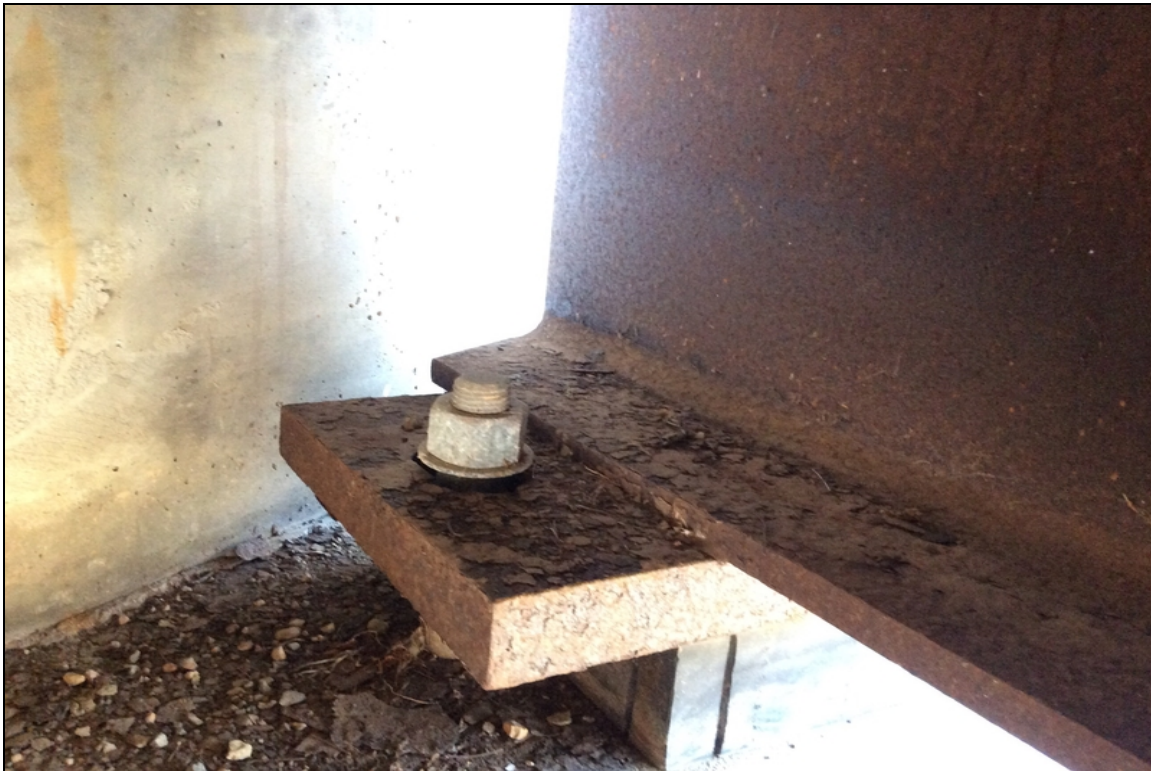
Corrosion with flaking rust.

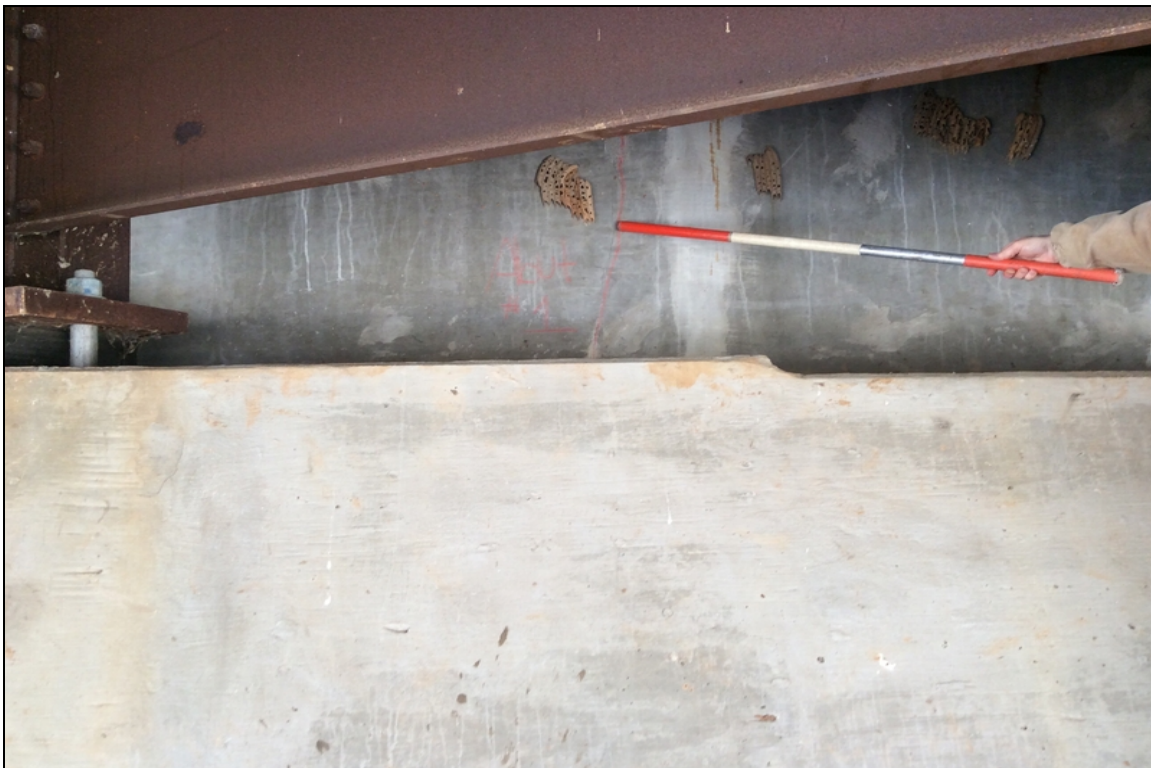
Vertical cracking in backwall.

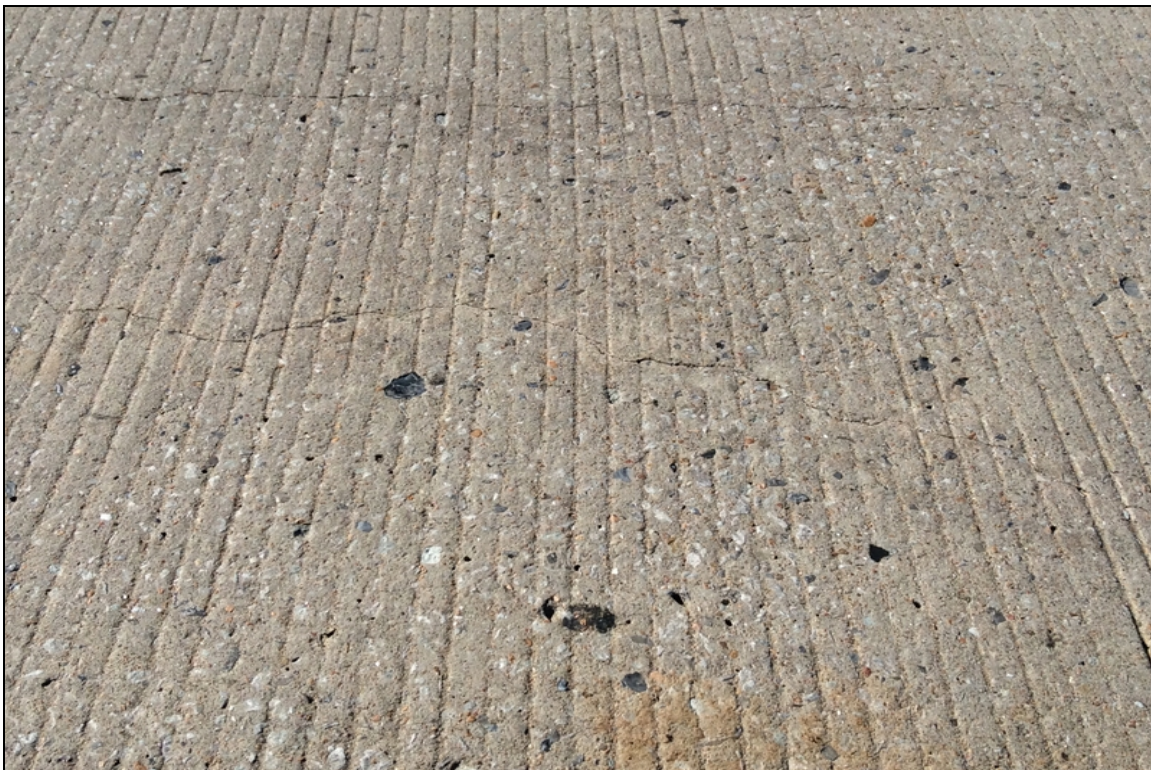
Cracking span 1 Left side near bent1

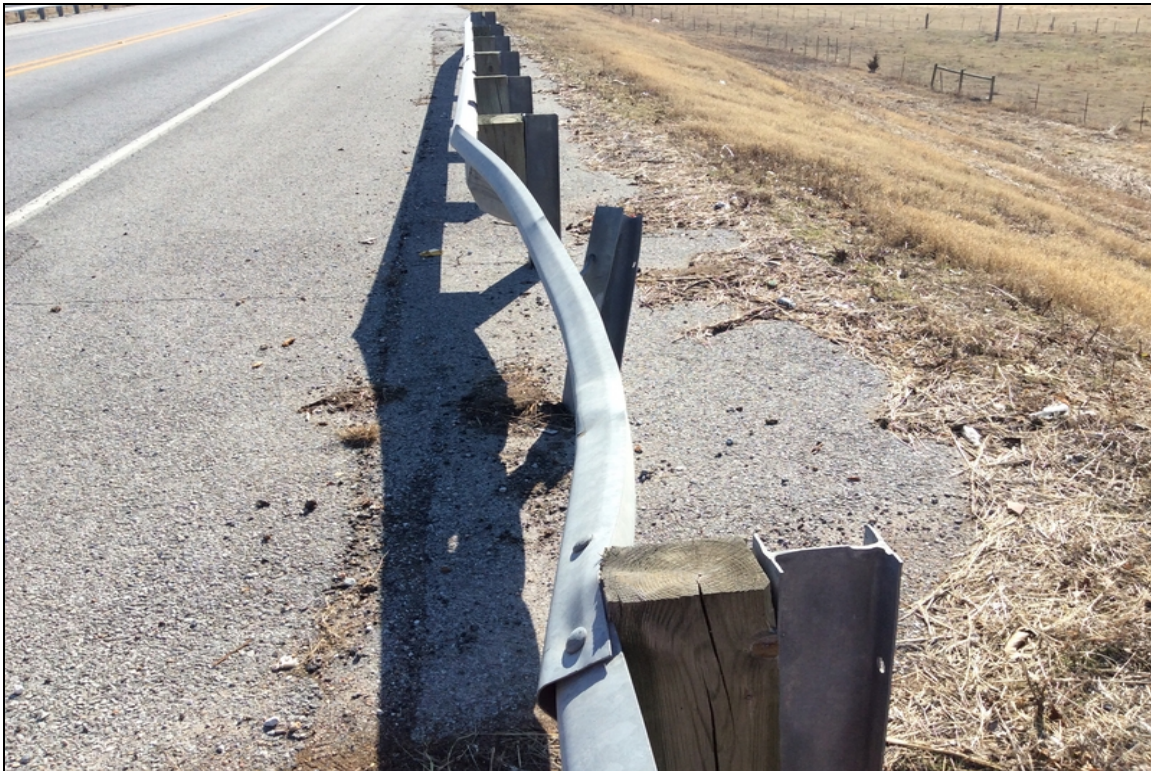
Collision damage at guardrail approximately 20 feet from bridge end. Southwest railing.

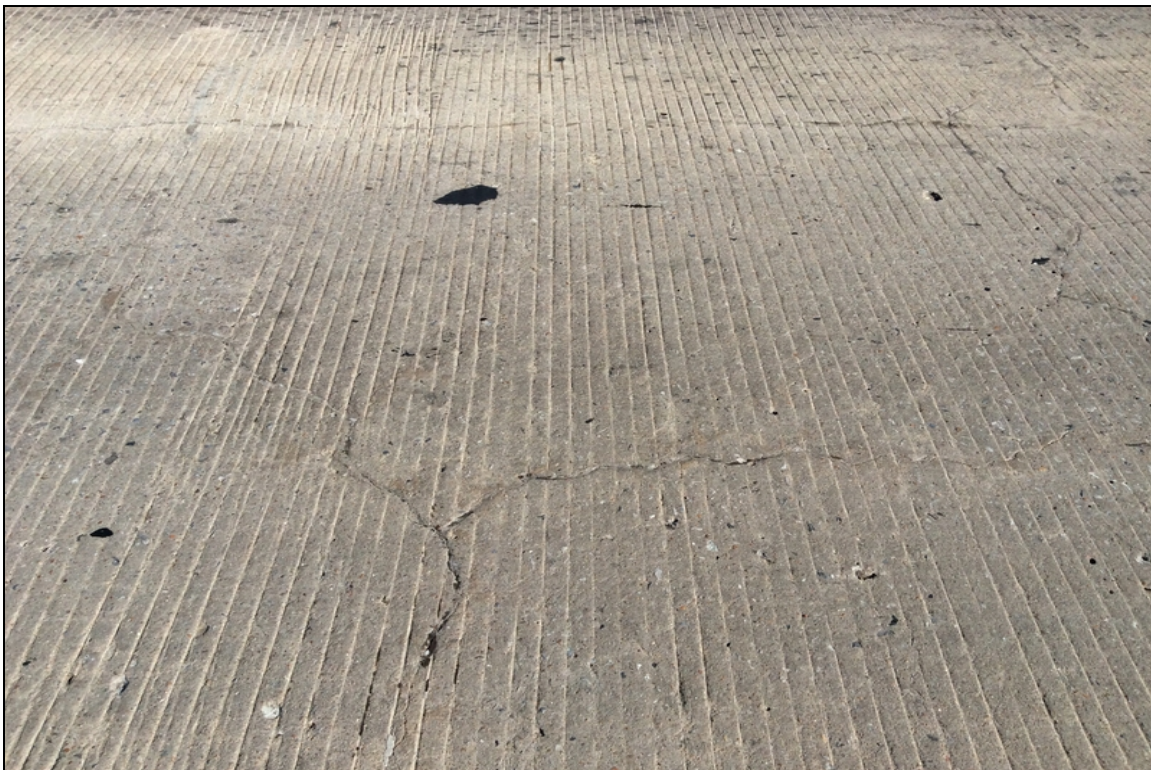
Cracking span 1 right side near mid span.

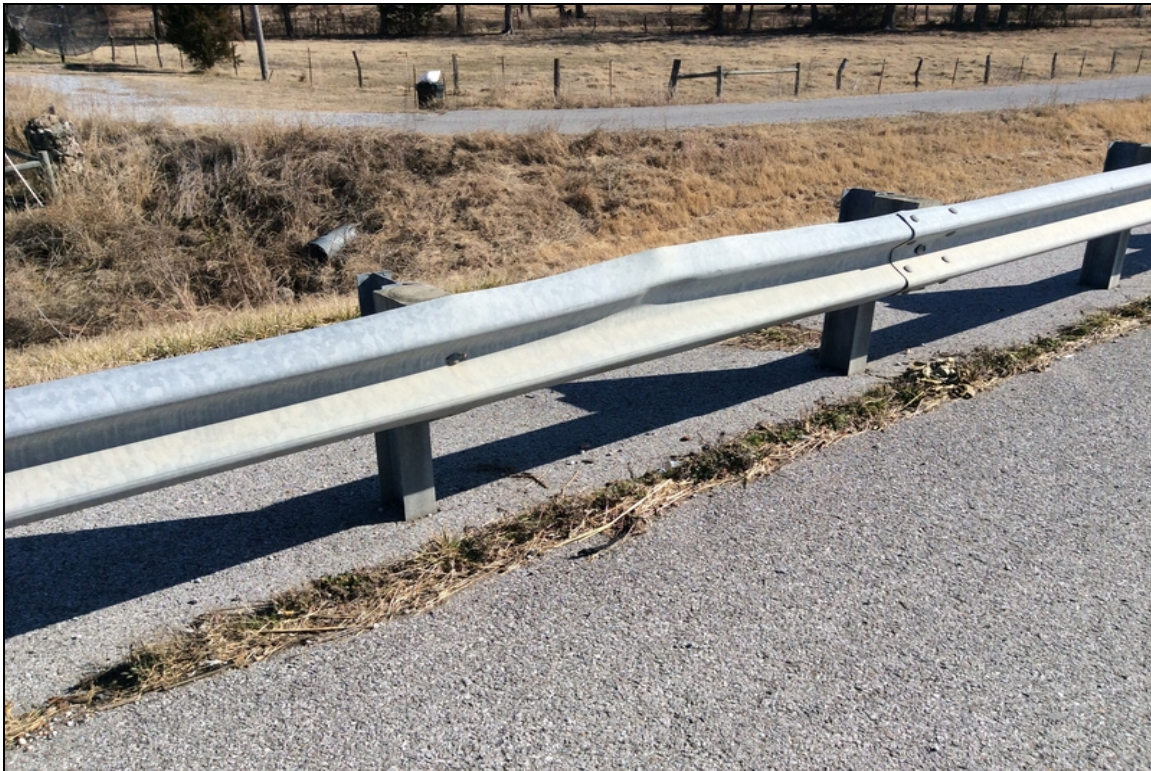
Collision damage at guardrail approximately 60 feet from bridge end. Southeast railing.

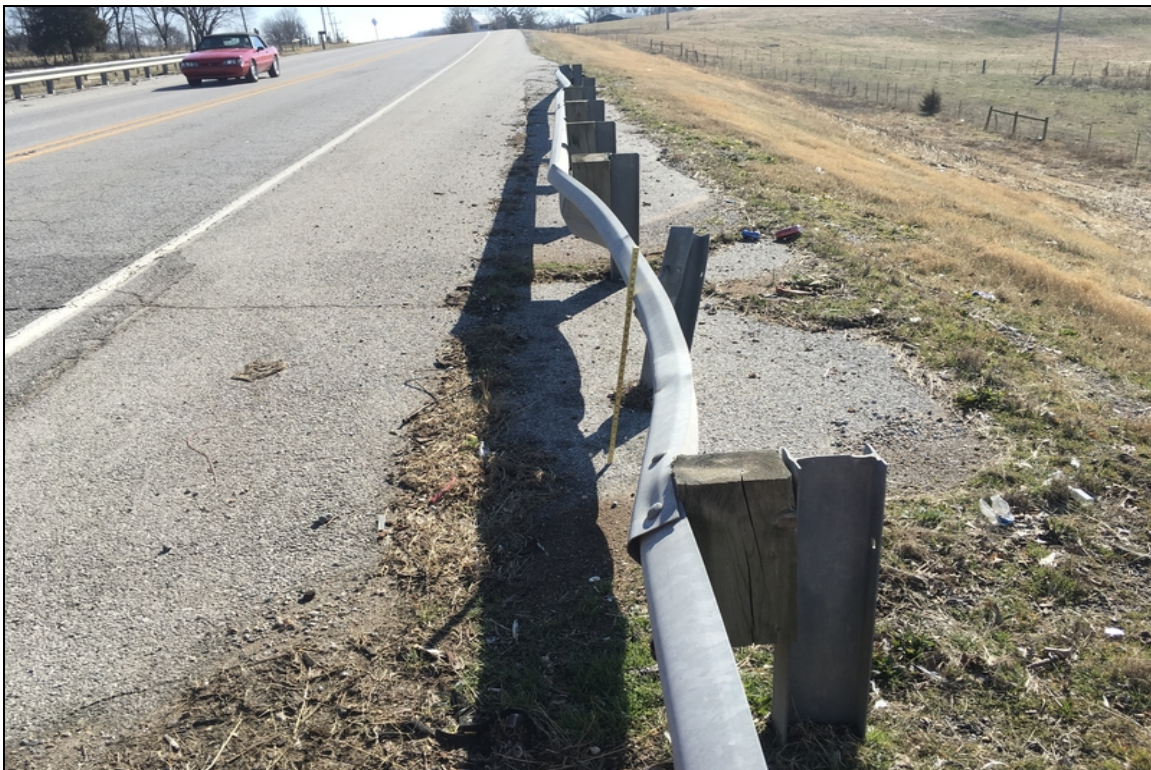
Approach rail damage at the right end of the structure.

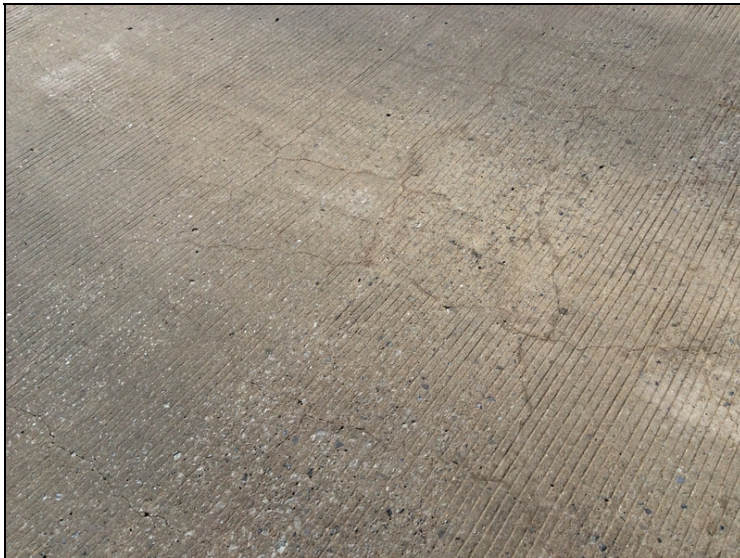
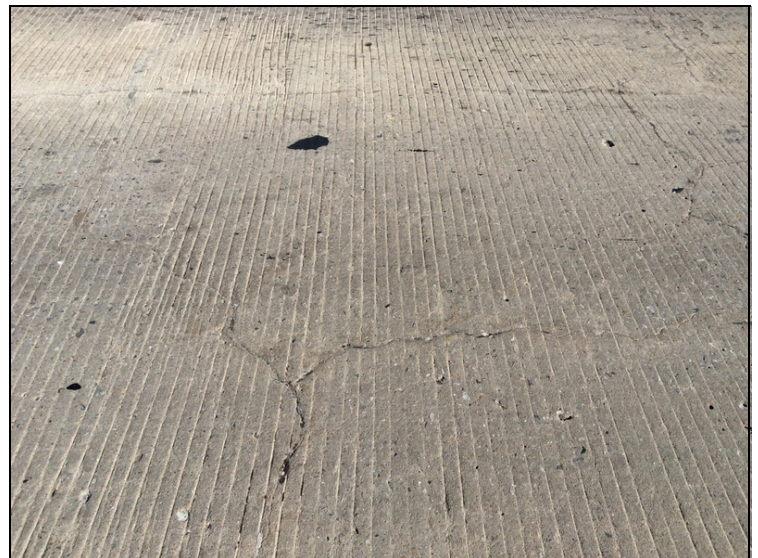
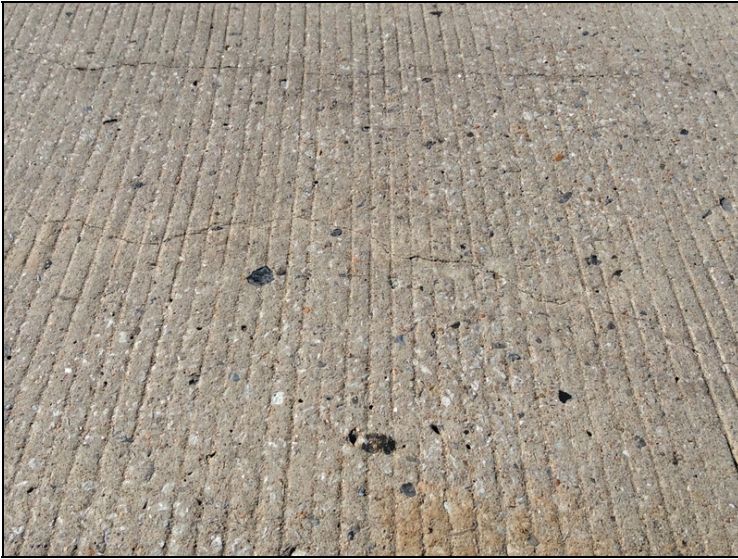
Deck - The driving surface of the deck has numerous sealable cracks in all spans. The deck has full length longitudinal cracks in several locations with areas of heavy mapcracking.

Mapcracking.

Deck cracking.

Longitudinal deck cracking.

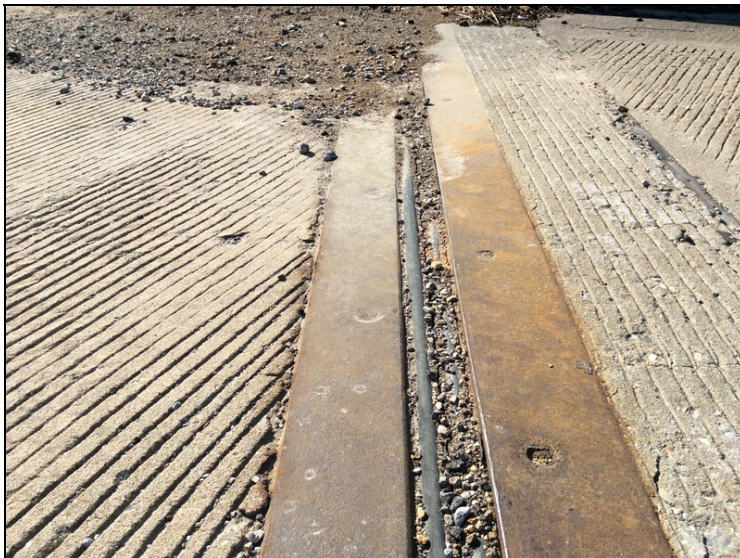
Abutment #1-Debris impactation in compression joint.
