Bridge #06995(Routine)

SH 59 Benton 2 over CHALYBEATE CREEK

Team Lead: Benjamin Smith Inspection Date: January 27, 2020

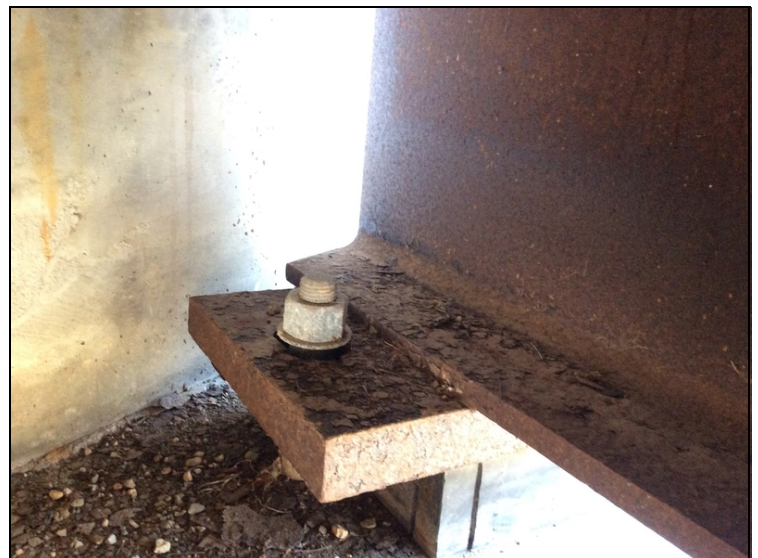
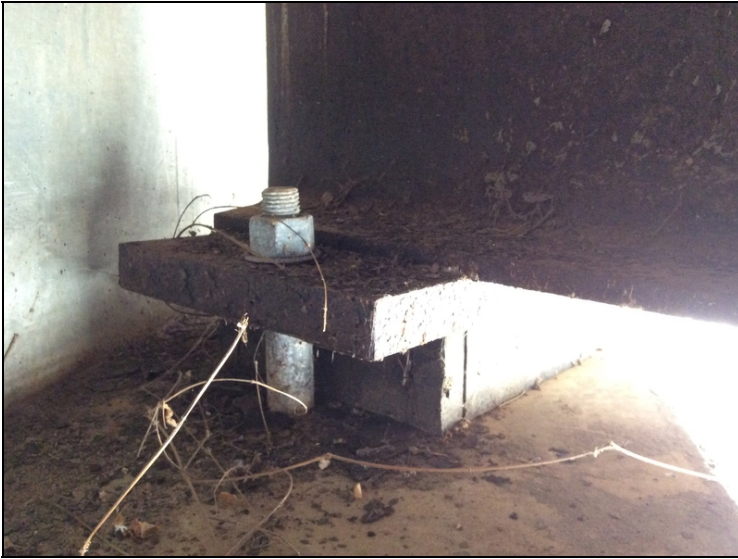
Expansion joints - The compression joint seals have heavy debris impactation in the gutters. The seals leak water in locations allowing water to leak onto the Superstructure causing corrosion and abnormal weathering to the steel protective coating of the girder ends and bearing devices over abutments.

abnormal weathering to girder end and bearing device.

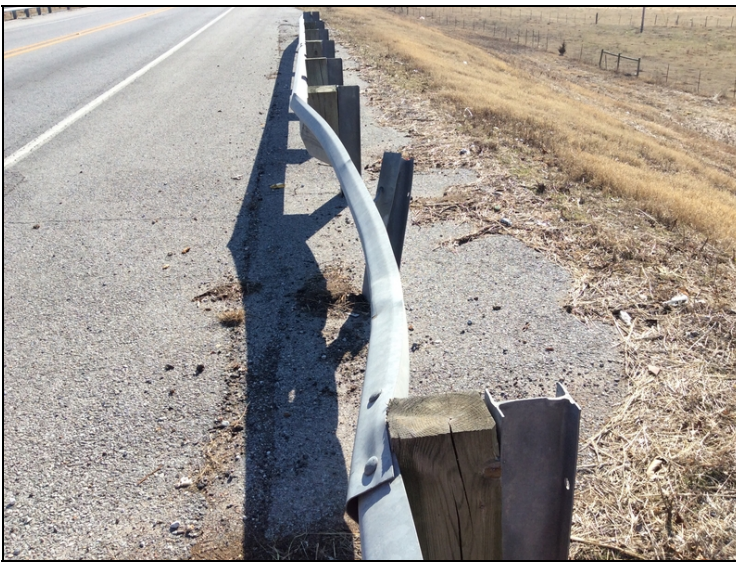
South approach railing - The Southwest railing has collision damage that has broken the railing loose from one post and caused out-of-plane bending in a section of the railing that has created a "pocket" in the railing.

Southwest approach railing-Collision damage that has created a pocket in the railing.

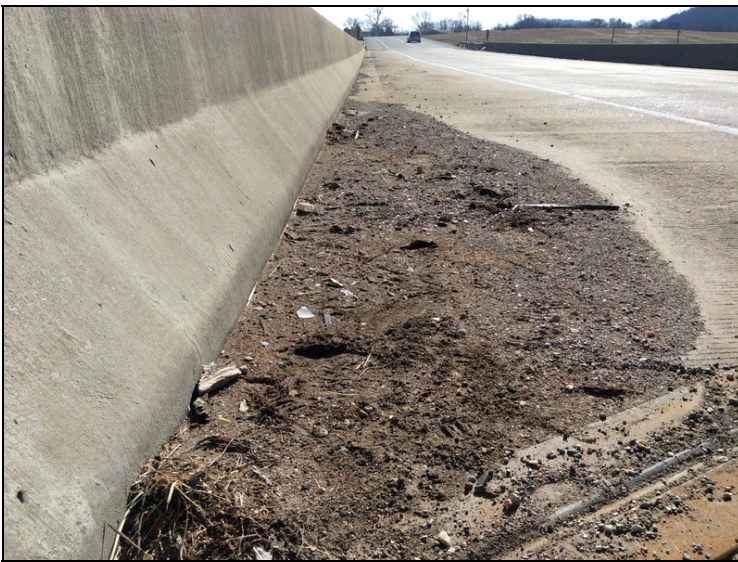
Deck - The gutters on the right and left sides of span #1 have moderate dirt and debris accumulation near North bridge end.

The gutters in span #1 have dirt and debris accumulation near North bridge end.
