Bridge #06996(Routine)
SH 59 Benton 2 over KCS RR and BUTLER CREEK

Location: 5.9 MI N JCT SH 72 & 59

Team Lead: Tommy Dohn Inspection Date: April 21, 2016

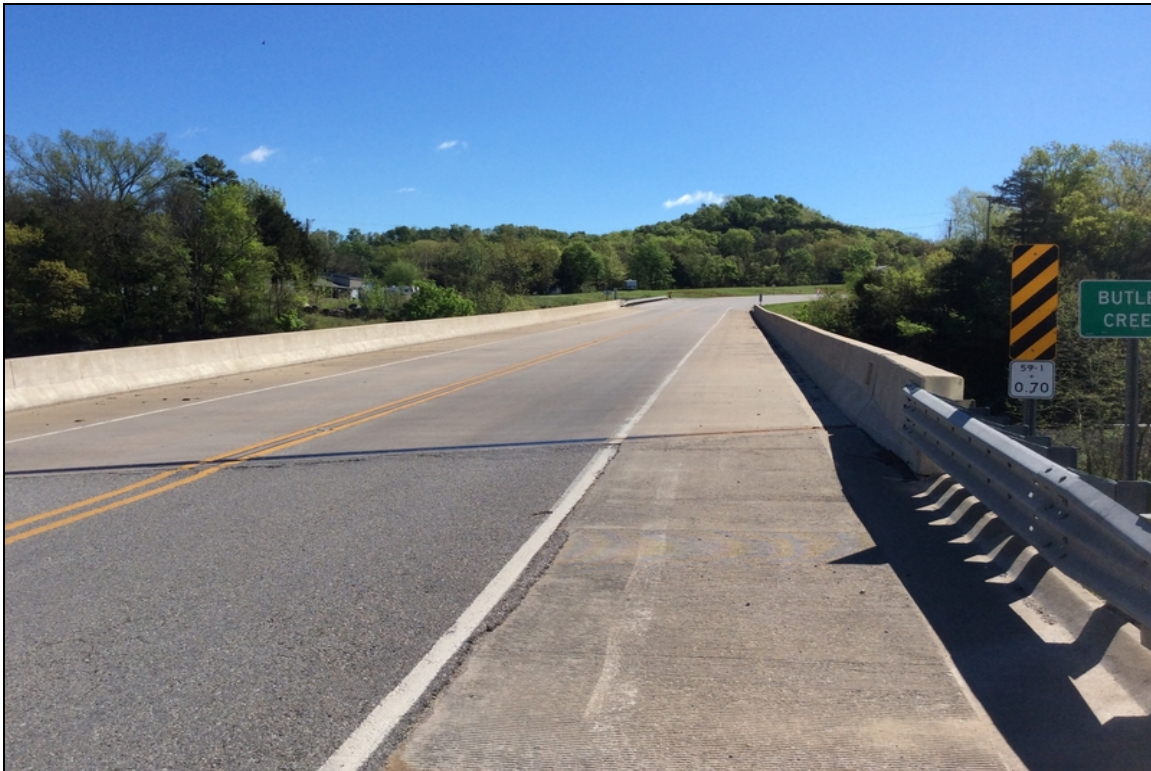
Approach view in direction of log mile.
