Asset #01003(Routine)

SH 7 Boone Co. over MO. & NO. AR R.R.

Location: NORTH CITY LIMITS BERGMAN

Team Lead: Benjamin Smith, Inspection Date: 09/19/2022

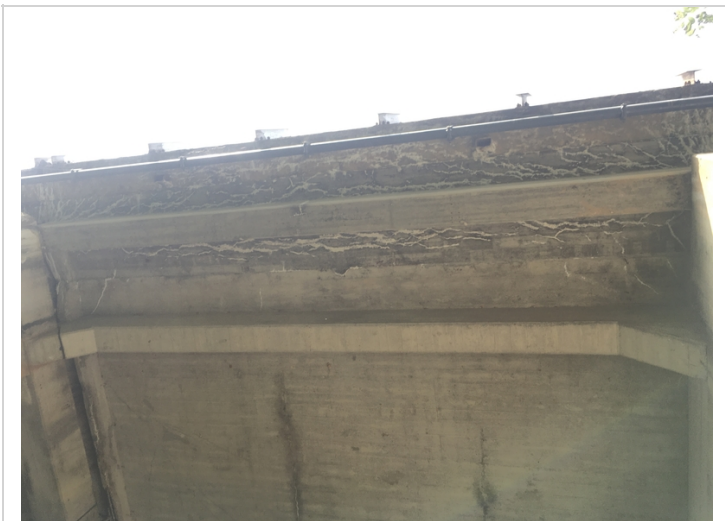
Span #1- the left deck overhang has heavy map cracking with efflorescence for a length of 28' and on the interior side of beam #1 for the length of the span (28'). The diaphragm over bent #1 has spalling with exposed rebar.

Typical view of efflorescence cracking in the left and right deck edges.

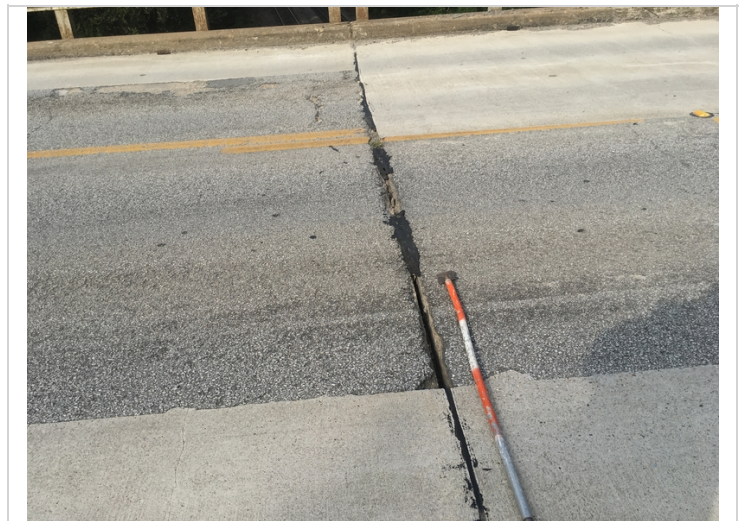
(301) Abutment #1 pourable seal has 29' of impaction.							
Bent #1 pourable seal has 7' of impaction.							
Bent #2 pourable seal has 5' of impaction and 6' of cs4 leakage.							
Bent #3 pourable seal has 4' of cs2 leakage.							
Abutment #2 pourable seal has 29' of impaction.							
311	Movable Bearing	EA	2	0	2	0	0
1000	Corrosion	EA	2	0	2	0	0

Typical view of joint seals.

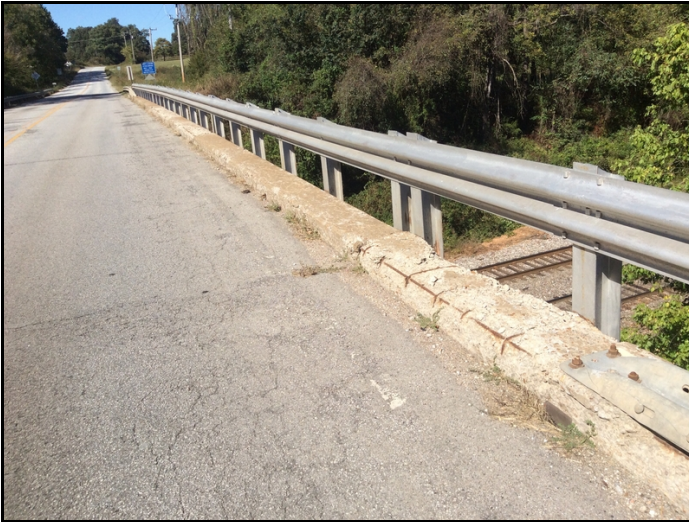
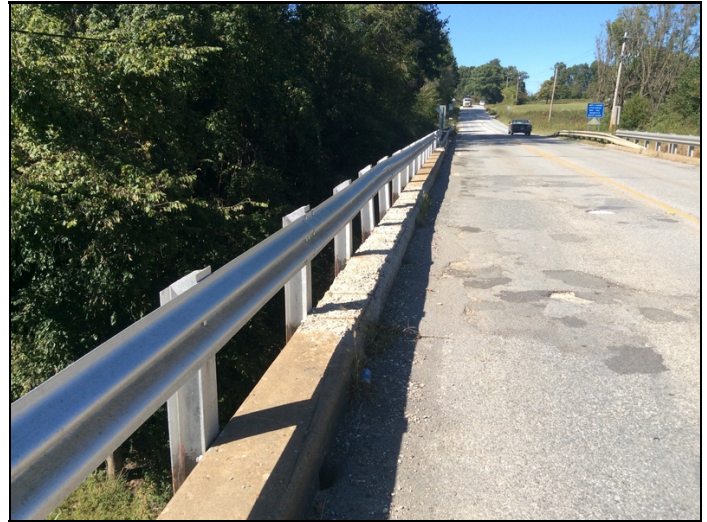
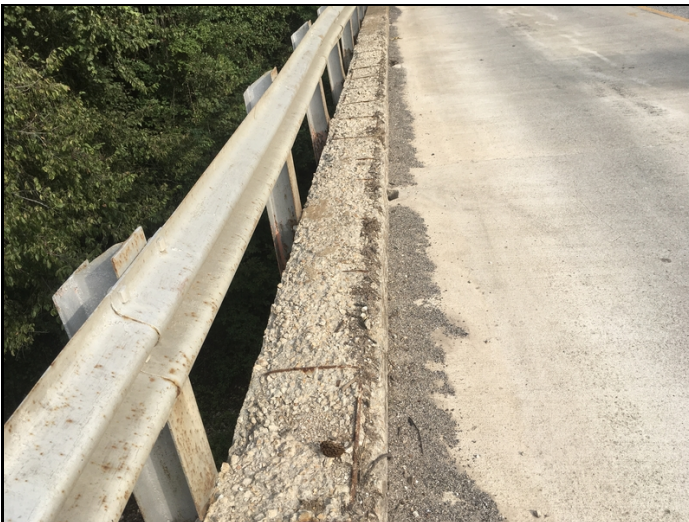
Right lane- has 917' of sound concrete patched areas in the gutter line. The curb has 48' of exposed rebar with 115' of spalling and deterioration. The deck at the joint area at the end of span #1 is in contact with the beginning of span #2, this condition is visible on the right curb section.

Left lane- has 1,348' of sound concrete patched areas in the gutter line. The curb has 68' of spalling and deterioration with 61' of exposed rebar.

The left & right side curb sections are deteriorating with areas of exposed rebar at spans #1 #3 & #5.

View of deterioration with exposed rebar in the left and right curb sections.

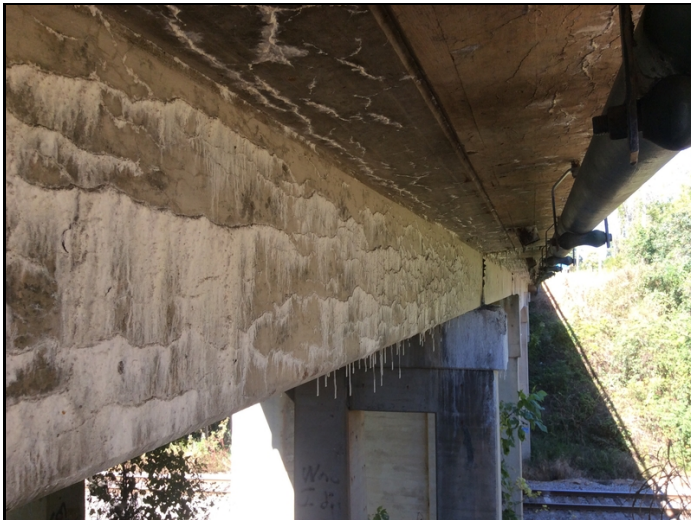
Tee beams #1,4 have a heavy concentration of efflorescence map cracking at most locations.
Span #3 concrete girders have minor deterioration with random efflorescence cracking in the tee beams.

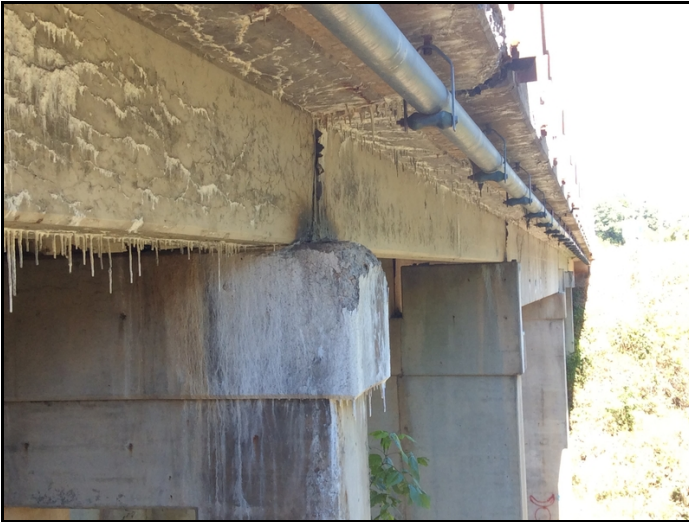
The right end of the bent #1 cap has concrete deterioration for 2'.

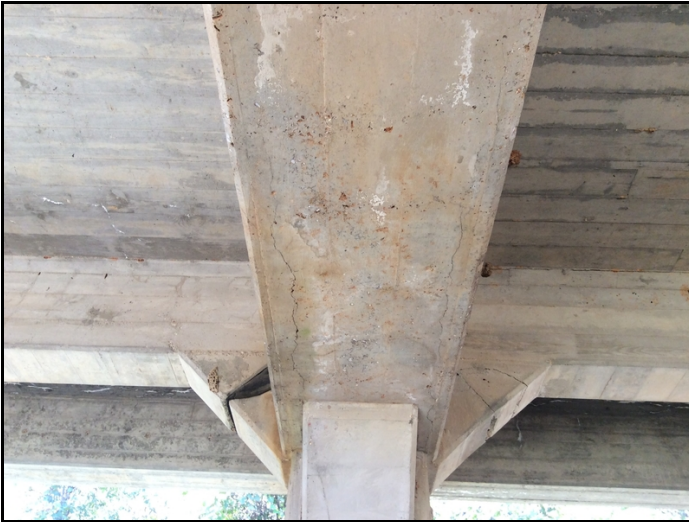
The bent #4 cap has longitudinal de lamination on the vertical face and under surface of the cap.

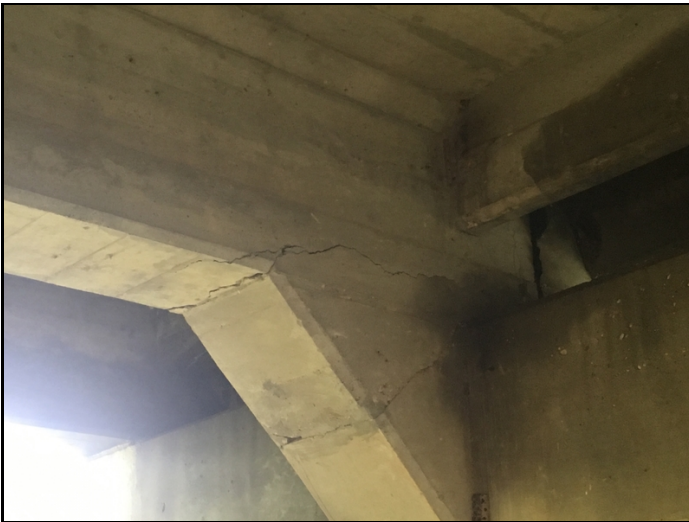
Tee beams #2,3 both have a 3' long longitudinal crack that extends from over bent #4 into span #5.

3' long horizontal crack at the beginning of span #5 in beam #3. Beam #2 also has the same crack at the same location.

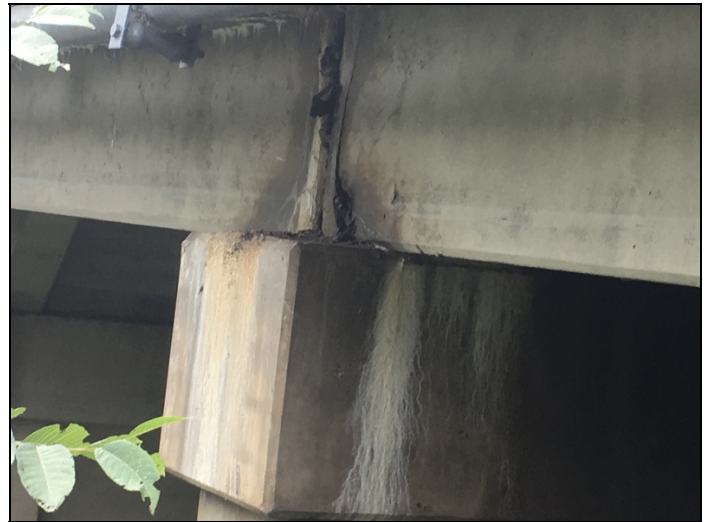
Tee beam #4 has a vertical delamination at the beginning of span #5 over bent #4.

Vertical delamination on beam #4 at the beginning of span #5 over bent #4.

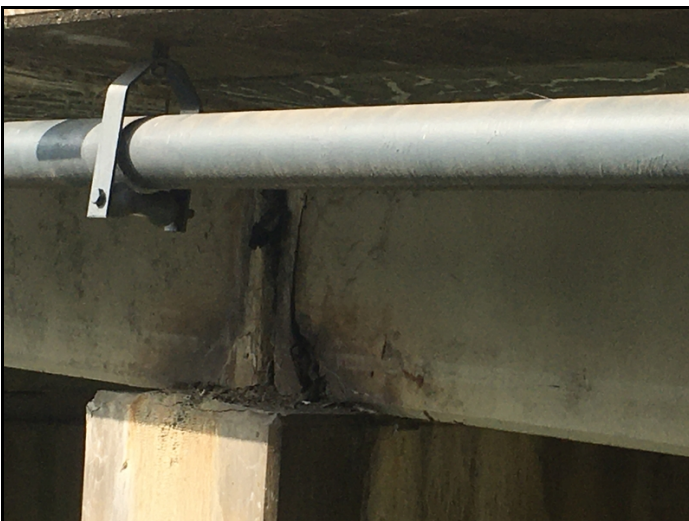
Vertical delamination on tee beam #4 over bent #4.
