Asset #01396(Routine, Underwater type 2)

SH 7 Boone Co. over E. SUGAR LOAF

Location: 4.25 MI SW JCT OF SH 14

Team Lead: Benjamin Smith, Inspection Date: 09/19/2022

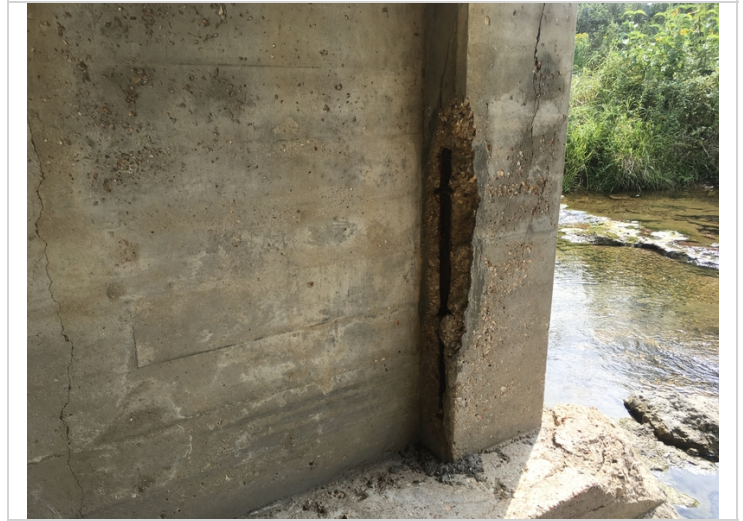
205	Reinforced Concrete Column	EA	4	0	0	4	0
1090	Exposed Rebar	EA	4	0	0	4	0
<p>(205) Bent #1 columns-</p> <p>Right column-The right column has a large spall with exposed vertical rebar and moderate width vertical cracking. The exposed rebar has initial section loss.</p> <p>Left column- has a small spall with exposed rebar at the top of the column on the span #2 side.</p> <p>Bent #2 columns-</p> <p>Left column- has a 14" spall with exposed rebar below the bent cap on the span #3 side.</p> <p>Right column- has a large delaminated area on the span #3 side.</p>							
210	Reinforced Concrete Pier Wall	LF	38	16	20	2	0
1080	Delamination/Spall/Patched Area	LF	2	0	0	2	0
1130	Cracking (RC and Other)	LF	20	0	20	0	0
<p>(210) The pier wall consists of 13' of web wall between the columns, and 6' of pier wall on the left side of column #1.</p> <p>Pier wall #1- has 9' of diagonal and vertical hairline cracks. The footing is exposed for the length of the wall, but is cast on solid rock.</p> <p>Pier wall #2- has 11' of vertical and horizontal hairline cracking and a 2' patched area on the span #2 side.</p>

Right column of bent #1 has a spall with exposed rebar.

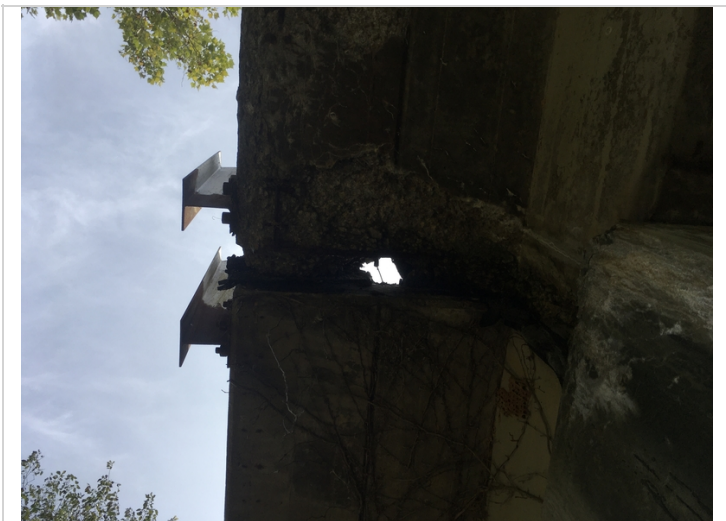
301	Pourable Joint Seal	LF	54	0	42	11	1
2310	Leakage	LF	12	0	0	11	1
2350	Debris Impaction	LF	42	0	42	0	0
<p>(301) Bent #1 pourable seal- has 5' of cs3 leakage and 1' of cs4 leakage. It has 21' of debris impaction.</p> <p>Bent #2 pourable seal- has 6' of cs3 leakage and 21' of debris impaction.</p>							
311	Movable Bearing	EA	6	6	0	0	0
<p>(311) Moveable bearings- No noteworthy deficiencies at this inspection.</p>							
330	Metal Bridge Railing	LF	210	0	210	0	0
1000	Corrosion	LF	210	0	210	0	0
515	Steel Protective Coating	SF	630	315	0	315	0
3440	Effectiveness (Steel Protective Coatings)	LF	315	0	0	315	0

The pourable joint seal has Cs4 leakage at the bent #1 left deck edge.

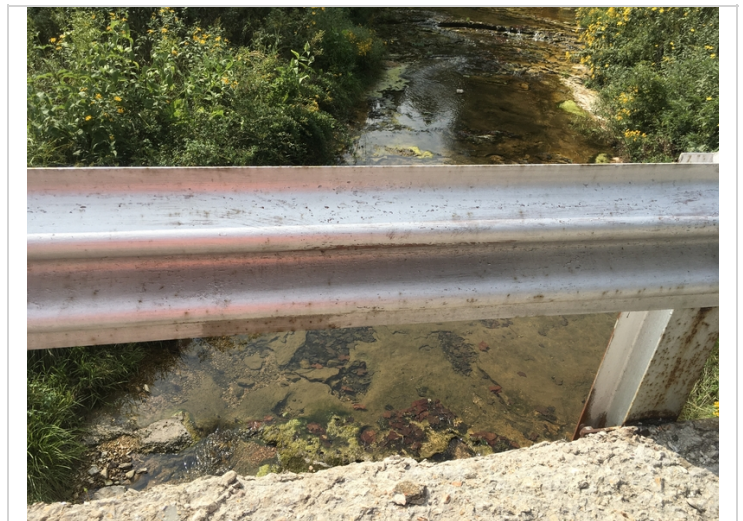
ELEMENTS	DESCRIPTION	UNITS	TOTAL	CS1	CS2	CS3	CS4
	(330) Left side- has freckled rust forming on the front side. Back side has corrosion. The lower portion of the bridge rail posts have not been repainted and have a rust coating.						
	Right side- has freckled rust forming on the front side. Back side has corrosion. The lower portion of the bridge rail posts have not been repainted and have a rust coating.						
	Approach railing- no deficiencies noted.

Freckled rust beginning to form on front side of railing.

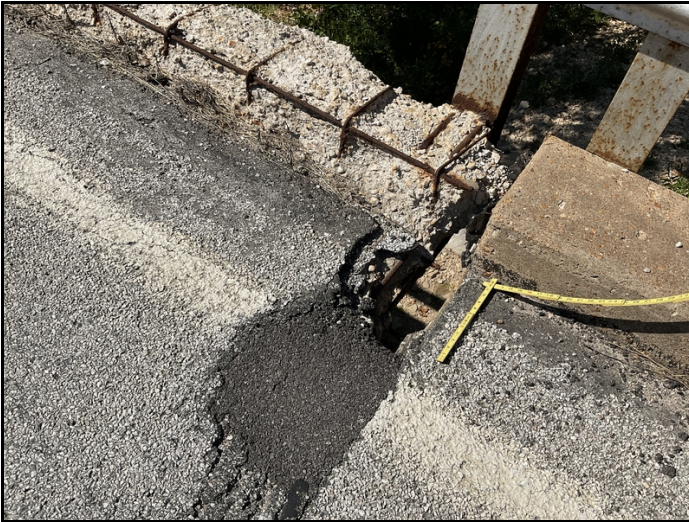
The deck at the joint area at bent #1 has a full depth failure in the gutter line of the left lane at the end of span #1.

Spalling in the left lane at the end of span #1.

Priority: B - Pressing

Type of Work: Repair (General)

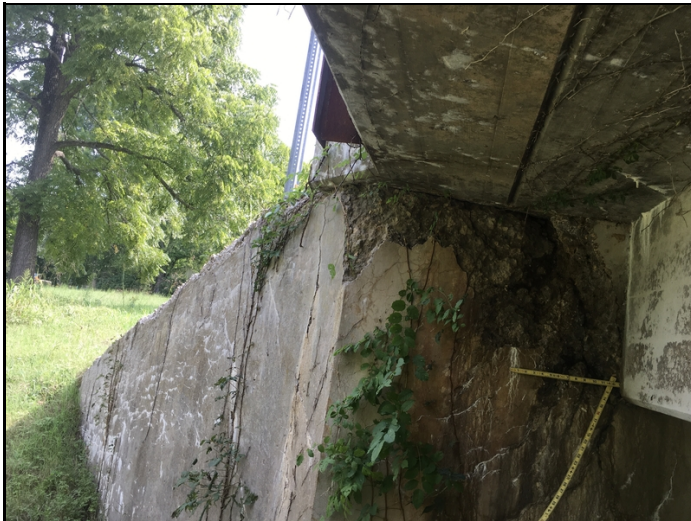
Abutment #2 has a large area of concrete deterioration, map cracking with efflorescence and spalling on the left side of stem wall adjacent to tee beam #1. The left wing wall has heavy map cracking with concrete deterioration and spalling along the top of the wing wall.

Abutment #2 has a large area of deteriorated concrete with efflorescence map cracking next to beam #1. The left wing wall has heavy map cracking with concrete deterioration and spalling along the top of the wing wall.

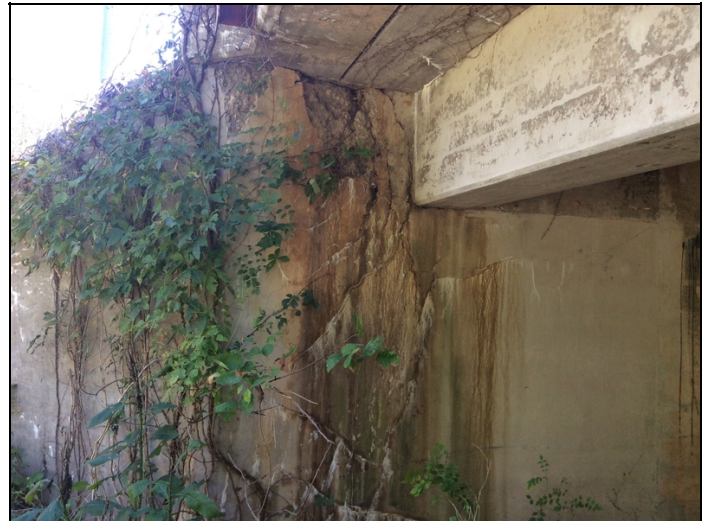
Abutment #2, Left side, Concrete deterioration with mapcracking and spalling.

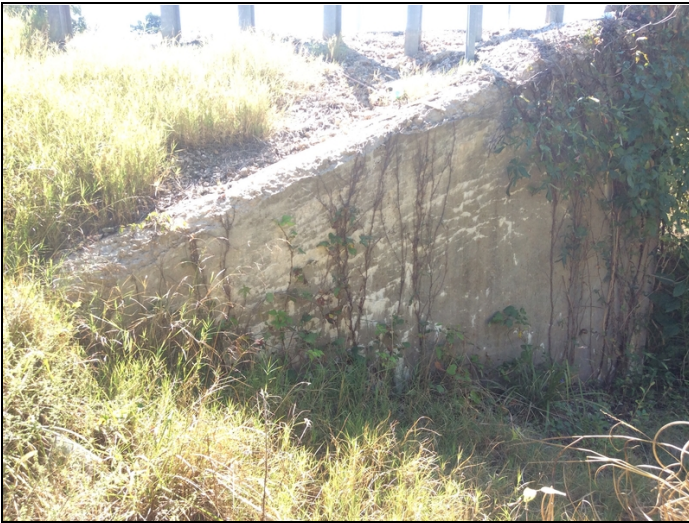
Northwest wing wall, Concrete deterioration and spalling

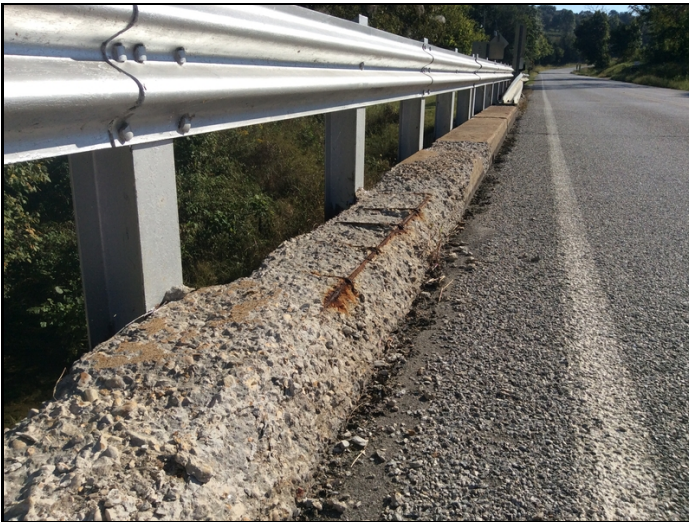
The concrete curb sections on the left and right sides of the structure have large areas of concrete deterioration and spalling with exposed rebar.

Span #2, Left side, concrete deterioration / spalling with exposed reinforcing steel to curb.

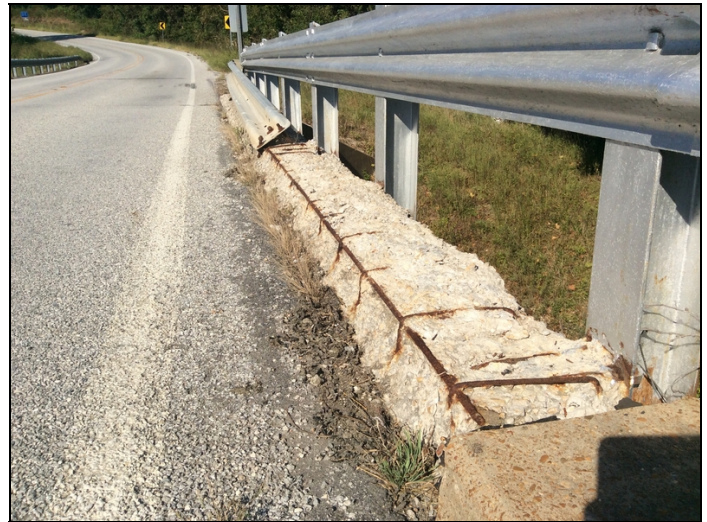
Span #1 concrete curb, Left side, concrete deterioration with exposed reinforcing steel to curb.

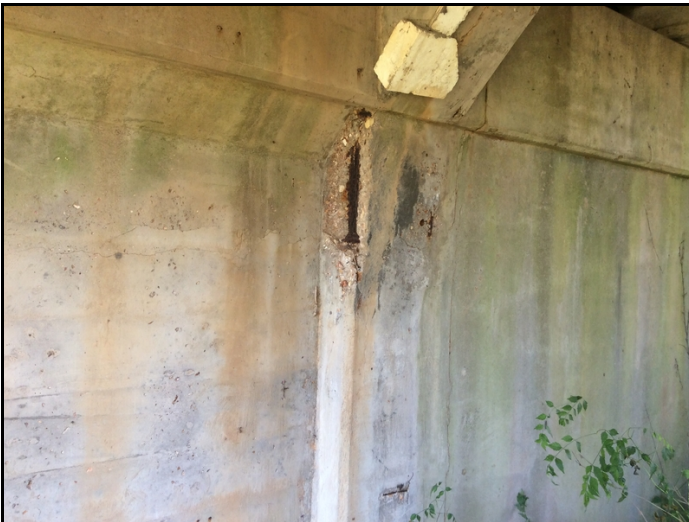
Bent #2- the left column has a 14" spall with exposed rebar below the bent cap, the right column has a spall with rebar exposed on the span #3 side.

Bent #3, column #1 has a 14" spall with exposed primary reinforcing steel below bent cap.

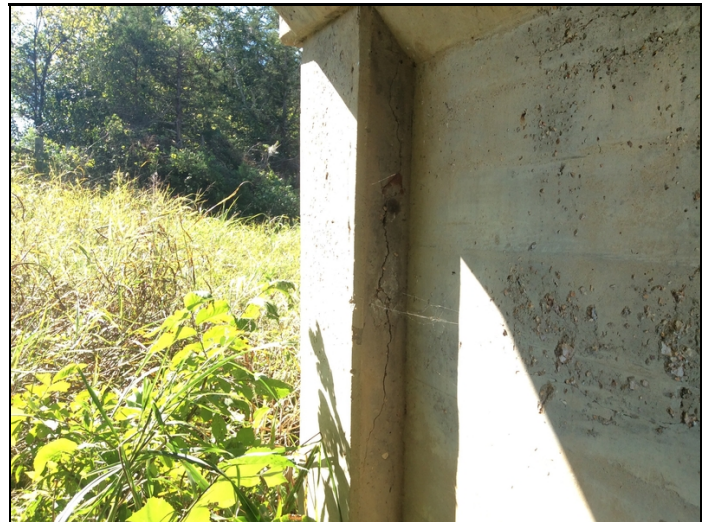
Bent #3, Right column, large delaminated area.

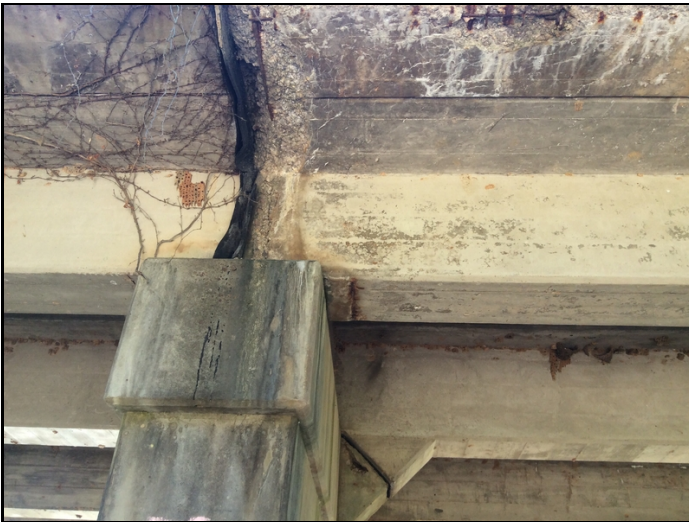
Tee beam #1 in span #1 has an area of spalling with rebar exposed over bent #1.

Girder #1 of span #1 over bent #2 has an area of spalling.

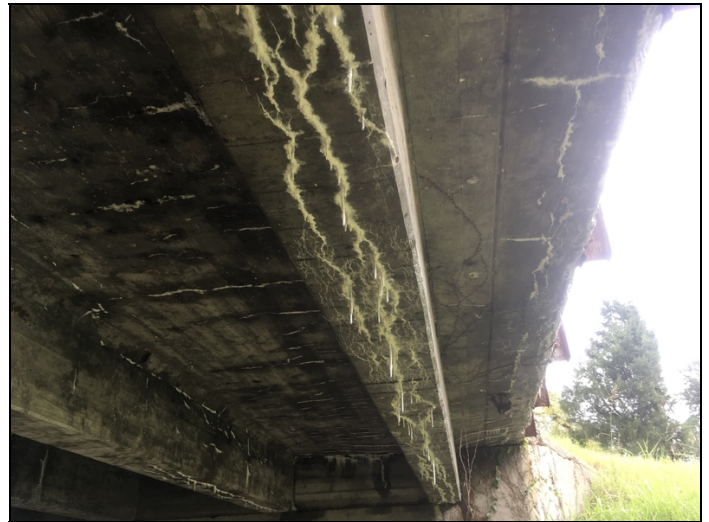
Tee beam #4 has heavy efflorescence map cracking in spans #1,3.

Right over hang and undersurface condition of beam #4 in span #3.
