Asset #M0205(Routine)

SH 7 Boone over SUGARLOAF

Location: 15.59 MI NE JCT US 65

Team Lead: Benjamin Smith, Inspection Date: 07/05/2022

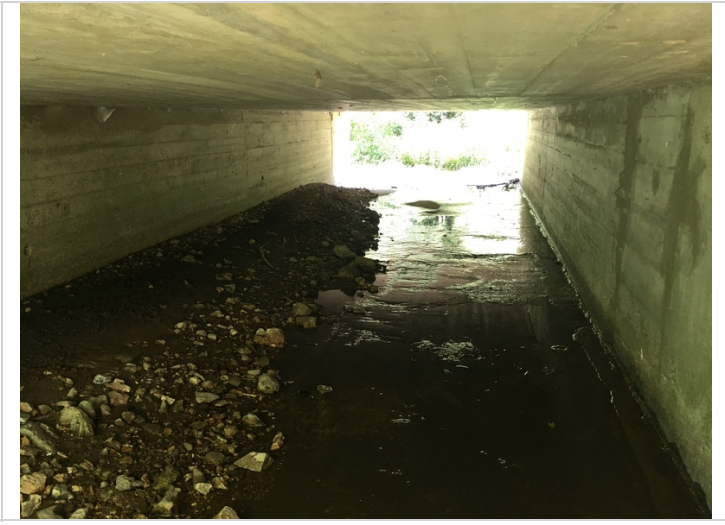
Barrel interior condition.

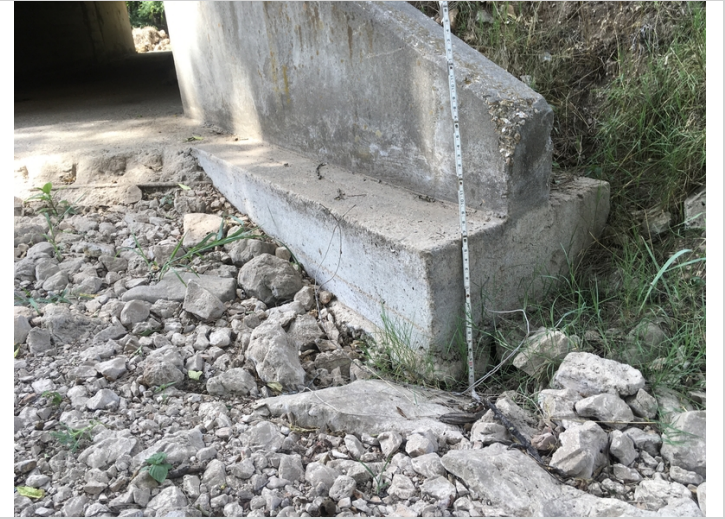
The right wing wall of barrel #2 has up to 17" of the vertical face of the footing exposed.

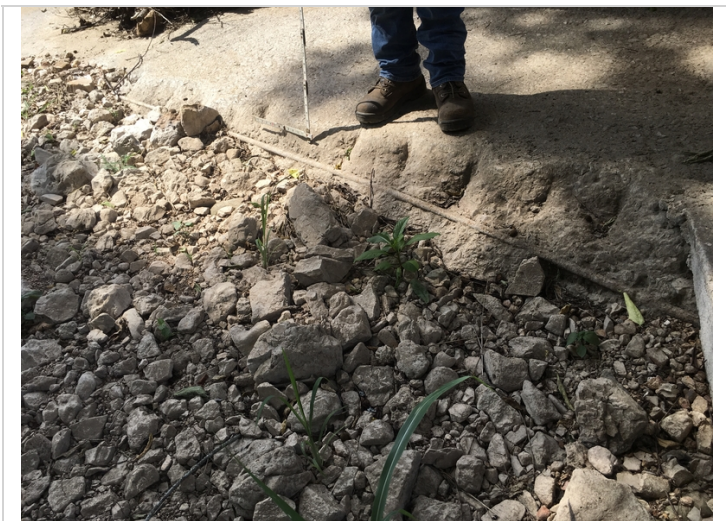
Exposed rebar in the edge of the bottom slab at the inlet end of barrel #2.

The inlet end of the bottom slab of barrel 2 has spalling with exposed rebar.

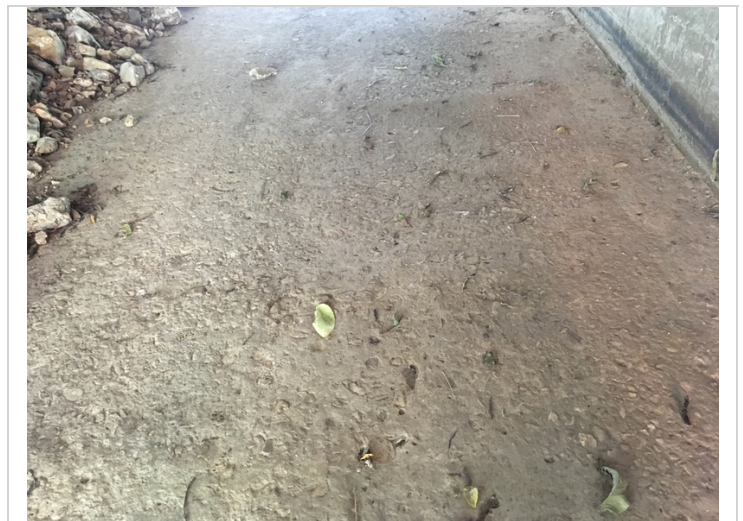
(241)							
Barrel #1- has 2' of hairline vertical cracking in the back wall and 34' of cs2 abrasion in the visible portion of the barrel floor. The floor has 12" to 18" of stream bed material build up for most of the floor. No cracking noted in top slab. No deficiencies noted on right or left wing walls.							
Barrel #2- has 1' of hairline vertical cracking in the back wall and 35' of cs2 abrasion in the barrel floor. The barrel floor has 8" to 12" of stream bed material build up along the back wall. Barrel #2 has 1' of cs3 exposed rebar in the edge of the bottom slab at the inlet end. No cracking was noted in top slab. No deficiencies were noted on the left wing wall. The right wing wall has up to 17" of the vertical face of the footing exposed with minor embankment erosion behind the wall.							
The right head wall has a spall with no rebar exposed at the top corner over barrel #2. No deficiencies noted on the left headwall.

Abrasion in barrel floors.

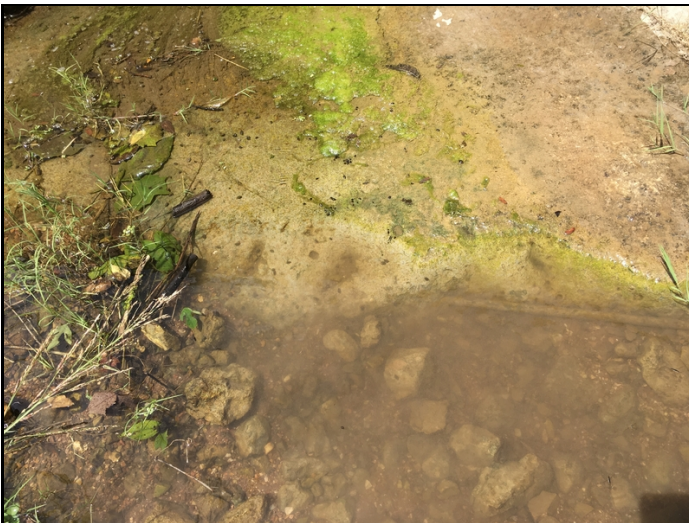
The inlet of barrel 2 has spalling with exposed rebar in the barrel floor.

Type of Work: Repair (General)
