Bridge 03870 Inspection Report

AR 12 Madison Co. over STANLEY CREEK

Location: 1.2 miles West of CLIFTY

Team Lead: Benjamin Smith Inspection Date: 01/09/2026

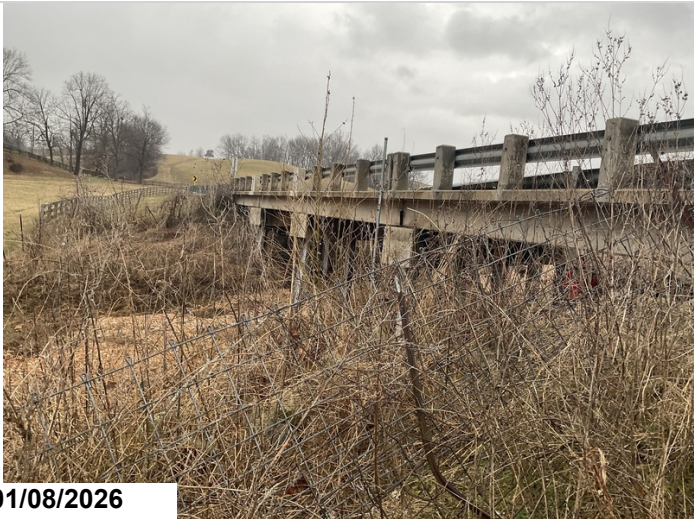
Elevation view.

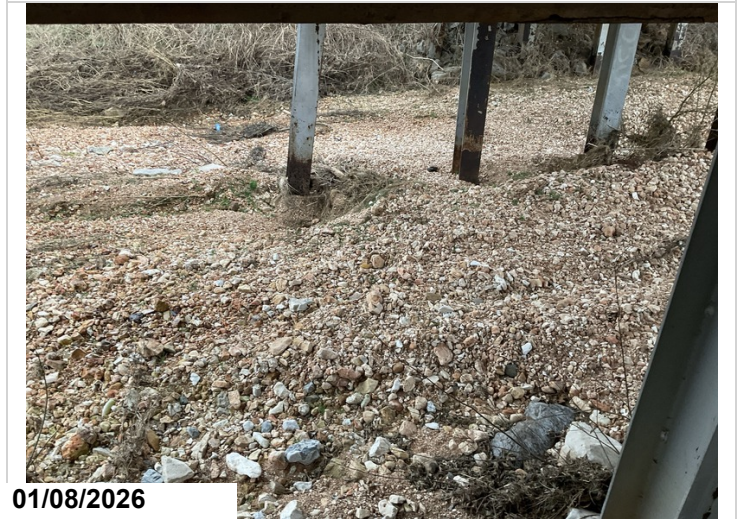
The channel beneath the structure flows mainly in spans #2,3. The channel has minor local scour near bent #2. Abutments #1,2 have large rock channel protection on the slopes.

Channel beneath the structure.

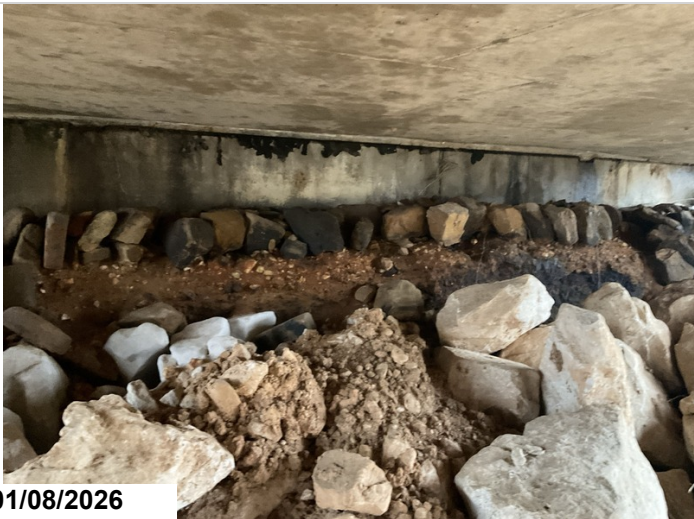
Abutment #1 general view.

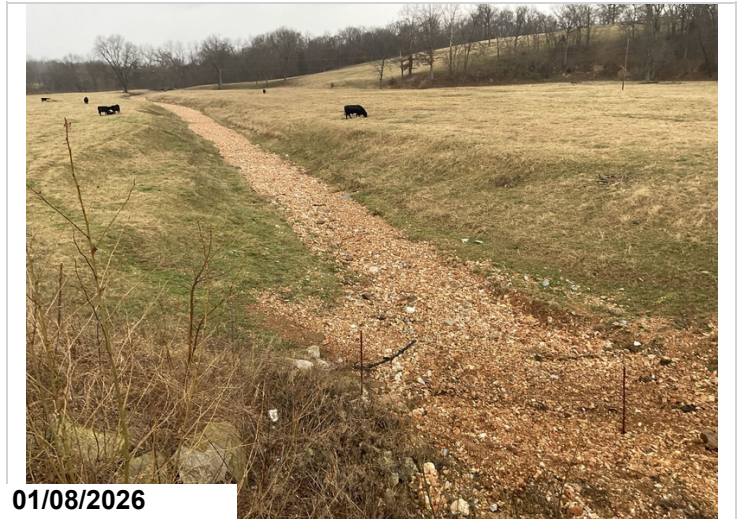
The downstream channel is well vegetated. The channel alignment is good.

Downstream channel view.

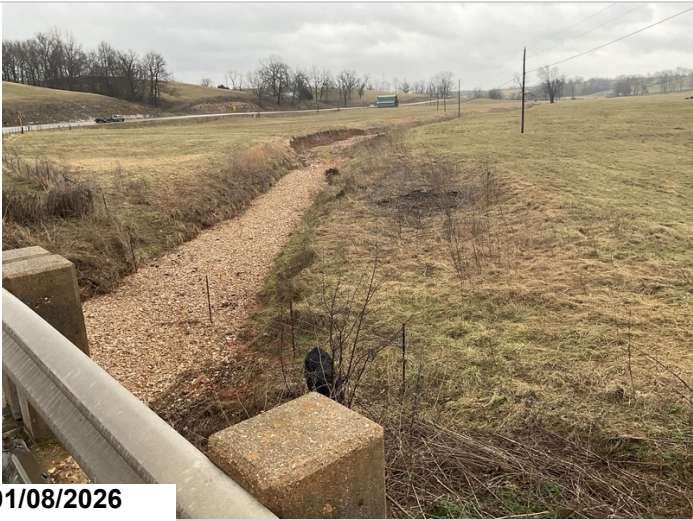
The upstream channel is mostly vegetated. The channel banks far upstream have erosion and bank slumping. The channel alignment is good.

Upstream channel view.

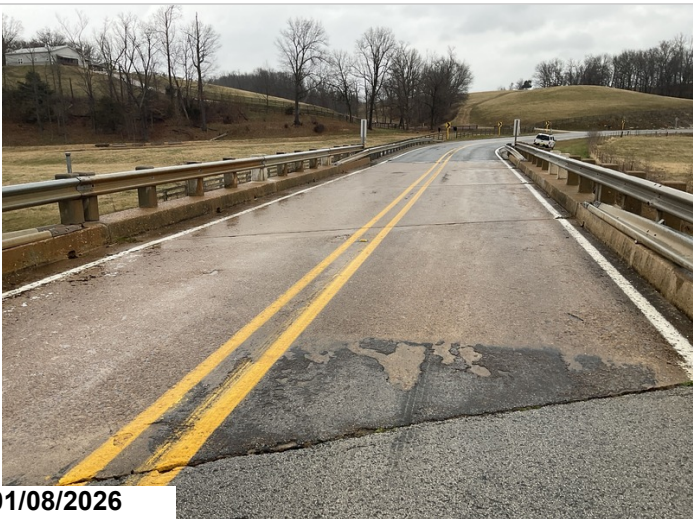
The deck is in satisfactory condition with spalling, pop outs and abrasion in the driving surface

Driving surface view.

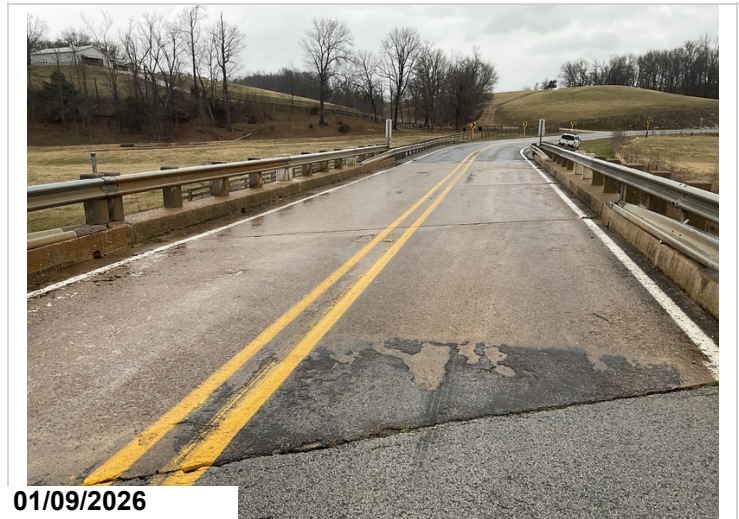
Driving surface view.

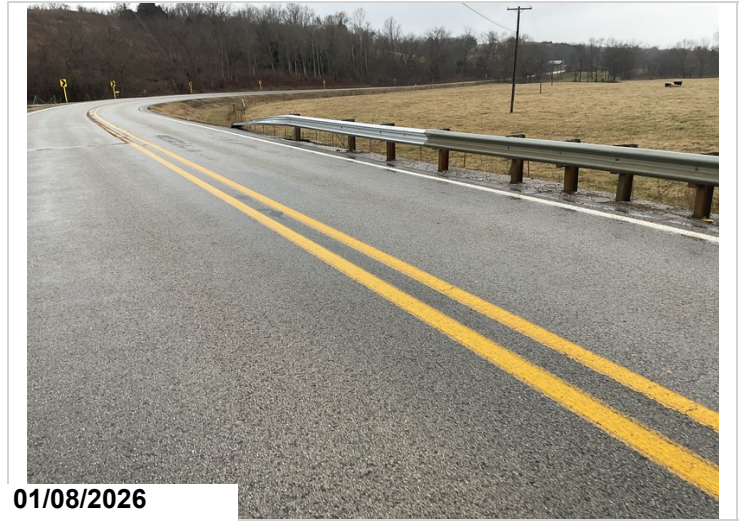
Beginning left approach railing replaced.

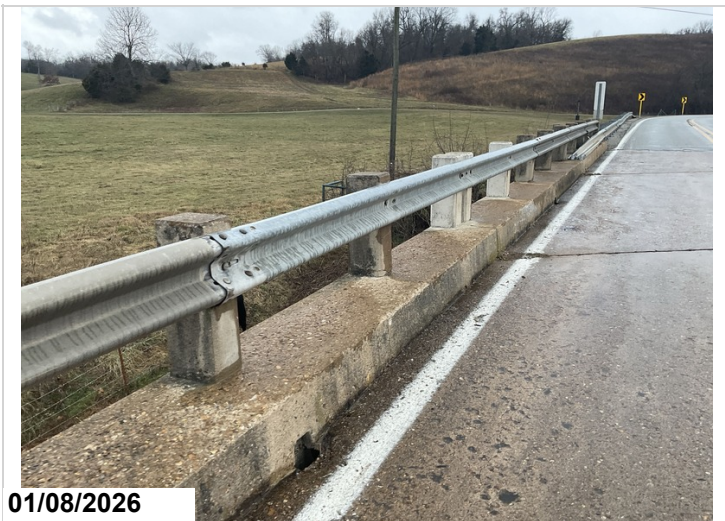
The collision damage has been repaired.

Collision repair on the right railing.

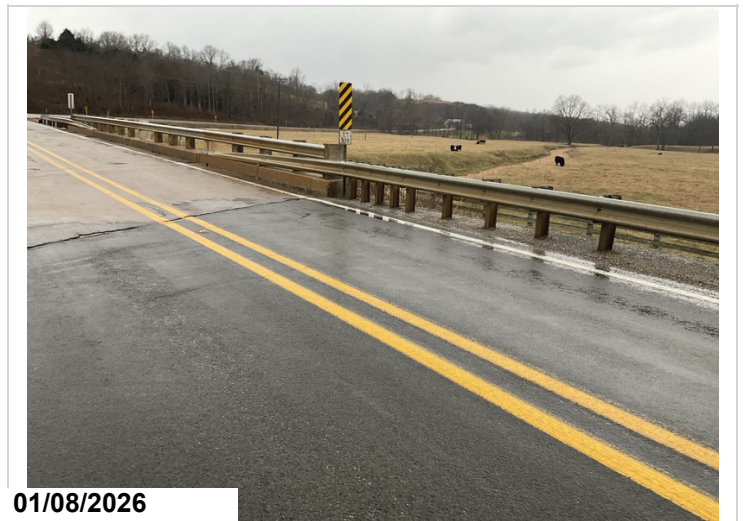
Transition area.

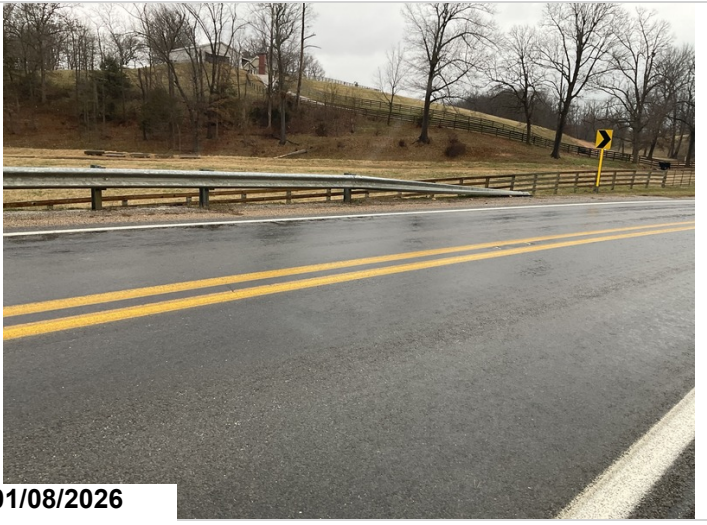
Typical approach rail end treatment.

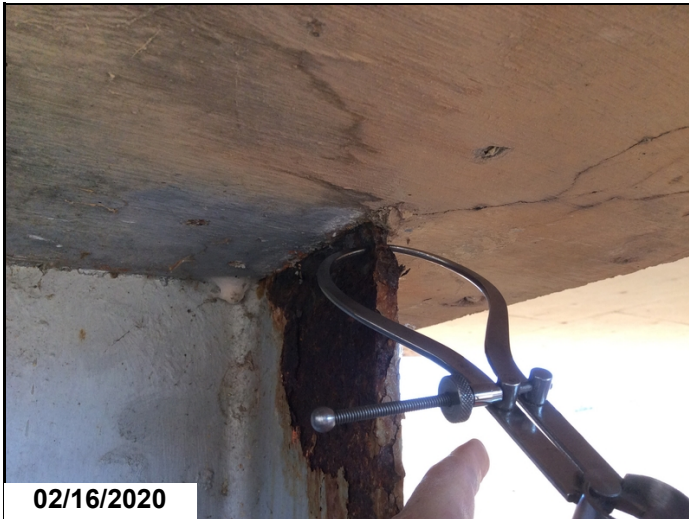
02/16/2020

Substructure - Steel piling has a failing paint system with active corrosion at the cap interface and at the bases. The flanges of piling at the cap interface have section loss that ranges from initial up to 1/4". The bases of piling have flaking rust with moderate pitting in some locations.

1/4" section loss bent #2 pile #2 at cap interface.

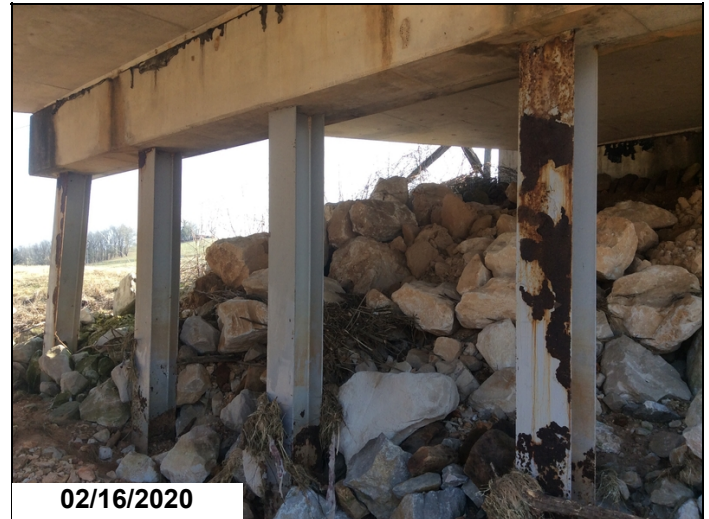
02/16/2020

Bents #2 thru #4 steel piles
Visible rust and corrosion.

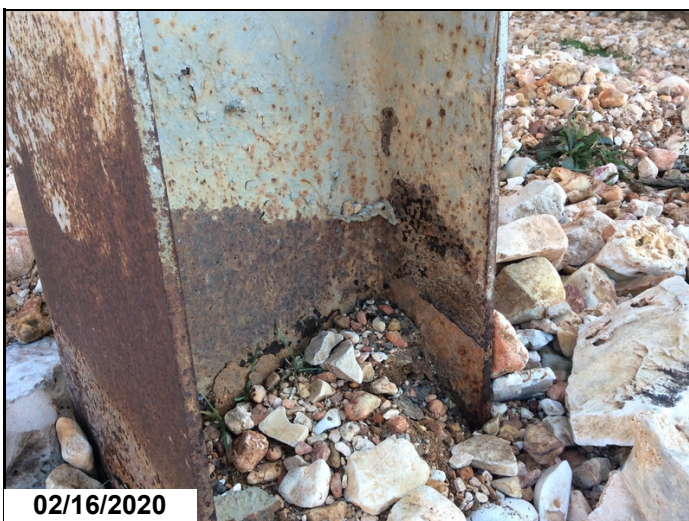
02/16/2020

Bent #2, pile #1-Pitting to flanges at base.

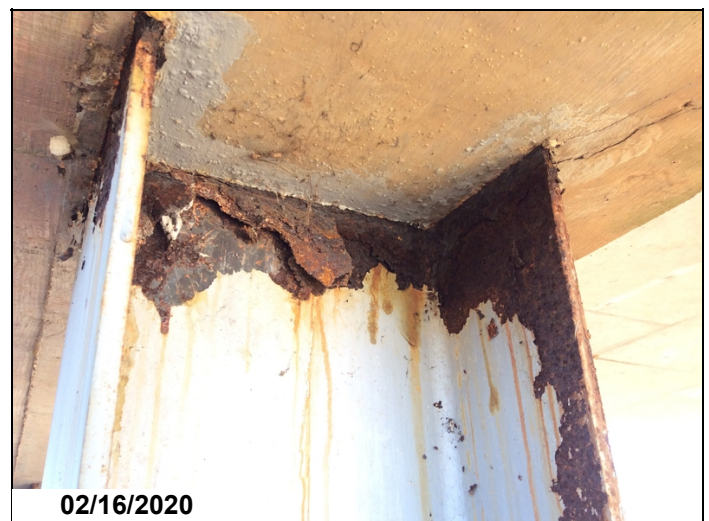
02/16/2020

Bent #1, pile #4-Corrosion with section loss at cap
interface.

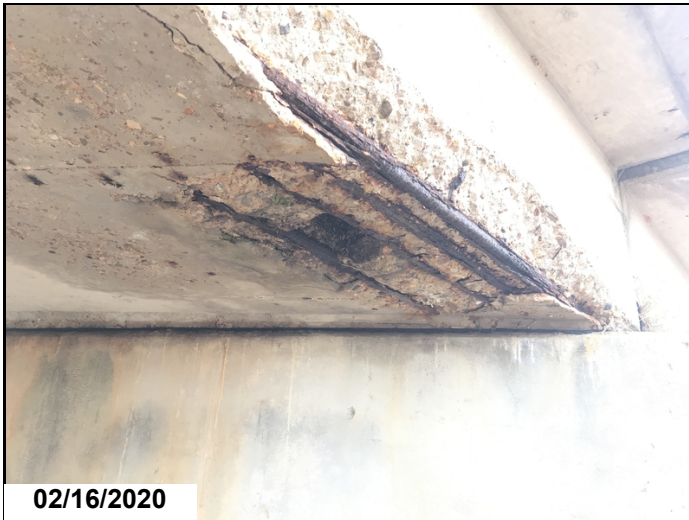
Slab - The undersurface of the slab has delaminated and spalled areas with exposed reinforcing steel around the deck drains.

Typical view of steel exposed around deck drains.

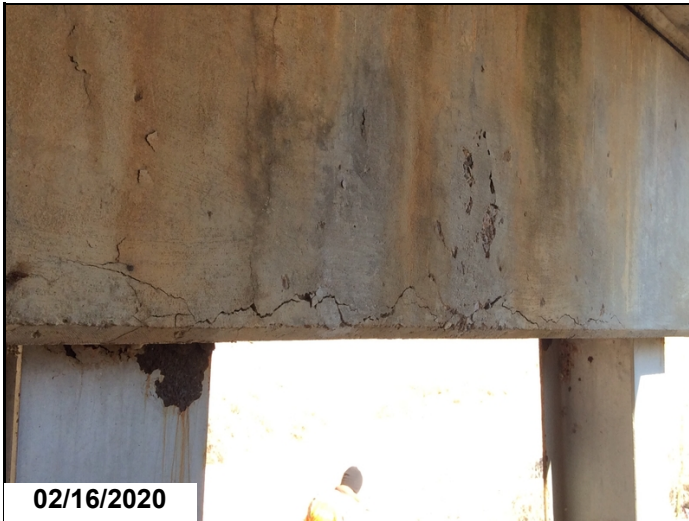
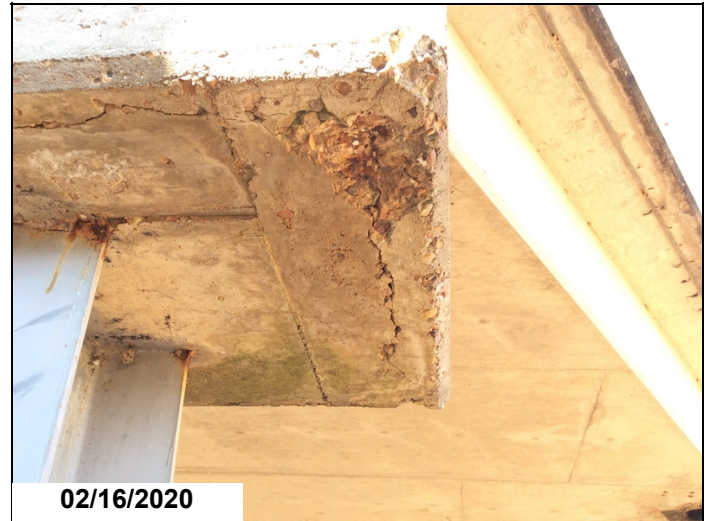
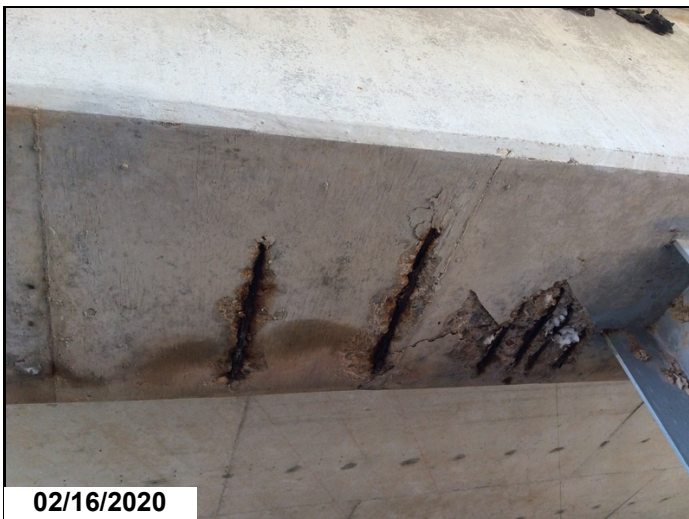
Bent #3 between pile #2 and #3

Bent #3 cap- has 11' of delaminated areas CS3 along the base of the ahead side with 4' of exposed rebar CS3 on the undersurface. The span #3 face has 1' of delamination CS3, 1' of cracking CS2.

Substructure - Bent caps have delaminated and spalled areas. The most notable area is bent #3 which has delaminated areas along the bottom edge of the ahead side and delaminated and spalled areas in the undersurface. The undersurface between piles #2 and #3 has several spalls that expose reinforcing steel with section loss.

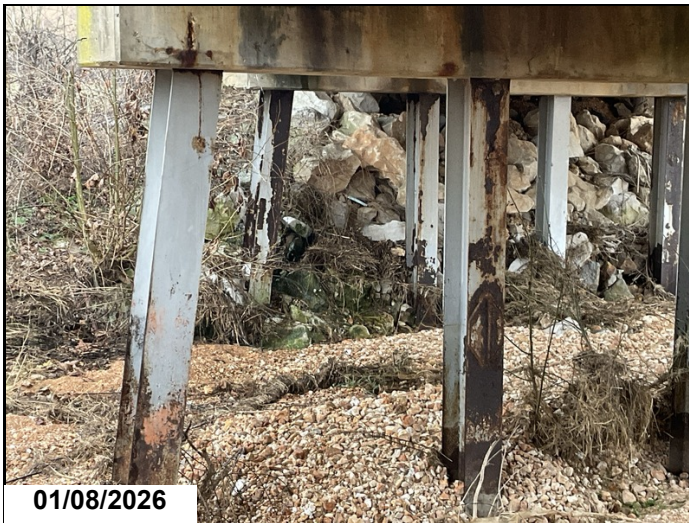
East embankment - The East embankment has an area of erosion with rip-rap displacement near bent #1

Rip rap has been replaced at abutment #1.

Large rock has been placed on the embankment.

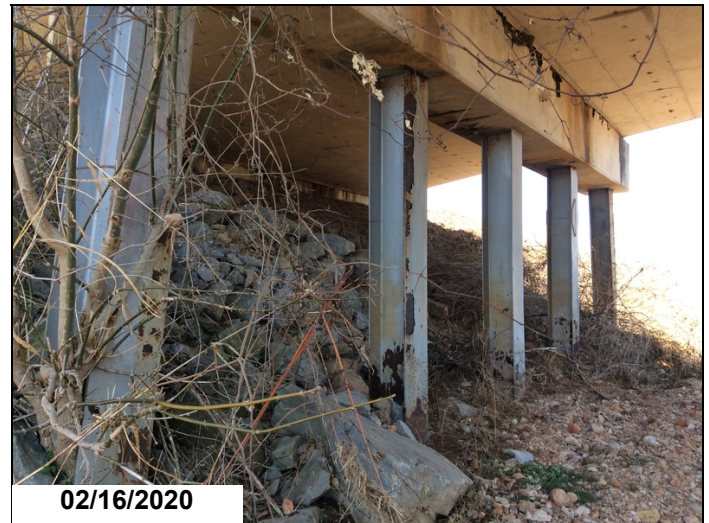
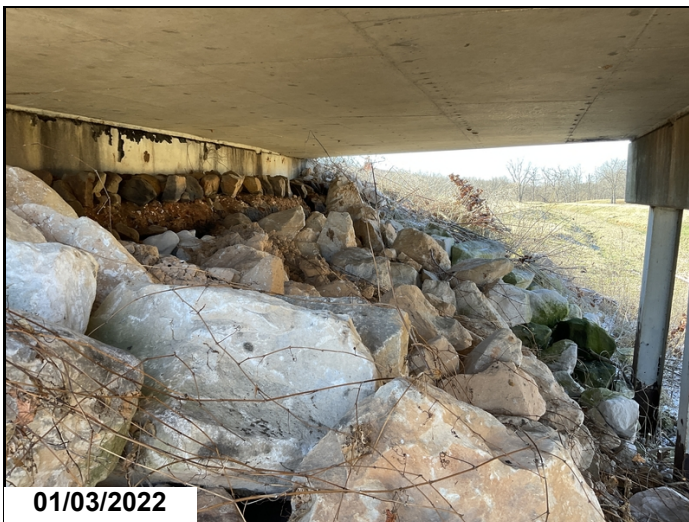
Embankment at abutment #1 settlement.

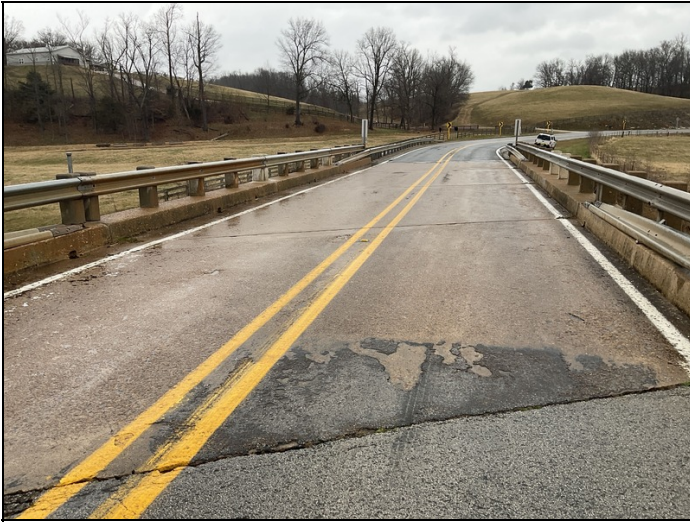
Driving surface view.

A-61 - Polymer Overlay Advised (Yes)
