## Bridge 03871 Inspection Report

**AR 12 Madison Co. over STANLEY CREEK**

**Location: West of the CITY LIMITS of CLIFTY, ARK.**

**Team Lead: Benjamin Smith Inspection Date: 01/13/2026**

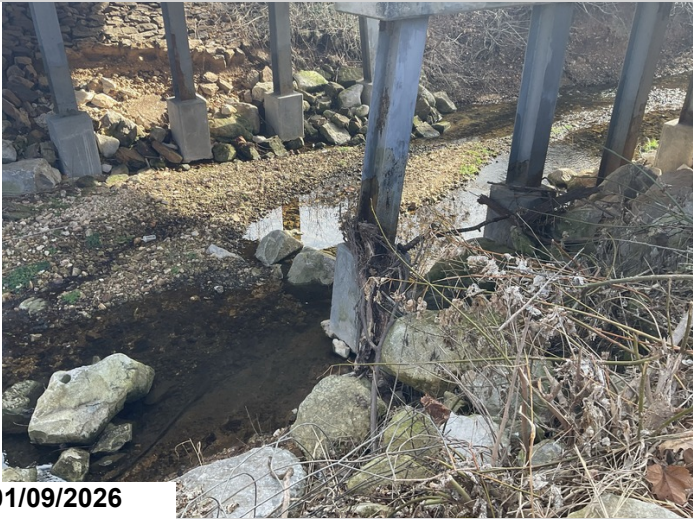
The channel beneath the structure flows mainly in span #2. The abutment slopes have rip rap. The abutment #2 slope has an 8' by 23' area of rock displacement.

Channel beneath the structure.

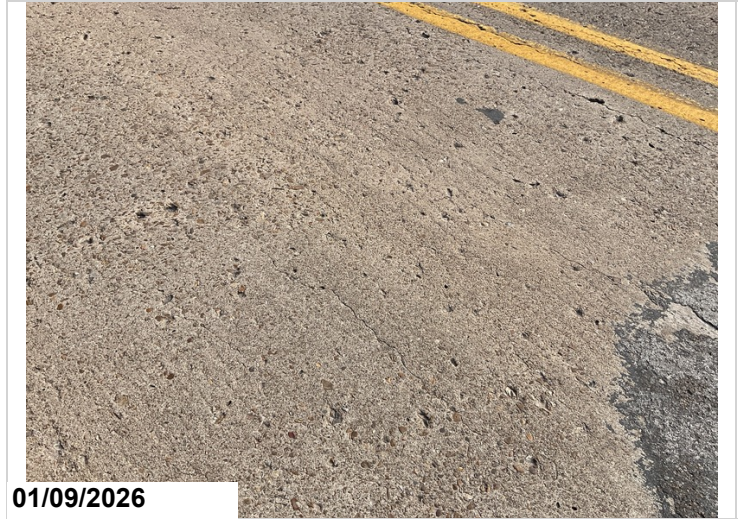
The deck is in satisfactory condition with a few asphalt patched areas and spalling with unsealed cracking.

Unsealed cracking in the deck.

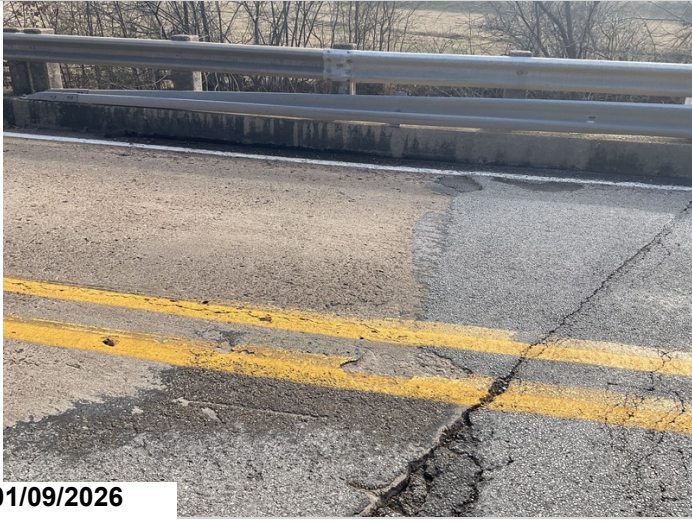
Typical asphalt patched areas in the deck.

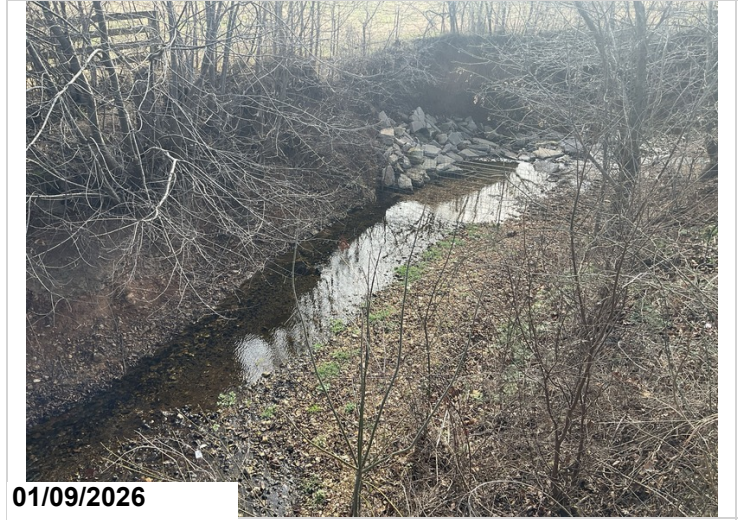
The downstream channel banks have erosion and slumping.

Downstream channel view.

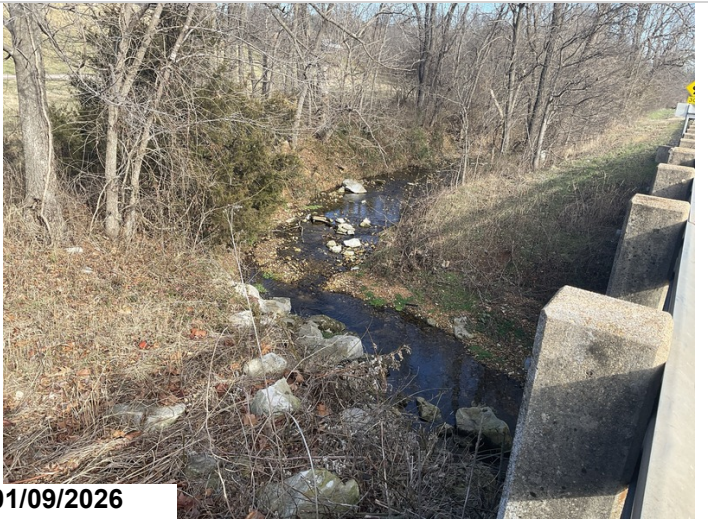
The upstream channel banks have erosion and slumping. The channel alignment is poor and swings toward abutment #1.

Upstream channel view.

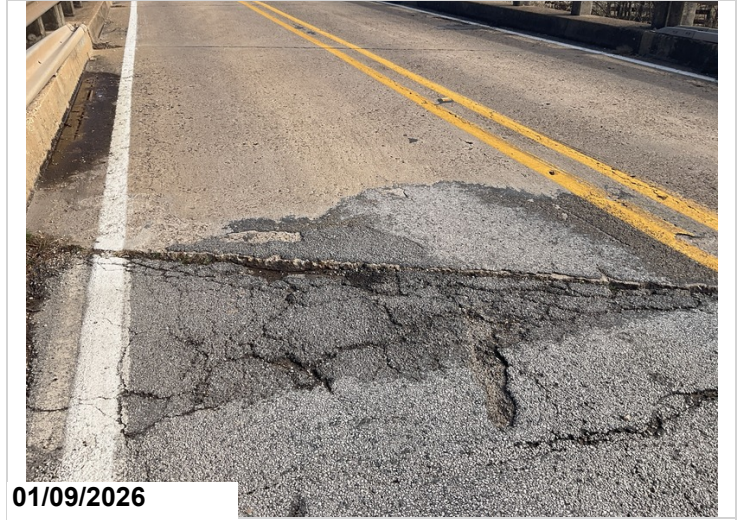
The beginning left lane at abutment #1 needs leveling.

Approach leveling needed at the beginning left lane.

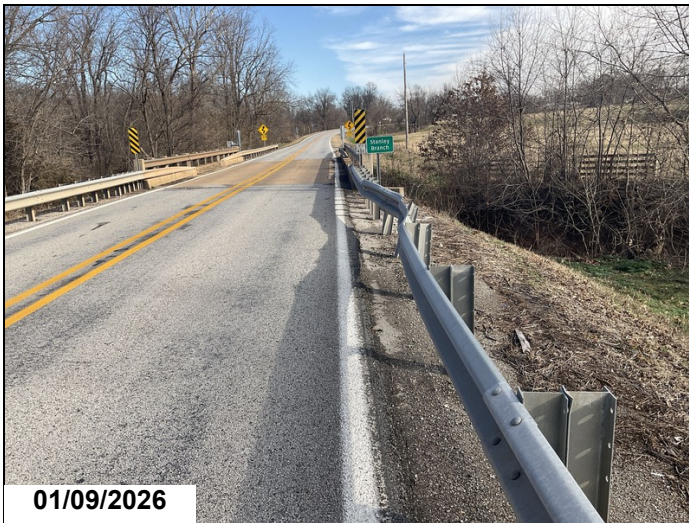
The beginning left approach railing has collision damage and out of plane bending.

21' of right beginning approach railing damage.

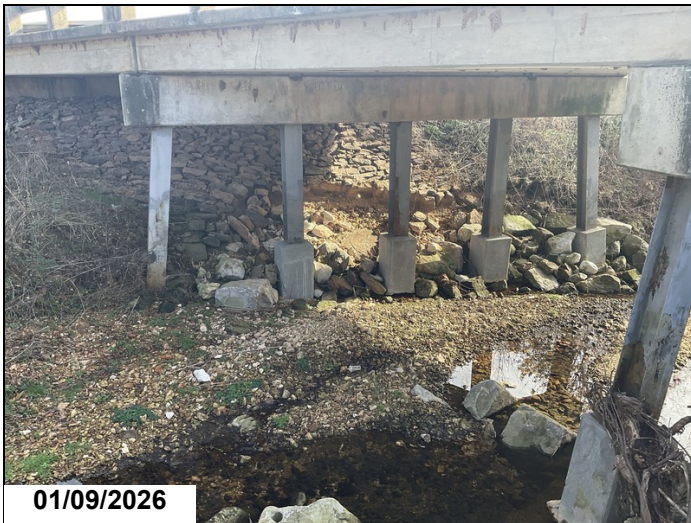
Some of the rip rap is displaced at the abutment #2 slope. The channel alignment is poor.

The base of the abutment #2 embankment has an 8' by 23' area of rip-rap displaced.

Area of rip rap displacement at the abutment #2 slope. 8' by 23' long.

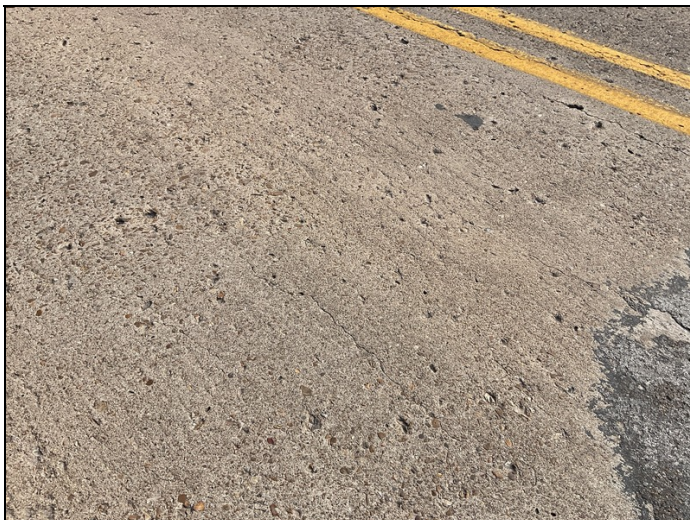
Unsealed cracking in the deck.

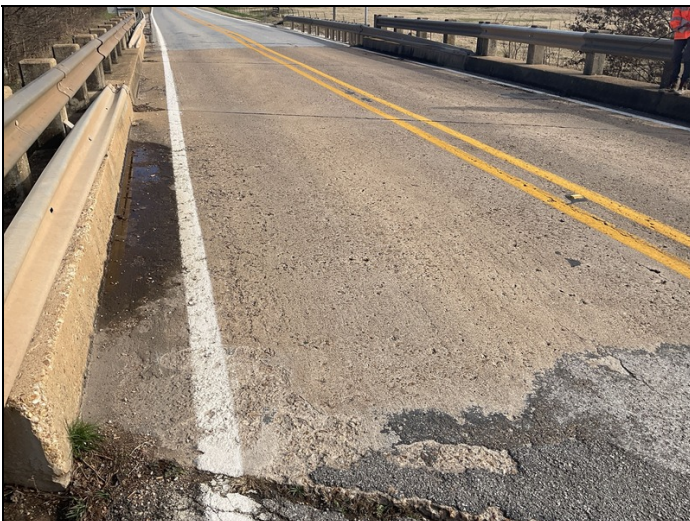
The driving surface has unsealed cracking and asphalt repaired areas with pop outs though out.

Driving surface view.

**A-61 - Polymer Overlay Advised (Yes)**

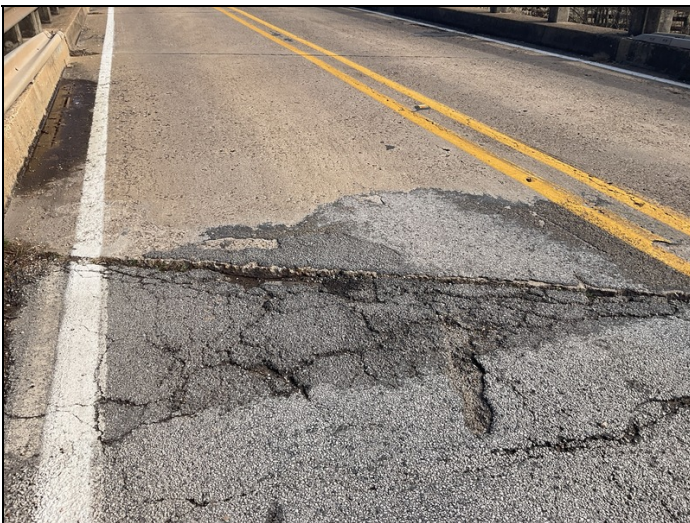
Approach leveling needed at the beginning left lane.

**A-66 - Approach minor pothole/leveling needed (Yes)**  
The beginning left lane at abutment #1 needs leveling.
