## Bridge B5946 Inspection Report

Asset #B5946(Routine, Underwater type 2)

I 49 Benton 1 over SPRING CREEK

Team Lead: Benjamin Smith Inspection Date: 04/29/2024

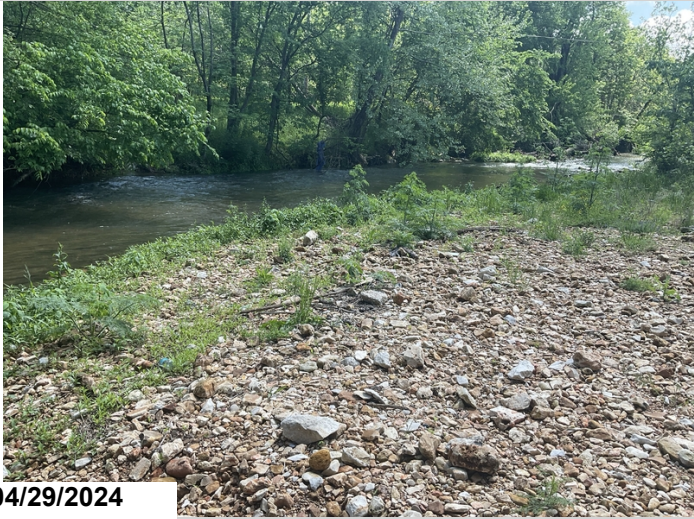
**61 - Channel/Channel Protection** (6 - Bank is beginning to slump. River control devices and embankment protection have widespread minor damage. There is minor stream bed movement evident. Debris is restricting the channel slightly.)  
The upstream channel swings toward the abutment #2 side of the channel. The upstream channel is vegetated.  
The channel beneath the structure has rip rap placed on the abutment #2 side. Insignificant scour was noted around some of the columns.

Upstream channel view.

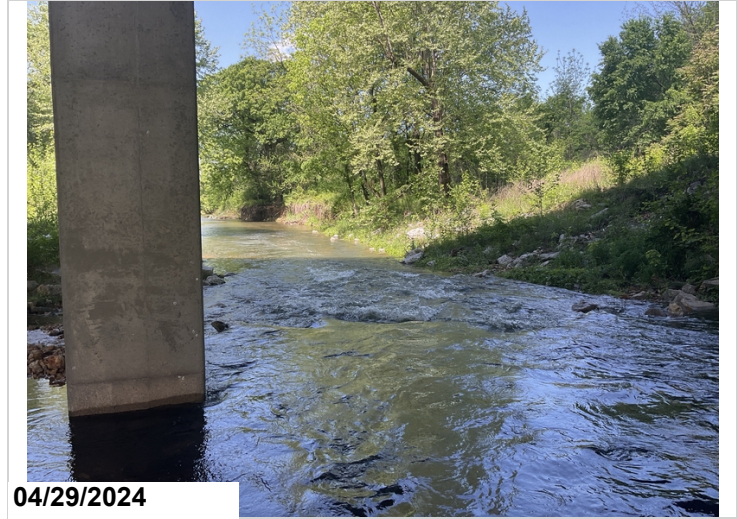
The downstream channel has large areas of bank slumping. The downstream channel is vegetated.

Downstream channel view.

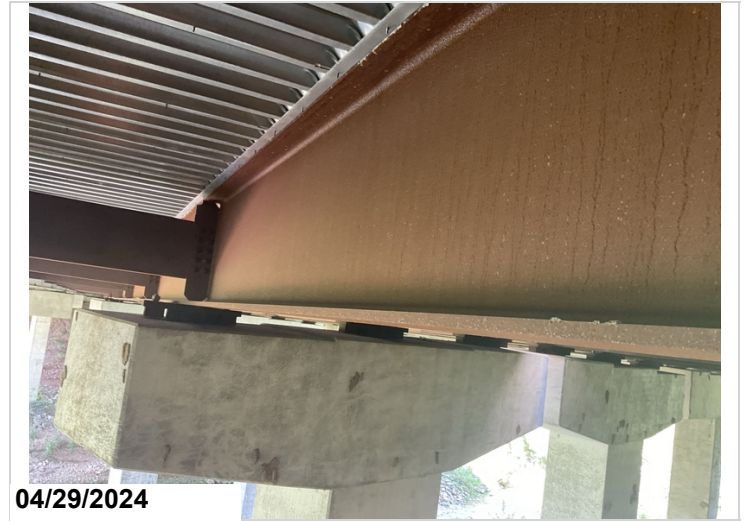
Weathering steel beam condition.

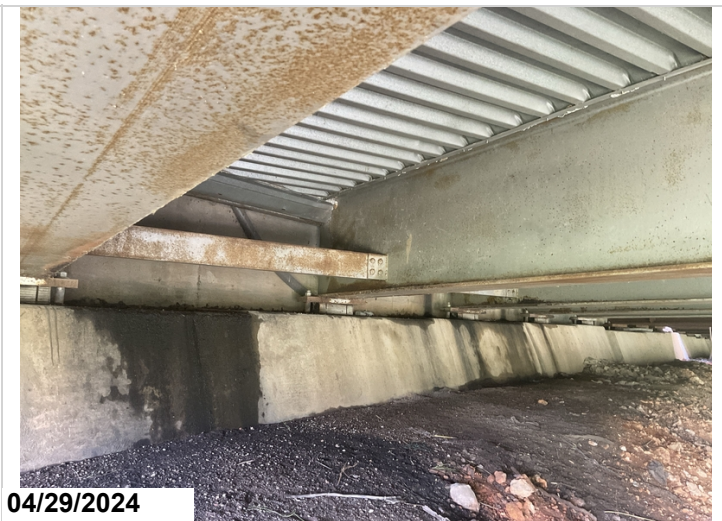
Many of the beam ends at the abutments have cs3 corrosion on the bottom flanges.

Typical beam corrosion at the beginning of span #1.

**A-60 - Full Girder Painting Needed (Yes)**

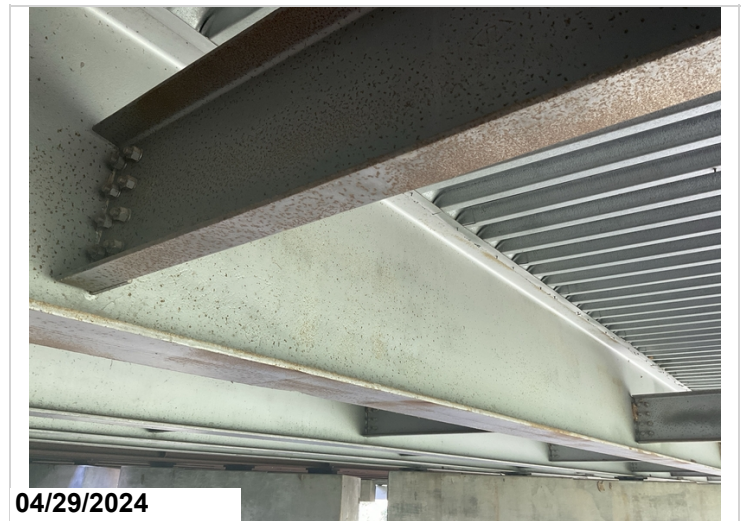
The beams through out the structure have freckled rust with areas of general cs2 corrosion. The exterior bottom flange of beam #9 has cs2 corrosion for the length of the structure.

Typical painted beam coating condition.

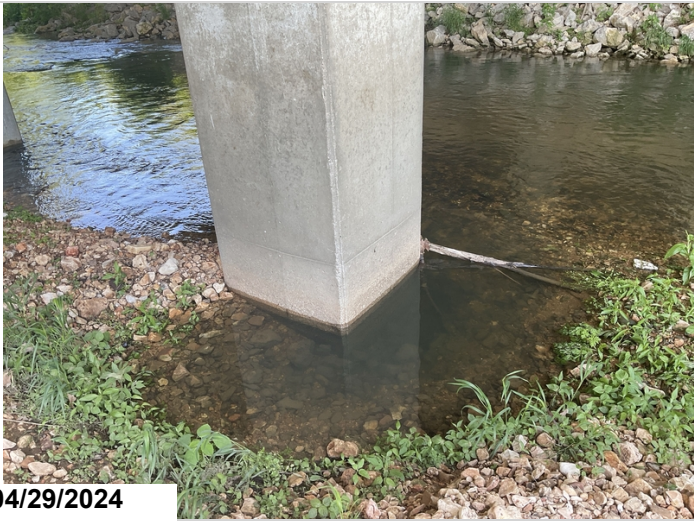
Column #2 of bent #2 is showing cs2 abrasion.

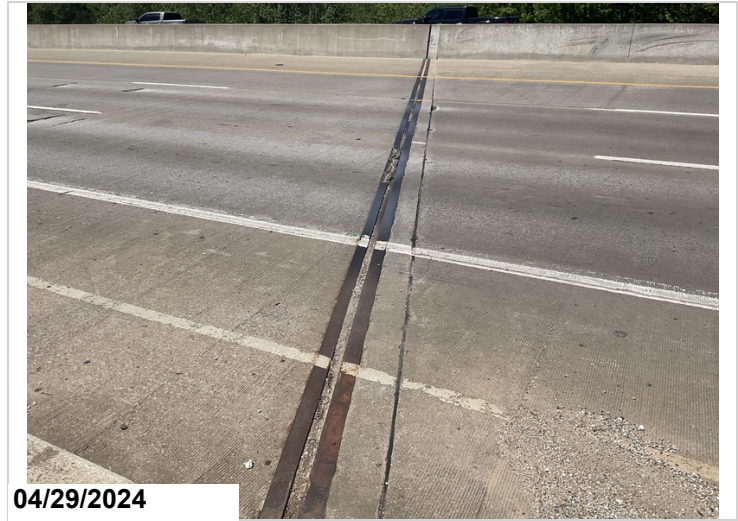
Abutment #2 seal condition.

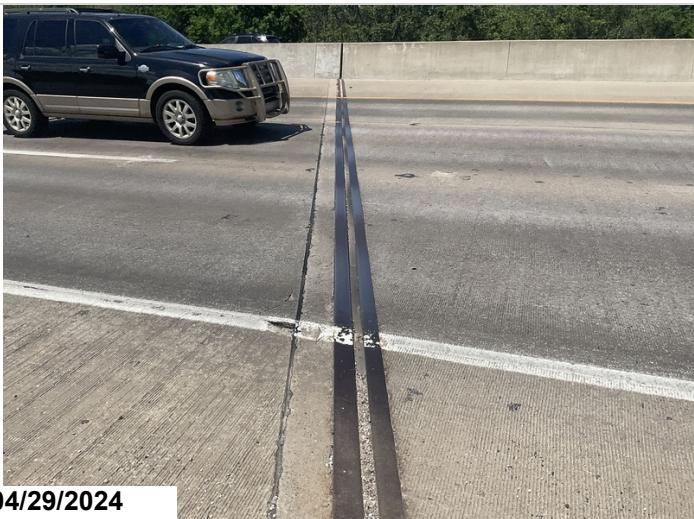
Abutment #1 seal condition.

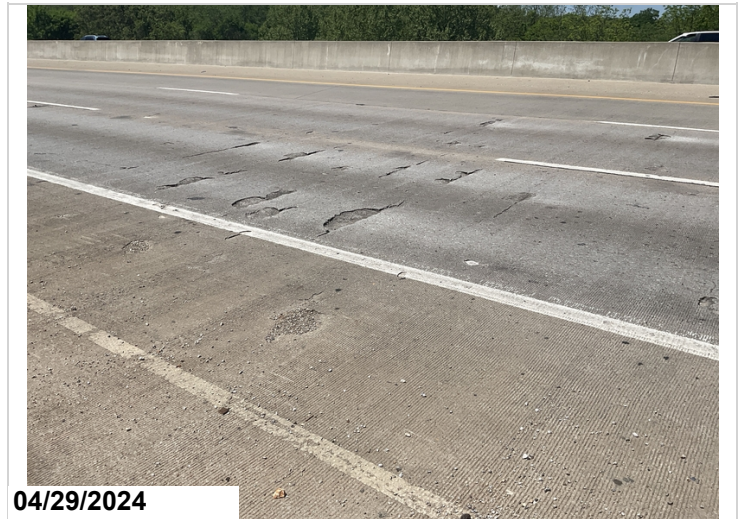
The deck surface has moderate amounts of large cs3 delamination and spalling with exposed rebar.

Span #4 delamination

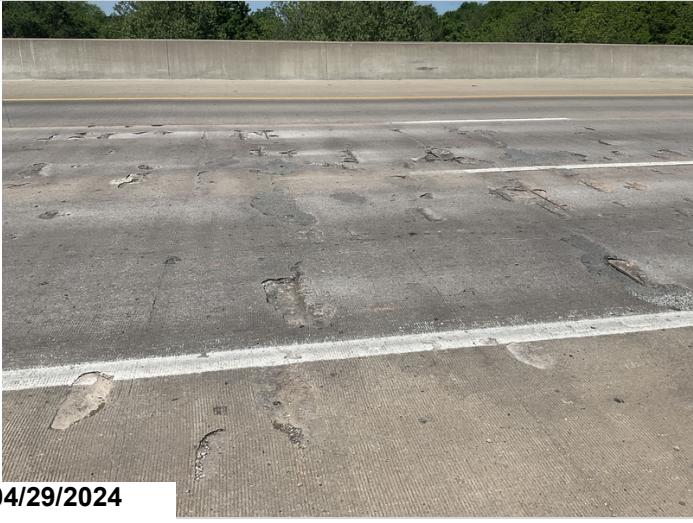
Span #2 delamination

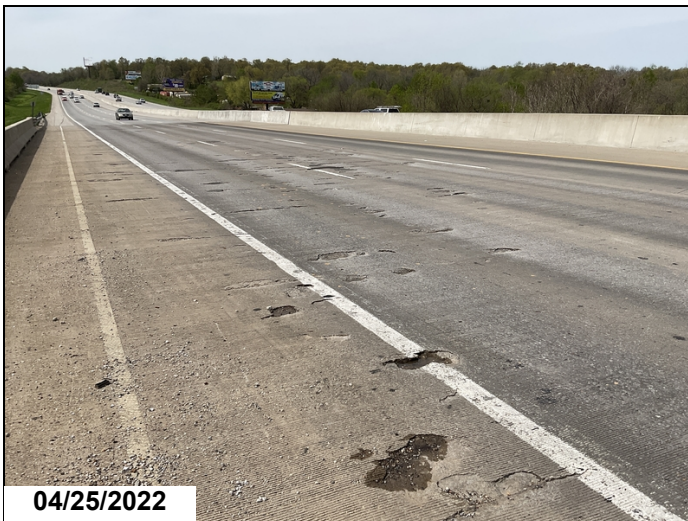
Deck Surface: Spans #2,#3, #4 have spalls with exposed rebar and cs3 delamination. Some spalls are approximately 2" in depth at the deepest point.

04/13/2020 WNR: Spalls and exposed steel have gotten worse since the last inspection.

View of spalls in span #2 spalls

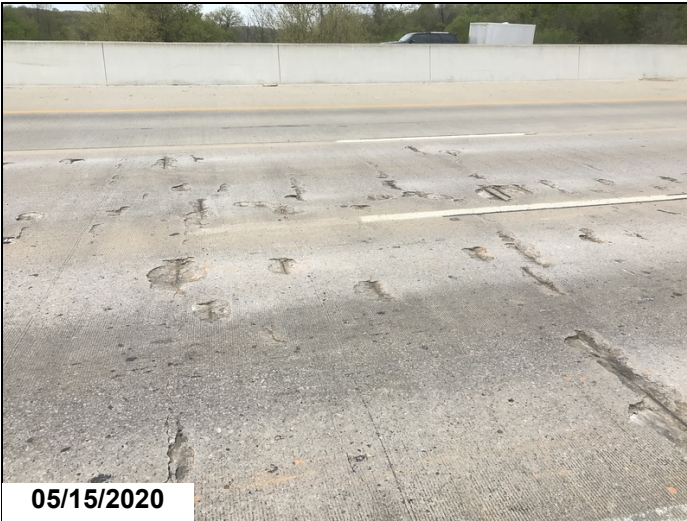
Span #2 middle and right lane numerous spalls with steel exposed.

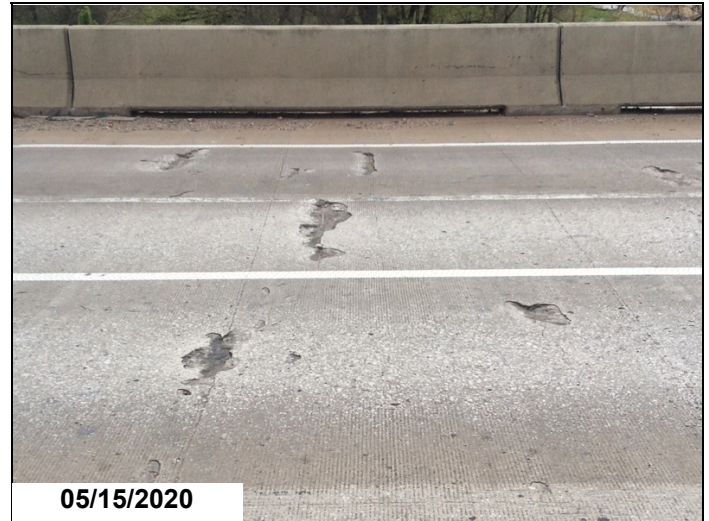
Deck span 2 - scattered deep spalls with steel exposed.
