Bridge #M2052(Routine, Fracture Critical)
SH 148-SEC 02-4.08 over National or Ditch #6

Location: 1.1 MI W JCT I 55

Team Lead: Richard Jones **Inspection Date:** November 10, 2021

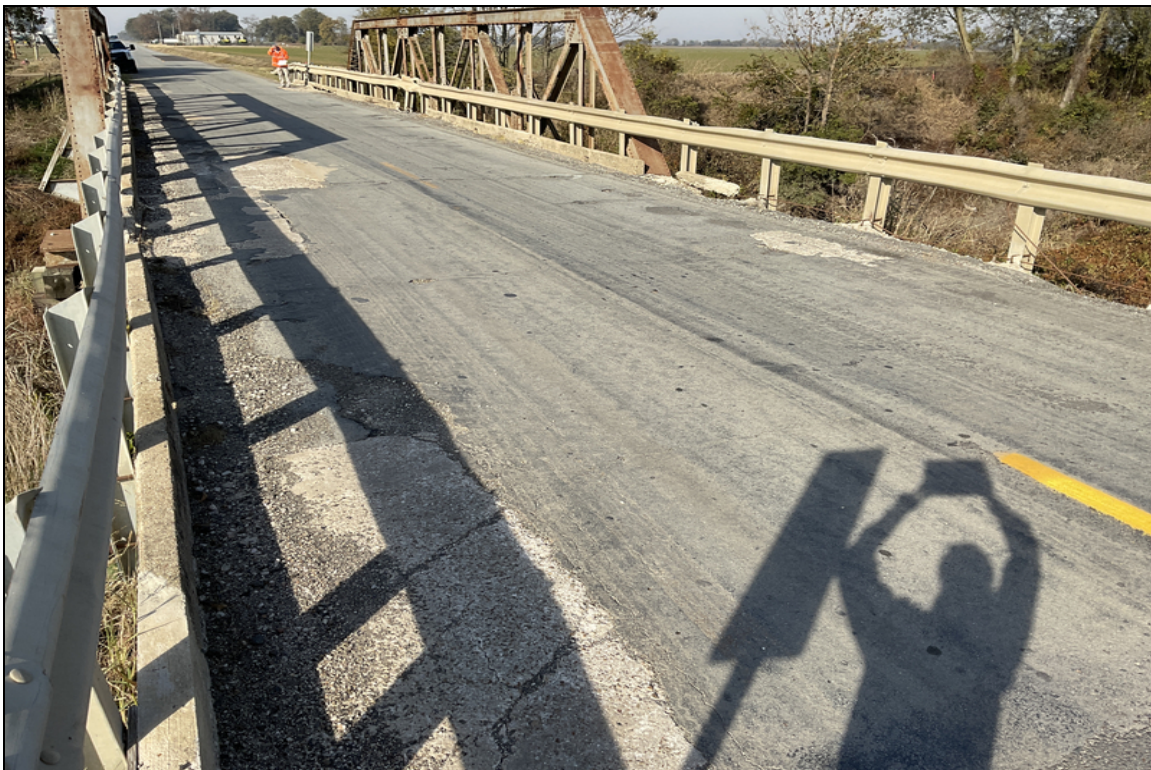
wearing surface

Asphalt wearing surface is raveling out along outside wheel path. Wearing surface has several potholes or depressions with map cracking.

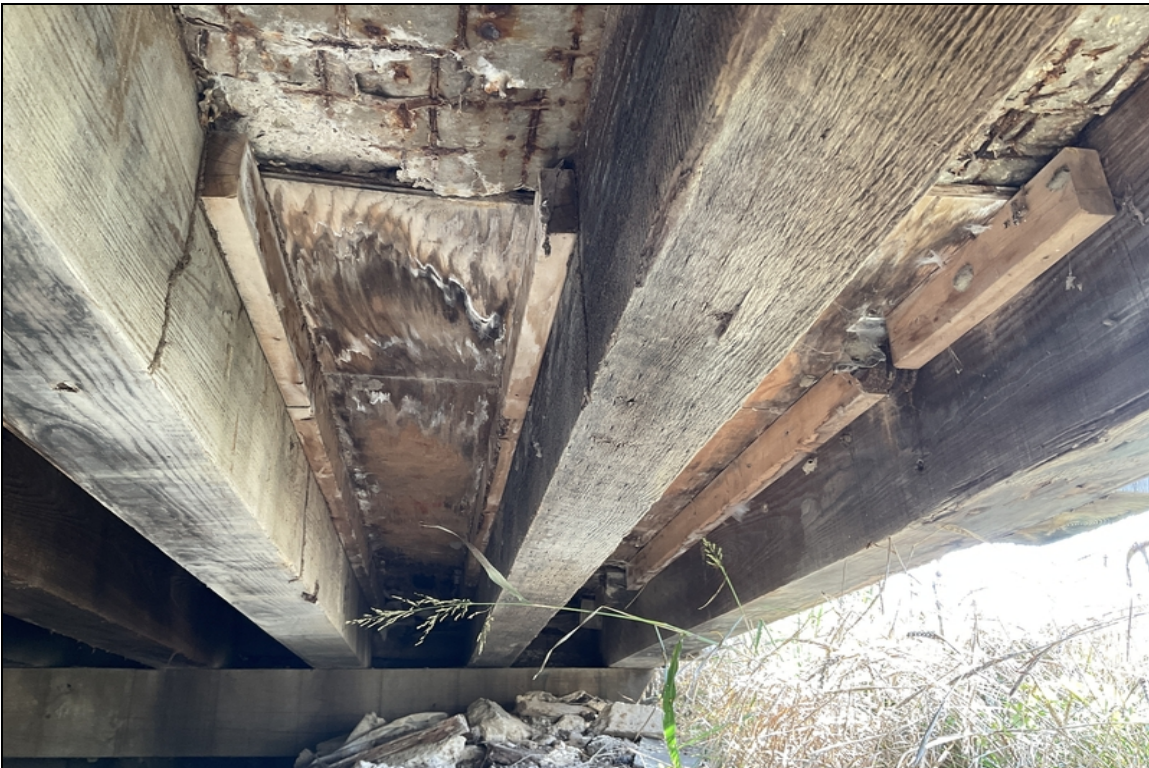
Span 1 bays 1 and 2

Span 1 has a full depth patch approximately 5' x 9' in bays 1 and 2.

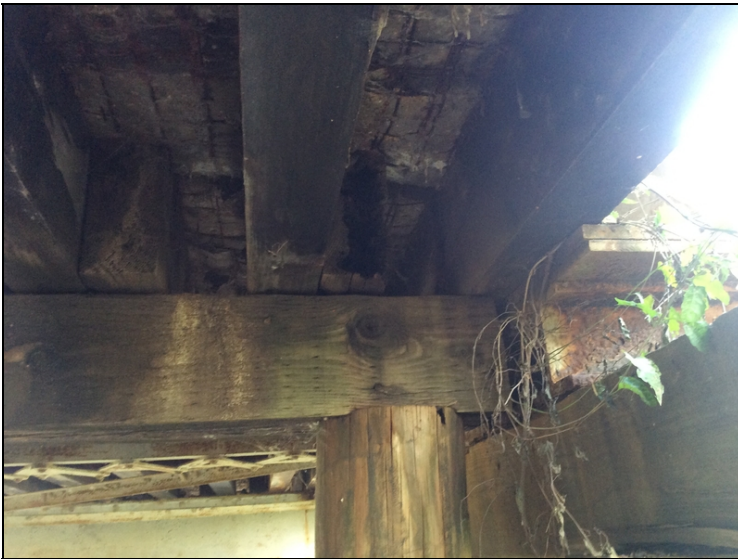
Span 3 bent 3 timber stringers 3, 13, and 14 have 2' on end that is decayed with up to 50% loss of section.
Span 3 bent 4 stringer 8 is decayed and hollow on end.

Span 3 stringer 13 over bent 3.

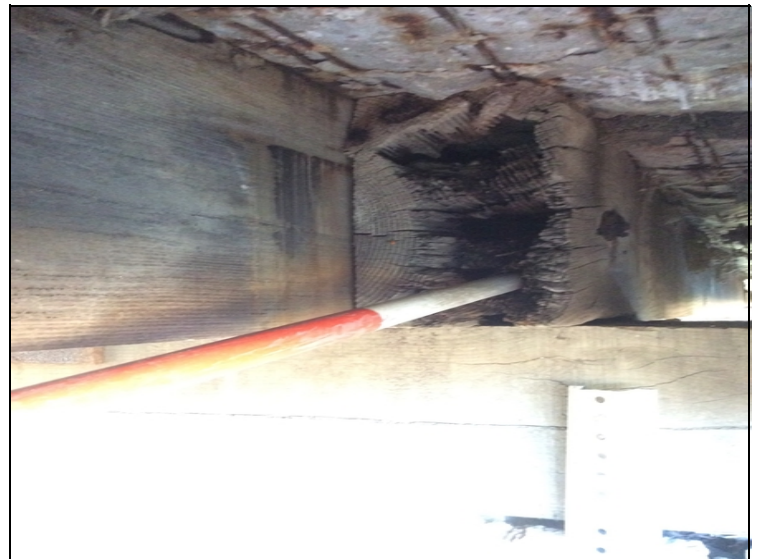
Span 3 stringer over bent 3

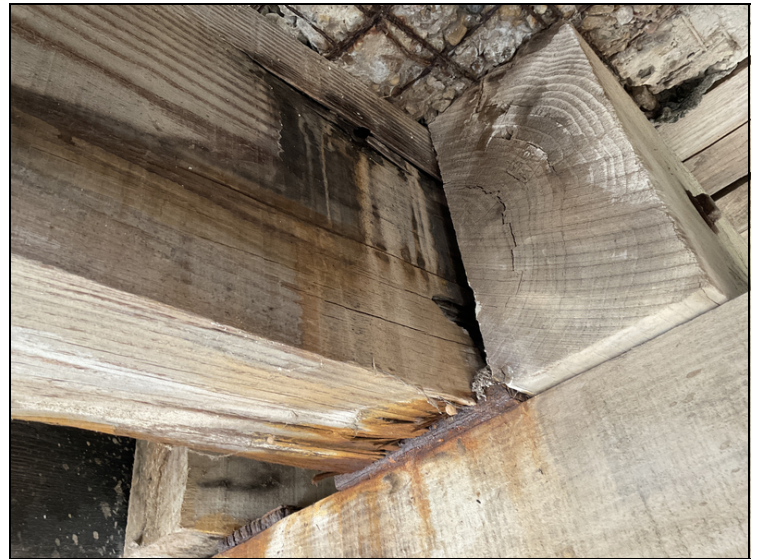
Span 3 bent 3 stringer 3

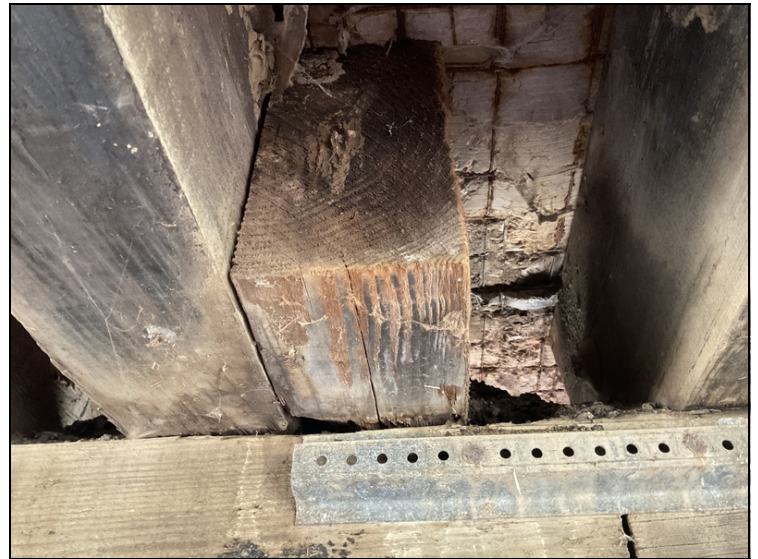
Span 3 bent 4 stringer 8

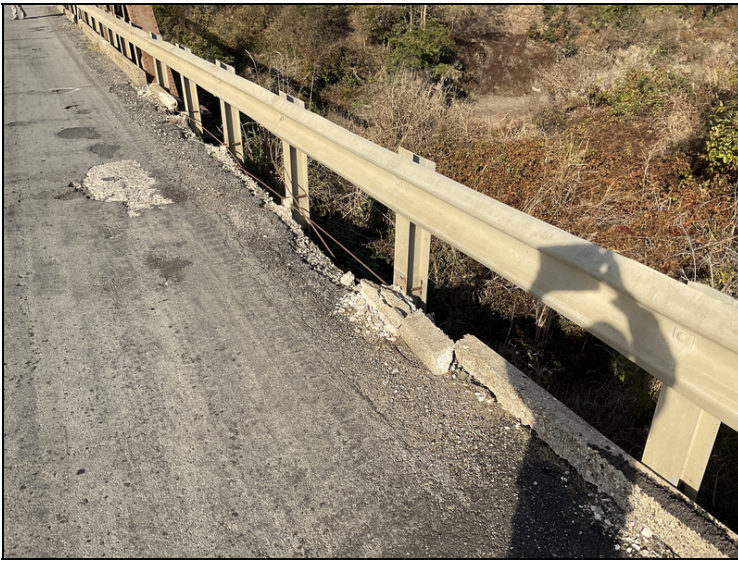
Lt and Rt edges of deck have advanced concrete disintegration. Rt curb is missing for most of spans 1, 2, 4, and 5. Lt and Rt gutters/edge of travel lanes have several full depth patches. Most patches are in fair to poor condition.

Span 1 and 2 Rt

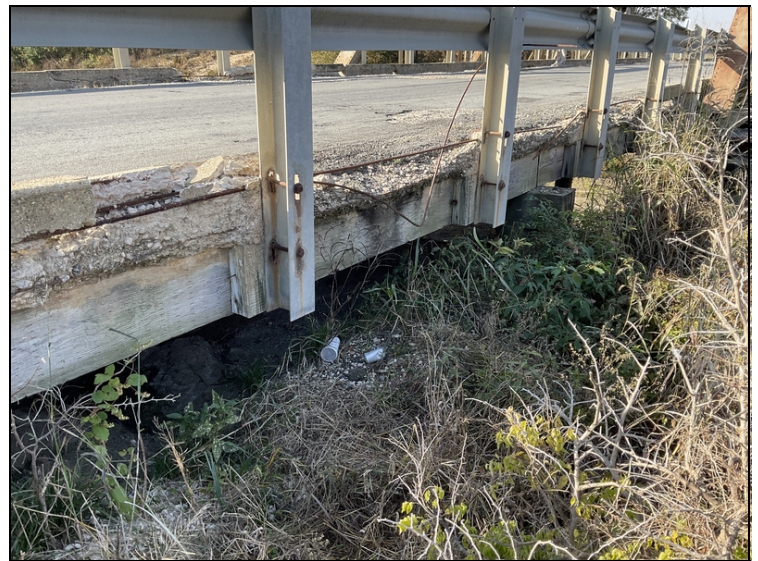
Span 1 and 2 Rt

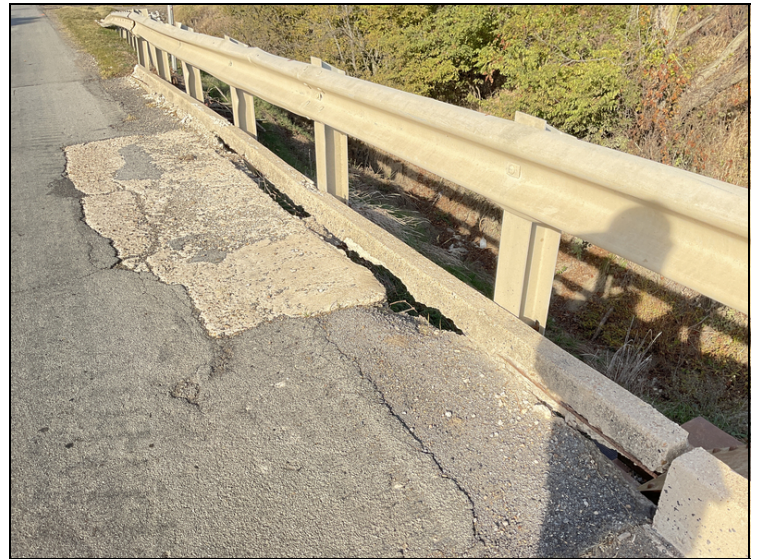
Span 4 and 5 Rt

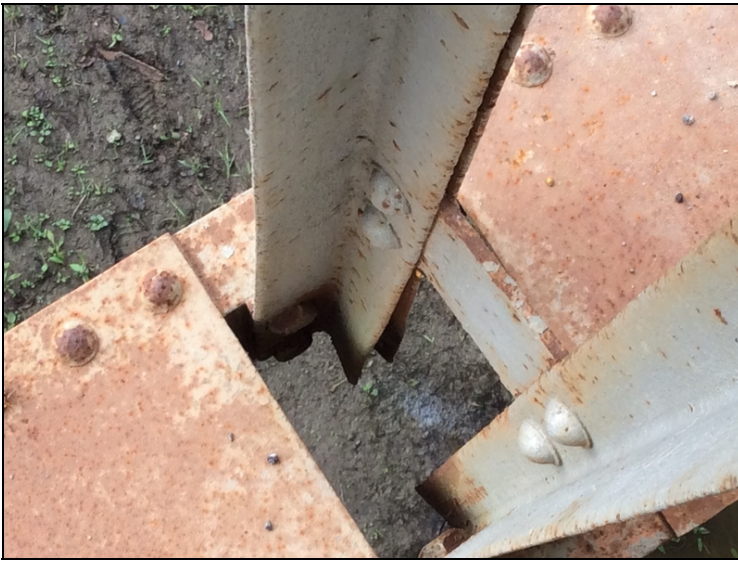
Bottoms of truss verticals have pack rust buildup between angles with up to 1" of distortion to angles.
Truss verticals have a line of section loss along connection to lower chord.

Left truss unit L3 connection pack rust.

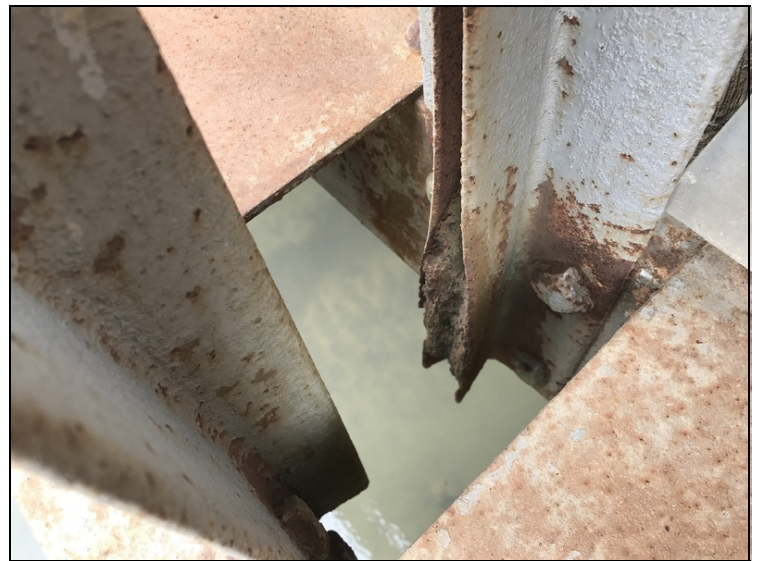
LT Side vertical L3

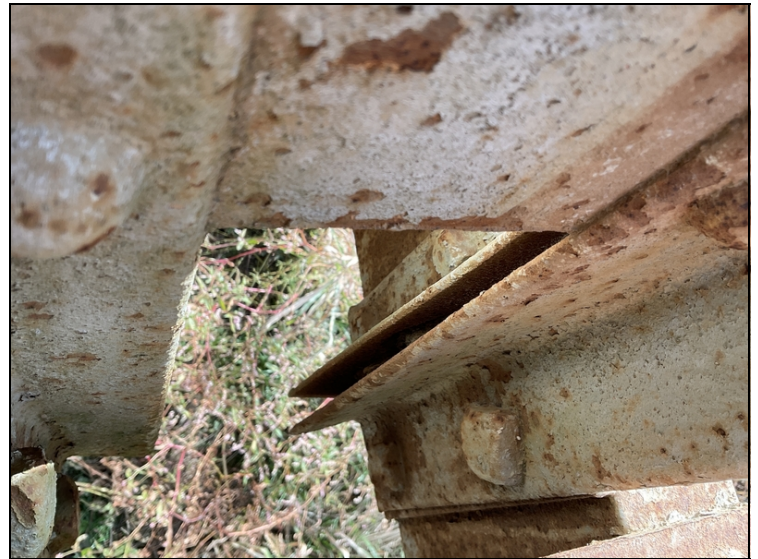
Typical of verticals

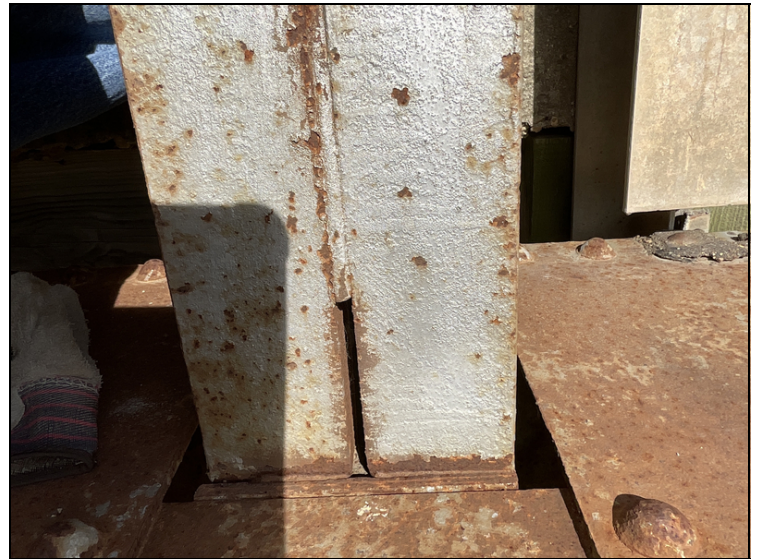
Typ verticals at LC connection

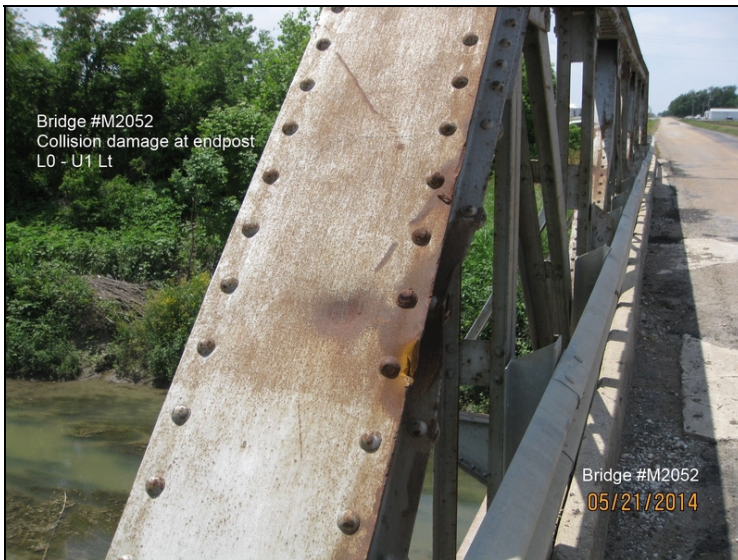
M2052 Lt end post at beginning 05212014

Lt Truss - Top chord between L0 and U1 has collision damage 7' ahead of L0. Interior channel of top chord is bowed.

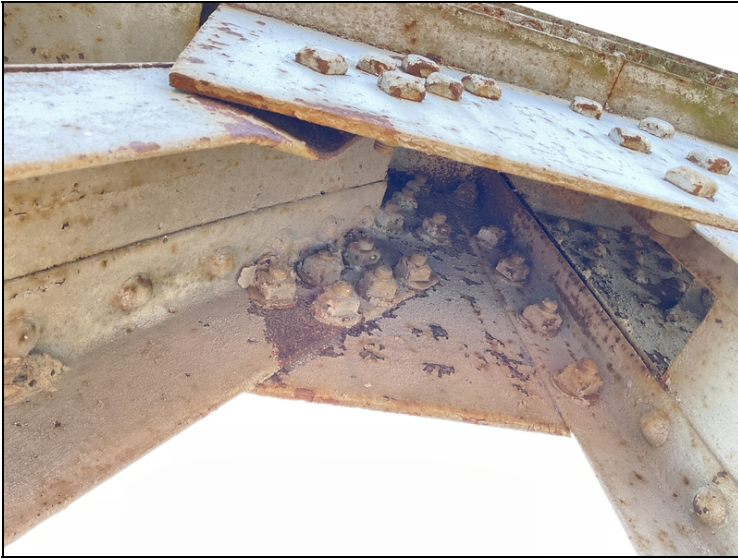
L2 - U3 diagonal Lt

L2 – U3 diagonal has impact damage. Diagonal is bowed and is 4" out of alignment. Interior angle of diagonal is bowed under U3 gusset.

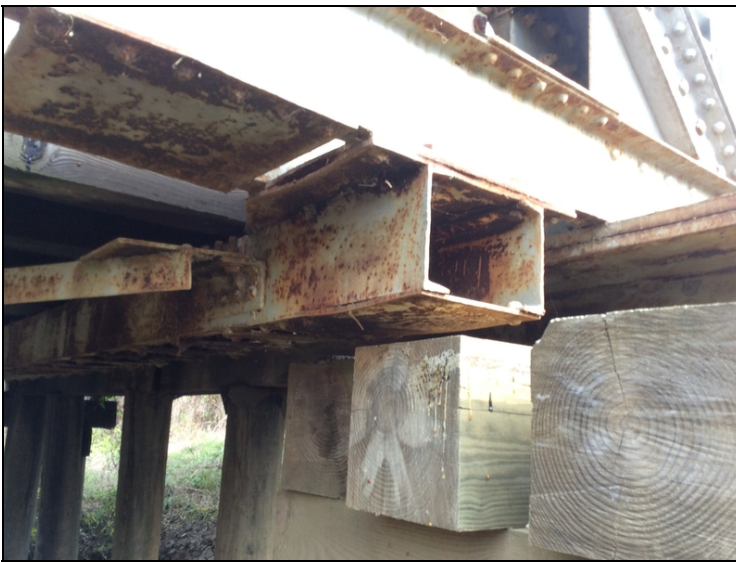
Truss struts and lower laterals have areas of pack rust and some section loss.

Left end of lower lateral brace bent 3.

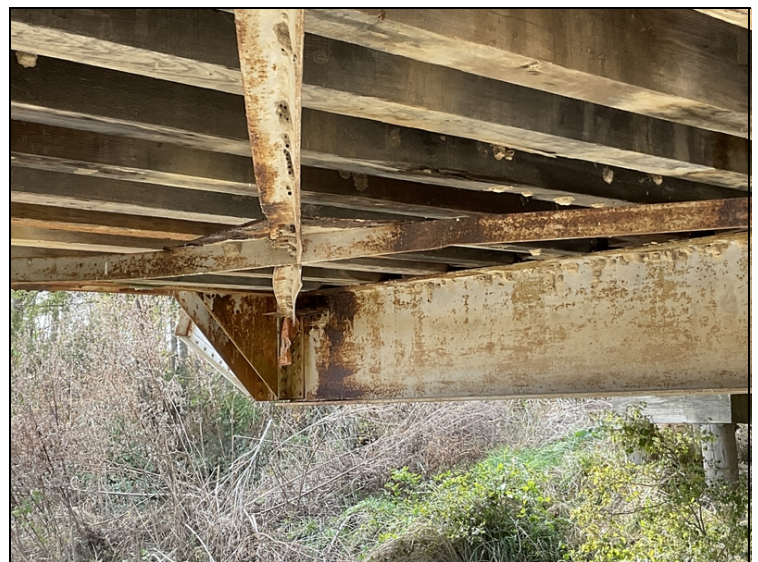
Lower laterals

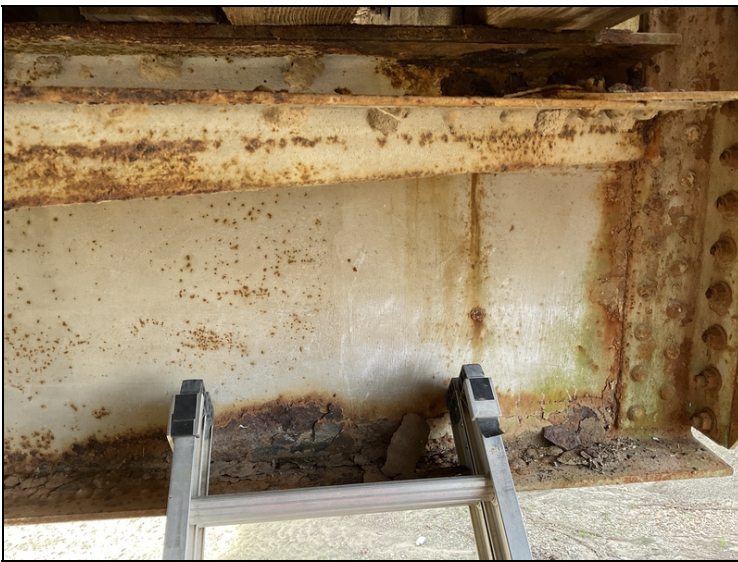
Floor beam 1 Rt

Floor beams have flaking rust with some section loss near Lt and Rt ends. A few rivet heads have heavy section loss. Floor beams have some minor section loss at lower lateral connections.

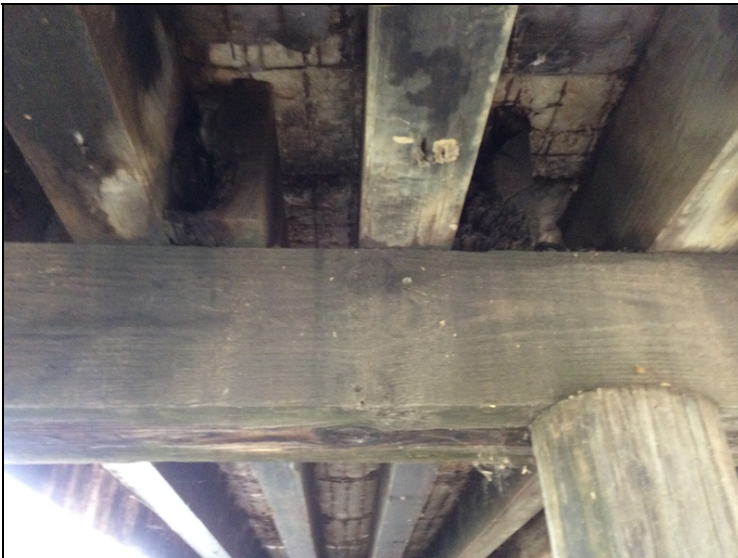
Span 2 bent 3 girders 11, 12, and 14 are decayed with up to 60% loss of section on end.

Span 2 girders 11 & 12.

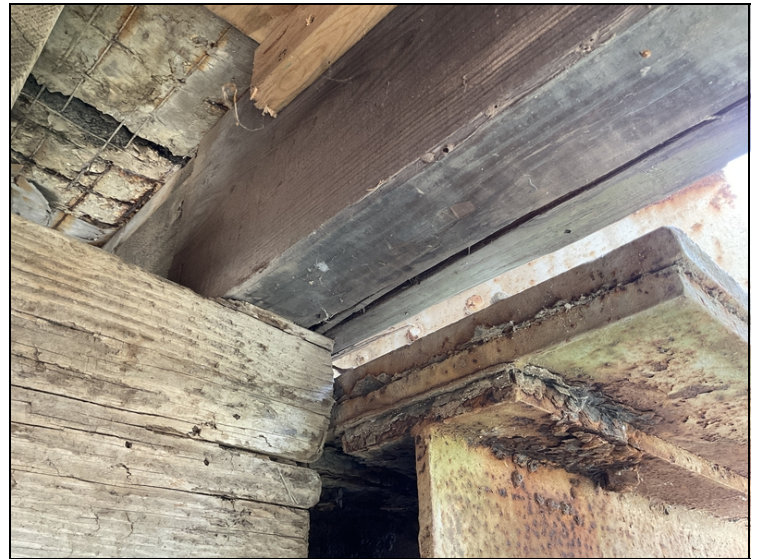
Span 4 bent 4 girder 1 is split over cap and for 3' into span.

Span 4 girder 1

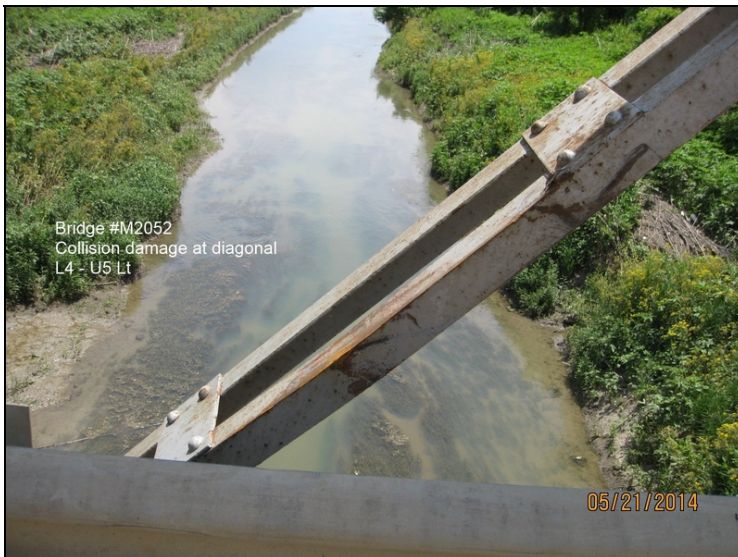
M2052 Lt L4 - U5 diagonal 05212014

L0 exterior gusset plate has minor section loss along connection to lower chord.
L2 vertical has minor collision damage.
L4 vertical has collision damage and is bowed and twisted up to $\frac{3}{4}$ " out of alignment.
L5 vertical has minor distortion from collision damage.
Top chord from U7 – L8 has minor collision damage.

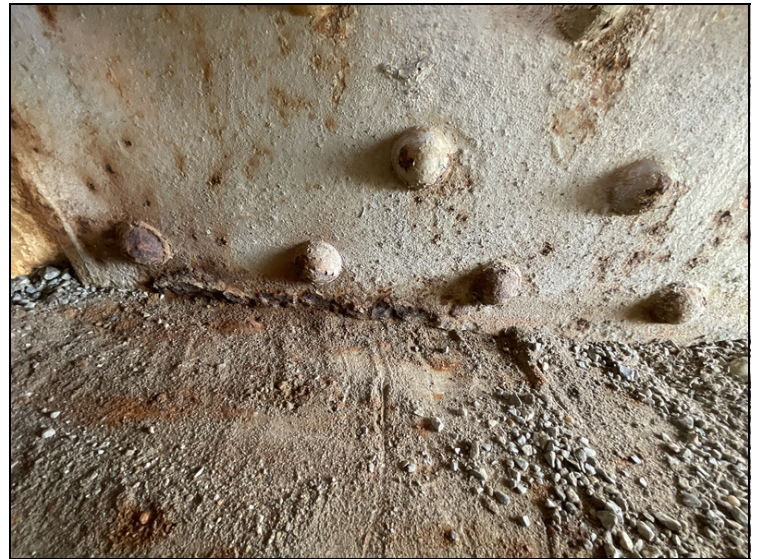
L0 Lt interior gusset plate

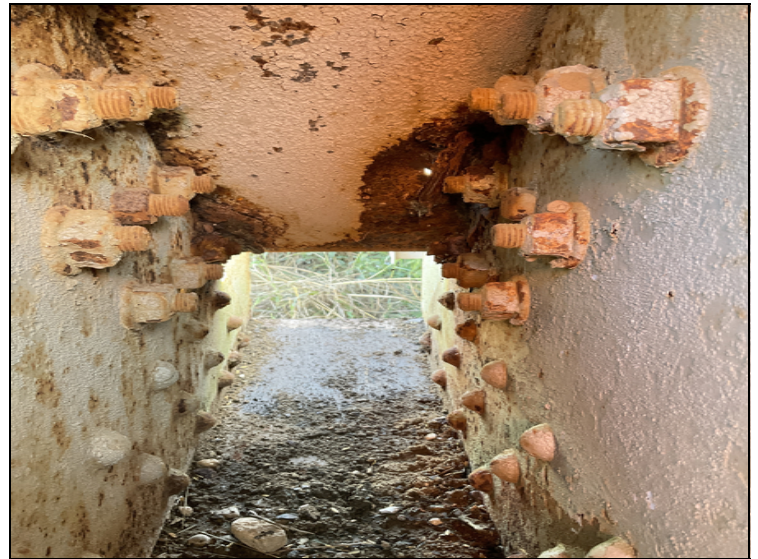
L0 Rt

L0 top plate has a 1" diameter hole rusted through. Interior gusset plate has a 4" area of $\frac{1}{8}$ " section loss.
L2 vertical has minor collision damage.
L5 vertical has minor collision damage.
L6 lower chord has $\frac{1}{4}$ " of pack rust between chord and interior gusset.
L8 exterior gusset plate has up to $\frac{1}{8}$ " section loss along connection to lower chord. Top plate has a 1" diameter hole rusted through.

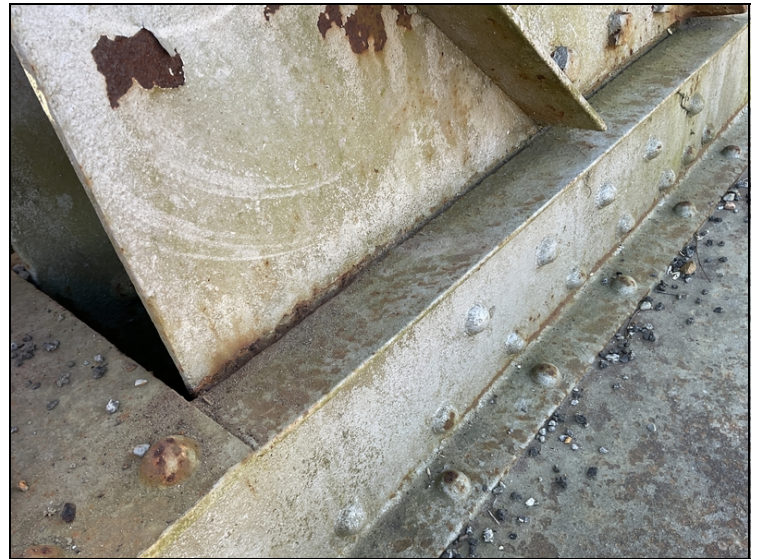
L8 Rt

L8 exterior gusset plate has up to 1/8" section loss along connection to lower chord. Top plate has a 1" diameter hole rusted through.

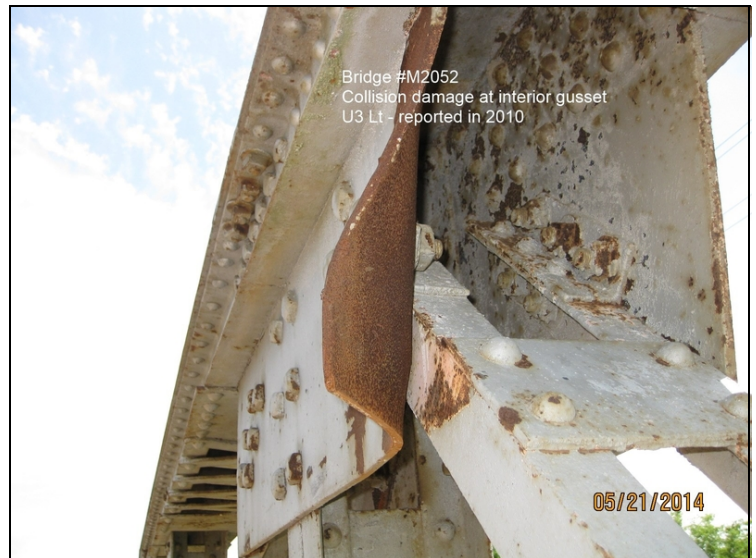
M2052 Gusset Plate U3 Lt. side 05-21-2014 - old damage

U3 interior gusset is bent 4" out at corner.

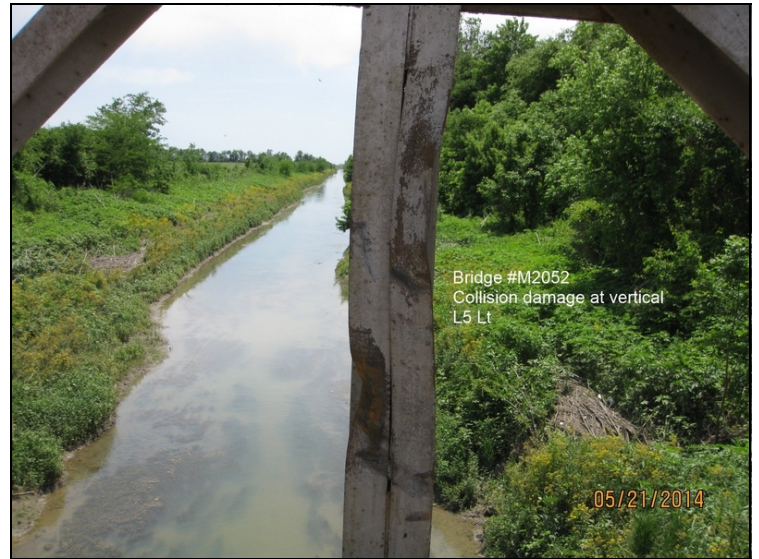
M2052 Lt L5 vertical 05212014

L5 vertical has minor distortion from collision damage.

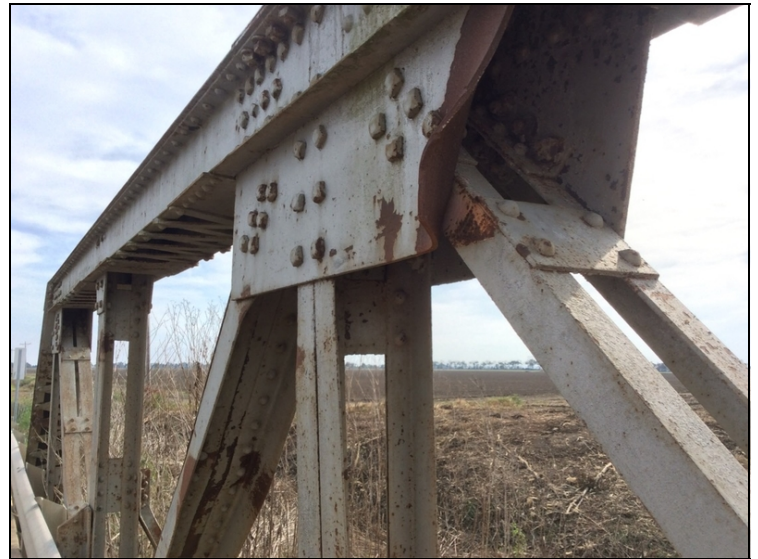
M2052 U5 - L6 diagonal Lt 05212014

U5 – L6 diagonal has collision damage and is bowed and twisted up to 11" out of alignment. Interior angle of diagonal has a crack at top and bottom connections. Angle is cracked in the vertical plane through 1 bolt hole at top and bottom connections. Cracks appear to have arrested at 2nd bolt hole.

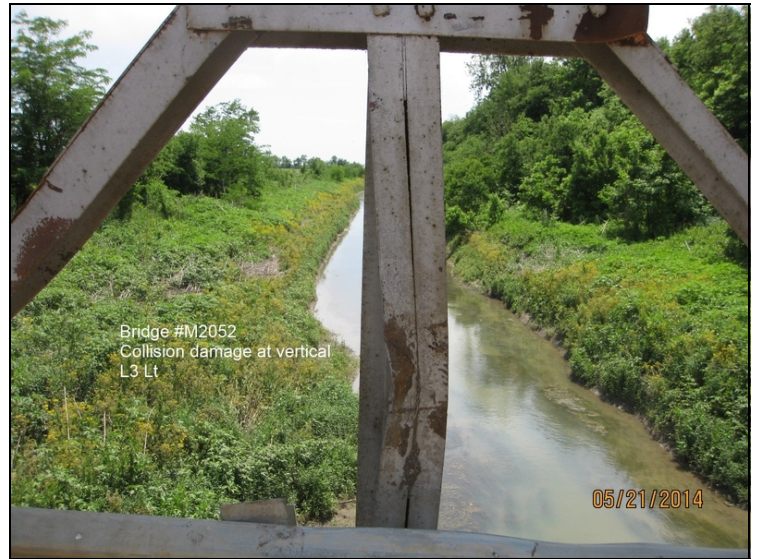
M2052 Lt L3 vertical 05212014

L3 vertical has collision damage. Interior angles of vertical are bowed and twisted up to 2.75" out of alignment.

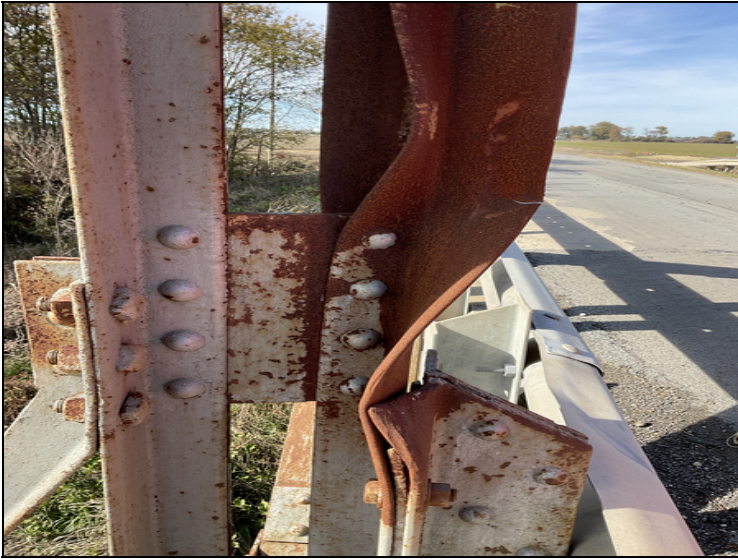
L6 Lt

L6 vertical has collision damage. Interior angles are bowed and twisted up to 6.5" out of alignment. Angle on back side has a ¾" tear.

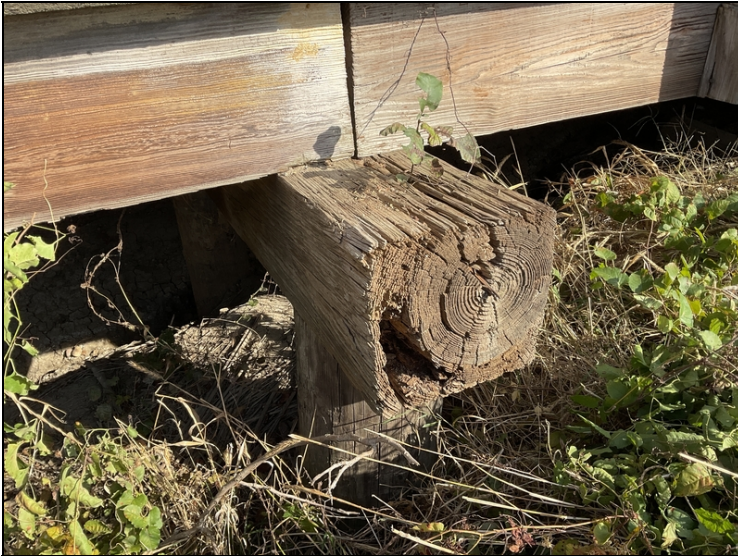
Bent 2 Lt

Bent 2 cap has 1.5' on Lt end that is decayed and hollow with approximately 30% section loss.
Bent 4 cap has 1' on Rt end and 4' on Lt end that is decayed and partially hollow on top.
Bent 4 Rt sub cap over piles 9a and 9b has some core decay.

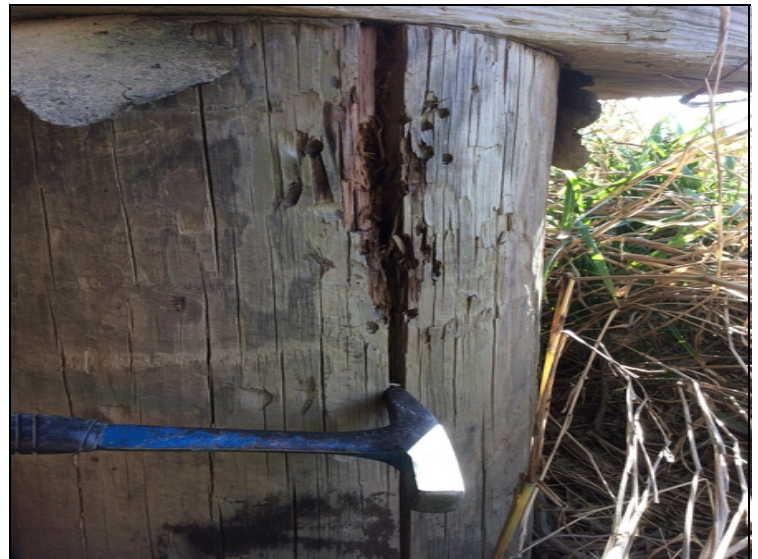
Bent 3 pile 4 has a delaminated area on 1 side.

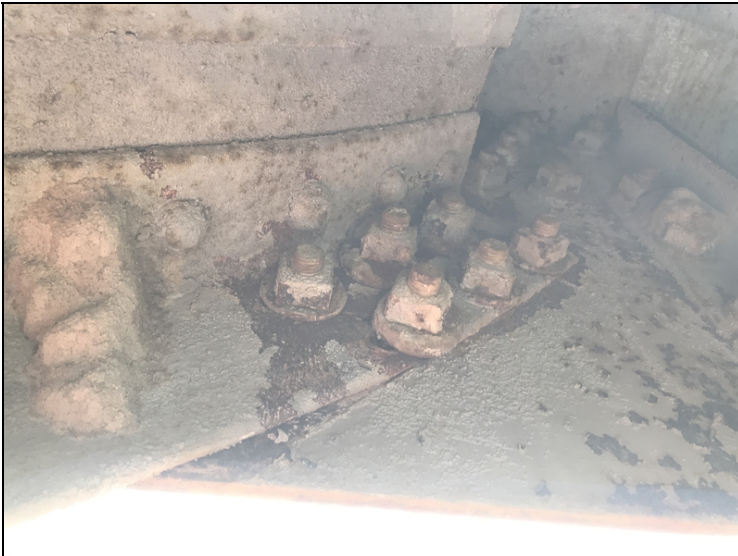
Lt truss - U5 – L6 diagonal has collision damage and is bowed and twisted up to 11" out of alignment. Interior angle of diagonal has a crack at top and bottom connections. Angle is cracked in the vertical plane through 1 bolt hole at top and bottom connections. Cracks appear to have arrested at 2nd bolt hole.

U5 connection to diagonal to L6

to District bridge crew for repair. Several angles and plates make up this member; crack is one of the steel angles. KAW 11/27/18

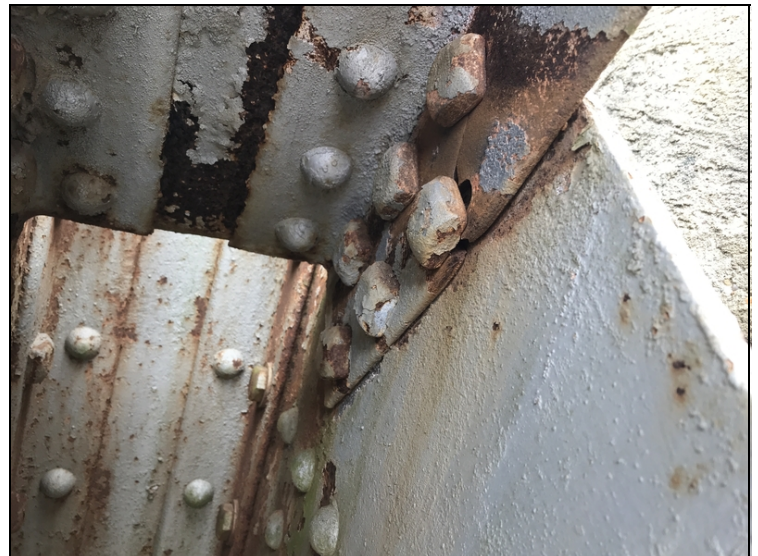
L6 crack pic 1

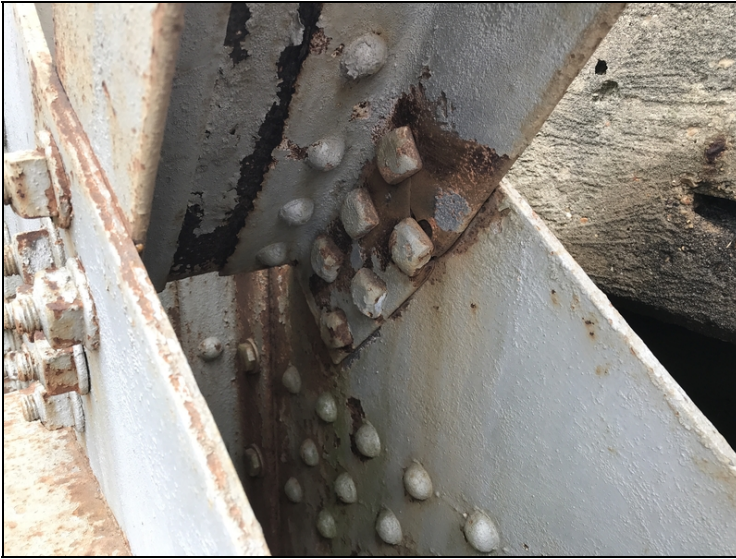
L6 crack

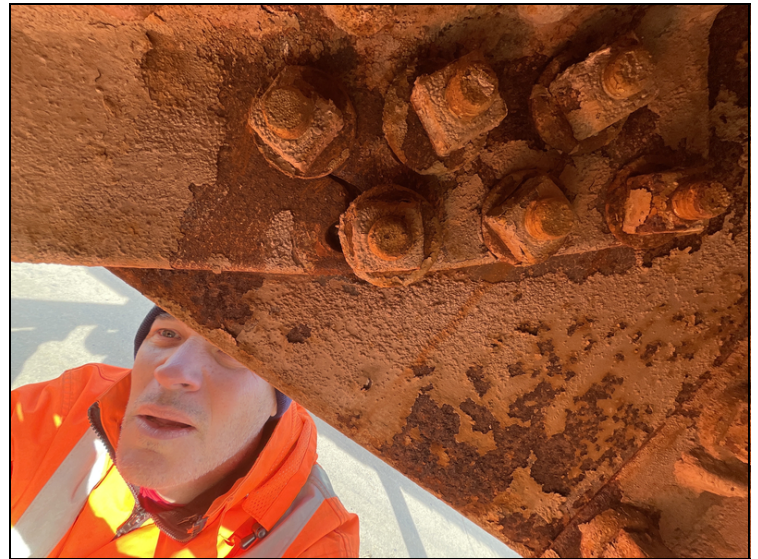
2021 - Interior angle of U5 - L6 diagonal Lt top
