Asset #02459(Routine, Underwater type 2)

US 49-02- LM 12.73 over JACKS CREEK

Location: 3.20 MI N JCT OF SH 135

Team Lead: Richard Jones Inspection Date: 05/08/2023

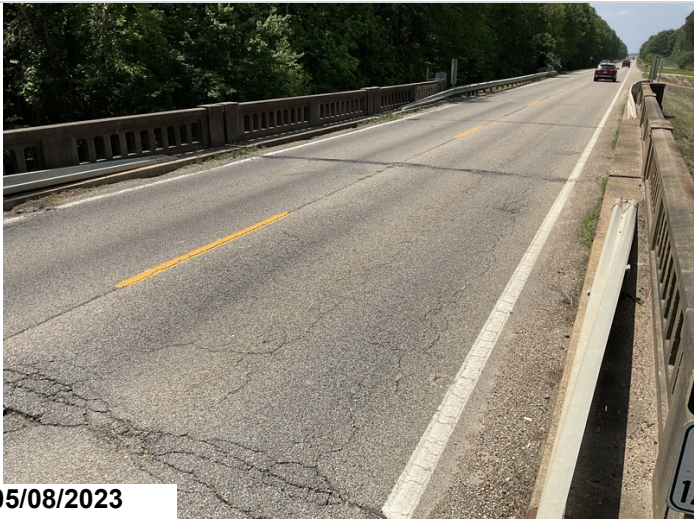
Wearing surface has several longitudinal, map, and transverse cracks. Asphalt is raveling out over joints.

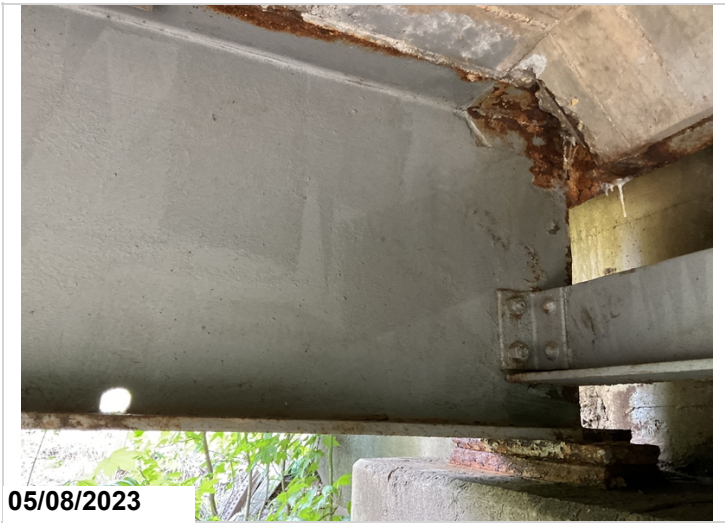
(107) Exterior beams have areas of corrosion along top flange. Several repairs were made to beam ends in 2020 by HBM crew.							
Span 1 bent 1 girder 1 was t spliced in 2020. Span 1 bent 1 girder 4 was t spliced in 2020.							
Span 1 bent 2 girders 1, 2, and 4 were t spliced in 2020. Span 2 bent 2 girders 1 and 4 were t spliced in 2020.							
Span 2 bent 3 girder 1 was t spliced in 2020. Span 3 bent 3 girders 1 and 4 were t spliced in 2020.							
Span 3 bent 4 girder 1 was t spliced in 2020.							
215	Reinforced Concrete Abutment	LF	72	20	0	52	0
1130	Cracking (RC and Other)	LF	4	0	0	4	0
6000	Scour	LF	48	0	0	48	0

Span 1 bent 1 girder 4 - typ girder repair

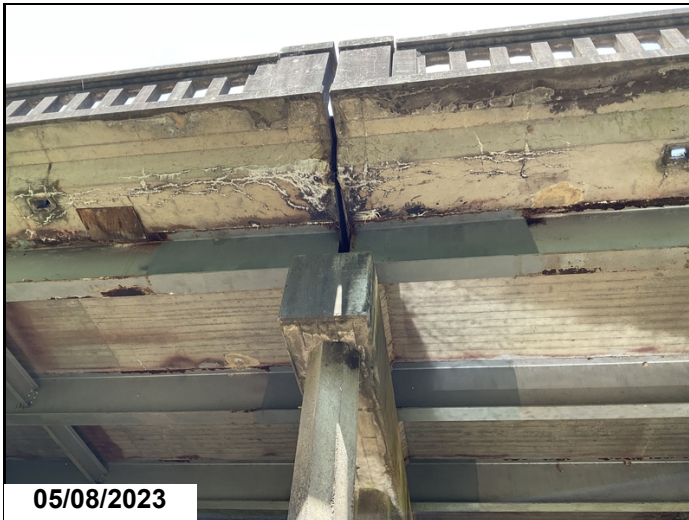
Lt overhang at bent 3

Soffit is in overall good condition, but has several cracks with efflorescence along exterior girders and overhangs. Overhangs have some initial concrete disintegration.

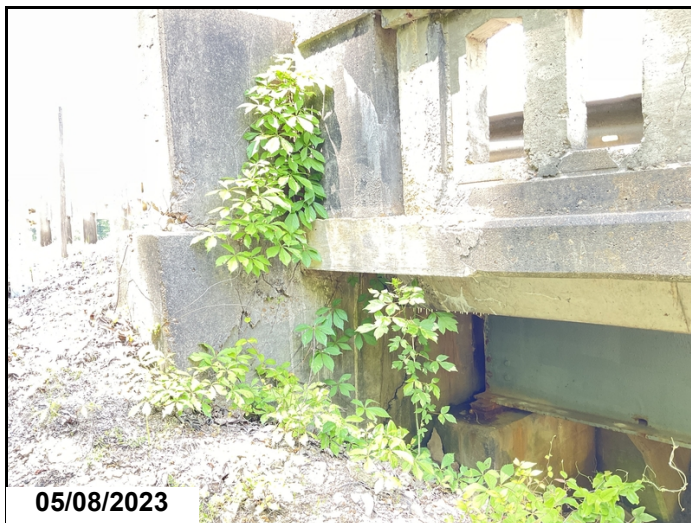
Bent 4 Lt

Embankment has some erosion at Lt and Rt ends of bent 4.

Left wing/end post at bent 4 abutment is cracked from past collision damage.

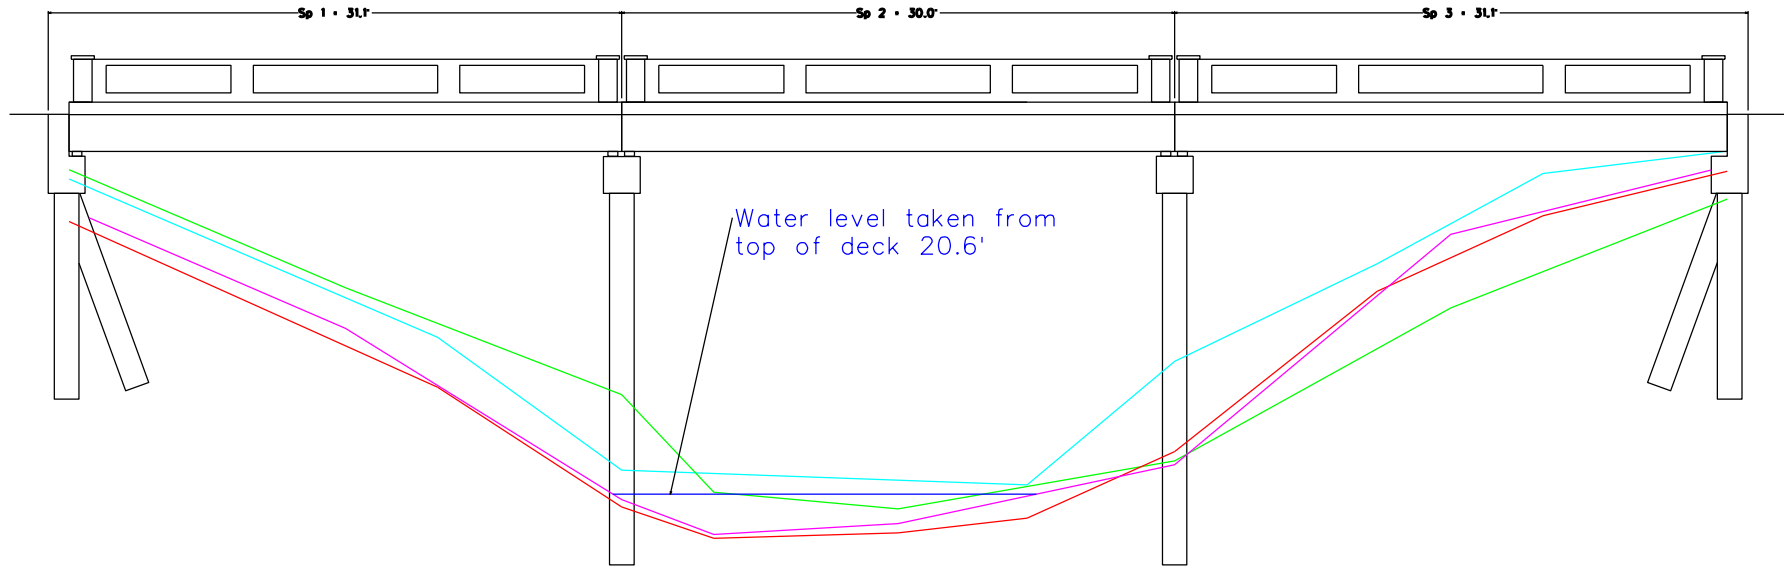
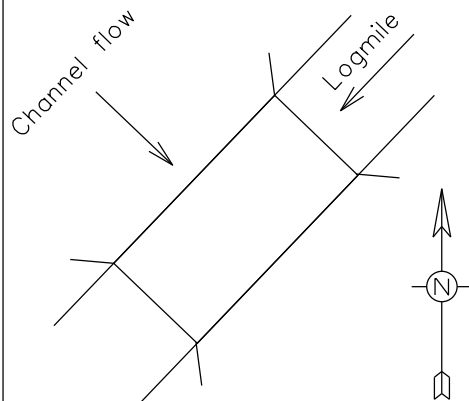
Overall Length = 92.25'

5 ft. – 6 ft. of channel scour has occurred at Bents 2 & 3 since bridge was built as per layout sheet.
Lt and Rt ends of bent 4 abutment have embankment erosion. Abutment has some undermining.

Channel profiled from top of deck on Rt side (upstream side)

Green soundings taken on 5/4/1990

Teal soundings taken on 6/4/1992

Red soundings taken on 5/15/2019

Pink soundings taken on 5/8/2023
