Asset #02460(Routine, Underwater type 2)

US 49-02- LM 11.86 over LOCUST CREEK

Location: 4.10 MI N JCT OF SH 135

Team Lead: Richard Jones Inspection Date: 05/13/2024

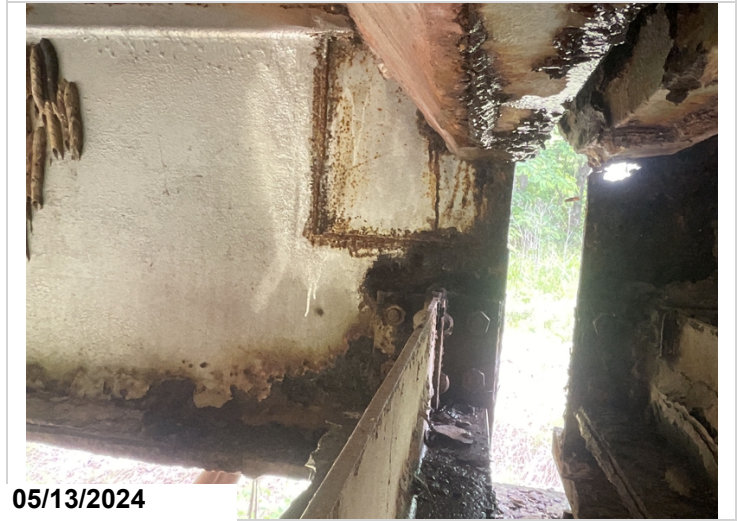
Span 2 bent 2 girder 4 has a welded web splice at haunch.

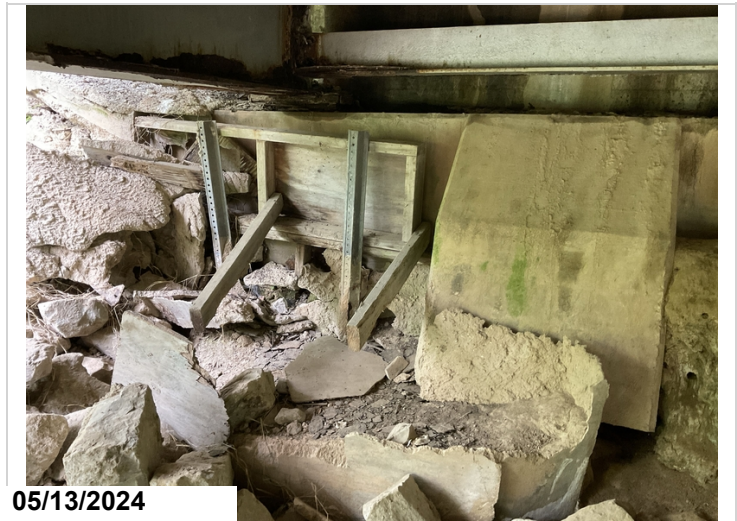
Bent 6 Lt scour repair

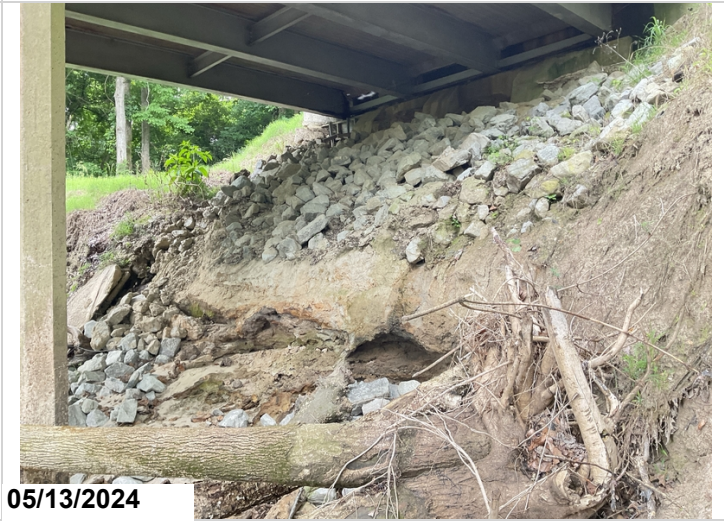
Toe of slope under span 5 has steep cut bank/embankment erosion.

Embankment under span 5 has scour at toe of slope with rip rap displacement

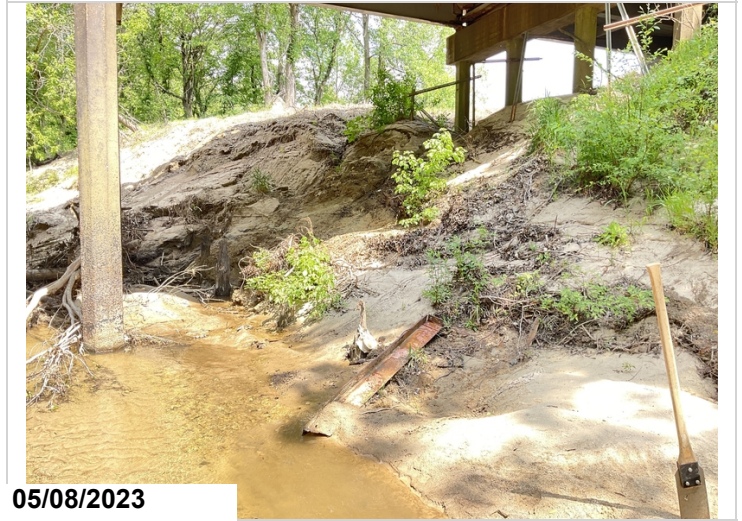
2023 - Embankment under span 2

Embankment under span 2 has a steep cut/erosion.

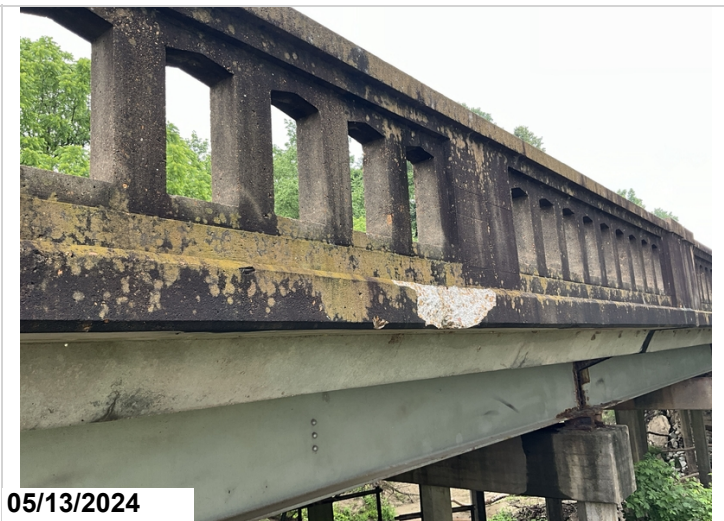
(331) Concrete rails have a few minor cracks, some with light efflorescence. Span 1 Rt overhang has a 2' spall near mid span. Lt bridge rail over bent 2 is leaning towards channel.

Span 1 Rt overhang has 2' spall near mid span cs3

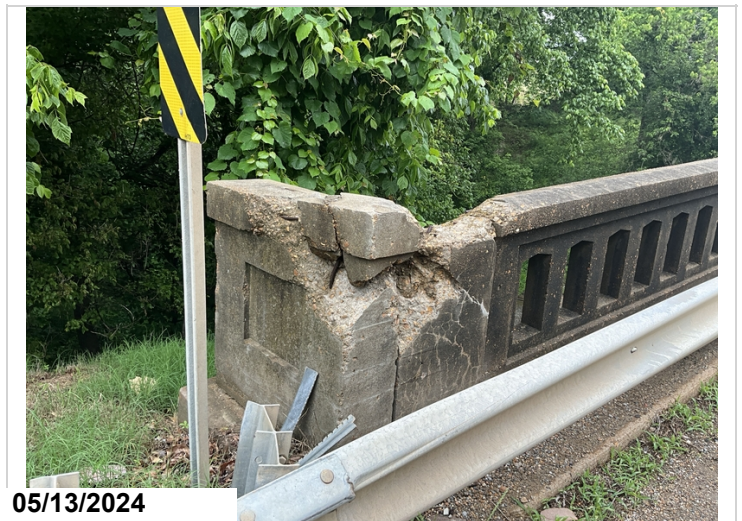
ELEMENTS	DESCRIPTION	UNITS	TOTAL	CS1	CS2	CS3	CS4
	Bridge rail end posts at bent 6 have spalls from past collision damage. Rt wing has rebar exposed.

Bent 6, Right side: collision damage at bridge rail end post with exposed rebar cs2

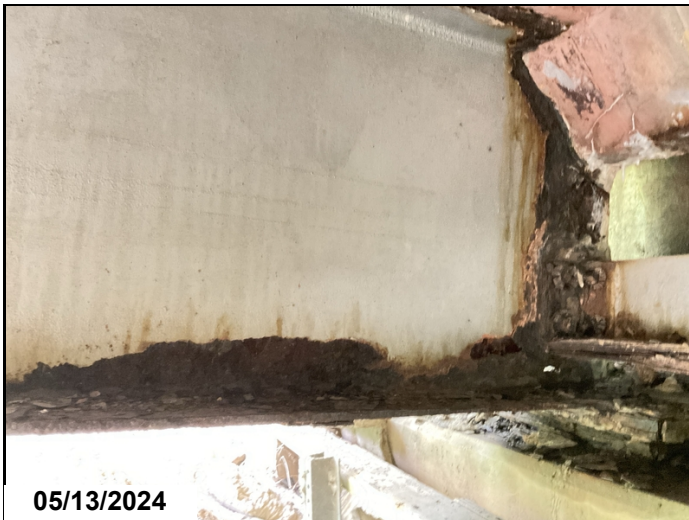
Span 5 bent 6 girder 1 has 3' of moderate to advanced section loss around concrete haunch, diaphragm connection and along bottom flange. Bottom of web has a 2" x 1" hole below diaphragm. Rt bottom flange is knife edged for 1' near bearing.

**Type of Work:** T-Splice

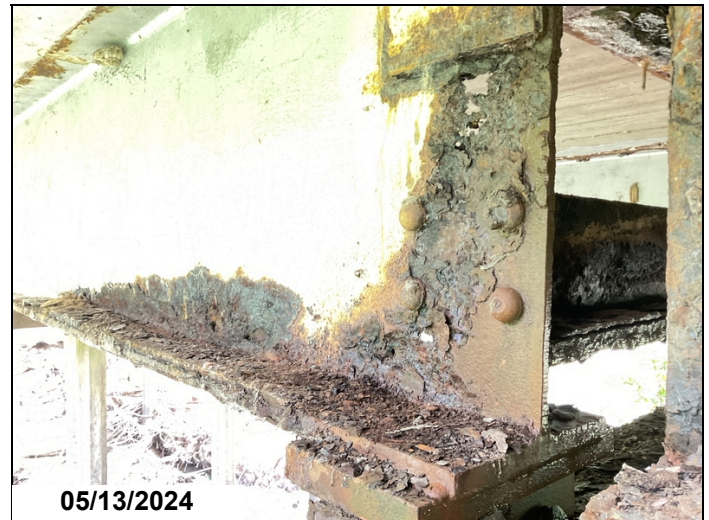
Span 2 bent 2 girder 1 has welded web plates at web below haunch. Web has a 2" x 4" hole below plates, a 5" x 1" hole under diaphragm connection, and a 12" x up to 3" area of heavy loss with two 1" diameter holes rusted through web starting 21" from end. Rt bottom flange has section loss and is knife edged.

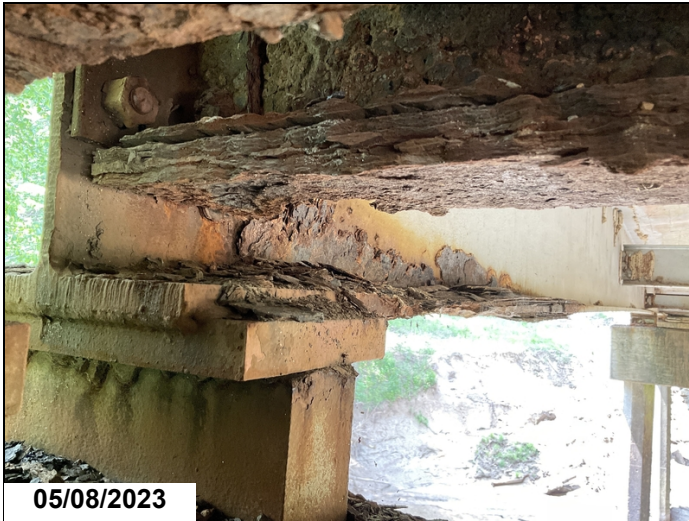
2023 - Span 2 bent 2 girder 1

Span 2 bent 2 girder 1 has welded web plates at web below haunch. Web has a 2" x 4" hole below plates, a 5" x 1" hole under diaphragm connection, and a 12" x up to 3" area of heavy loss with two 1" diameter holes rusted through web starting 21" from end. Rt bottom flange has section loss and is knife edged.

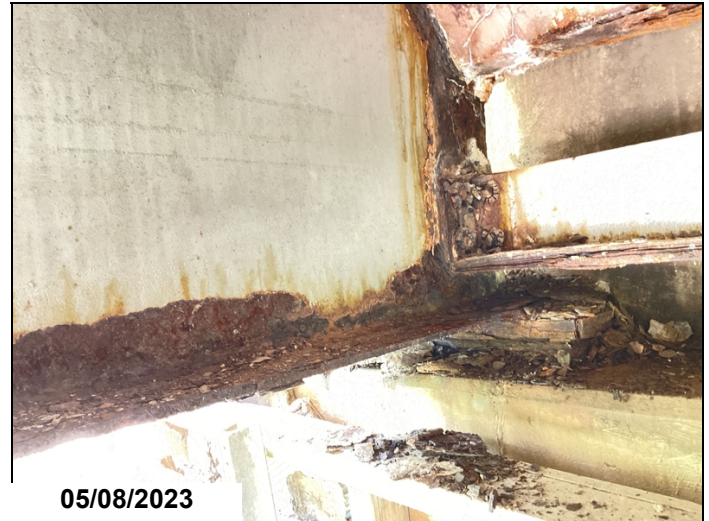
2023 - Span 5 bent 6 girder 1

Span 5 bent 6 girder 1 has 3' of moderate to advanced section loss around concrete haunch, diaphragm connection and along bottom flange. Bottom of web has a 2" x 1" hole below diaphragm. Rt bottom flange is knife edged for 1' near bearing.

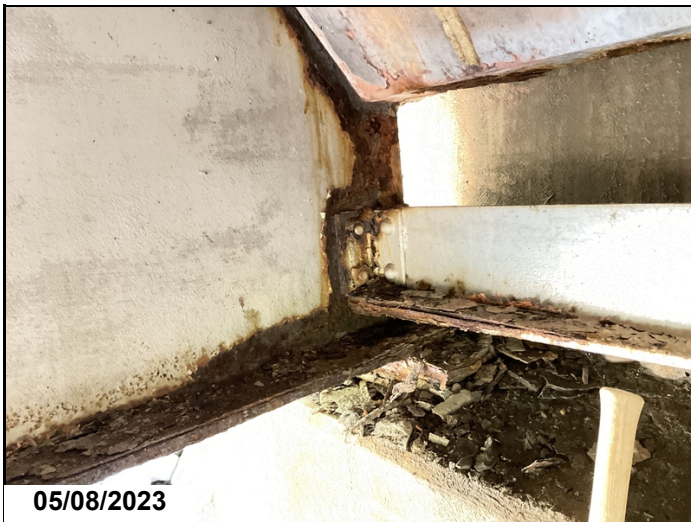
2023 - Span 1 bent 1 girder 4

Span 1 bent 1 girder 4 has 2' of rust with areas of up to 1/8" section loss at web below haunch, around diaphragm connection, and along bottom of web.

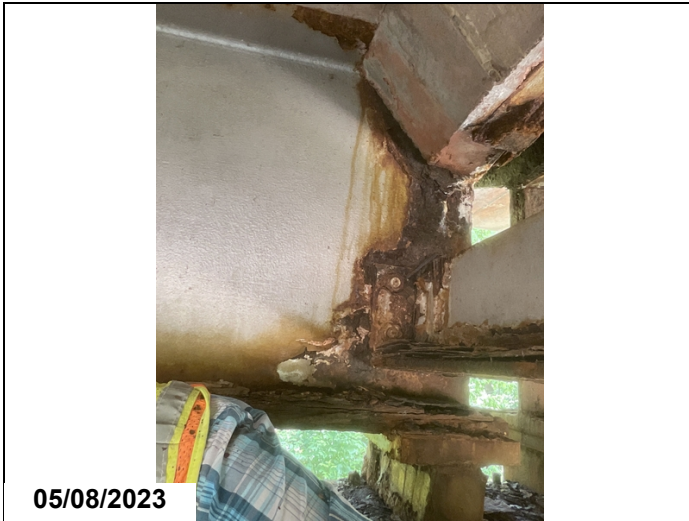
2023 - Span 1 bent 2 girder 1

Span 1 bent 2 girder 1 has heavy section loss at web below haunch, around diaphragm connection, and on bottom flange near bearing.

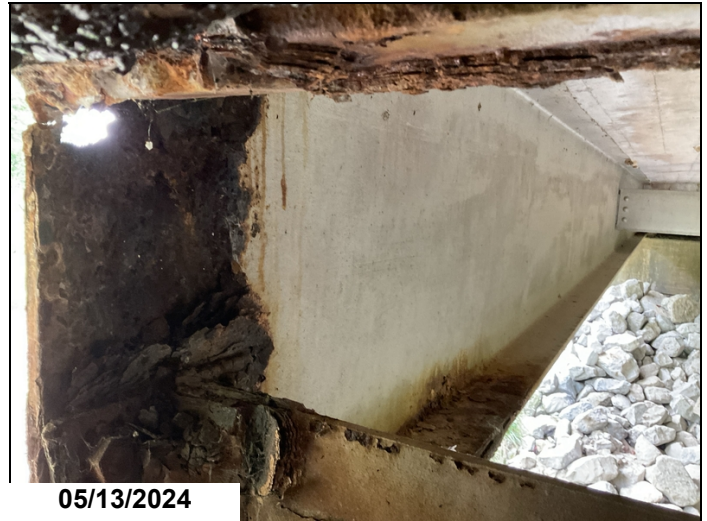
Span 1 bent 2 girder 4 has a 2" x 1" hole at web below haunch.

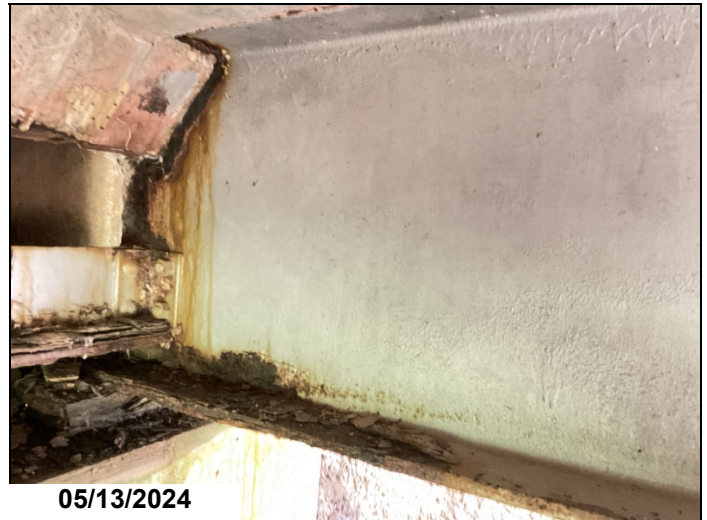
Span 5 bent 6 girder 4 has 2' of moderate section loss (up to 3/16") at web below haunch, diaphragm connection and along bottom of web.

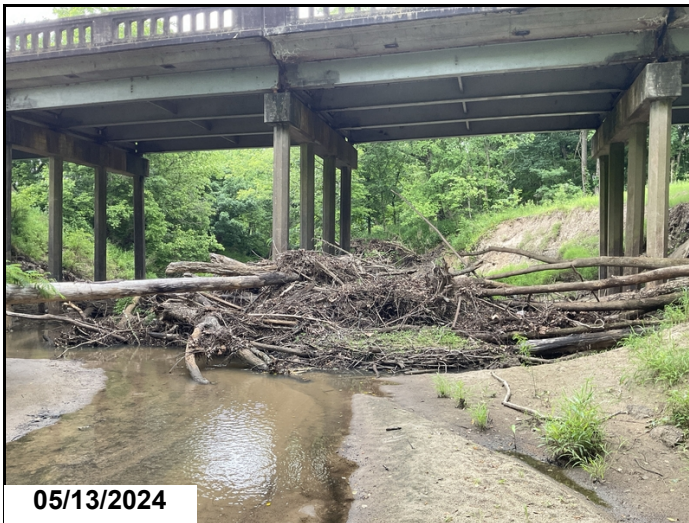
Large drift is built up at bents 3 - 5.

2024 - Large drift at 4 and 5

**Type of Work:** Channel Work/Drift Removal

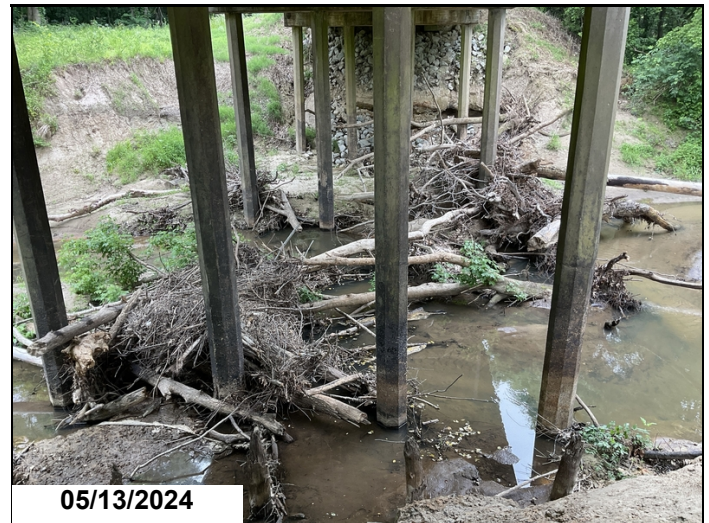
Drift at 3 - 5

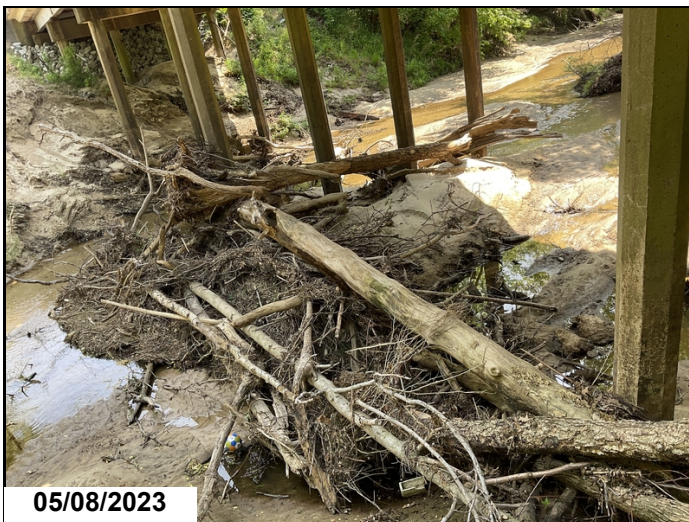
2023 - Drift at bents 3 - 5

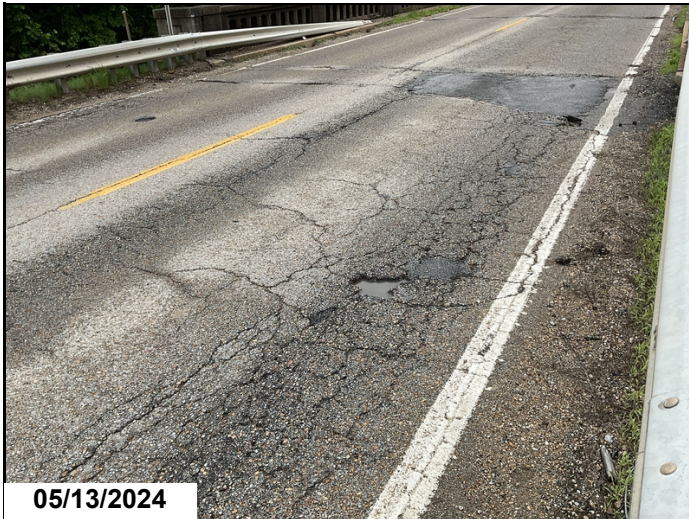
Approach roadway at beginning

Approach roadways have settlement at each end of bridge. Asphalt is cracked, rutted, and has several potholes. Asphalt wearing surface has widespread areas of map cracks. Asphalt is cracked, delaminated, and raveling out over joints.

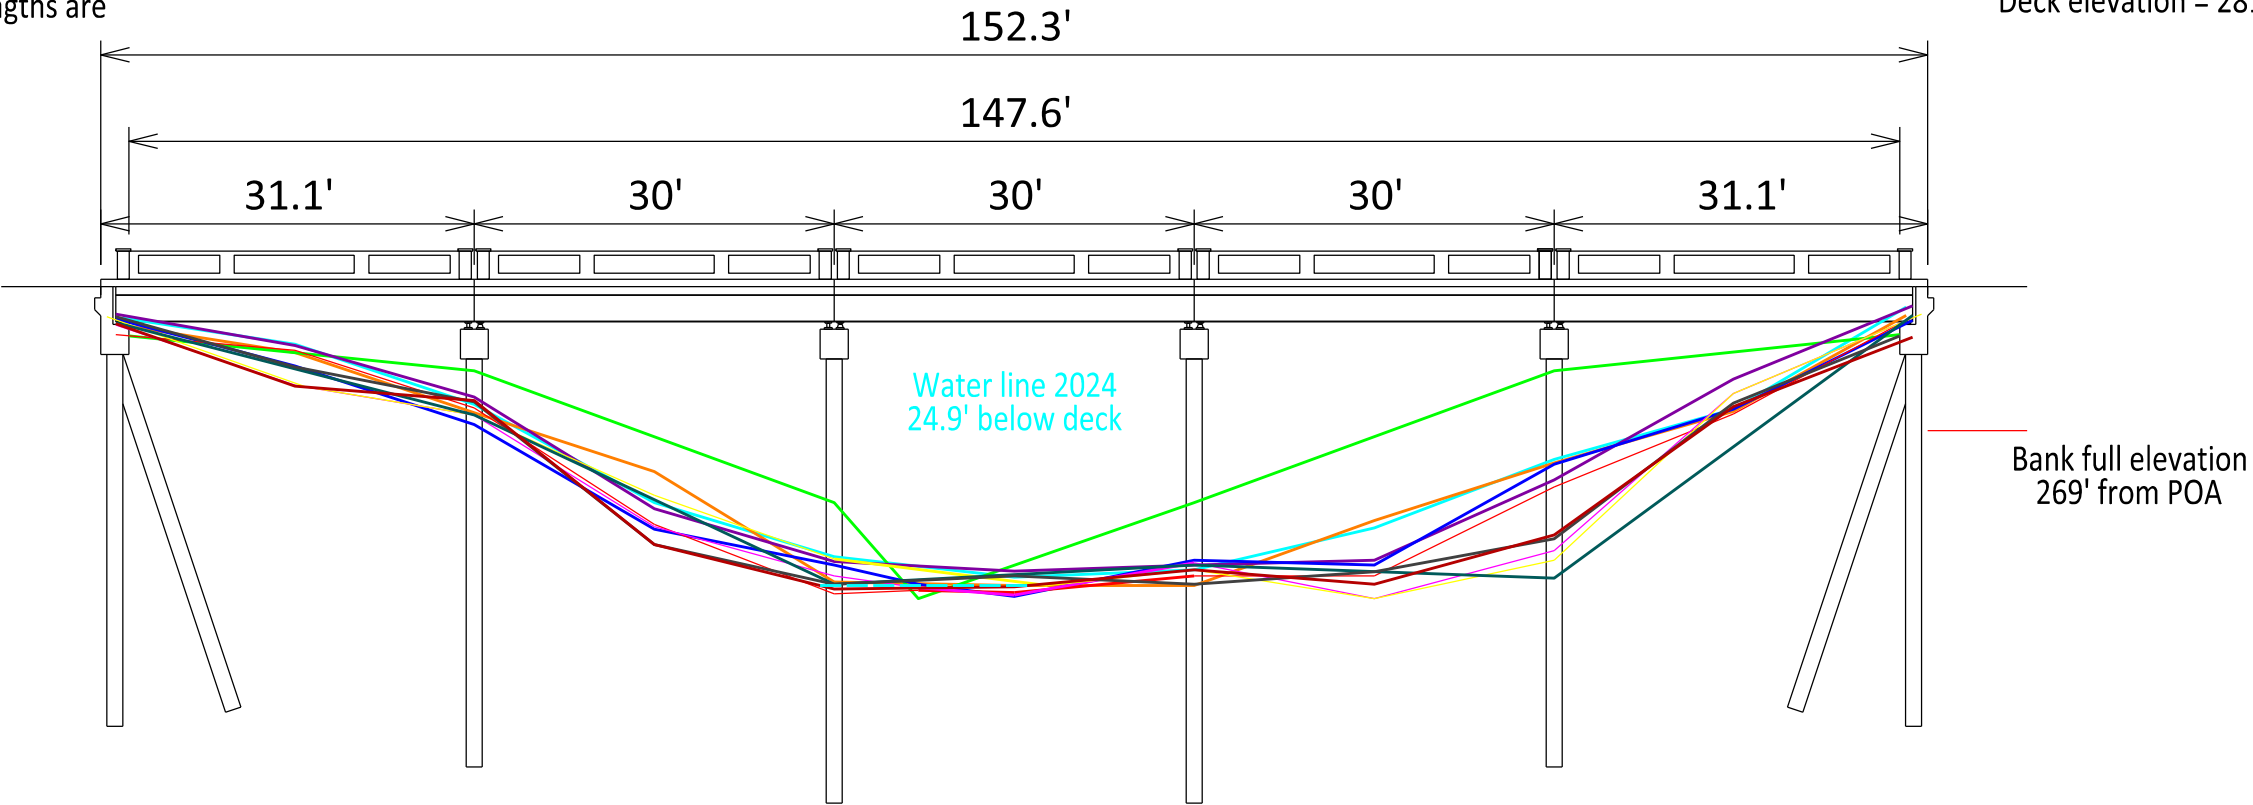
Channel scour has widened the original channel since construction in 1947 and caused loss of pile penetration at interior bents.
