Bridge Inspection Report

02140
SH 77-02- LM 3.71
over
DITCH NO 21

Structure Number: 02140

Facility Carried: SH 77-02- LM 3.71

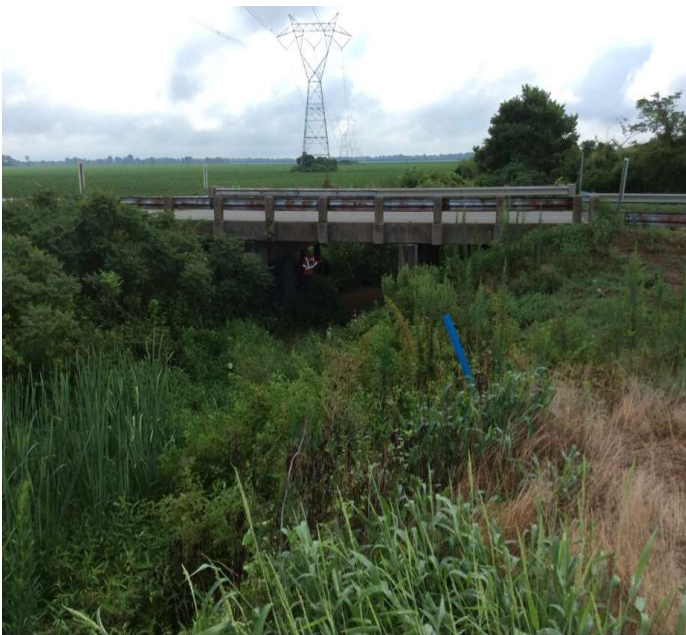
PHOTO 1 Description

Metal Bridge Rail has 60% paint deterioration and minor rust with pitting.

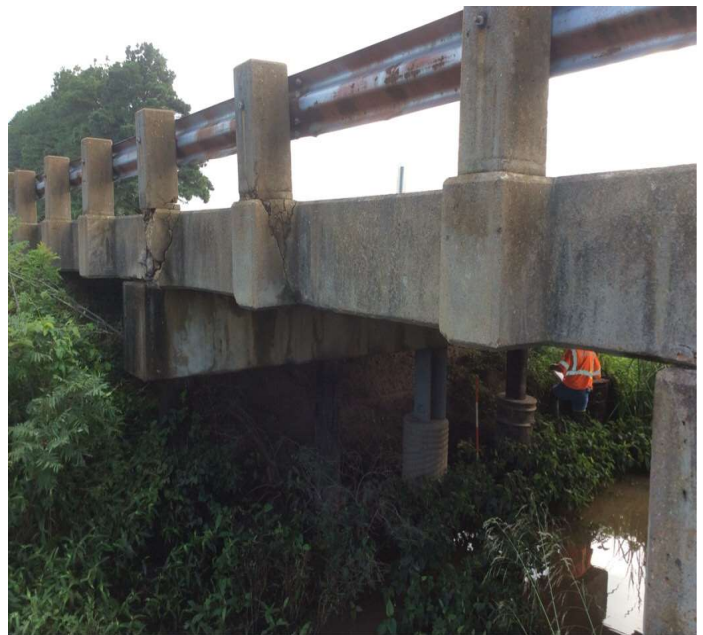
PHOTO 2 Description

Right side of Span 2 Bridge Rail has 2 Concrete Post are cracked and broke with rebar exposed, see 2016 photo.

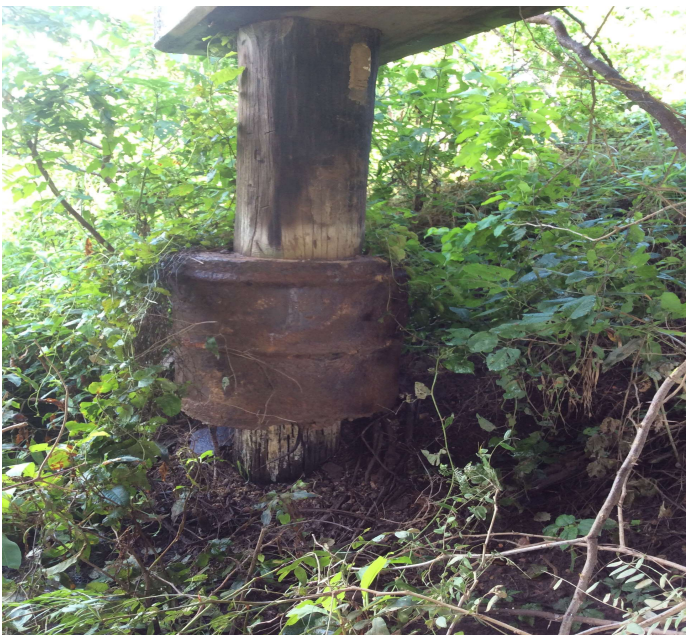
PHOTO 1 Description

Bent 2 Pile 5, below splice, has up to 1in. outside decay, see 2016 photo.

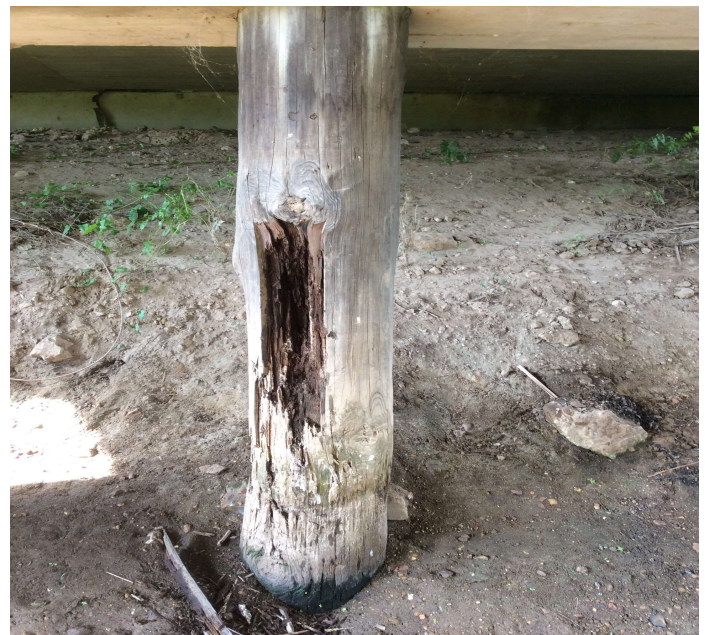
PHOTO 2 Description

Bent 3 Pile 3 has 4in. outside decay and section loss, see 2016 photo.

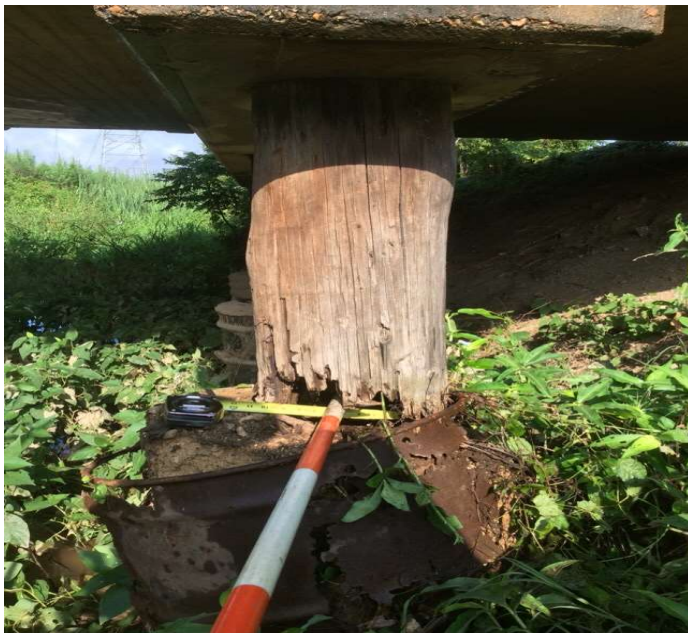
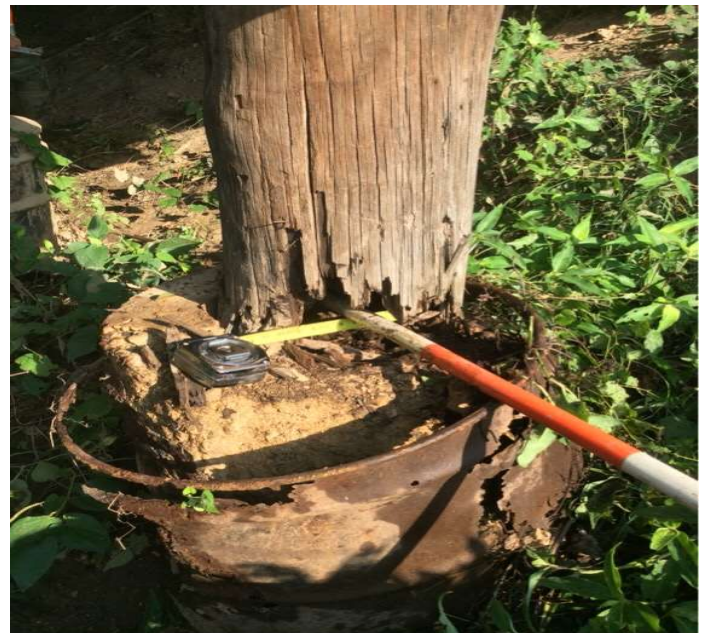
Bent 2 Pile 1 is hollow with crushing, little to no support, see 2016 photo.
