Bridge Inspection Report

02141

SH 77-02- LM 10.42

LEFT HAND CHUTE

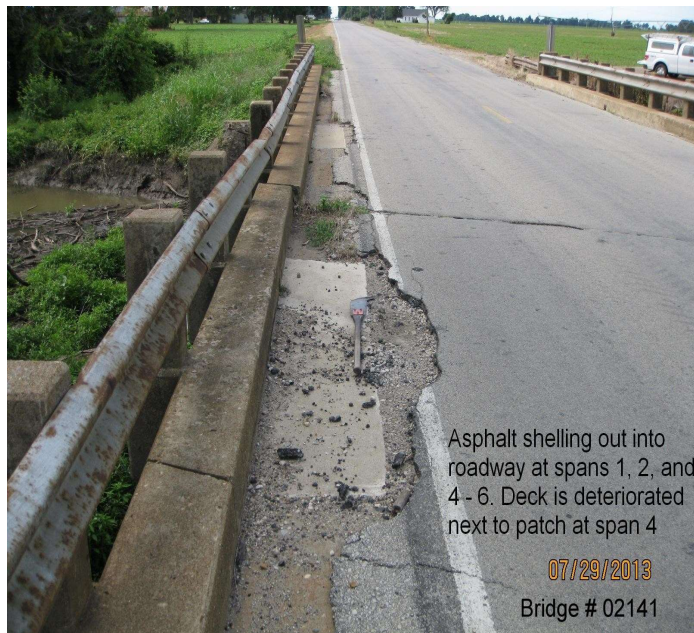
Deck has open cracks thru asphalt at joints.

Asphalt is shelled out on Lt edge of deck at spans 1, 2, 4, 5, and 6.

3 1/2 in. lateral shift of slab at Bt. 5 joint, no significant change this inspection.

PHOTO 1 Description 02141 07292013 Deck at spans 4 - 6

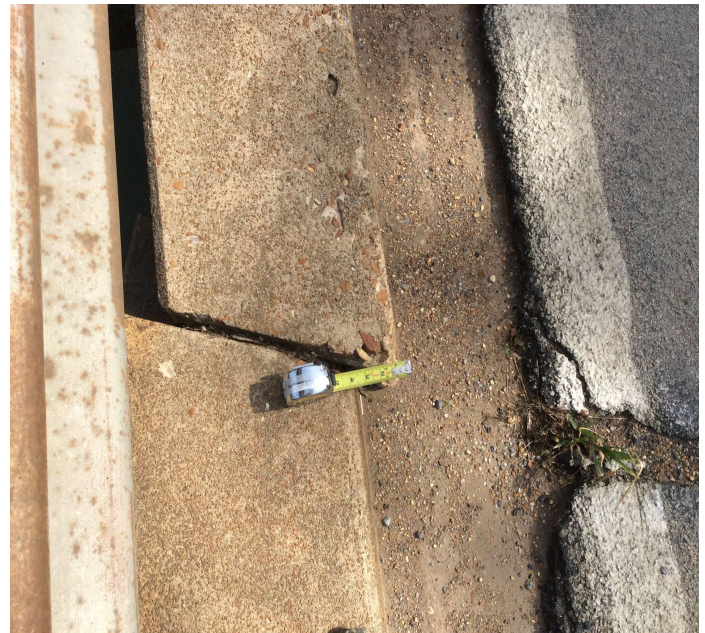
PHOTO 2 Description Bent 5 right curb lateral shift of slab.

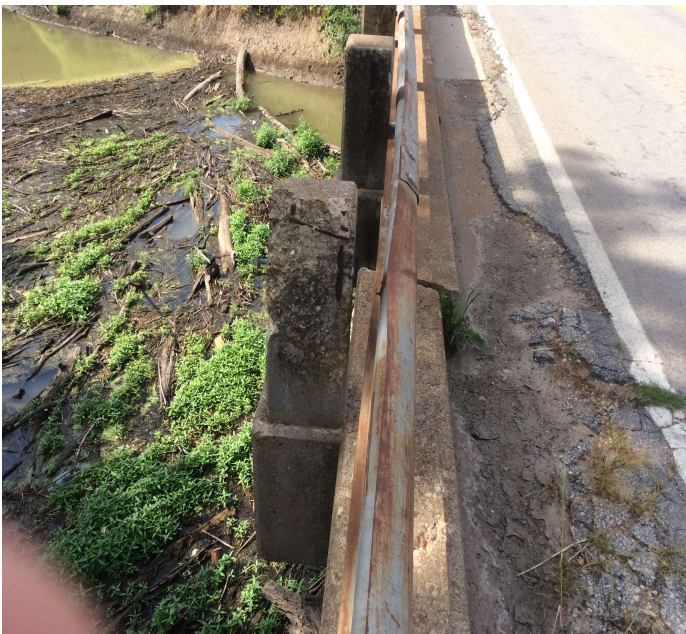
Rail has 30% paint deter. and rust forming.

Lt rail is loose at spans 4 and 5.

PHOTO 1 Description Bent 5 left guardrail

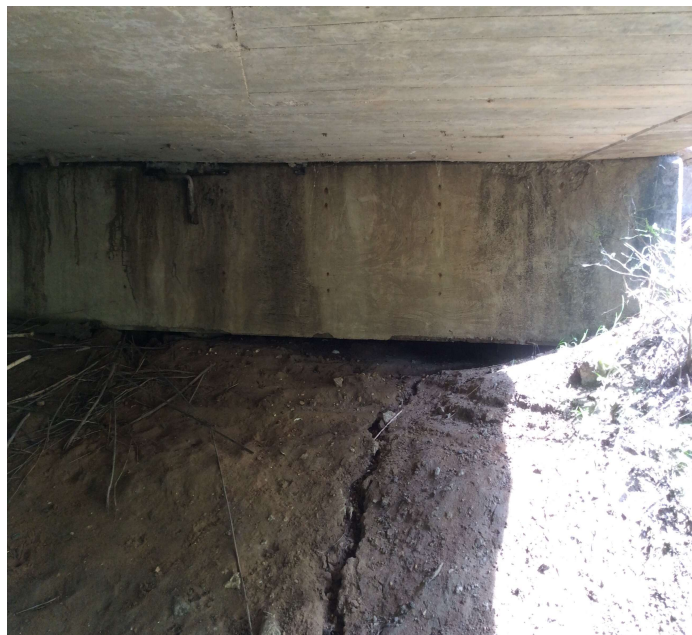
Bent 1 Cap has a 2ft. x 6in. spall with no rebar exposed, see 2015 photo.

PHOTO 1 Description Left end bent 1

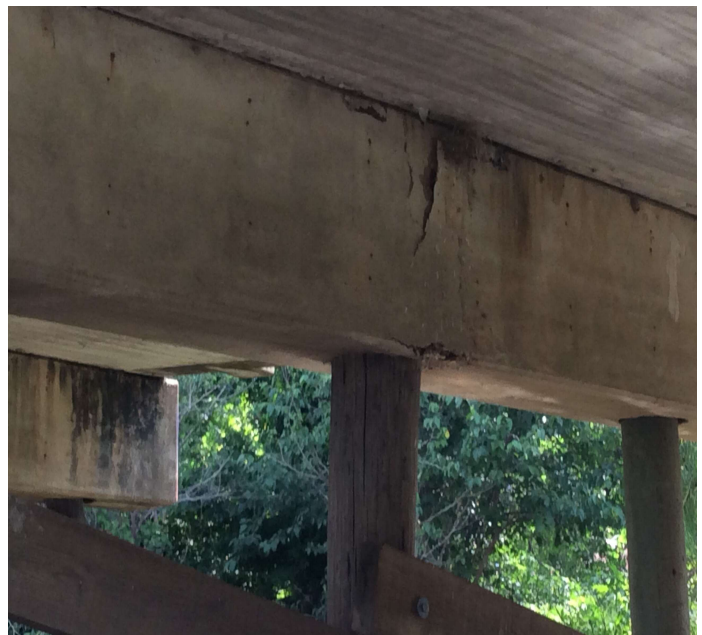
Bent 6 Cap near Pile 3 has 1ft. x 1ft. spall with rebar exposed on the bottom of cap with a delaminated area to the face of cap, see 2015 photo.

PHOTO 2 Description Bent 6 cap over pile 3 span 6 side.

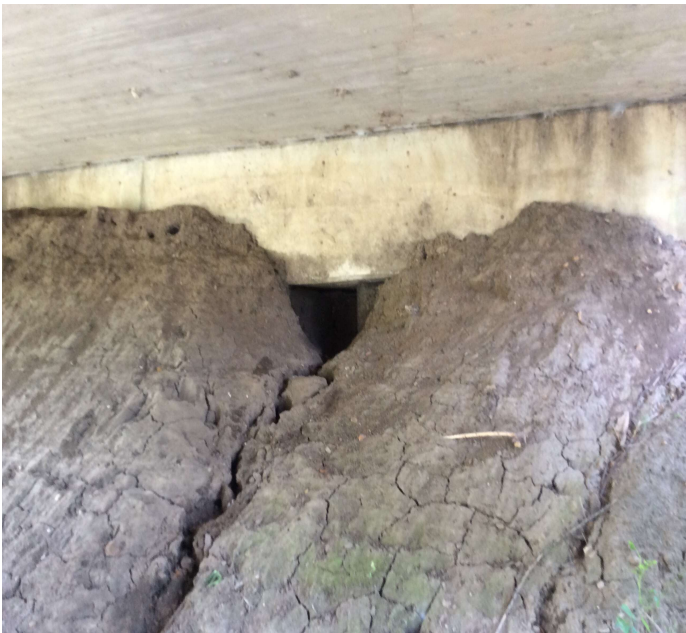
Moderate Slope Erosion under Span 8, no berm remaining right of centerline, and Bent 9 Abutment has 4ft. long x up to 1.5ft. deep and up to 2ft. undermining under cap exposing Pile 4, see 2015 photo for typical.

PHOTO 1 Description Bent 9 embankment erosion.

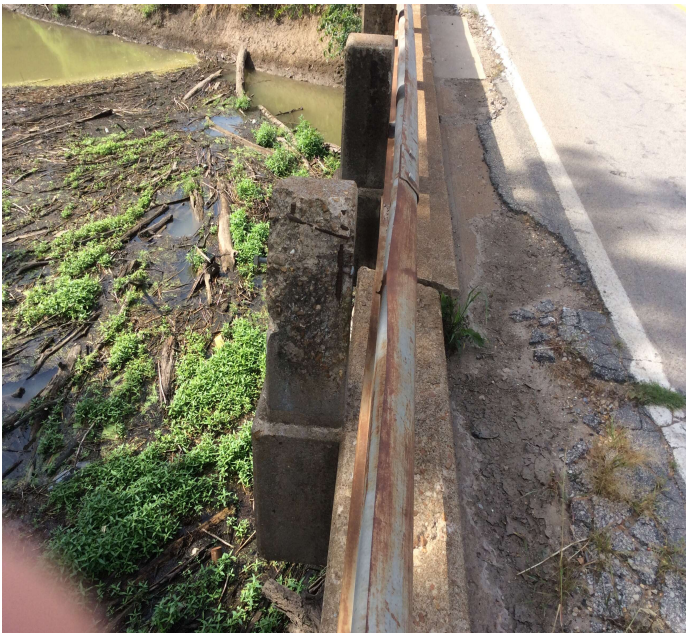
Left Concrete Curb Span 2 has a 3ft. x 1.5ft. of area deteriorated with section loss.

Right and Left edge of Gutter Line has delamination, spalls and patched areas, see 2015 & 2013 photo of Spans 4-6 photo for typical.

Span 4 Slab at left Gutter Line has a 4 ft. x 1.5 ft. area of heavy deterioration and delamination adjacent to previous concrete patch, see 2015 & 2013 photo.

PHOTO 1 Description Bent 5 left guardrail

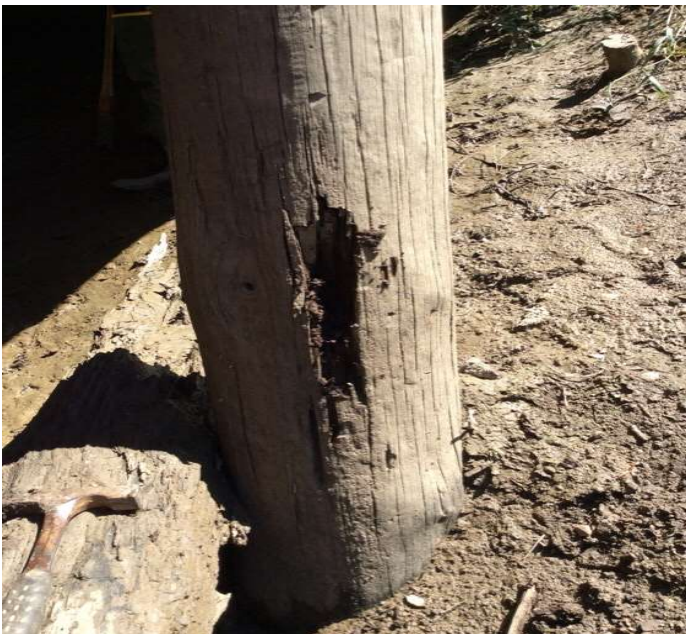
PHOTO 1 Description

Bent 2 Pile 1 is decayed and partially hollow near groundline.

Bent 3 Pile 1 is decayed and partially hollow 4ft. above groundline.

Bent 7 Pile 1 is decayed and partially hollow 3ft. above groundline.

Bent 8 Pile 5 is decayed and partially hollow, see 2016 photo.

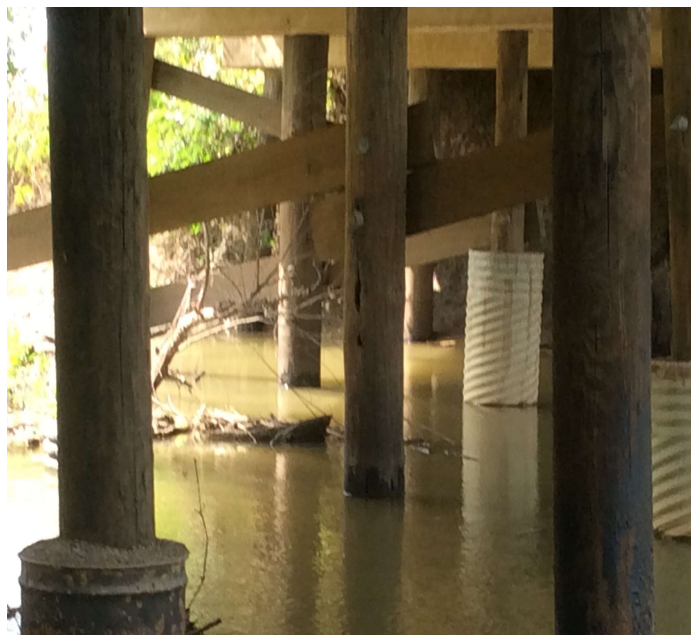
Bent 6 Pile 3 is decayed and mostly hollow 1 1/2in. shell and hollow, see 2015 & 2016 photo.

PHOTO 1 Description Bent 6 pile 3

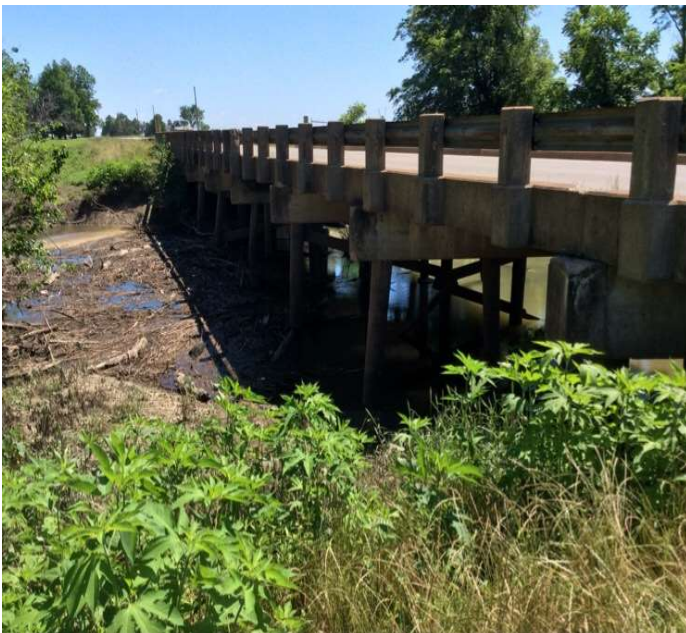
PHOTO 1 Description

Large Drift up stream across entire channel lodged on piles; see 2016 photo of upstream channel view.

Copy to Miss 1 crew for removal when they get a chance
