Bridge Inspection Report

02870
SH 77-02- LM 7.16
over
LITTLE RIVER

Structure Number: 02870

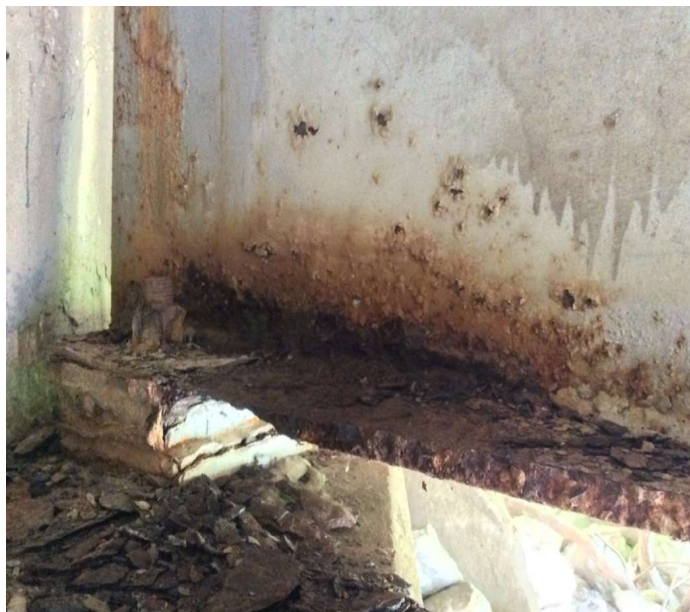
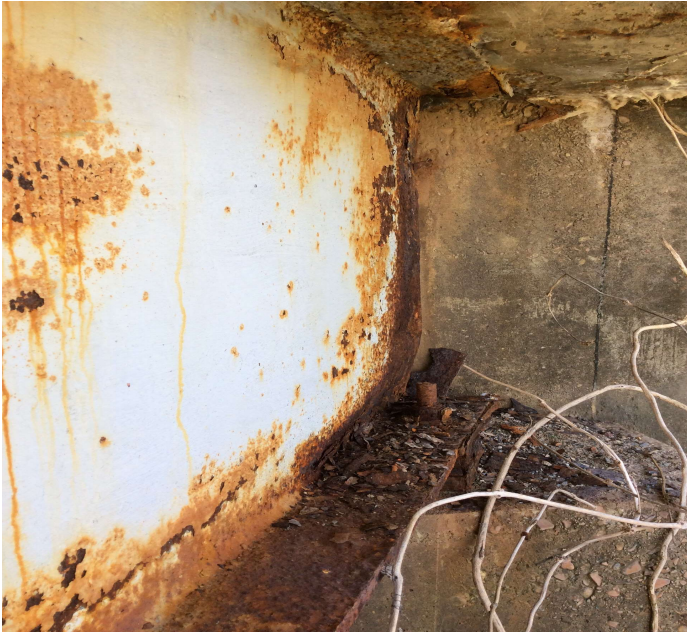
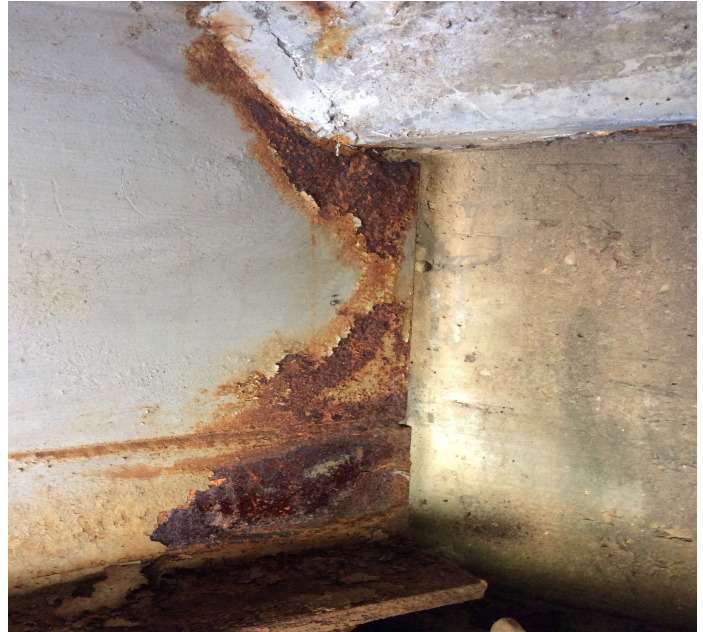
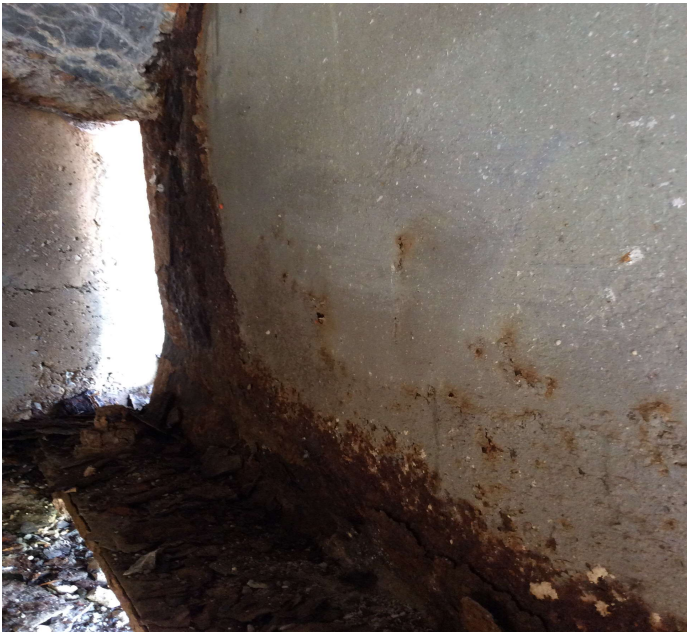
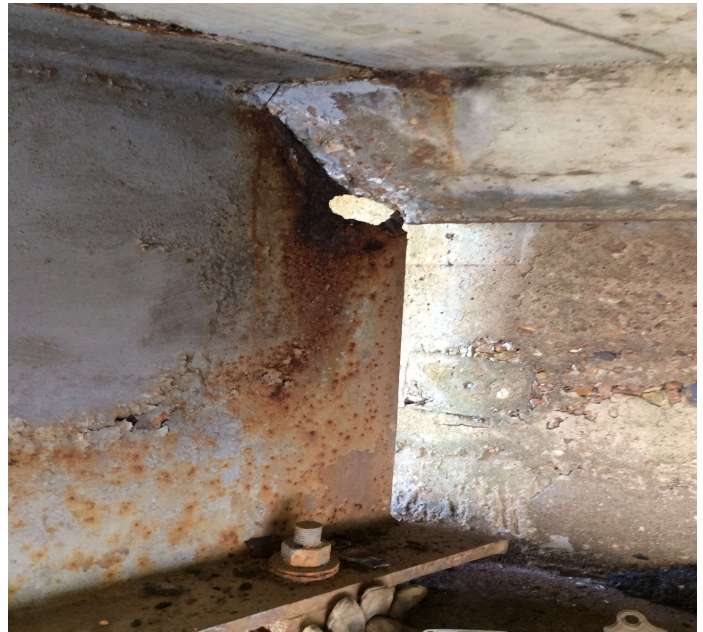
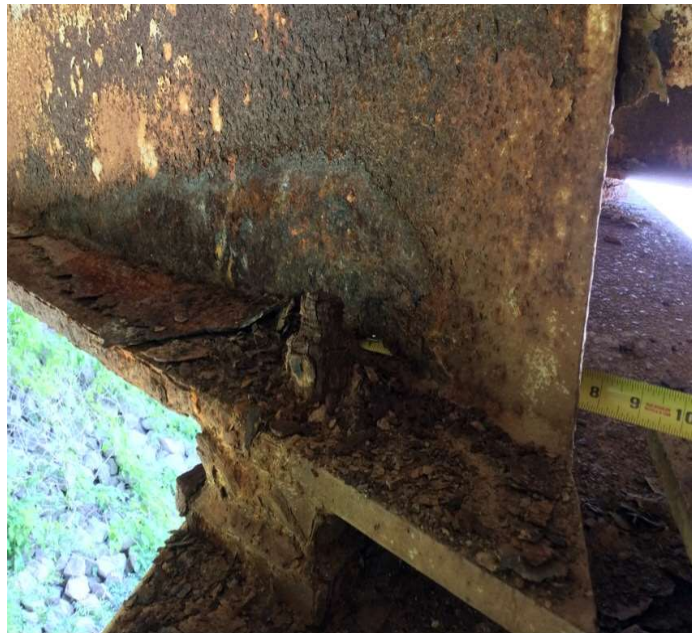
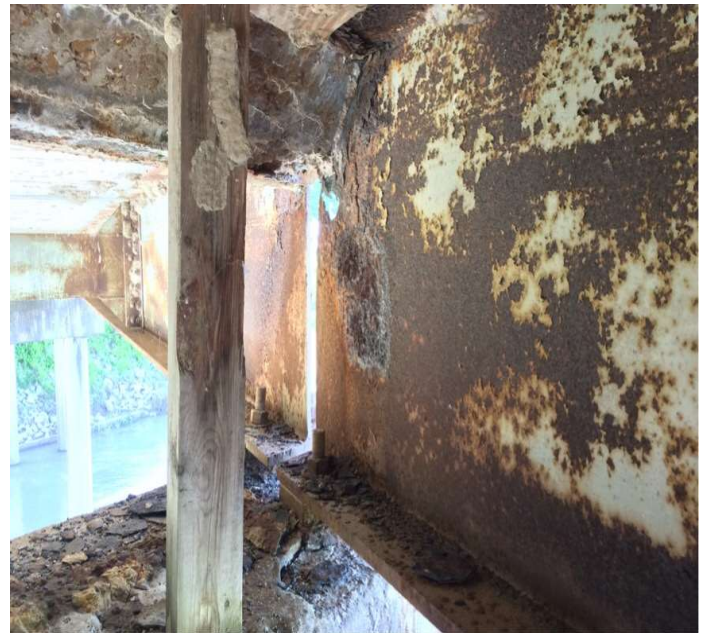
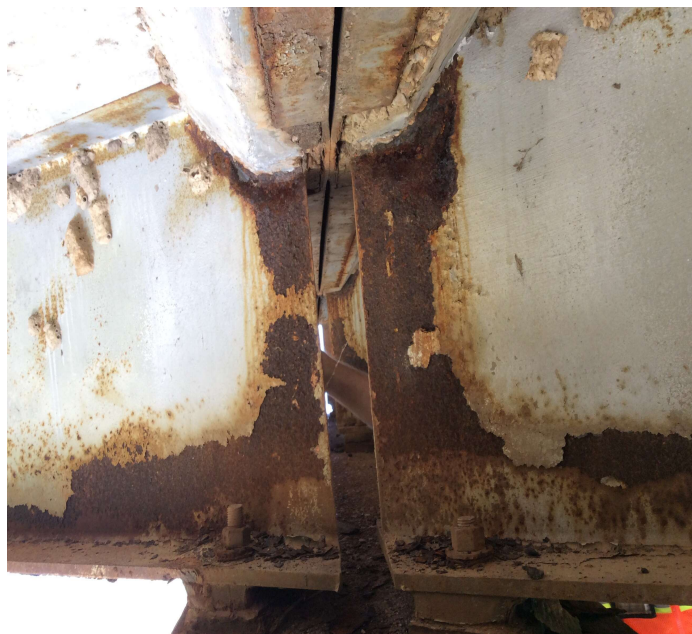
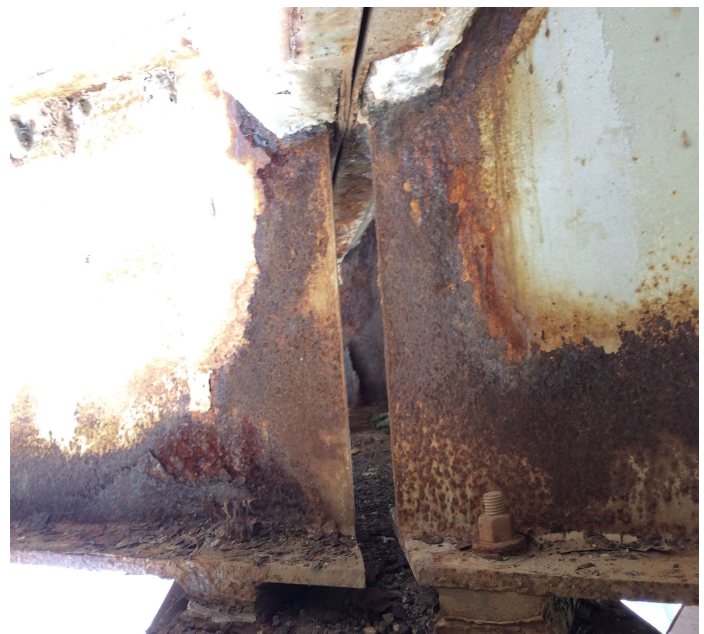
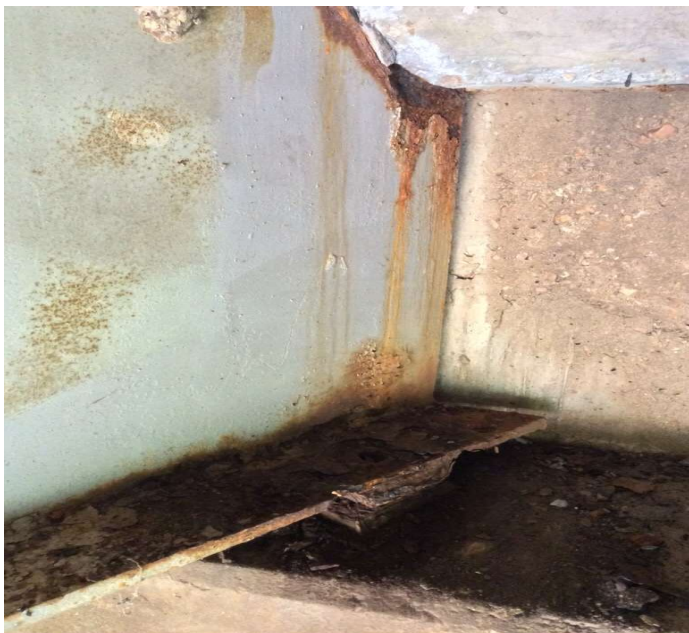
Several girder ends have section loss at web below haunch and at bottom flange:

Span 1 Girder 2 over Bent 1 has the right side flange knife edged with up to 3/4in. section loss at bottom flange near bearing.

Span 1 Girder 4 over Bent 1 has the left side flange knife edged with up to 3/4in. section loss at bottom flange near bearing. Both anchor bolts are missing. Web has a 1/16in. diameter hole near concrete haunch.

Spans 1&2 Girder 3 Bent 2 has section loss at bottom flange.

Span 1 Girder 3 Bent 2 has a 4" x 3/4" hole in web at haunch.

Span 2 Girder 5 Bent 3 has a 4" x 2" hole in web at haunch.

Span 3 Girder 3 Bent 3 has a 1 1/2" x 3/8" hole in web at haunch.

Span 3 Girder 3 Bent 4 has two small holes (1/8") in web at haunch.

Span 4 Girder 3 Bent 4 has a 1 1/2" x 3/4" hole in web at haunch.

Span 4 Girder 3 Bent 5 has a 1" x 3/4" hole in web at haunch.

Span 5 Girder 3 Bent 5 has a 1" x 3/4" hole in web near concrete haunch.

Span 5 Girder 4 Bent 5 has a 2" x 3/4" hole in bottom of web over bearing 5" from end of girder.

Span 5 Girder 1 Bent 6 has a 5" x 1 1/2" hole in web at haunch.

Span 5 Girder 3 Bent 6 has a 1 3/4" x 3/4" hole in web at haunch.

Span 5 Girder 5 Bent 6 web at end of girder is bowed, possibly crushing.

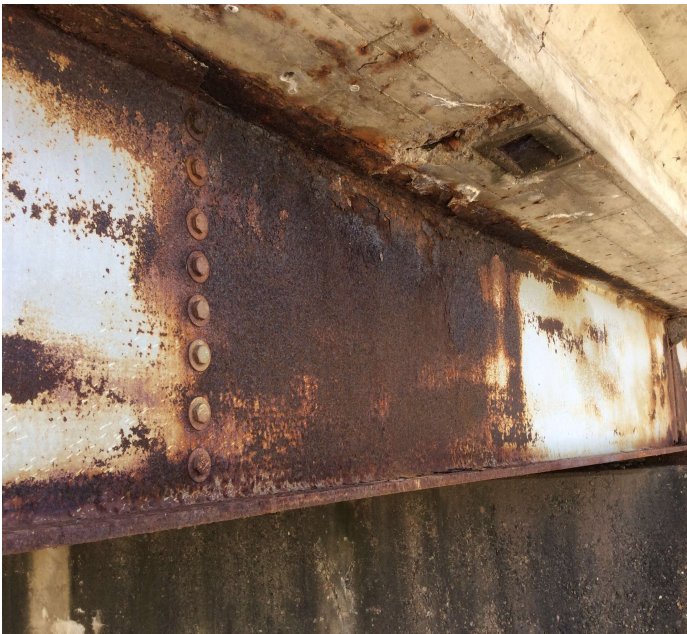
PHOTO 1 Description

Steel Girders have 60% paint deterioration and areas of surface rust with some section loss.

Ends of most Girders are rusted with section loss at haunch and bearings.

Exterior girders 1 and 5 have rust and section loss throughout spans especially below drain openings.

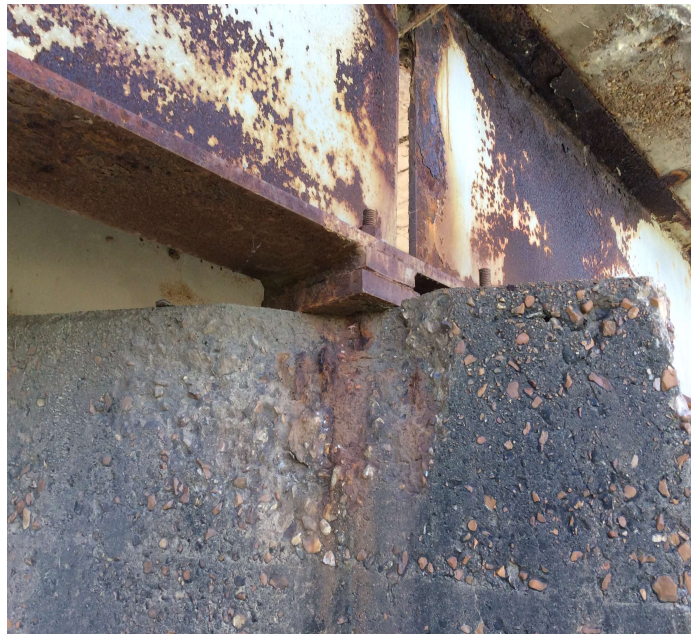
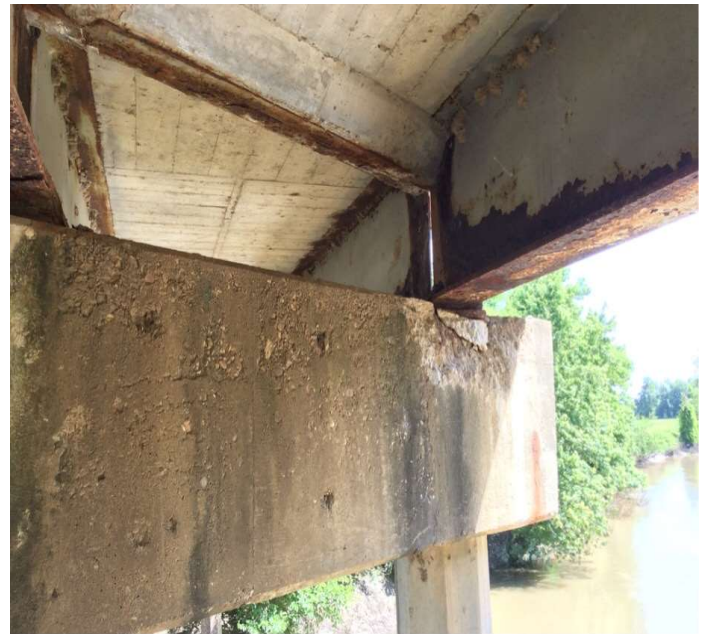
Bent 2 and 3 caps have spalls under bearings, (Approx. 20% loss of bearing area):

Span 1 bent 2 bearing 5

Span 3 bent 3 bearing 1

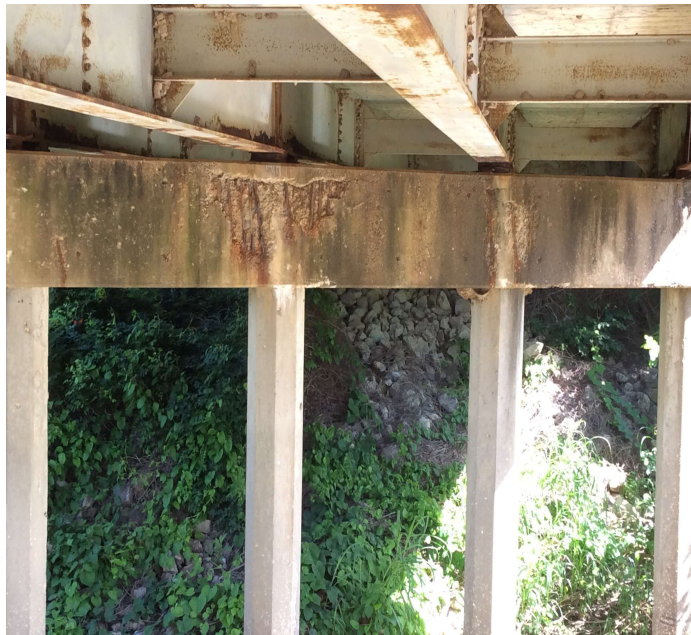
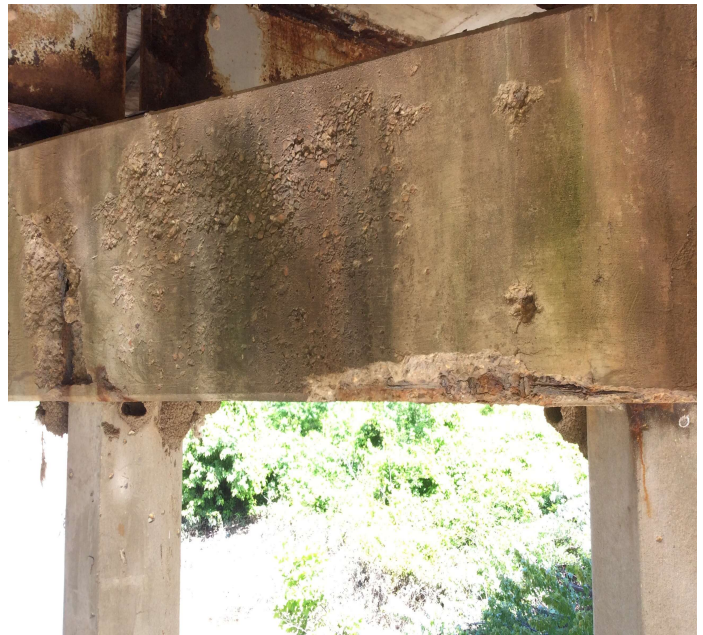
Bent 2 cap on ahead side has 1.5' x 1.5' x 1" deep spall near pile 2, and 3.5' x 2' x 2" deep spall with exposed rebar near pile 3, Exposed rebar has up to 50% section loss.

Bent 3 cap on ahead side has a 1.5' x 1' x 2" deep spall near pile 4. Bottom of cap has a 2.5' x 6" x 2" deep spall between piles 3 and 4 with exposed rebar. Exposed rebar has up to 50% section loss.

Bent 4 cap has several small spalls with rebar exposed on bottom of cap. (10')

Bent 6 abutment has a spalled area with rebar exposed.

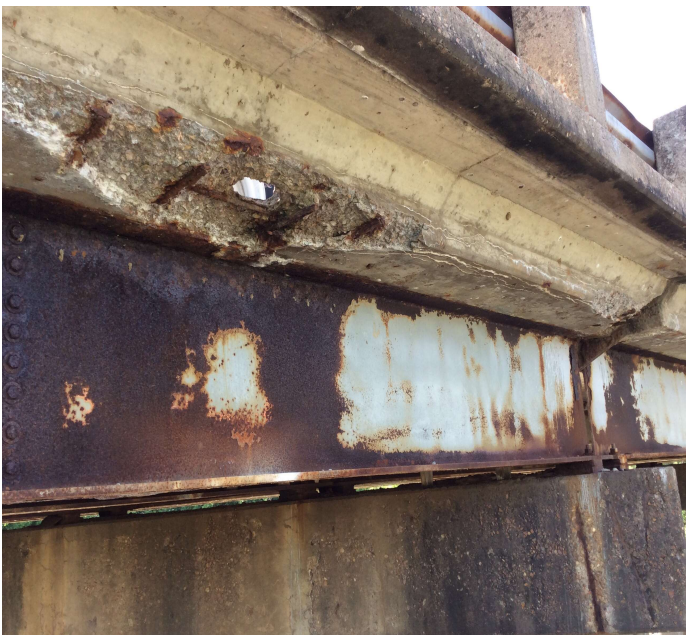
PHOTO 1 Description

Lt and Rt curbs are deteriorated with section loss.

Lt and Rt overhangs have moderate deterioration, cracking with efflorescence, and several spalls with rebar exposed.
