Bridge Inspection Report

02871
SH 77-02- LM 6.83
over
LITTLE RIVER

Structure Number: 02871

Facility Carried: SH 77-02- LM 6.83

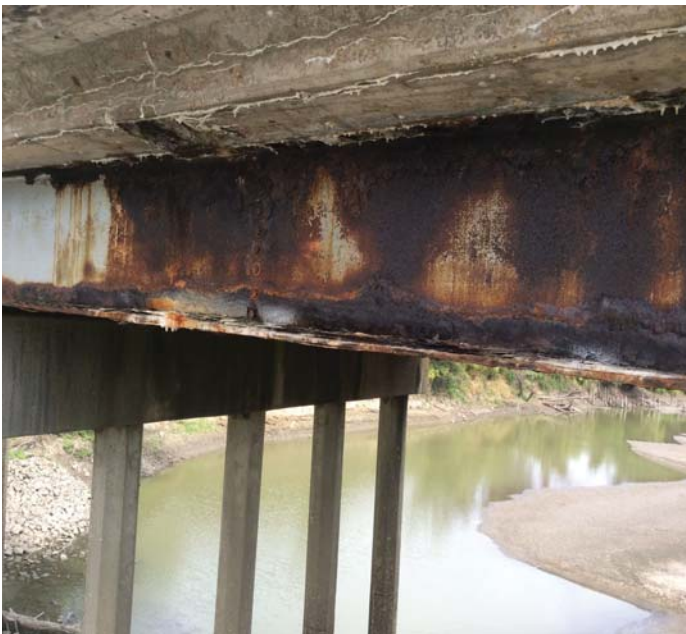
Exterior Girders are rusted with up to 5/8in. section loss to web and flanges at drain openings, especially Spans 3,4 & 8, see Span 4 Girder 5 for typical.

PHOTO 1 Description 02871 10-01-2015 Span 4 Girder 5.

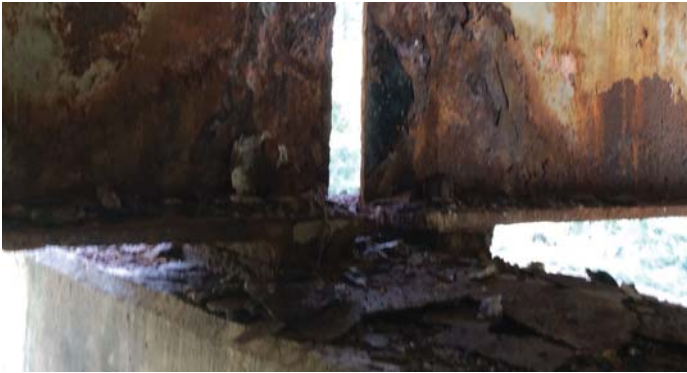
PHOTO 1 Description 02871 10-01-2015 Span 1 Girder 1 & Span 2 Girder 1 over Bent 2.

Span 1 & 2 Girder 1 Bent 2 pack rust with section loss especially at web , see photo 2015

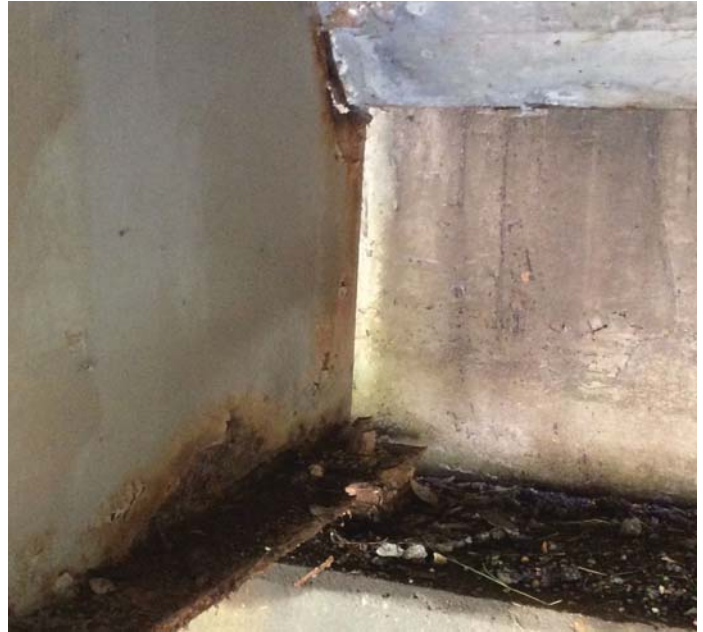
Span 1 Girder 2 over Bent 1 has 4in x 3/4in. hole in near concrete haunch and a 3/4in. x 2in. hole in the left flange near the bearing, see 2015 photo.

PHOTO 11 Description 02871 10-01-2015 Span 1 Girder 2 over Bent 1 bottom flange.

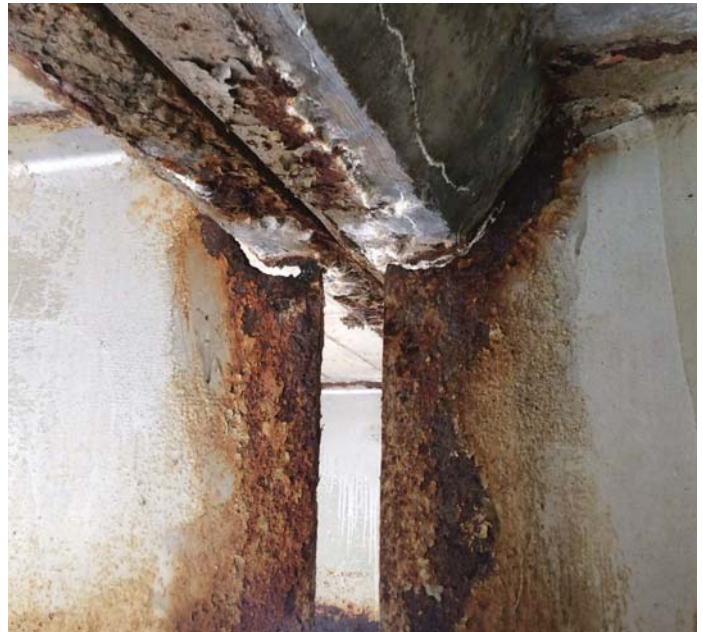
Span 1 Girder 3 over Bent 2 has a 7in. X 1/2in. hole rusted thru web at concrete haunch, see 2015 photo.

Span 2 Girder 3 Bent 2 has a 5in. x 1/2in. hole in web at haunch, See2015 photo.

PHOTO 12 Description 02871 10-01-2015 Span 1 Girder 3 & Span 2 Girder 3 over Bent 2.

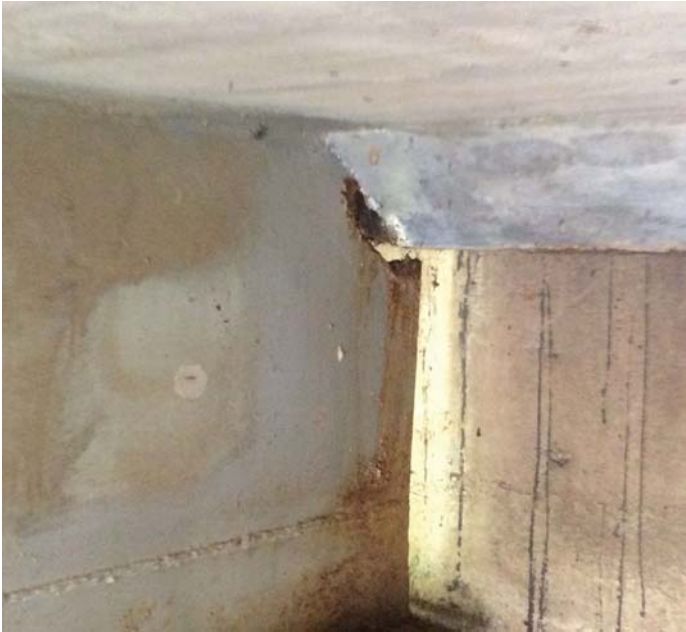
Span 1 Girder 3 over Bent 1 has 6 1/2in x 1in. hole in near concrete haunch, see 2015 photo.

PHOTO 13 Description 02871 10-01-2015 Span 1 Girder 3 over bent 1.

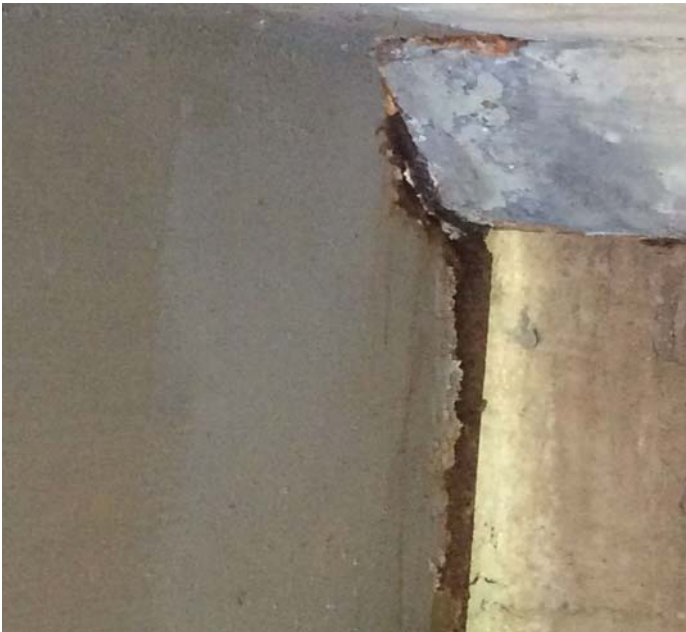
Span 1 Girder 4 over Bent 1 has 7in x 3/4in. hole in near concrete haunch, see 2015 photo.

PHOTO 14 Description 02871 10-01-2015 Span 1 Girder 4 over bent 1.

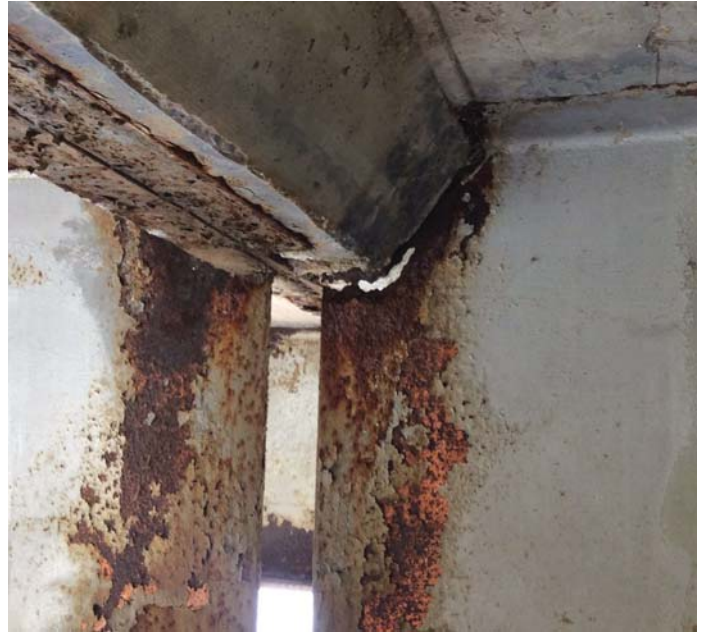
Span 1 Girder 4 Bent 2 has a 6in. x 3/4in. hole in web at haunch, See2015 photo.

PHOTO 15 Description 02871 10-01-2015 Span 1 Girder 4 over Bent 2.

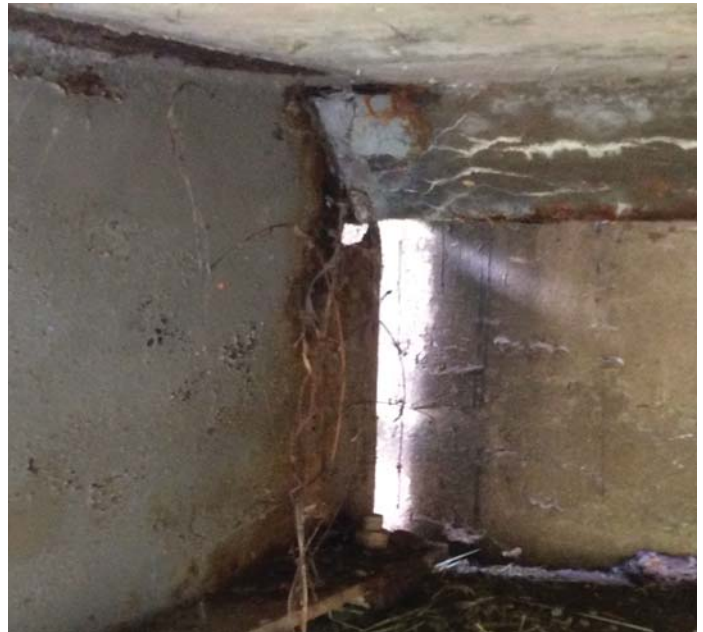
Span 1 Girder 5 over Bent 1 has 4in x 2 1/2in. hole in near concrete haunch, see 2016 photo.

PHOTO 16 Description 02871 10-01-2015 Span 1 Girder 5 over bent 1.

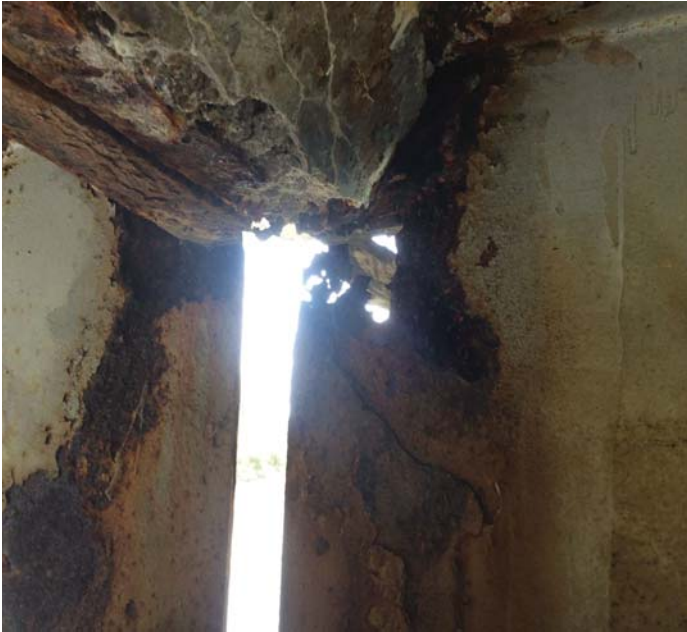
Span 1 Girder 5 Bent 2 has a 6in. x 6in. hole in web at haunch, See2015 photo.

PHOTO 17 Description 02871 10-01-2015 Span 1 Girder 5 over Bent 2.

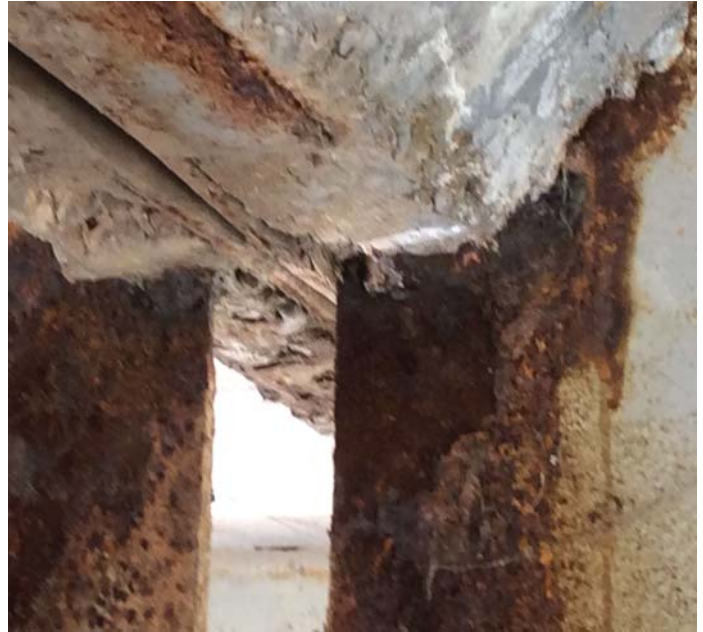
Span 3 Girder 3 Bent 4 has a 1 1/2in. x 3/4in. hole in web at haunch, see 2015 photo.

PHOTO 19 Description 02871 10-01-2015 Span 3 Girder 3 over Bent 4.

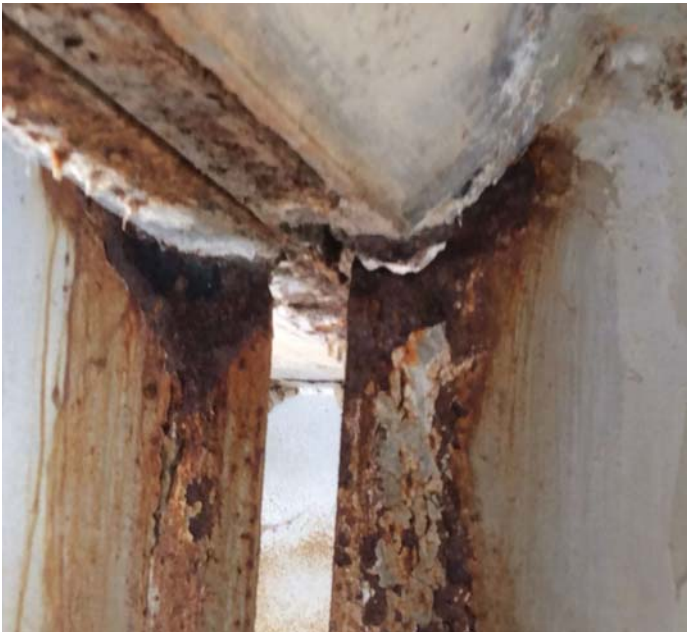
Span 2 Girder 4 Bent 3 has a 3 1/2in. x 1/2in. hole in web at haunch, see 2015 photo.

PHOTO 18 Description 02871 10-01-2015 Span 2 Girder 4 over Bent 3.

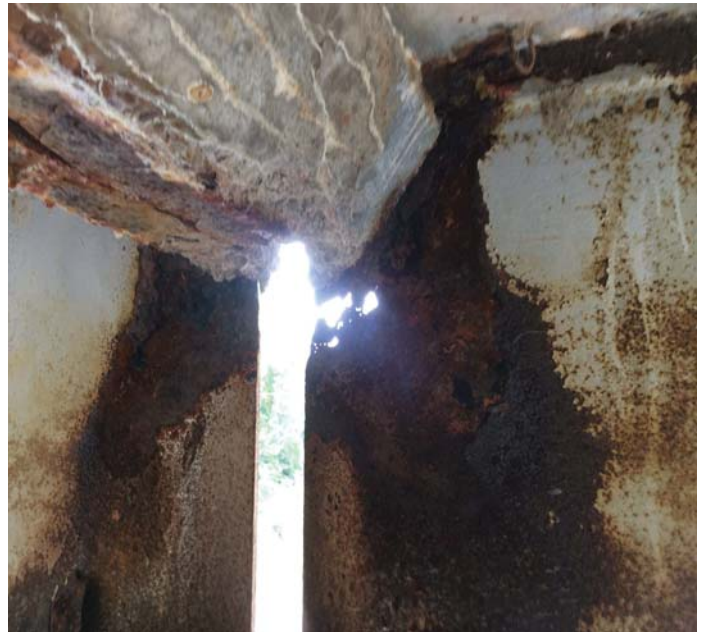
Span 3 Girder 5 Bent 4 has a 6in. x 2in. hole in web at haunch, see 2016 photo.

PHOTO 20 Description 02871 10-01-2015 Span 3 Girder 5 over Bent 4.

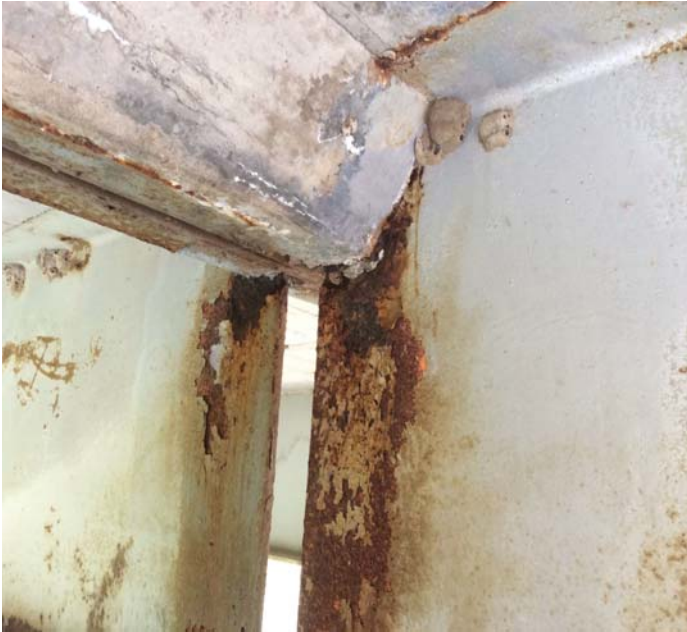
Span 4 Girder 2 Bent 5 has 4 1/2in. x 3/4in. hole in web at haunch, See 2015 photo.

PHOTO 21 Description 02871 10-01-2015 Span 4 Girder 2 over Bent 5.

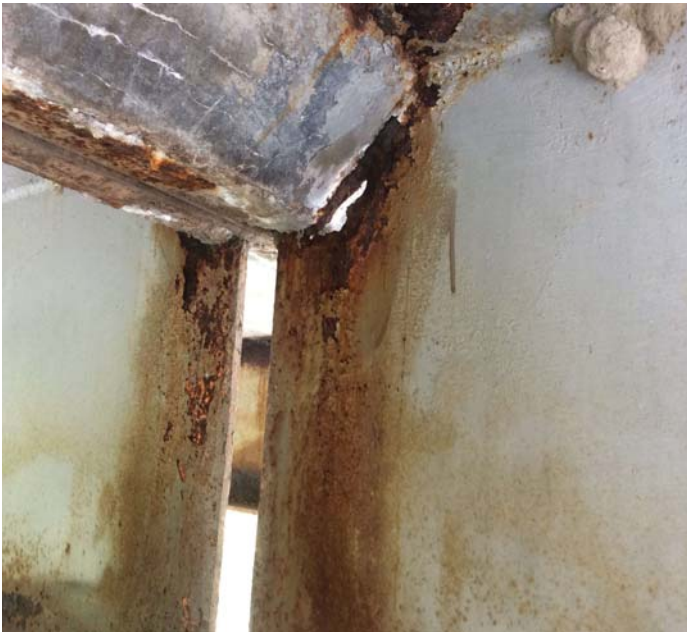
Span 4 Girder 4 Bent 5 has 4in. x 1in. hole in web at haunch, see 2015 photo.

PHOTO 22 Description 02871 10-01-2015 Span 4 Girder 4 over Bent 5.

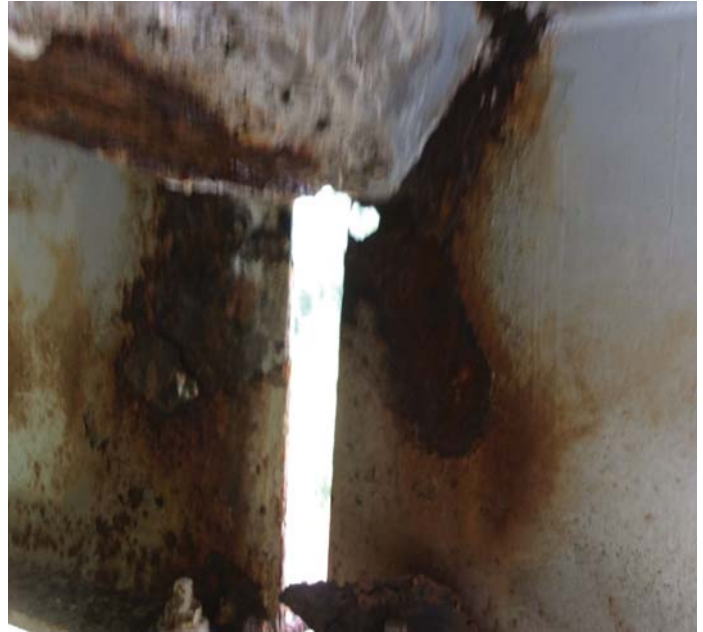
Span 4 Girder 5 Bent 5 has a 2in. x 1 1/2in. hole in web at haunch, see 2015 photo.

PHOTO 23 Description 02871 10-01-2015 Span 4 Girder 5 over Bent 5.

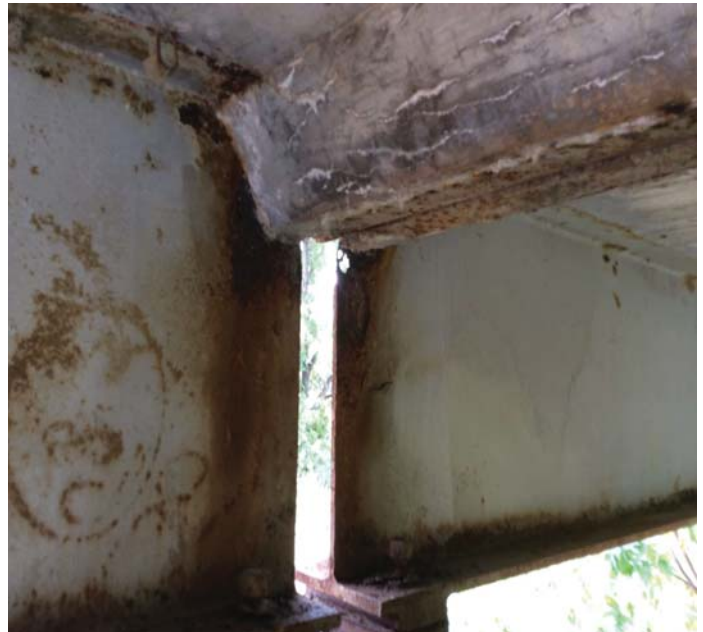
Span 5 Girder 1 Bent 5 has a 1 1/4in. diameter hole in web at haunch, see 2015 photo.

PHOTO 24 Description 02871 10-01-2015 Span 5 Girder 1 over Bent 5.

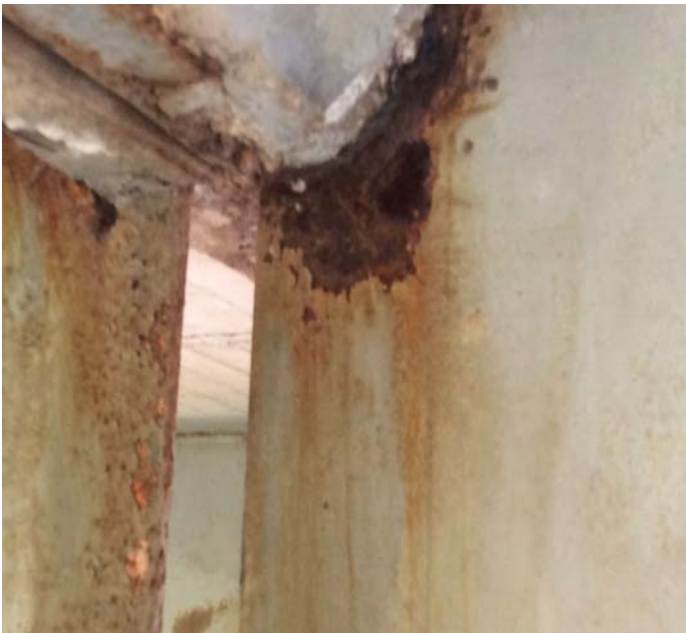
Span 5 Girder 2 Bent 6 has a 1/2in. diameter hole in web at haunch, see 2015 photo.

PHOTO 25 Description 02871 10-01-2015 Span 5 Girder 2 over Bent 6.

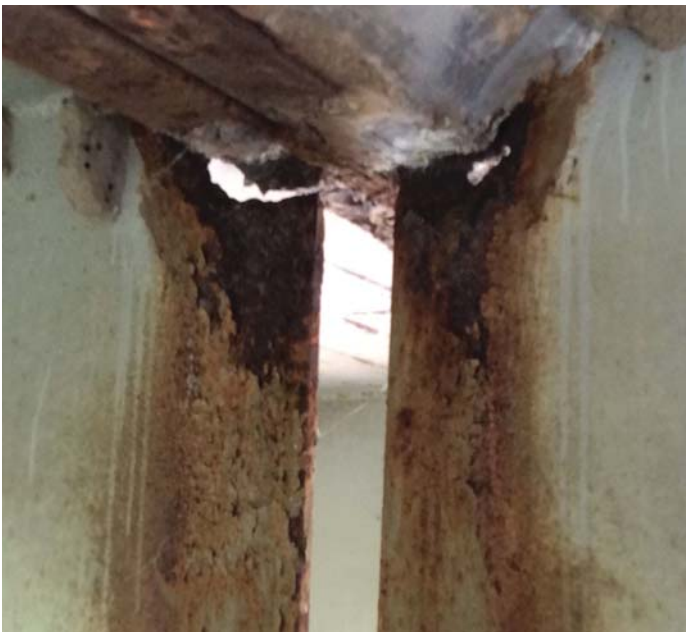
Span 5 Girder 3 Bent 6 has a 2in. x 1/2in. hole in web at haunch, see 2015 photo.

Span 6 Girder 3 over Bent 6 has a 6in. X 1in. hole rusted thru web at concrete haunch, see 2016 photo.

PHOTO 26 Description 02871 10-01-2015 Span 5 Girder 3 & Span 6 Girder 3 over Bent 6.

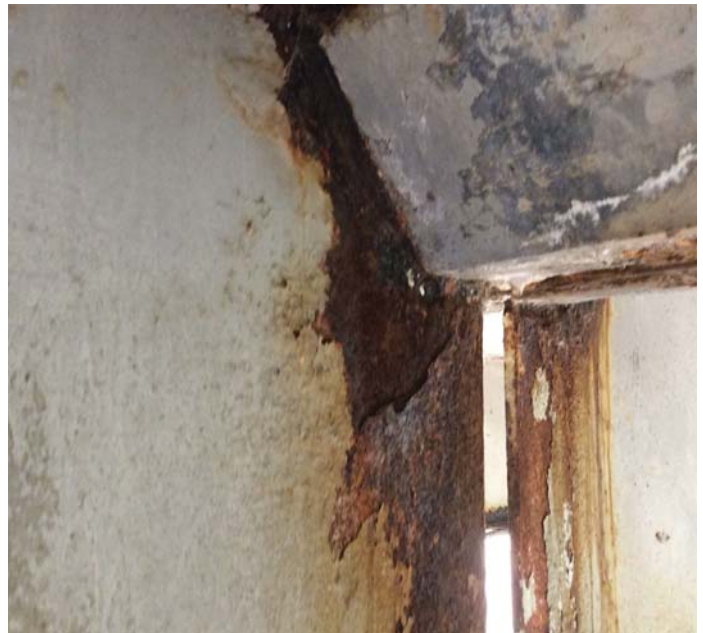
Span 6 Girder 2 over Bent 7 has a 1in. X 1/2in. hole rusted thru web at concrete haunch, see 2015 photo.

PHOTO 27 Description 02871 10-01-2015 Span 6 Girder 2 over Bent 7.

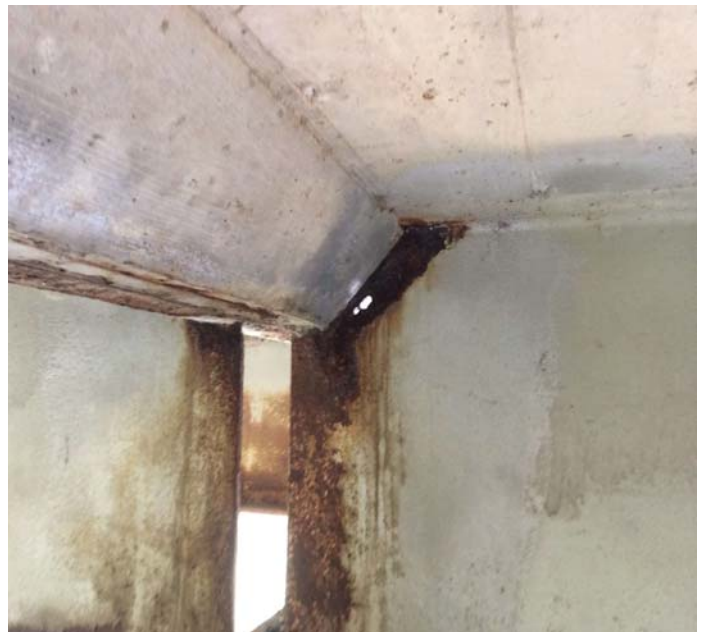
Span 6 Girder 4 over Bent 7 has a 4in. X 1 1/2in. hole rusted thru web at concrete haunch, see 2016 photo.

PHOTO 28 Description 02871 10-01-2015 Span 6 Girder 4 over Bent 7.

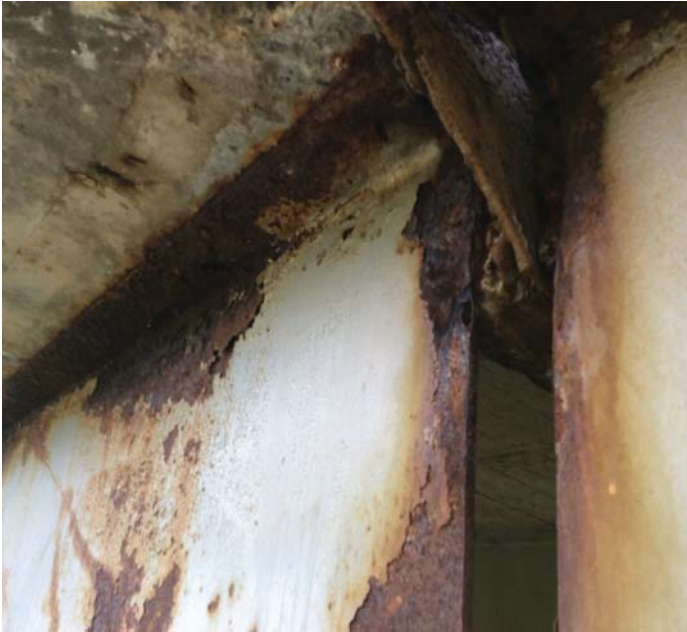
Span 7 Girder 1 over Bent 7 has a 1in. diameter hole rusted thru web at concrete haunch, see 2015 photo.

PHOTO 29 Description 02871 10-01-2015 Span 7 Girder 1 over Bent 7.

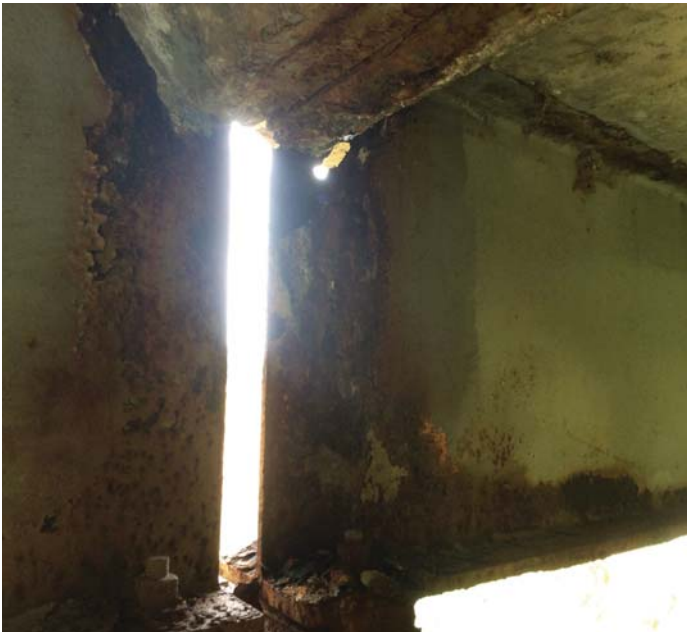
Span 8 Girder 1 over Bent 8 has a 4in x 1in. hole and 2 each 1in. diameter holes in web near concrete haunch, see 2016 photo.

PHOTO 30 Description 02871 10-01-2015 Span 8 Girder 1 over Bent 8.

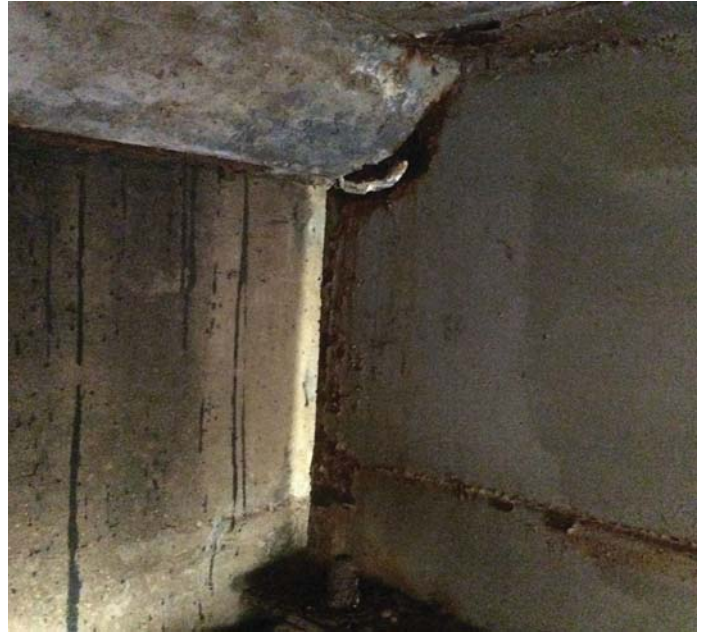
Span 8 Girder 3 over Bent 9 has a 5in x 3/4in. hole in web near concrete haunch, see 2015 photo.

PHOTO 31 Description 02871 10-01-2015 Span 8 girder 3 over bent 9.

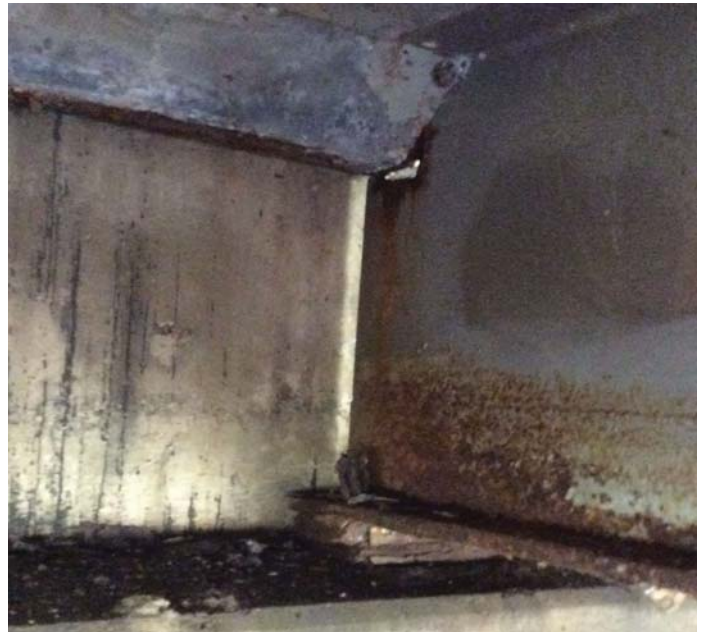
Span 8 Girder 4 over Bent 9 has a 4in x 3/4in. hole in web near concrete haunch, see 2016 photo.

PHOTO 32 Description 02871 10-01-2015 Span 8 girder 4 over bent 9.

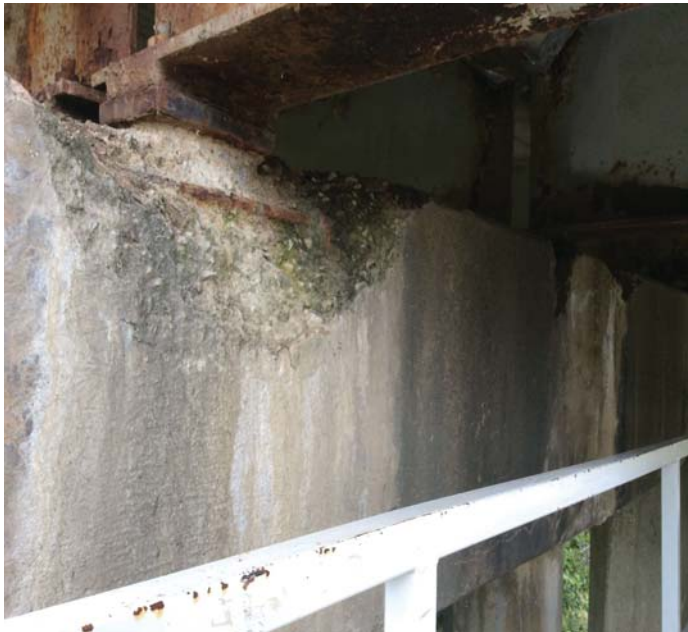
Bent 2 Cap has a 2.5ft. x 1.5ft. x 6in. deep spall and deterioration on Span 2 side under Girder 5 Bearing with 10% loss of bearing, see 2015 photo.

Bent 2 Cap has a 1ft. x 8in. x 6in. spall under Span 2 side under girder 4 with 5% loss of bearing, see 2015 photo.

PHOTO 1 Description 02871 10-01-2015 Bent 2 Cap Span 2 Side Right End under Girders 4 & 5.

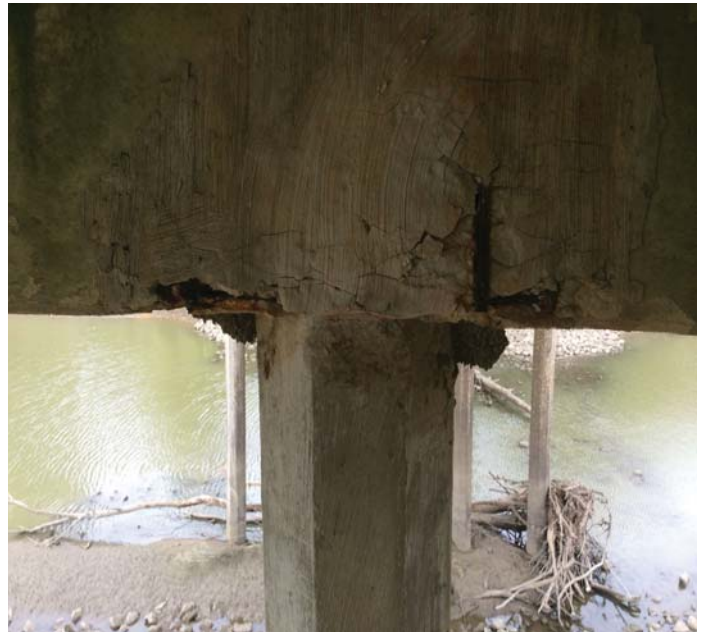
Bottom of Bent 5 Cap near Pile 3 has a shelled out area with rebar exposed, see 2015 photo.

PHOTO 2 Description 02871 10-01-2015 Bent 5 Cap Span 5 Side over Pile 3.

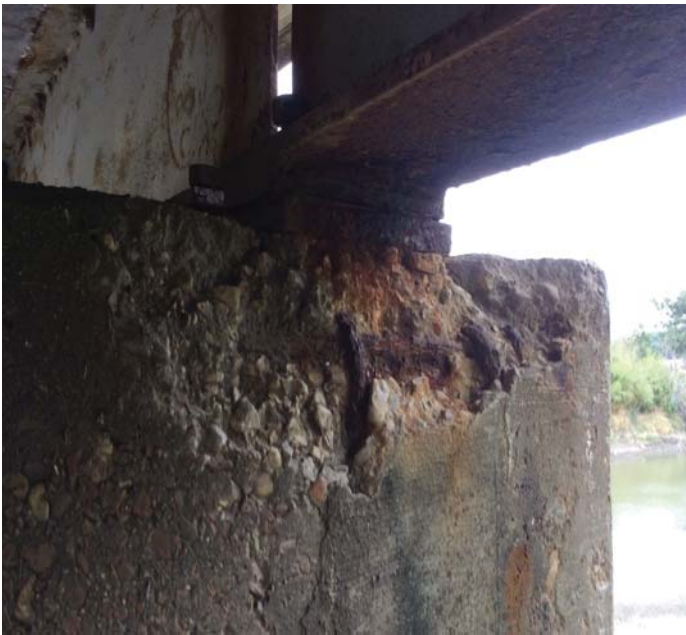
Left end of Bent 5 Concrete Cap near Girder 1 Bearing has a 2ft. X 9in. X up to 3 1/2in. deep spall and beginning to lose some bearing, see 2015 Photo.

PHOTO 3 Description 02871 10-01-2015 Bent 5 Cap Span 5 Side Under Bearing 1.

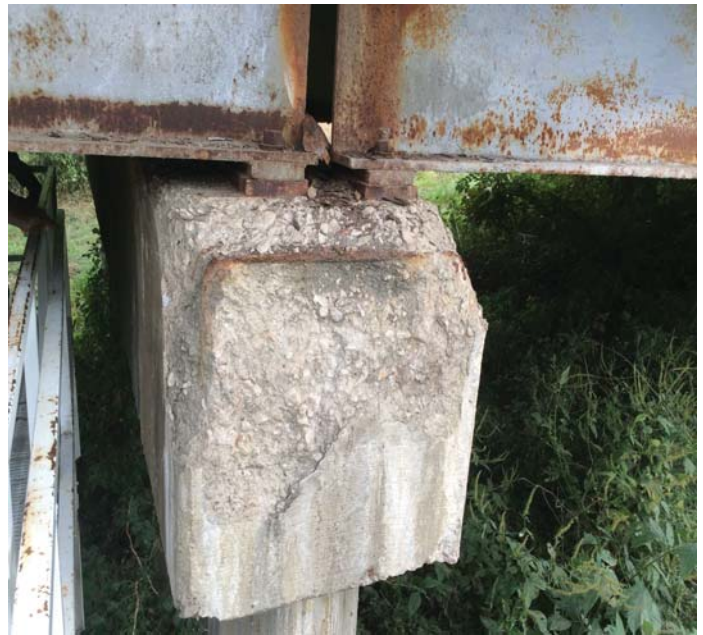
3ft. right end of Cap Bent 8 is deteriorated with rebar exposed, see 2015 photo.

PHOTO 5 Description 02871 10-01-2015 Right end Bent 8 Cap.

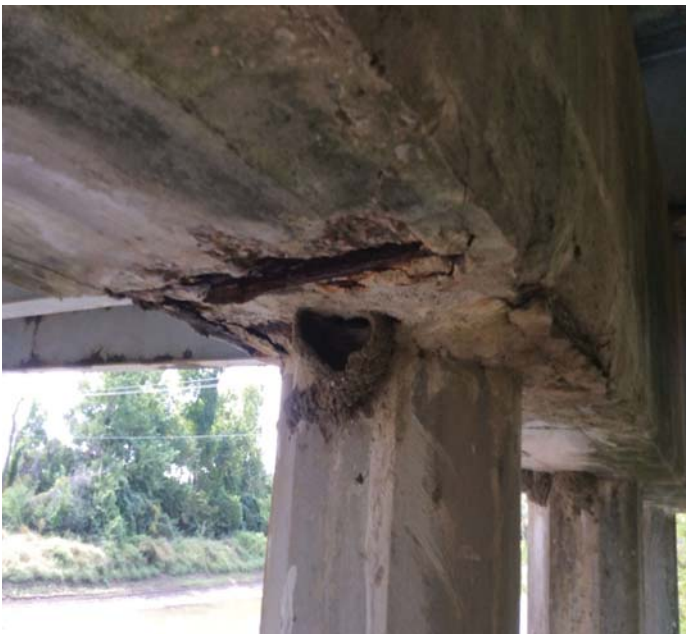
Bent 2 Concrete Cap has a 3ft. x 2ft. spall bottom of cap and heavy deterioration with some section loss to rebar, See 2015 Photo of bottom of cap.

PHOTO 4 Description 02871 10-01-2015 Bottom of Bent 2 Cap near Pile 3.

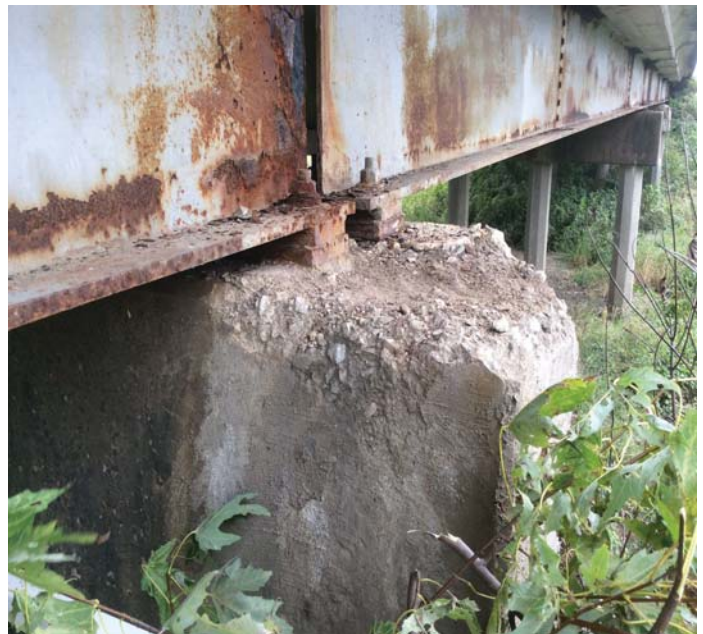
PHOTO 6 Description 02871 10-01-2015 Right End of Bent 5 Cap.

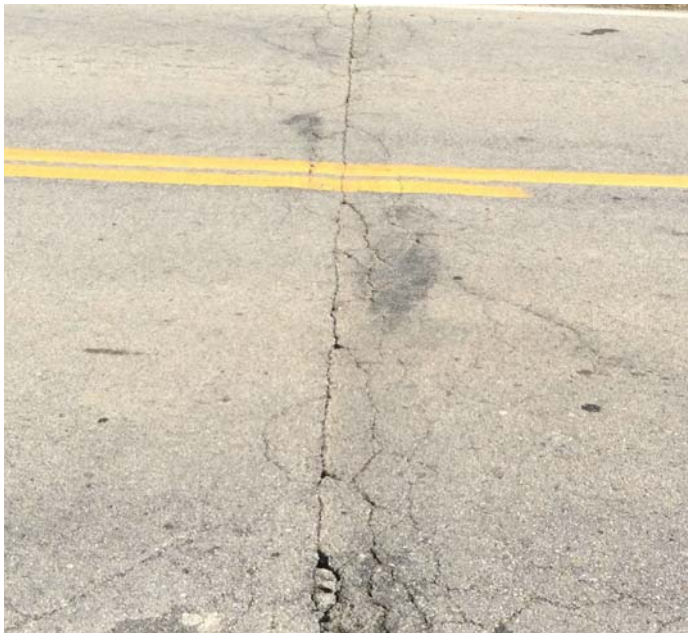
PHOTO 1 Description 02871 10-01-2015 Bent 4 joint.

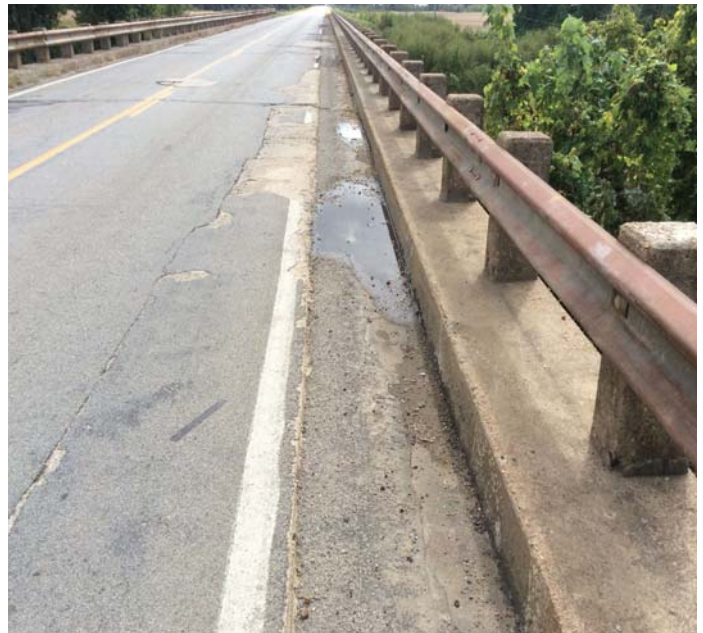
PHOTO 2 Description 02871 10-01-2015 Span 1 Right gutterline

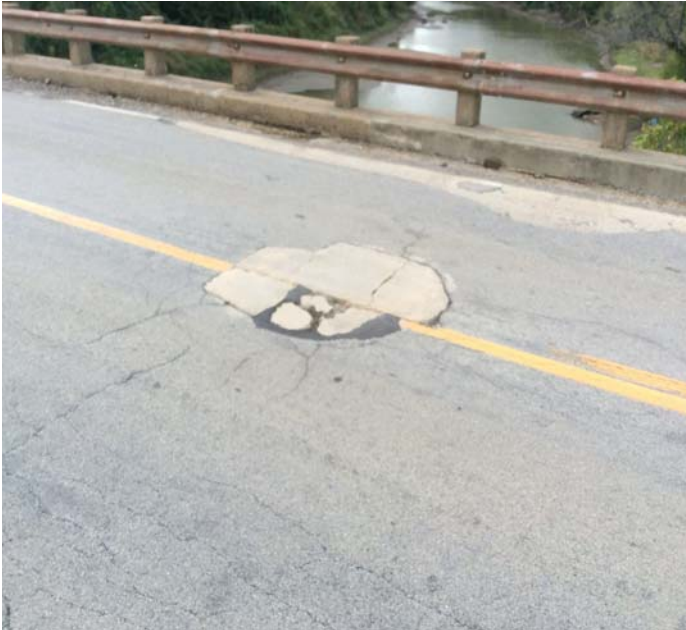
Span 2 Top of Deck near centerline has a 2ft. x 2.5ft. patch failure, broken and loose.

PHOTO 3 Description 02871 10-01-2015 Span 2 centerline repair.

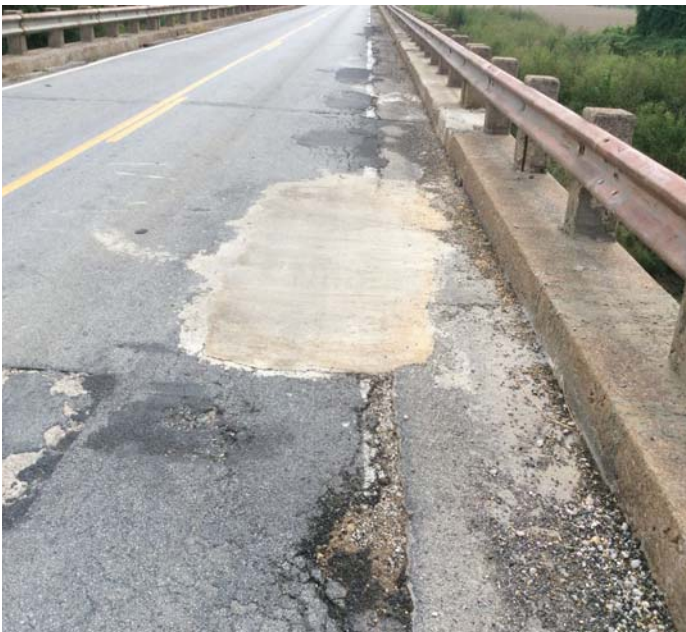
PHOTO 4 Description 02871 10-01-2015 Span 3 Right lane repair.

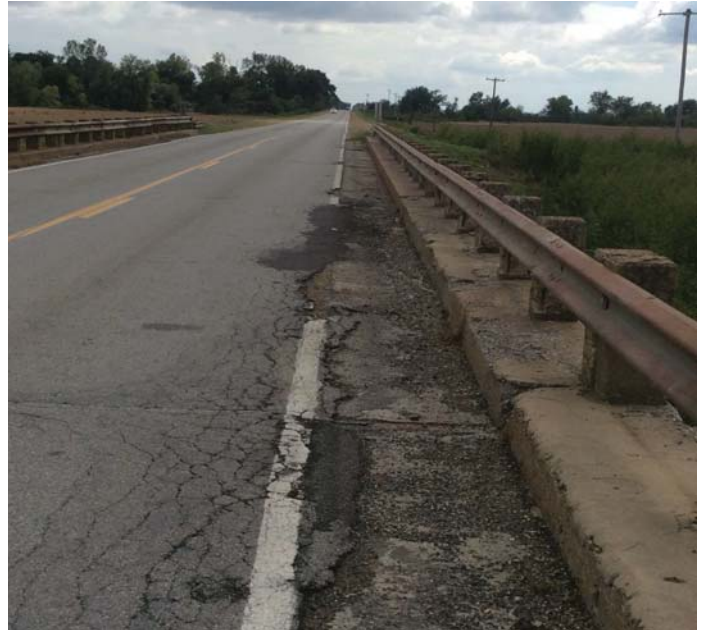
Span 5 left Gutterline has 28ft. of deterioration with some section loss with no exposed rebar.

PHOTO 5 Description 02871 10-01-2015 Span 5 Right gutterline.

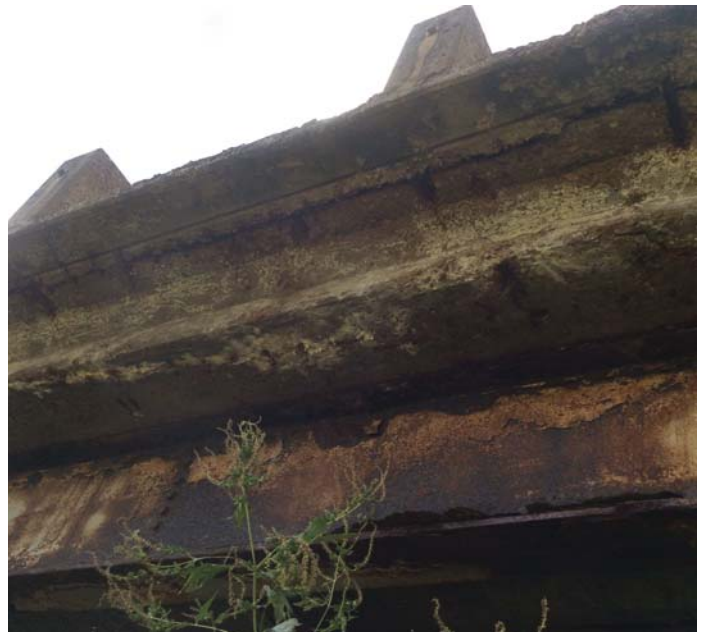
Left and right Overhangs have several shelled out areas with rebar exposed, see Span 8 left overhang for typical.

PHOTO 6 Description 02871 10-01-2015 Span 8 left overhang.

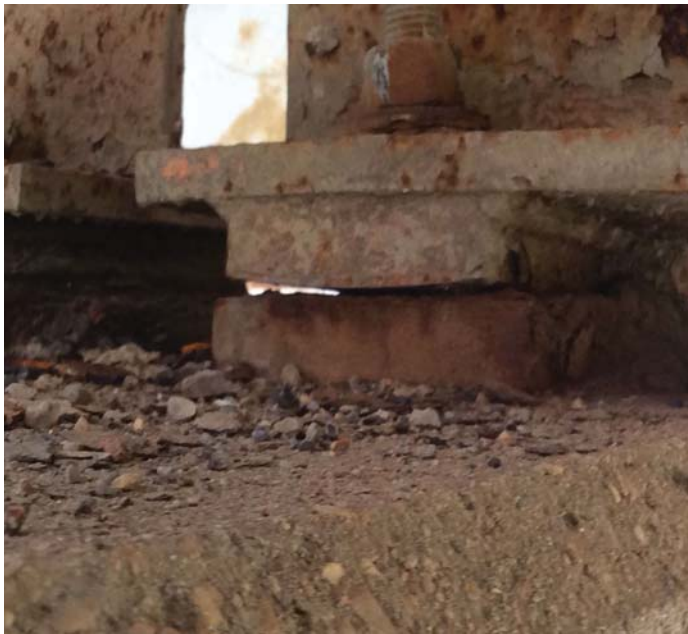
Span 2 Girder 2 Bent 3 is moving under traffic with a 1/8in. gap on the left end of bearing, see 2015 photo.

PHOTO 1 Description 02871 10-01-2015 Span 2 Girder 2 over Bent 3 Movement under traffic.

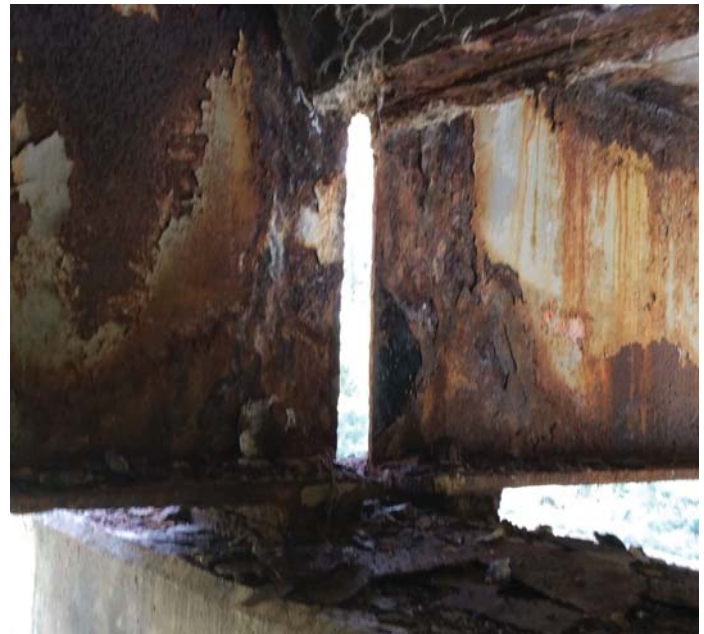
PHOTO 2 Description 02871 10-01-2015 Span 1 Girder 1 & Span 2 Girder 1 over Bent 2.

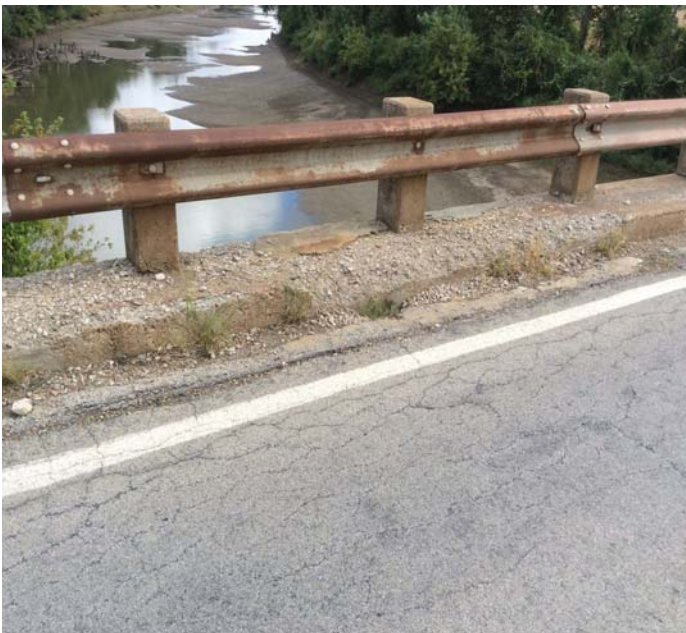
All Concrete Curbs has some deterioration with section loss.

PHOTO 1 Description 02871 10-01-2015 Span 2 Left Curb.

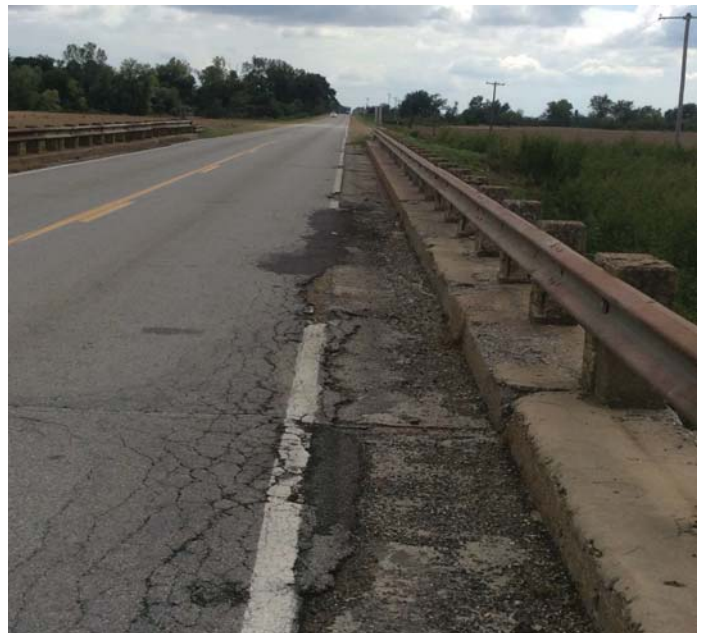
PHOTO 2 Description 02871 10-01-2015 Span 5 Right gutterline.

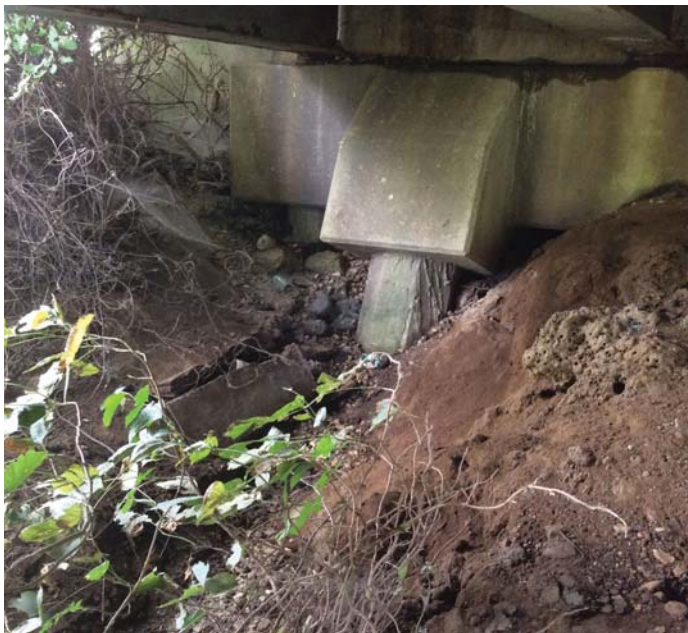
Bent 9 Slope Erosion has up to 1.5ft. erosion at abutment and up to 2ft. back under Cap, see 2015 photo.

PHOTO 1 Description 02871 10-01-2015 Bent 9 left end of abutment erosion.

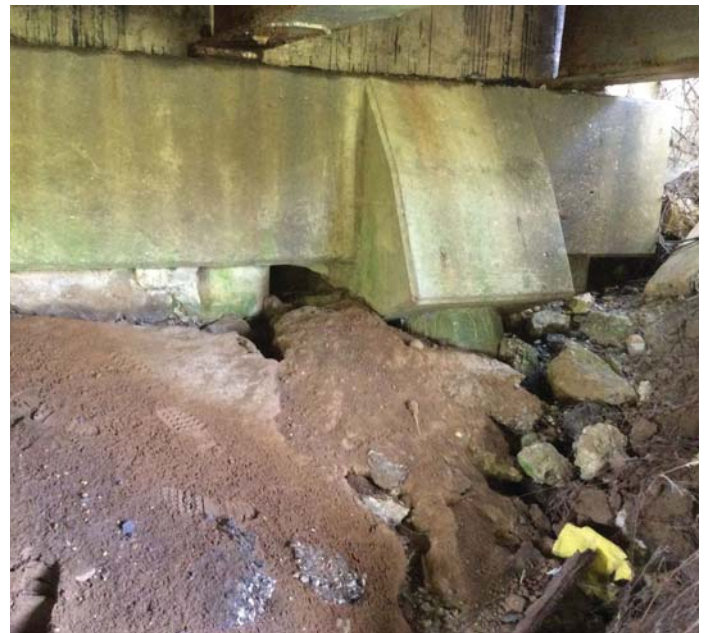
PHOTO 2 Description 02871 10-01-2015 Bent 9 right end of abutment erosion.

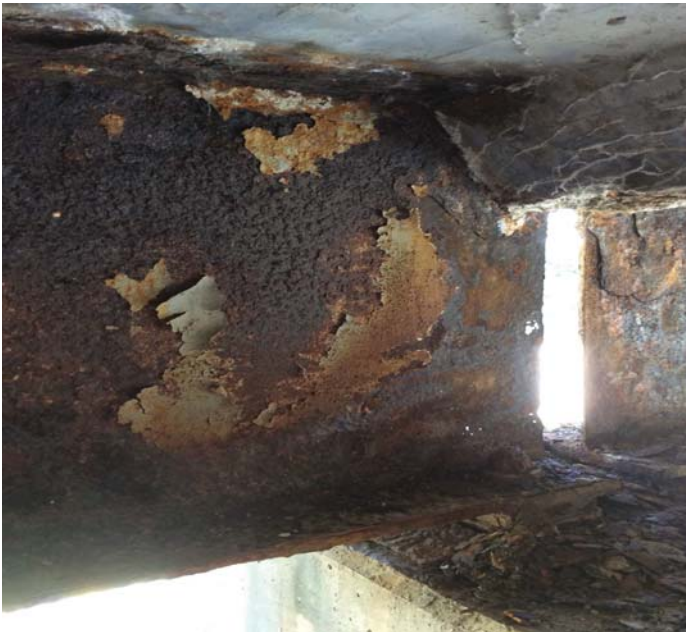
PHOTO 1 Description

Span 1 Girder 1 over Bent 2 has several holes in web up to 1in. in diameter and the girder is beginning to crush near the bottom flange, see 2016 photo.

forward to bridge crew - they have been evaluating caps and beams to schedule repairs
