# Bridge Inspection Report

02872

SH 77-02- LM 6.76

LITTLE RIVER

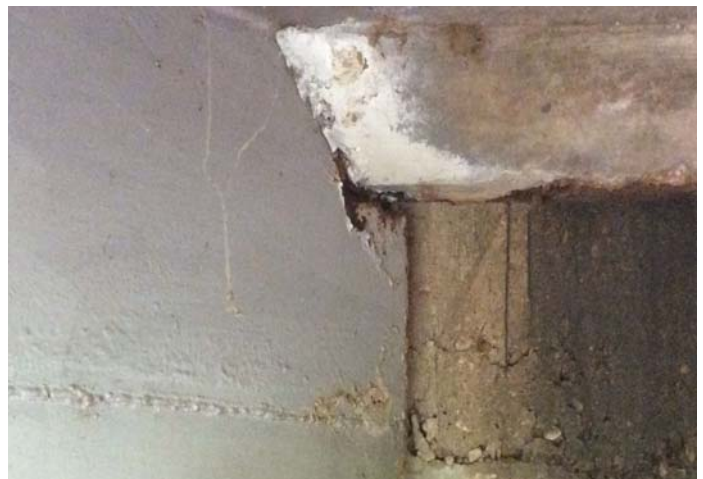
Span 1 Girder 3 Bent 1 has 5in. x 3/4in. hole in web at Haunch, see 2015 photo.

PHOTO 1      Description      02872 10-01-2015 Span 1 Girder 3 over Bent 1.

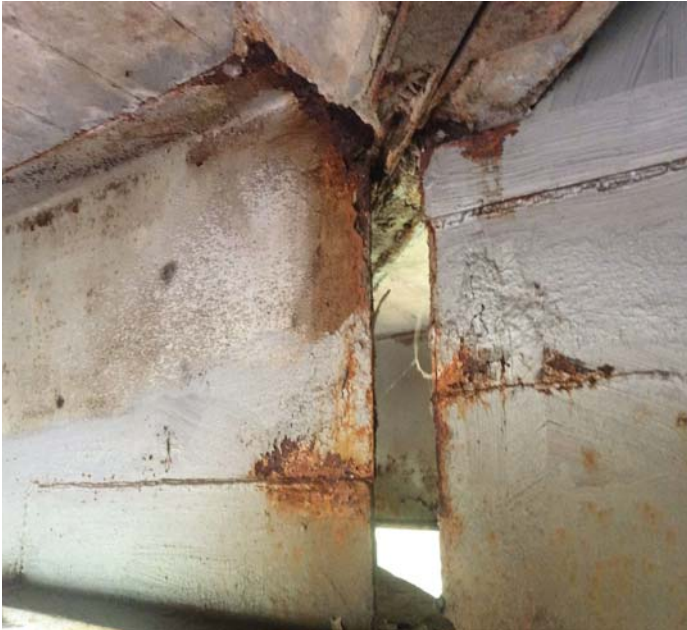
Span 1 Girder 3 Bent 2 has 1in. diameter hole in web at Haunch, see 2015 photo.

PHOTO 13 Description 02872 10-01-2015 Span 1 Girder 3 over Bent 2.

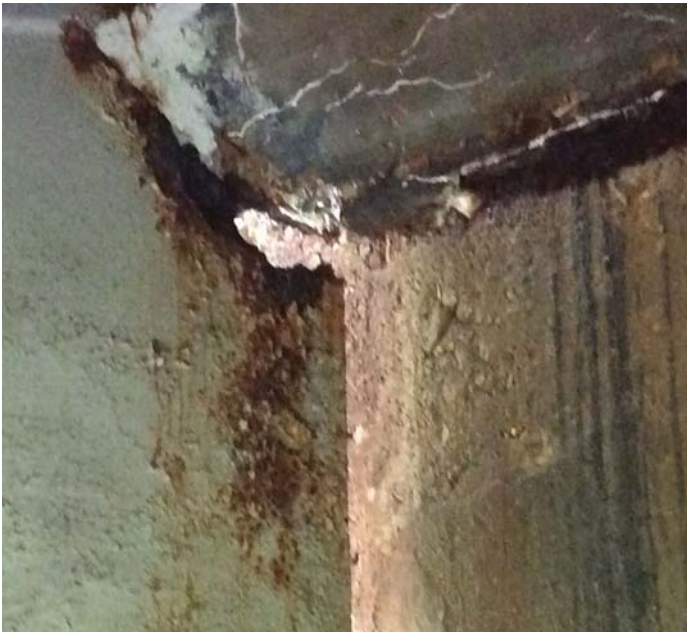
Span 1 Girder 5 Bent 1 has 5in. x 1 1/2in. hole in web at Haunch, see 2015 photo.

PHOTO 14 Description 02872 10-01-2015 Span 1 Girder 5 over Bent 1.

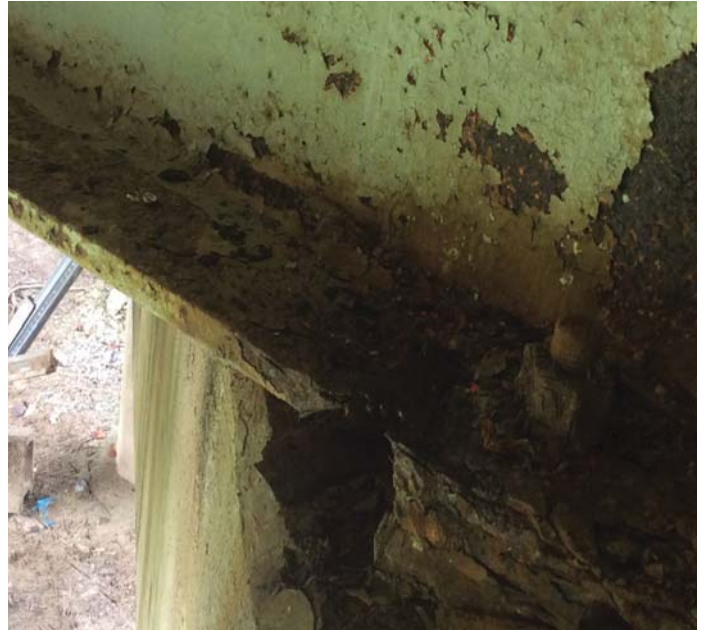
Span 2 Girder 2 Bent 2 has 1in. x 1/2in. hole in web at Haunch and a 1 1/2in. x 2in. hole in left flange, see 2015 photo.

PHOTO 15 Description 02872 10-01-2015 Span 2 Girder 2 over bent 2 bottom flange.

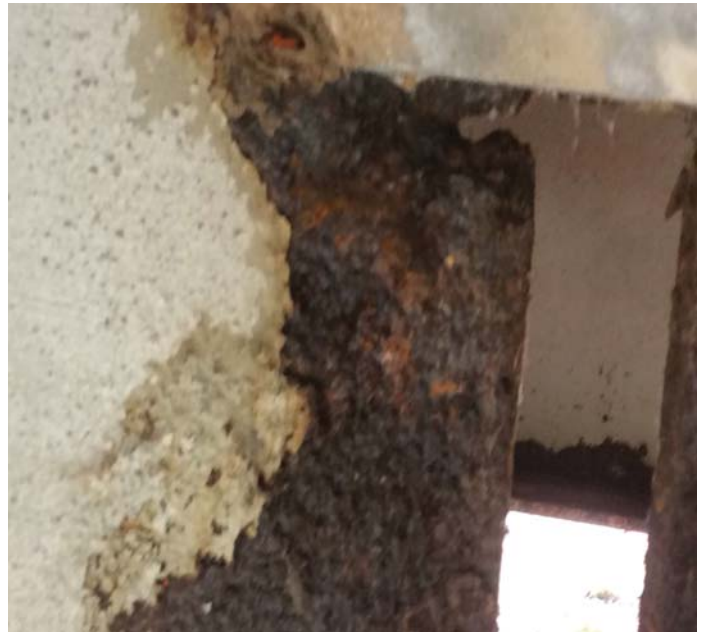
PHOTO 16 Description 02872 10-01-2015 Span 2 Girder 2 over bent 2.

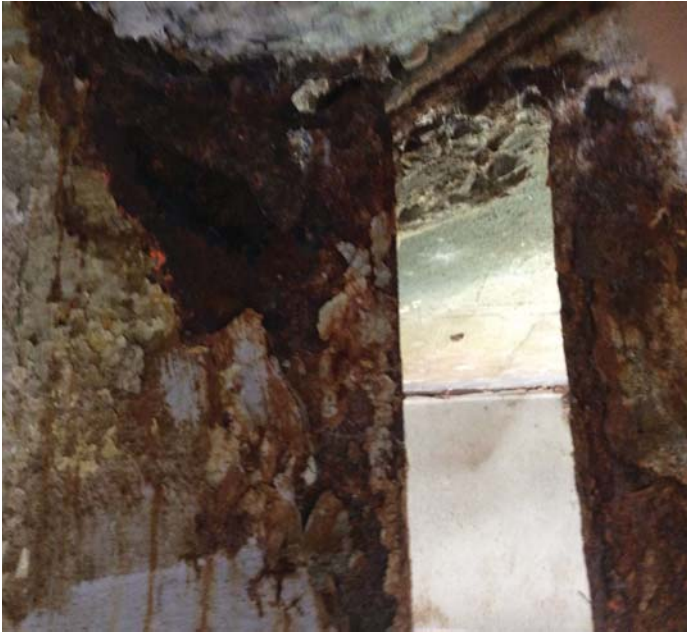
Span 2 Girder 2 Bent 3 has 5in. x 1/2in. hole in web at Haunch, see 2016 photo.

PHOTO 17 Description 02872 10-01-2015 Span 2 Girder 2 over Bent 3.

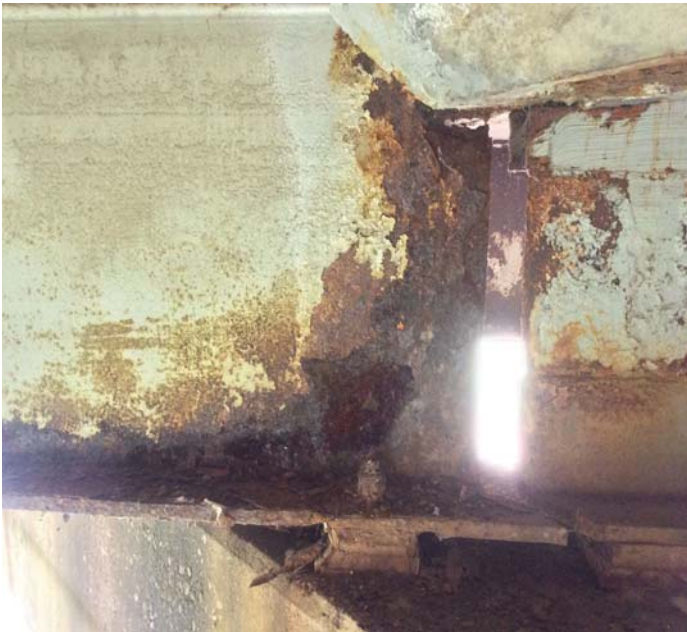
Span 2 Girder 4 Bent 2 has 3 1/2in. x 1/2in. hole in web at Haunch, see 2015 photo.

PHOTO 18 Description 02872 10-01-2015 Span 2 Girder 4 over Bent 2.

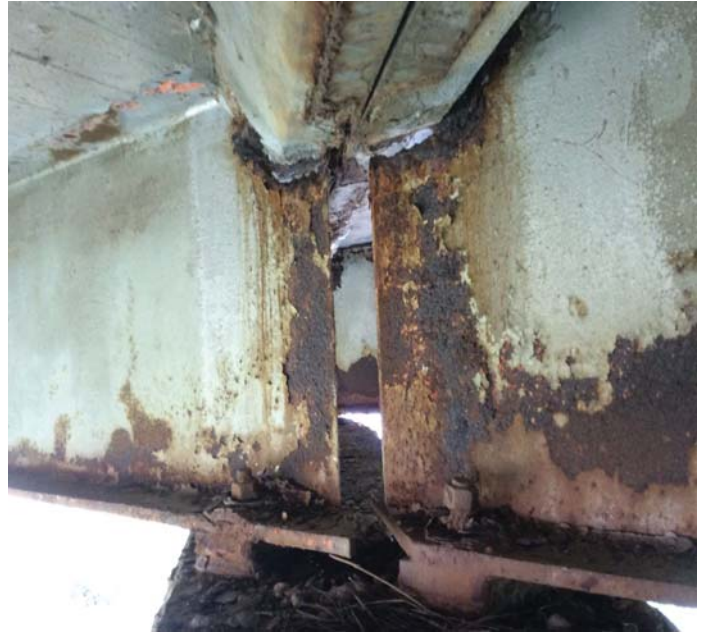
Span 3 Girder 4 Bent 4 has 6in. x 3/4in. hole in web at Haunch, see 2015 photo & 2016.

PHOTO 19 Description 02872 10-01-2015 Span 3 & 4 Girder 4 over Bent 4.

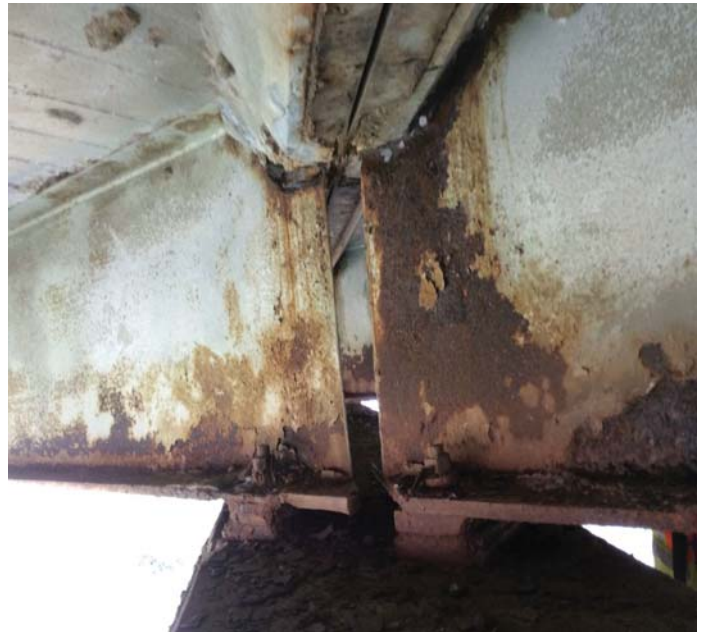
Span 3 Girder 2 Bent 4 has 1in. x 1/2in. hole in web at Haunch, see 2015 photo.

PHOTO 20 Description 02872 10-01-2015 Span 3 Girder 2 over Bent 4.

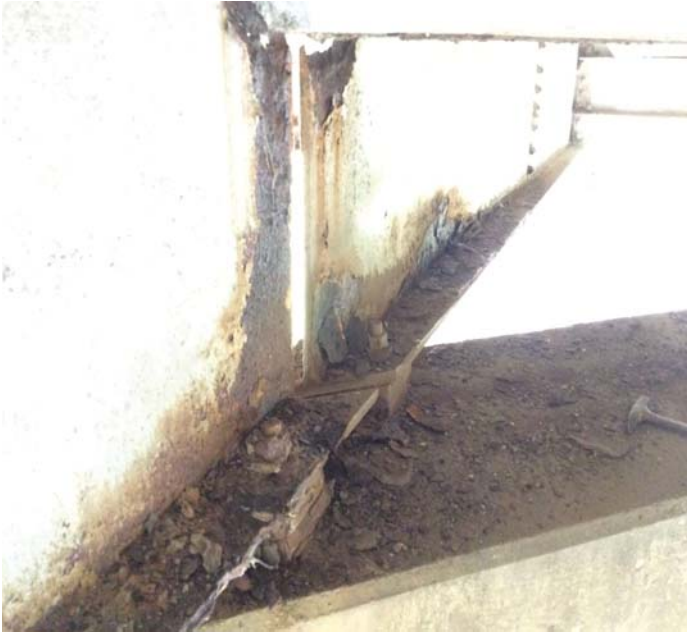
Span 3 Girder 3 Bent 4 has 7in. x 3/4 in. in web at Haunch and 2in. x 1in. hole near the bearing on right flange, see 2016 photo, and the left bottom flange beginning to get a knife edge.

PHOTO 21 Description 02872 10-01-2015 Span 3 Girder 3 over Bent 4 Bottom Flange.

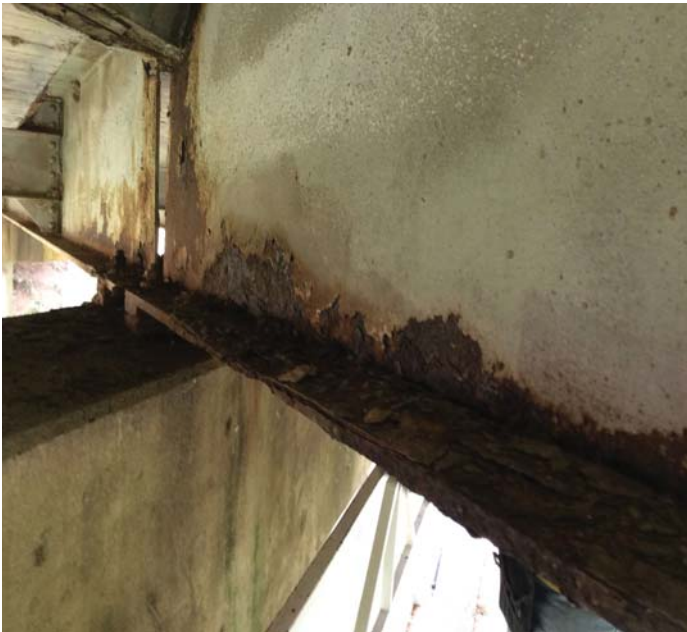
PHOTO 22 Description 02872 10-01-2015 Span 3 Girder 3 over Bent 4

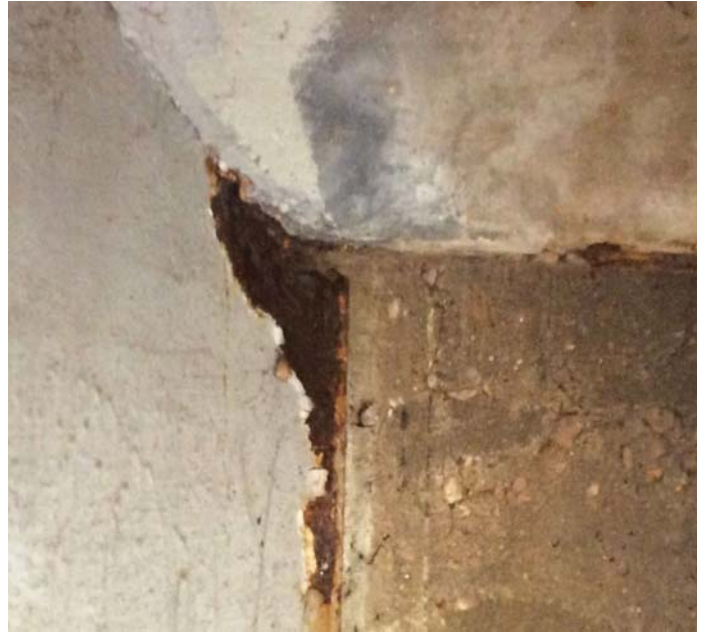
Span 5 Girder 3 Bent 6 has a 3in. x 3/4in. hole in web at concrete haunch, see 2015 photo.

PHOTO 23 Description 02872 10-01-2015 Span 5 Girder 3 over Bent 6.

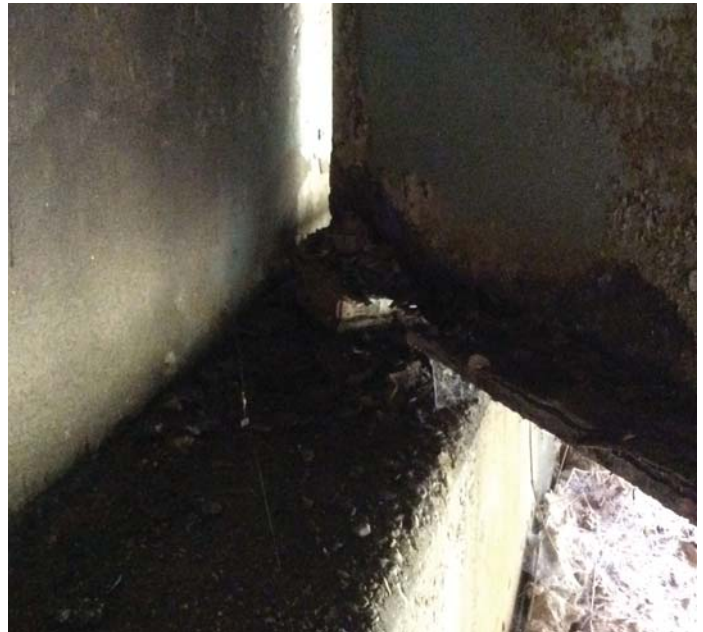
Span 5 Girder 4 Bent 6 has a 1in. diameter hole in web at Haunch and the left flange near bearing has a 3in. x 7in. hole and the right flange has a knife edge with a 1in. hole, see 2016 photos.

PHOTO 24 Description 02872 10-01-2015 Span 5 Girder 4 over bent 6 left bottom flange.

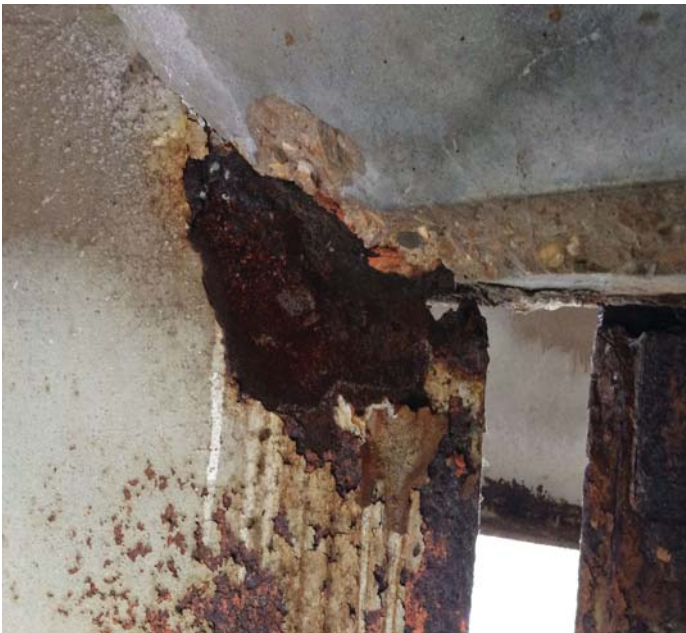
Span 5 Girder 5 Bent 5 has a 1/2in. diameter hole in web at Haunch, see 2016 photo.

PHOTO 25    Description    02872 10-01-2015 Span 5 Girder 5  
over Bent 5.

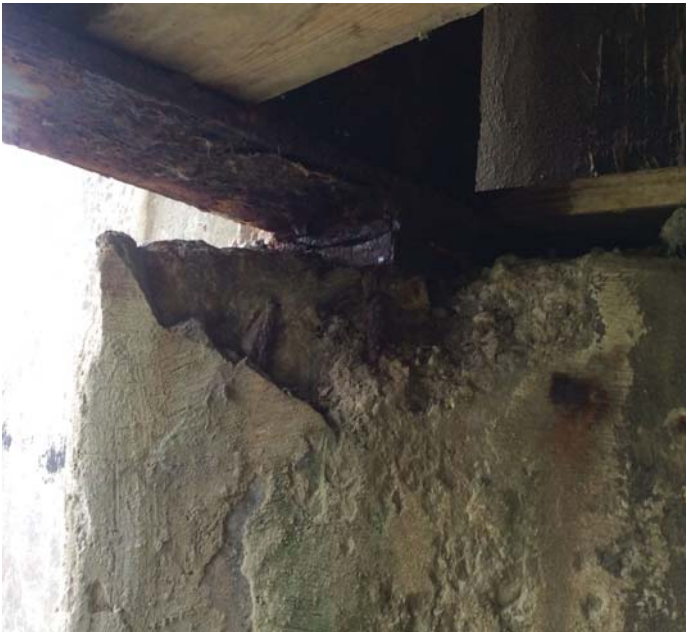
Majority of Bearings are rust covered with some section loss, see 2015 photos.

Majority of Anchor Bolts have heavy section loss with a few having complete section loss.

PHOTO 1      Description      02872 10-01-2015 Span 5 Girder 1 bearing @ bent 6.

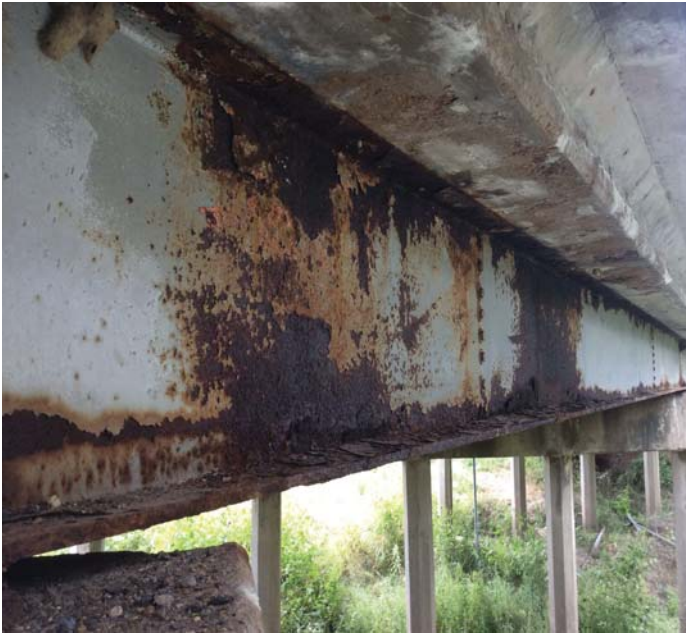
All Steel Girders are rusted with pitting and 4ft. on ends of Girders have up to 1/4in. section loss to web and bottom flange.

Exterior Girders are rusted with pitting and up to 1/4 in section loss to mostly top and bottom flanges, see 2015 photo of Span 3 Girder 5 for typical.

PHOTO 1      Description      02872 10-01-2015 Span 3 Girder 5.

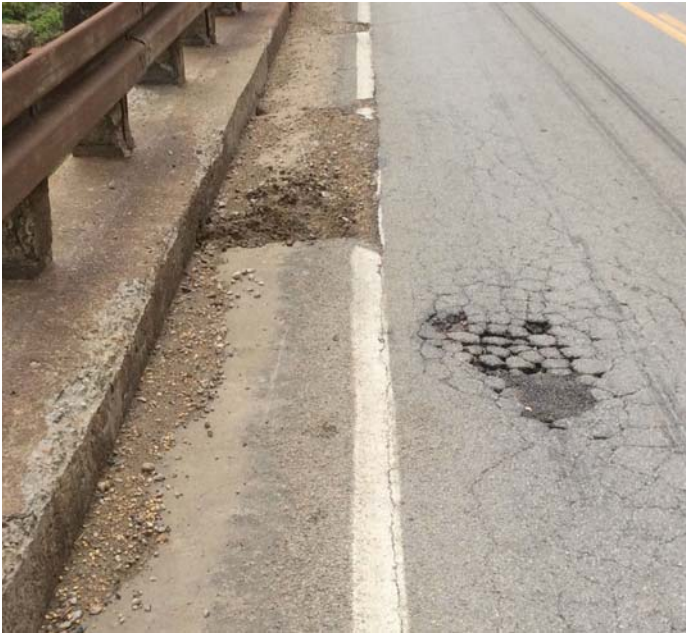
Top of Deck Asphalt Overlay has minor size and density sealable cracks with some impending spalls. Span 3 left lane has a 2ft. x 3ft. broken patch/ impending spall, see 2015 photo.

PHOTO 1      Description      02872 10-01-2015 Span 3 Left gutterline.

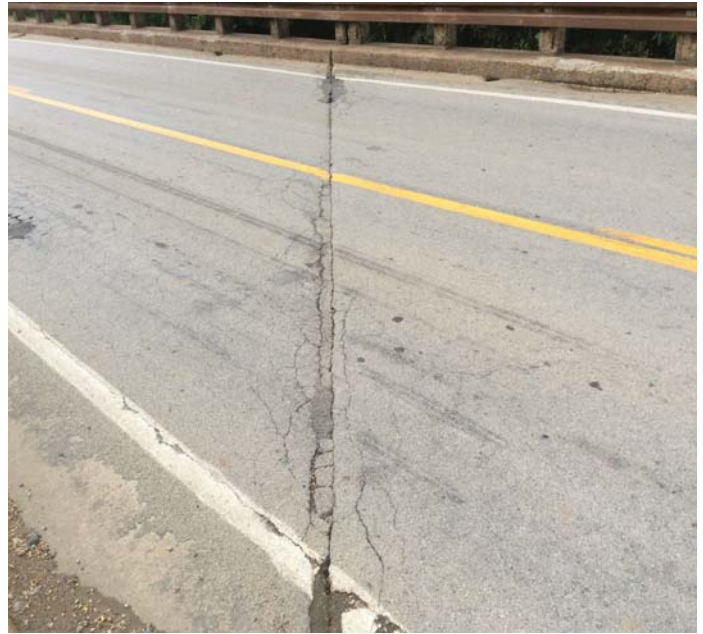
PHOTO 2      Description      02872 10-01-2015 Bent 3 joint spalls.

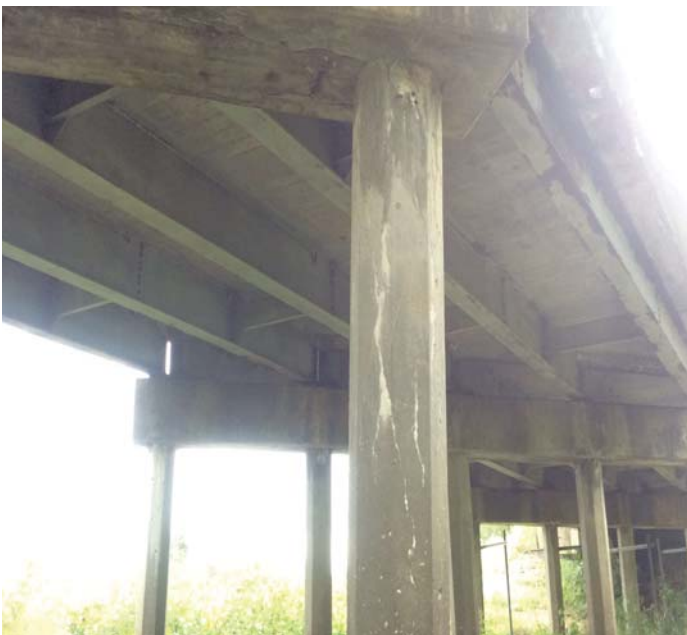
Top 10ft. of Bent 3 Pile 5 has moderate cracking with efflorescence visible, see 2015 photo.

PHOTO 1      Description      02872 10-01-2015 Bent 3 Pile 5.

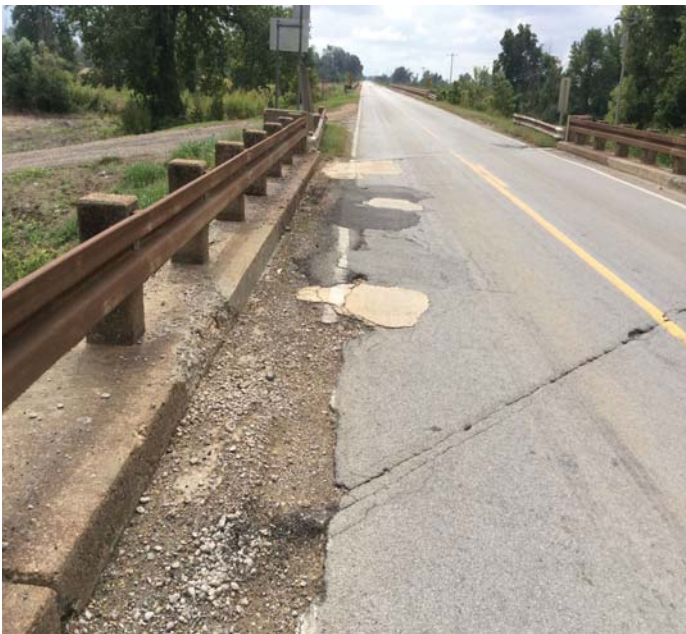
Top of Deck left Gutter line Span 5 has a 2.5 ft. x 20ft. x 2 in. deep deterioration with spalled out area.

PHOTO 1      Description      02872 10-01-2015 Span 5 Left gutterline & left lane.

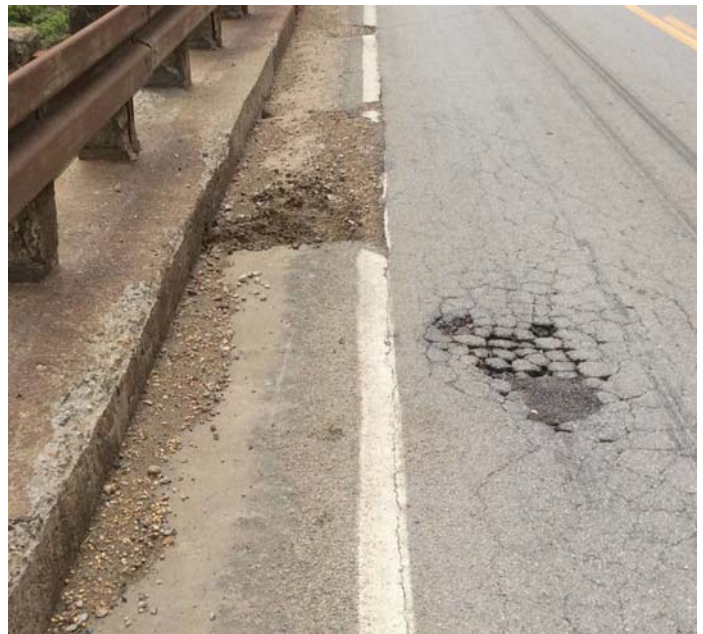
Top of Deck left Gutter line Span 3 has a 2.5 ft. x 10ft. x 2 in. deep deterioration and spalled out area.

PHOTO 2      Description      02872 10-01-2015 Span 3 Left gutterline.

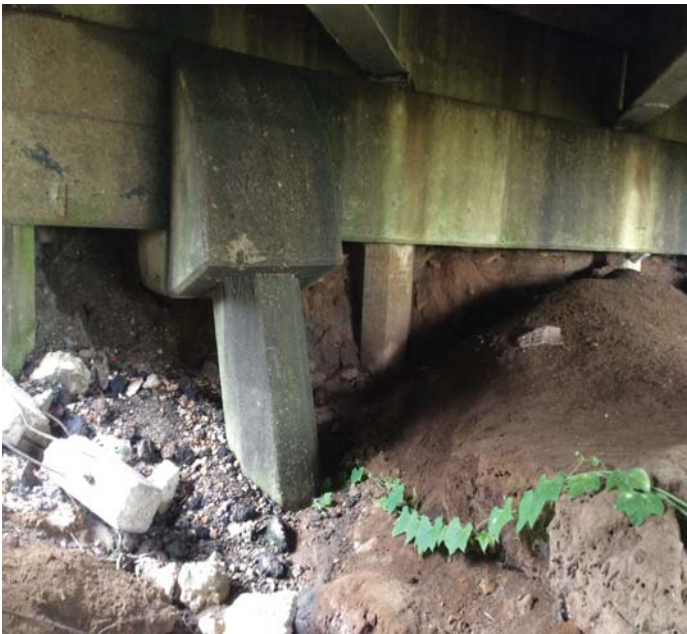
Heavy Slope Erosion and undermining of Bent 1 Abutment, 2 ft. deep x 2 ft. back under Cap has exposed piling, see 2012 photo.

PHOTO 1      Description      02872 10-01-2015 Bent 1 Abutment  
Right end

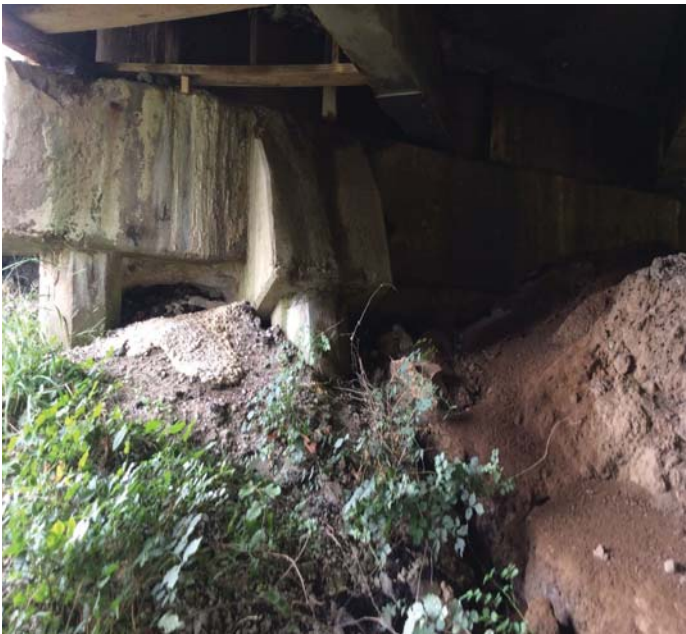
Heavy slope erosion from roadway runoff has undermined left side of Bent 6 Abutment, 2 ft. deep and 2 ft. back under, exposing piling, see 2012 photo.

PHOTO 1      Description      02872 10-01-2015 Bent 6 Left end

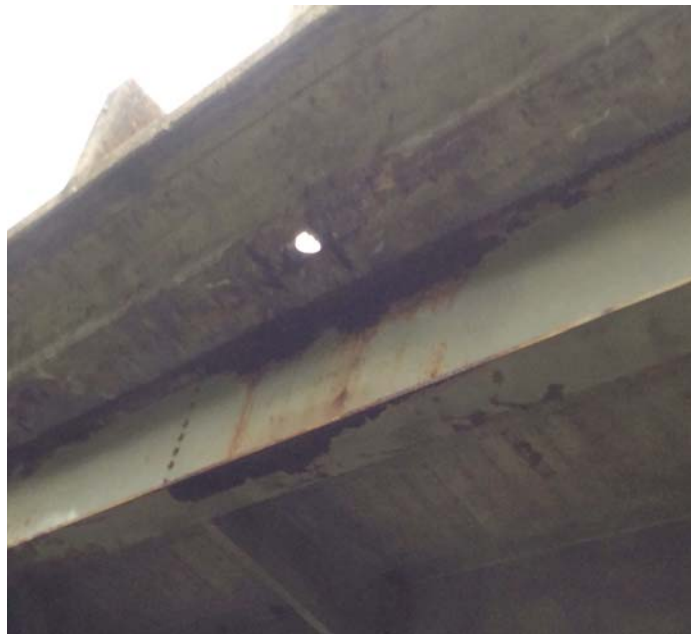
Left and right Overhangs have some spalled areas with rebar exposed, see 2015 photo of the right side of Span 4 at drain hole for typical.

PHOTO 1      Description      02872 10-01-2015 Span 4 right side first drain.

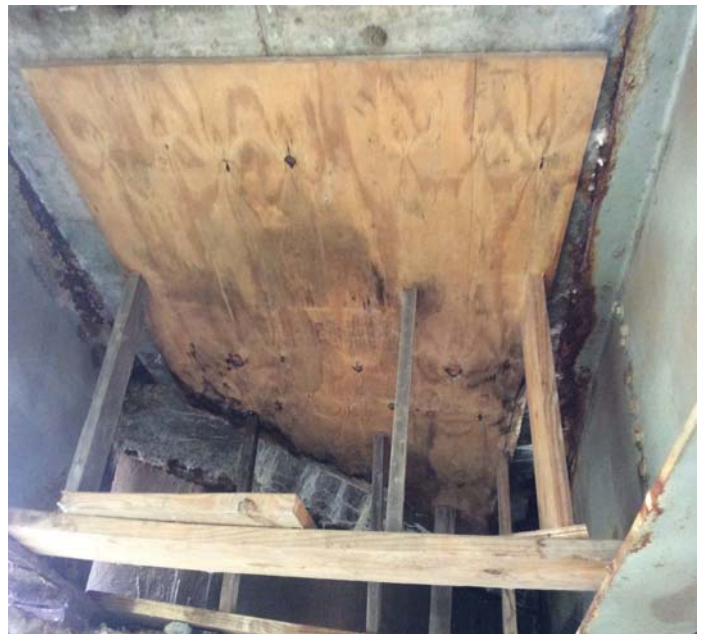
Bottom of Deck has some cracking with efflorescence.

PHOTO 2      Description      02872 10-01-2015 Span 5 Bay 1 @ bent 6.

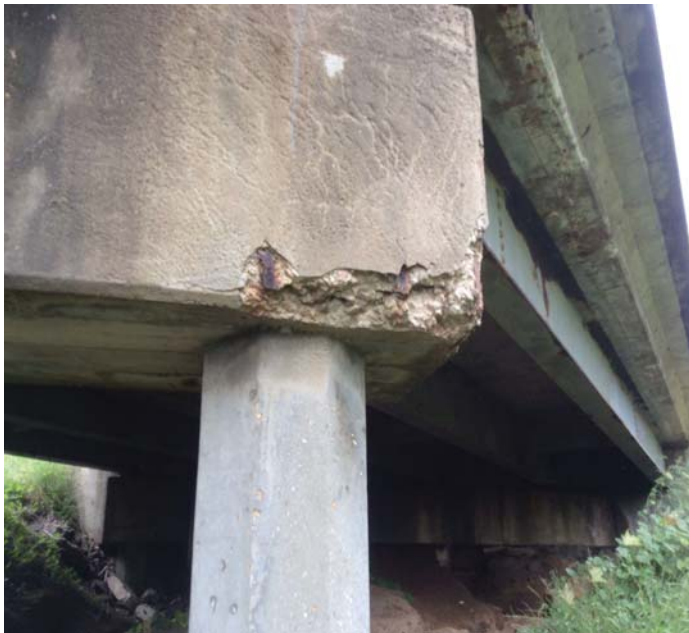
Left end of Bent 2 Cap has a 2ft. x 6in. shelled out with exposed rebar and a 2ft. x 4in. spall with rebar exposed at Pile 4 and 2ft. of deterioration near Girder 5, see 2015 photo of left end.

PHOTO 1 Description 02872 10-01-2015 Bent 2 Cap Left end

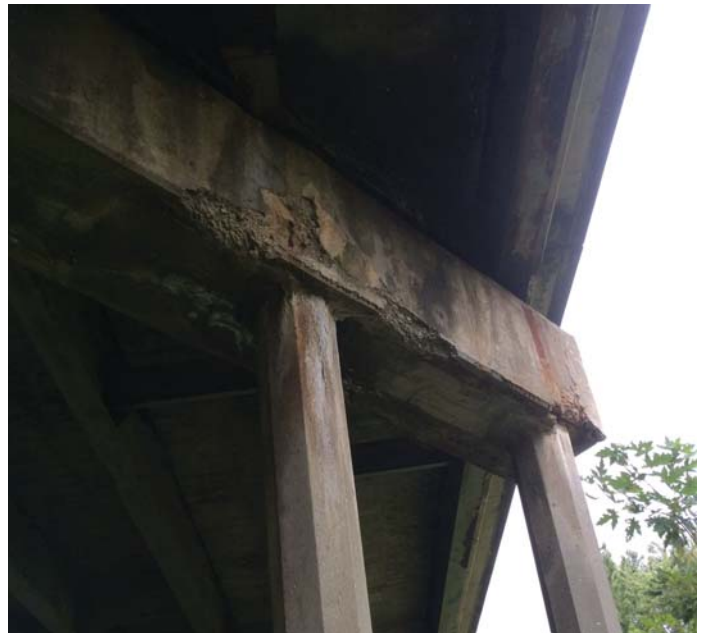
Bent 3 Cap has heavy deterioration and cracking with about 10ft. of rebar exposed due to lack of steel coverage, see 2015 photo.

PHOTO 2 Description 02872 10-01-2015 Bent 3 Cap Span 3 Side.

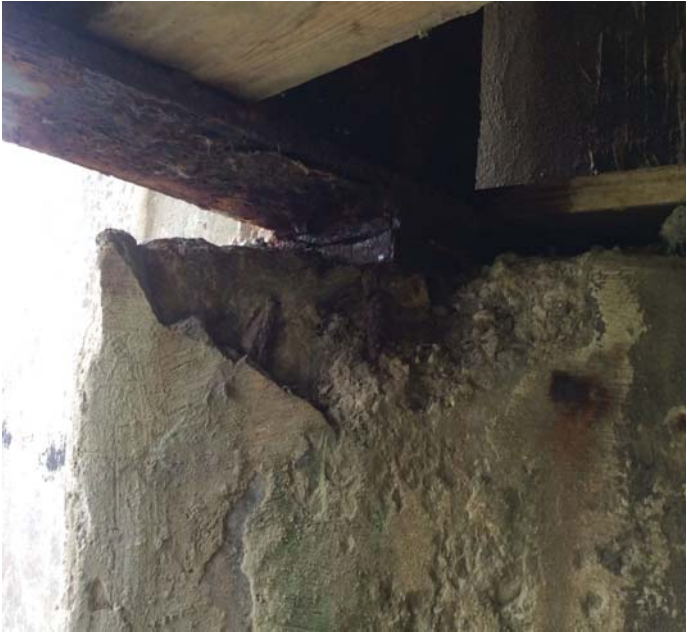
Bent 6 Cap Abutment has the left end of cap deteriorated under Bearing 1 with 1in. of loss of bearing, see 2015 photo.

PHOTO 3      Description      02872 10-01-2015 Span 5 Girder 1 bearing @ bent 6.

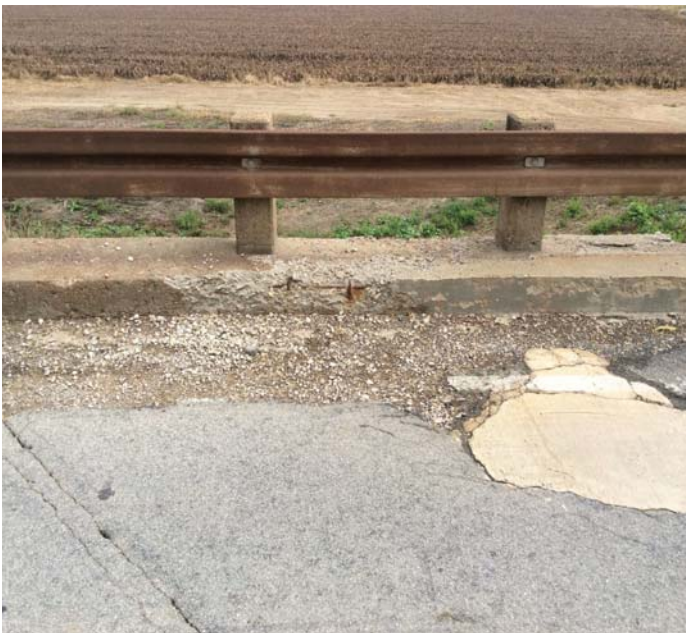
Several areas of concrete curbs are deteriorated with section loss and some rebar exposed.

PHOTO 1      Description      02872 10-01-2015 Span 5 left curb.
