Bridge Inspection Report

02873

SH 77-02- LM 5.97

LITTLE RIVER

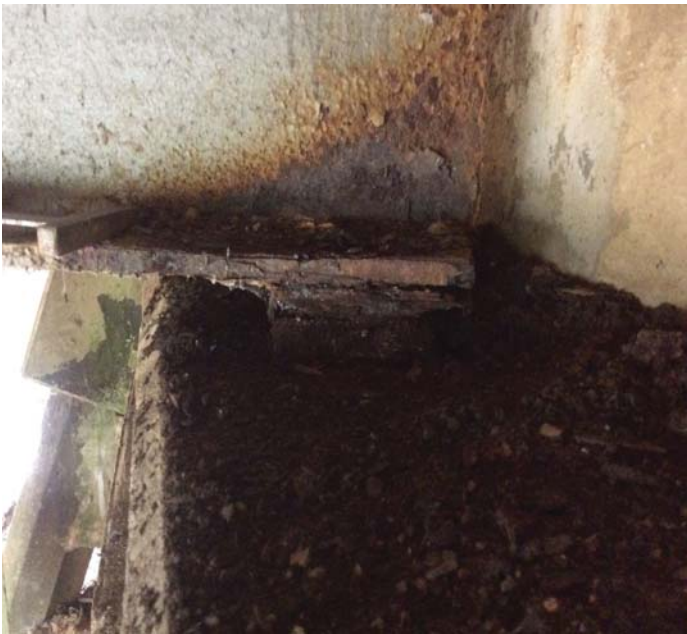
Span 3 Girder 3 Bearing Bent 4 has heavy rust with areas of 50% section loss, see 2015 photo.

PHOTO 1 Description 02873 09-30-2015 Span 3 girder 3 at bent 4 bearing.

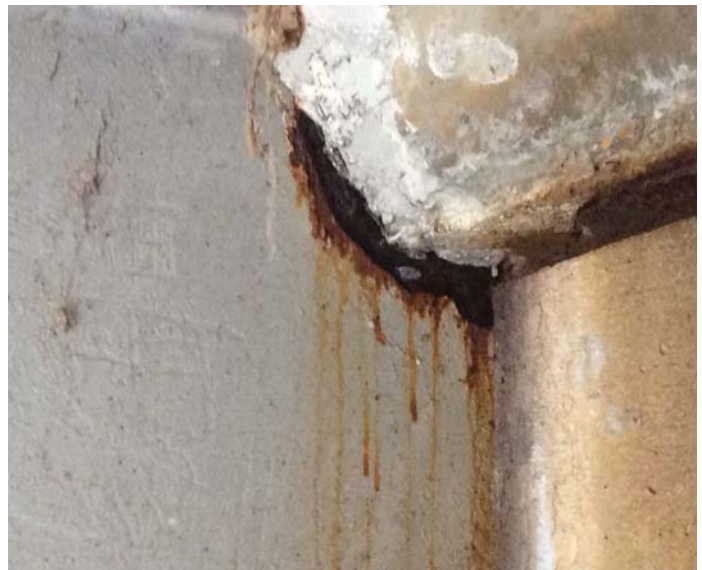
Span 1 Girder 3 Bent 1 has 1in. x 1/2in. hole in web near concrete diaphragm, see 2015 photo.
Span 1 Girder 5 Bent 1 has 1/2in. diameter hole in web near concrete diaphragm, see 2015 photo.
Span 1 Girder 1 Bent 2 has 3/4in. x 1in. hole in web near concrete diaphragm, see 2015 photo.
Span 1 Girder 2 Bent 2 has 2in. x 1in. hole in web at haunch, see 2015 photo.
Span 1 Girder 3 Bent 2 has 5 1/2in. x 1in. hole rusted thru web at haunch, see 2015 photo.
Spans 1&2 Girder 5 Bent 2 has 1/8in. section loss to bottom flange.
Span 2 Girder 1 Bent 2 rusted with 3in. x 1 1/4in. hole rusted thru web at haunch, see 2015 photo.
Span 2 Girder 3 Bent 2 rusted with 2in. x 1/2in. hole rusted thru web at haunch and a 1 1/2in. x 2in. hole in left bottom flange, see 2015 photo.
Span 2 Girder 4 Bent 2 has an 8in. x 1in. hole in web at haunch, see 2015 photo.
Span 2 Girder 1 Bent 3 has 9in. x 2 1/2 in. hole rusted thru web at haunch, see 2015 photo.

PHOTO 1 Description 02873 09-29-2015 span 1 girder 3 @ Bt 1

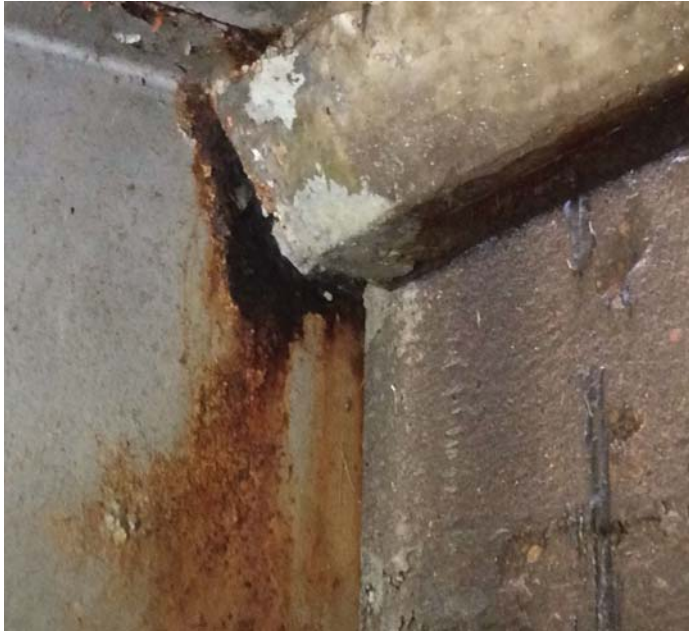
PHOTO 2 Description 02873 09-29-2015 Span 1 girder 5 @ Bt 1

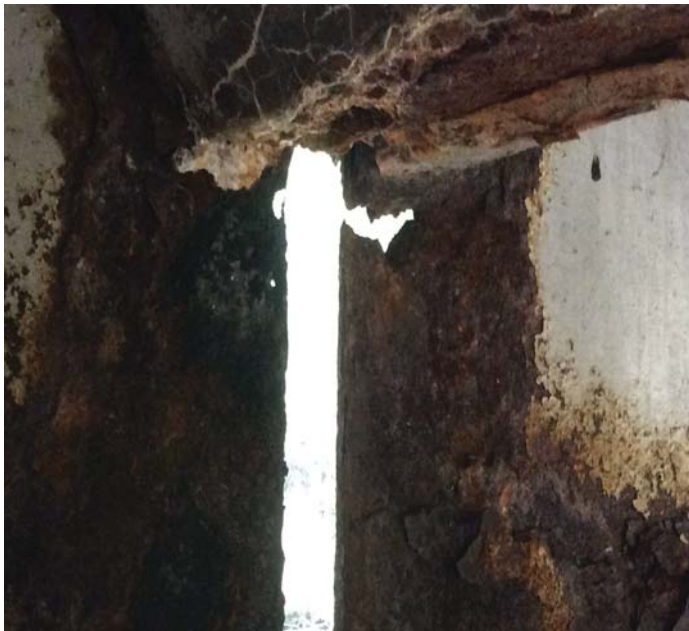
PHOTO 3 Description 02873 09-30-2015 Span 1 Girder 1 & span 2 girder 1 over bent 2.

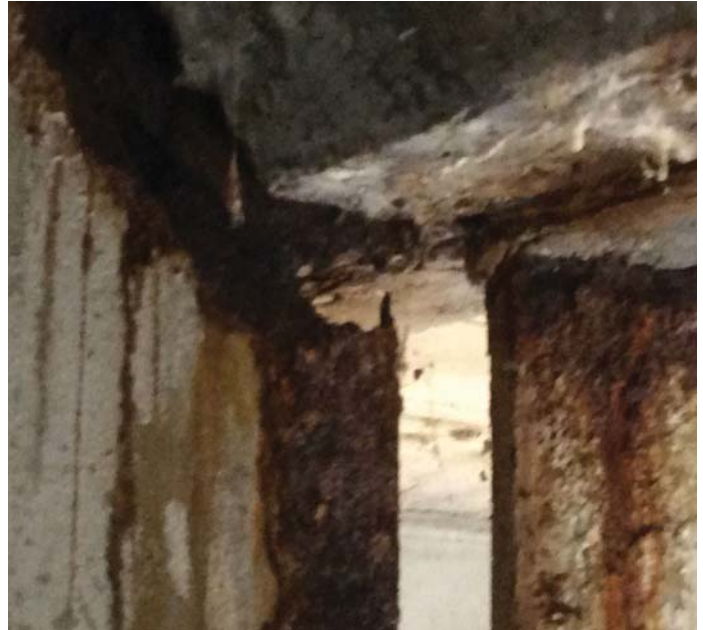
PHOTO 4 Description 02873 09-30-2015 span 1 girder 2 over bent 2.

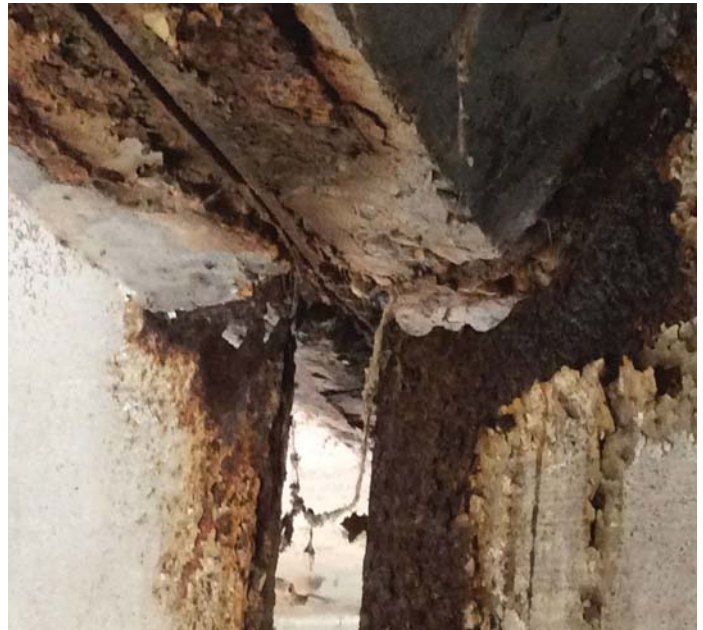
PHOTO 5 Description 02873 09-30-2015 Span 1 girder 3 & Span 2 girder 3 over bent 2.

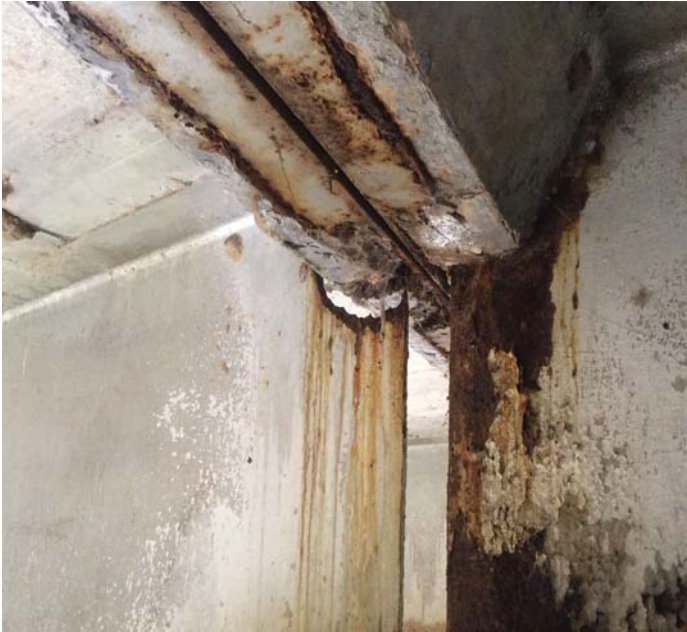
PHOTO 6 Description 02873 09-30-2015 Span 2 girder 4 over bent 2.

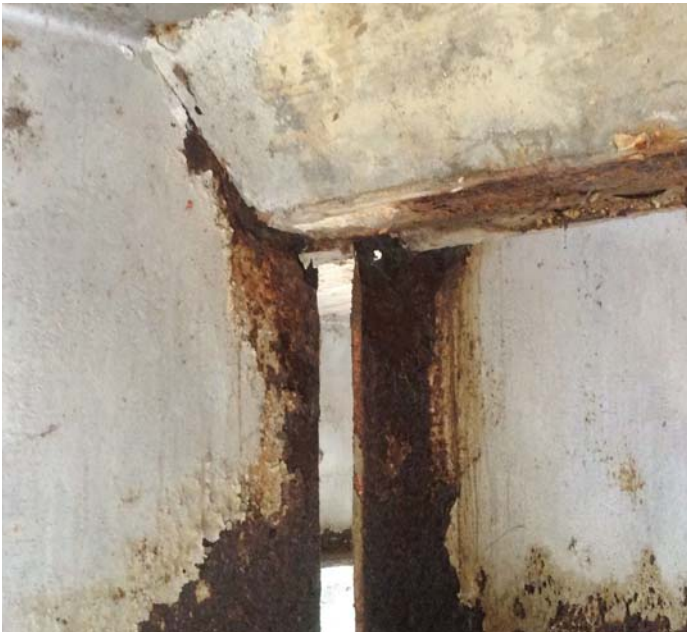
PHOTO 7 Description 02873 09-30-2015 span 2 girder 2 & span 3 girder 2 over bent 2.

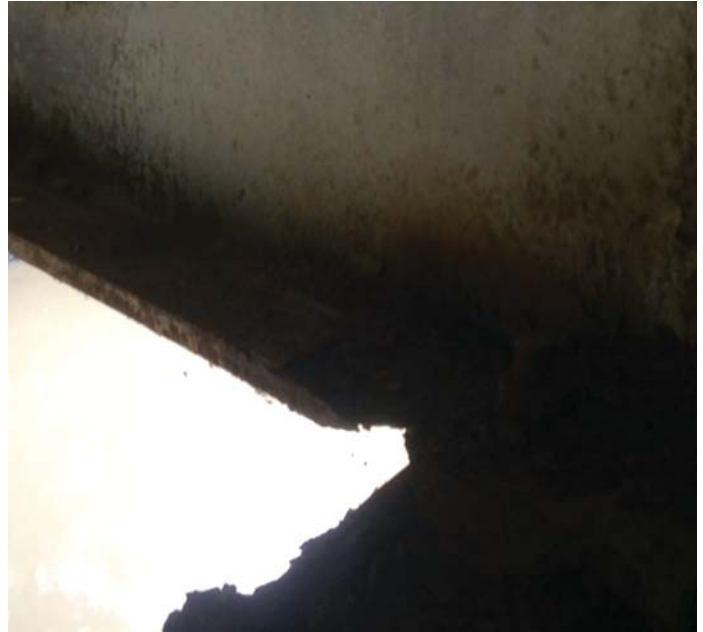
PHOTO 8 Description 02873 09-30-2015 Span 2 girder 3 over bent 2 left bottom flange

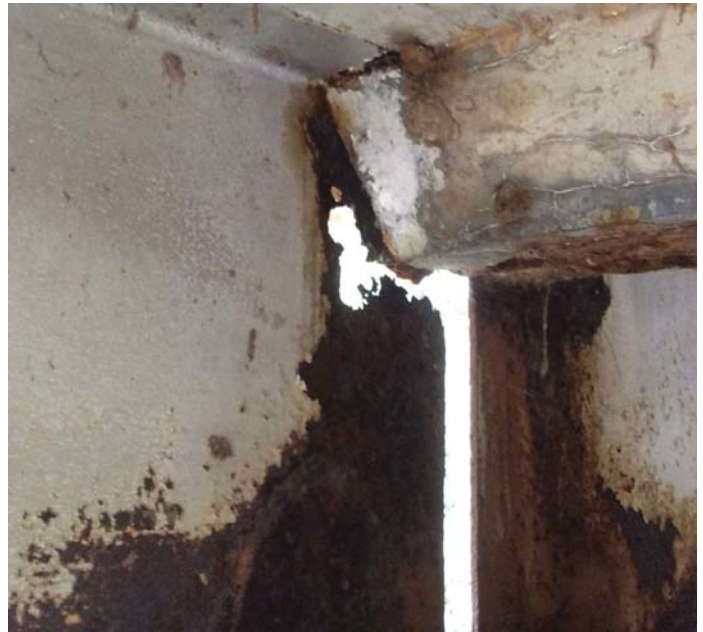
PHOTO 9 Description 02873 09-30-2015 Span 2 girder 1 over bent 3

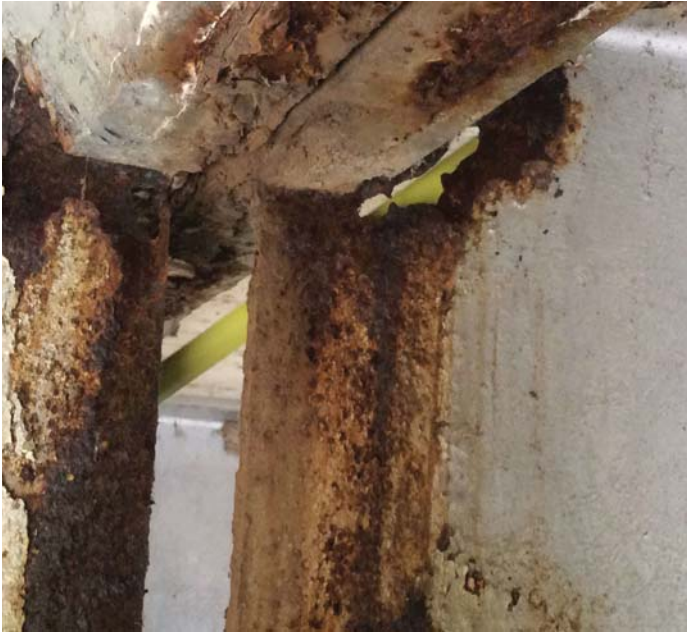
PHOTO 10 Description 02873 09-30-2015 Span 2 girder 3 & span 3 girder 3 over bent 3.

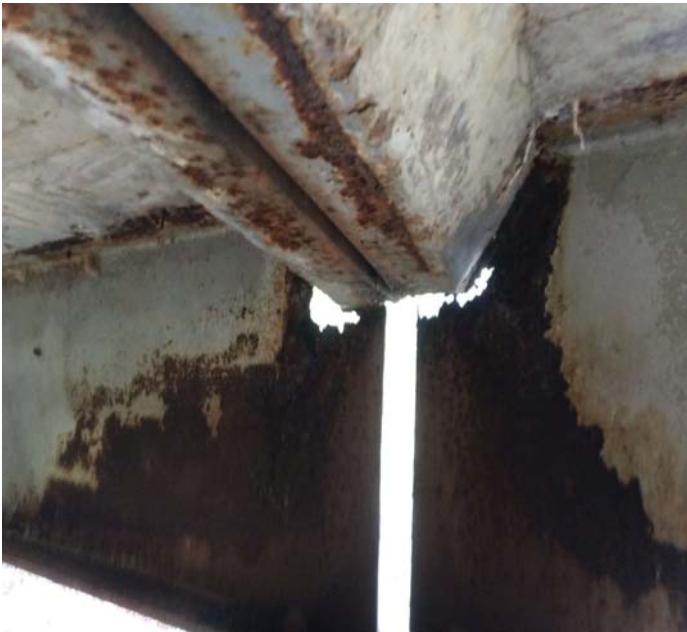
Span 2 Girder 2 Bent 3 has 1in. x 3/4in. hole rusted thru web at haunch, see 2015 photo.
Span 2 Girder 3 Bent 3 has 1in. x 1 1/2in. hole rusted thru web at haunch, see 2015 photo.
Span 2 Girder 5 Bent 3 has 7in. x 1 1/4in. hole rusted thru web at haunch, see 2015 photo.
Span 3 Girder 2 Bent 3 has 1/2in. diameter hole rusted thru web at haunch, see 2015 photo.
Span 3 Girder 3 Bent 3 has 5in. x 3/4in. hole rusted thru web at haunch, see 2015 photo.
Span 3 Girder 4 Bent 3 has 3in. x 3/4in. hole rusted thru web at haunch, see 2015 photo.
Span 3 Girder 5 Bent 3 has 6in. x 2in. hole rusted thru web at haunch, see 2015 photo.
Span 3 Girder 1 Bent 4 has 10in. x 1 1/2in. hole in web near concrete diaphragm, see 2015 photo.
Span 3 Girder 3 Bent 4 has 5in. x 1in. hole in web near concrete diaphragm, see 2015 photo.
Span 3 Girder 5 Bent 4 has 5in. x 3/4in. hole in web near concrete diaphragm, see 2015 photo.

PHOTO 11 Description 02873 09-30-2015 Span 2 girder 5 & span 3 girder 5 over bent 3.

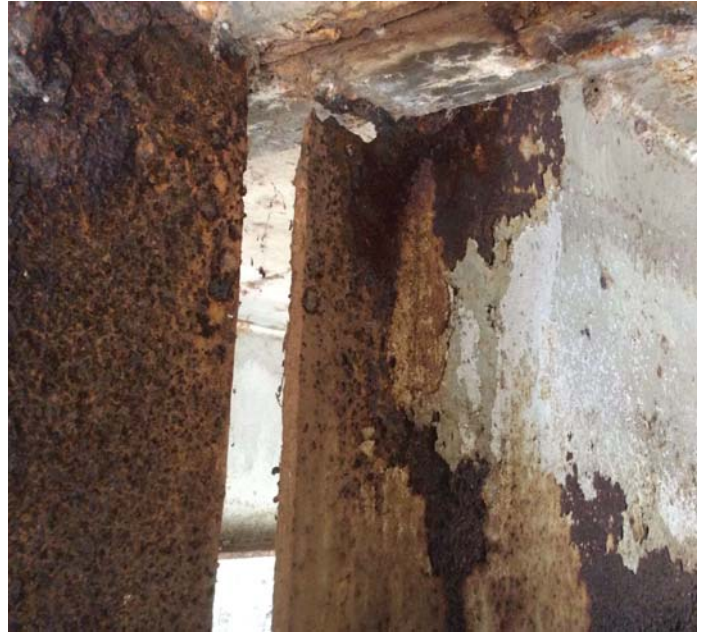
PHOTO 12 Description 02873 09-30-2015 Span 3 girder 4 over bent 3.

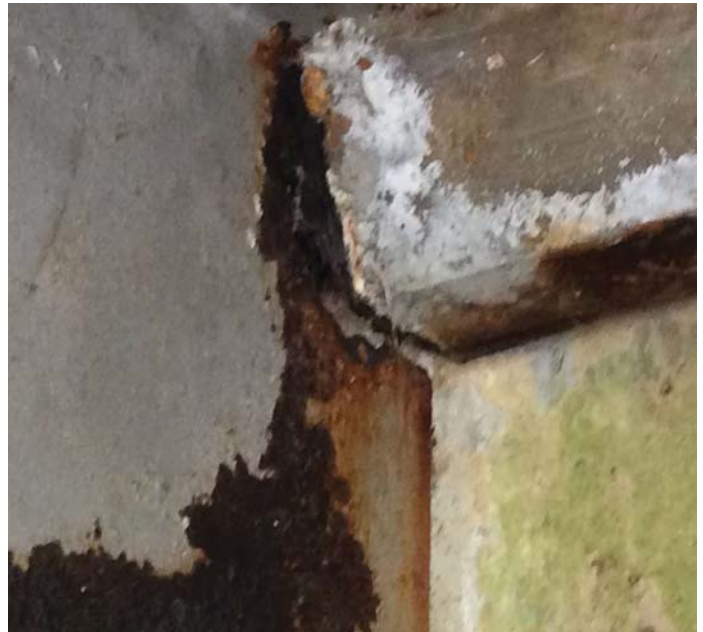
PHOTO 13 Description 02873 09-29-2015 Span 3 girder 1 @ Bent 4

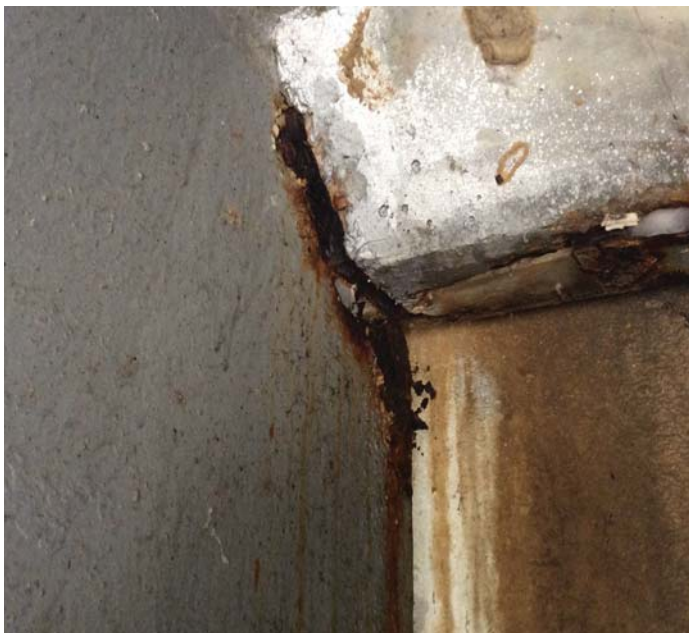
PHOTO 14 Description 02873 09-29-2015 Span 3 girder 3 @ bent 4

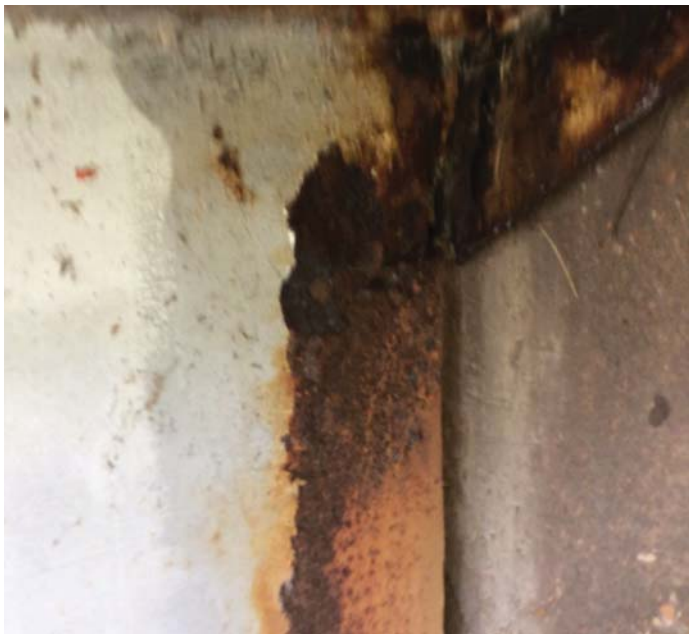
PHOTO 15 Description 02873 09-29-2015 Span 3 girder 5 @ Bent 4

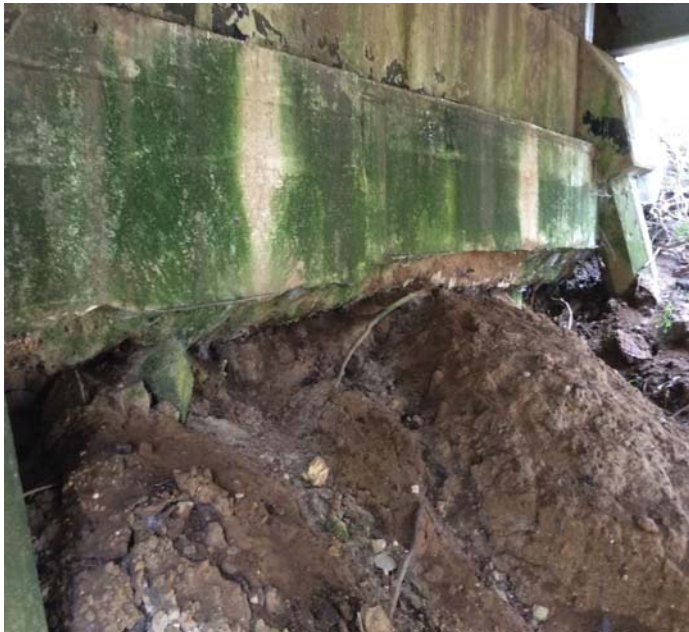
Heavy erosion due to Roadway Runoff Bents 1, up to 3ft. deep x 2.5ft. back under Abutments, see 2015 photo.
Heavy erosion due to Roadway Runoff Bents 4, up to 2ft. deep x 2ft. back under Abutments, see 2015 photo.

PHOTO 1 Description 02873 09-29-2015 Bent 4 Embankment erosion.

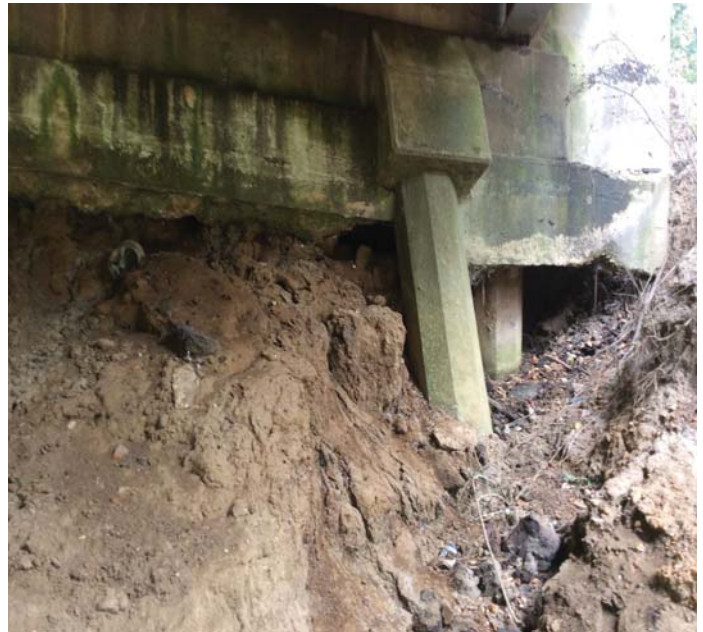
PHOTO 2 Description 02873 09-29-2015 Left end bent 1 abutment

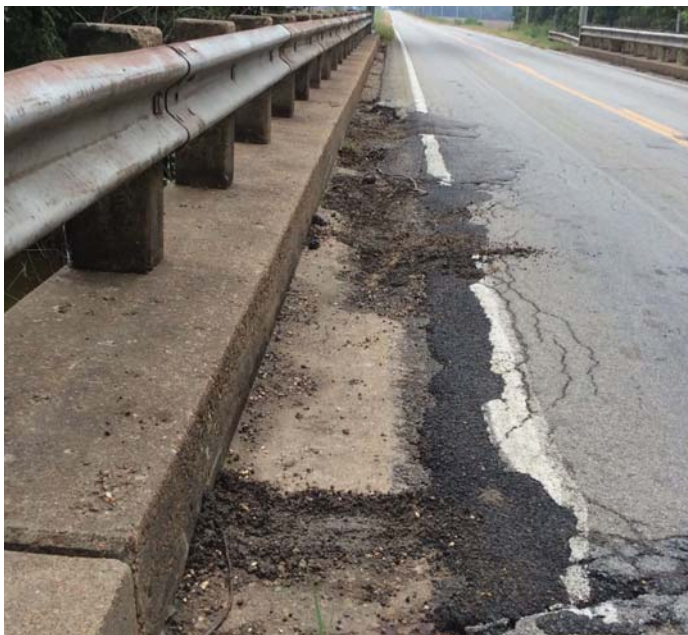
Concrete Deck with Asphalt Overlay has 3ft. x 10ft. area of heavy cracking and impending spall in left lane of Span 1. Span 1 left Gutter line has a 2ft. x 1ft. spall without rebar exposed and a 2.5ft. x 28ft. x 2in. deep spall with exposed rebar with section loss, see 2015 photo.

PHOTO 1 Description 02873 09-29-2015 Left gutterline Span 1

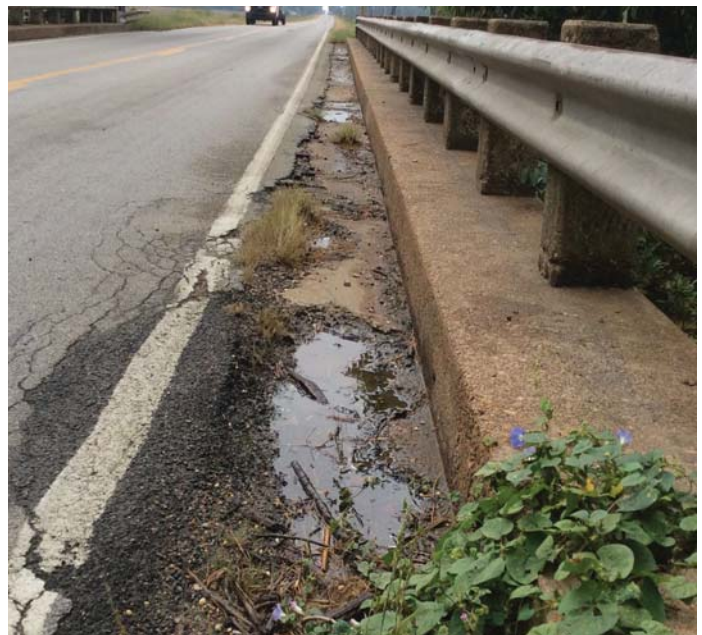
Span 1 right Gutter line has a 1ft. x 12ft. x 1in. deep spall without rebar exposed and has a 2.5ft. x 19ft. x 2in. deep and a 2.5ft. x 8ft. x 2in. deep and a 2ft. diameter x 2in. deep spall with exposed rebar, see 2015 photo.

PHOTO 2 Description 02873 09-29-2015 Right gutterline Span 1

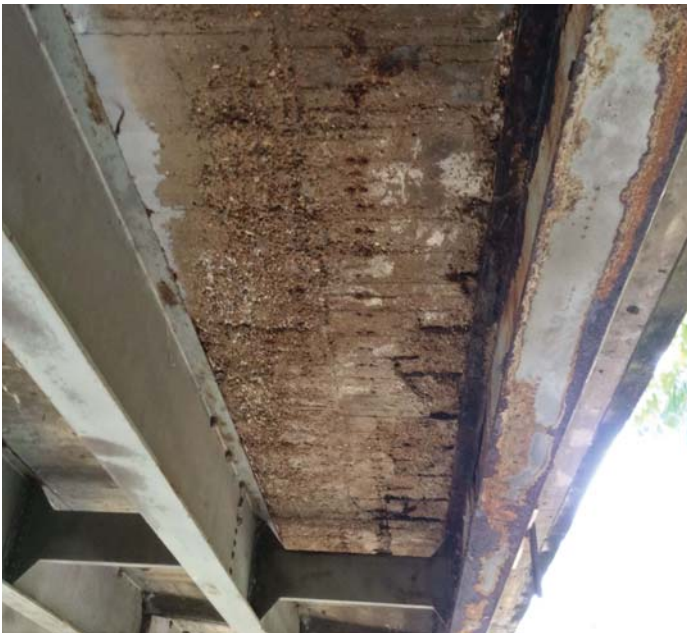
Concrete Soffit Span 1 between Girders 4&5 has 2ft. wide x 20ft. long x 2in. deep shelled out bottom of deck with rebar exposed, See photo 2015

PHOTO 3 Description 02873 09-29-2015 Span 1 Bay 4

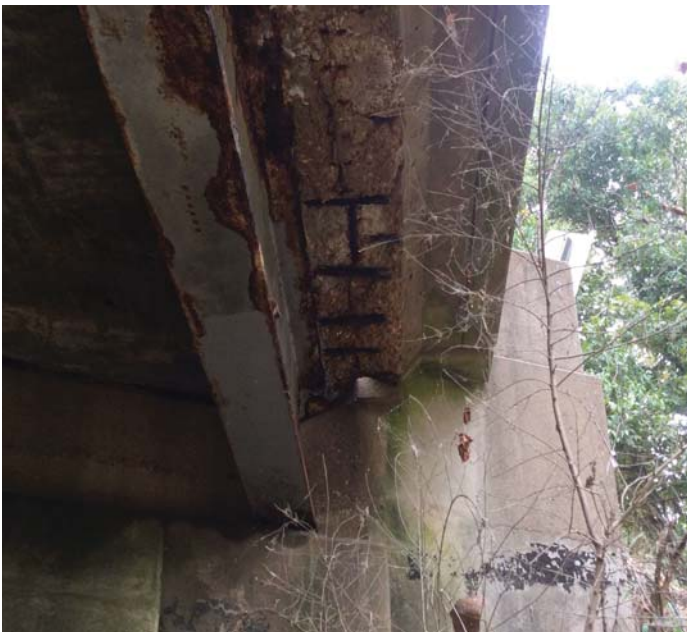
Span 1 left Overhang has an area 1.5ft. wide x 4ft. long x 2in. deep shelled out area with rebar exposed, 30% section loss to rebar.

PHOTO 4 Description 02873 09-29-2015 Span 1 left overhang

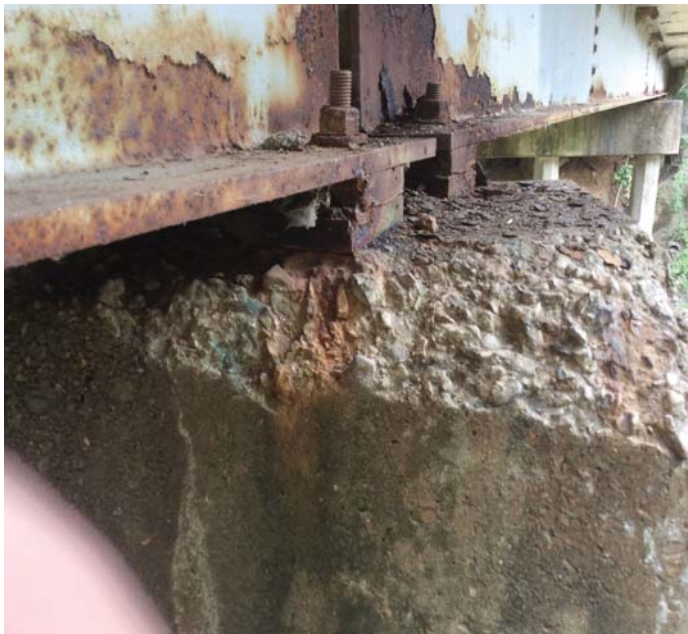
has a 2ft. x 6in. spall with no rebar exposed and a 4ft. x 1.5ft. x 4in. deep spall face of cap under girder 4 with rebar exposed and some cracking with impending spalls.

PHOTO 1 Description 02873 09-30-2015 Left end bent 3 cap under span 3 girder 1.

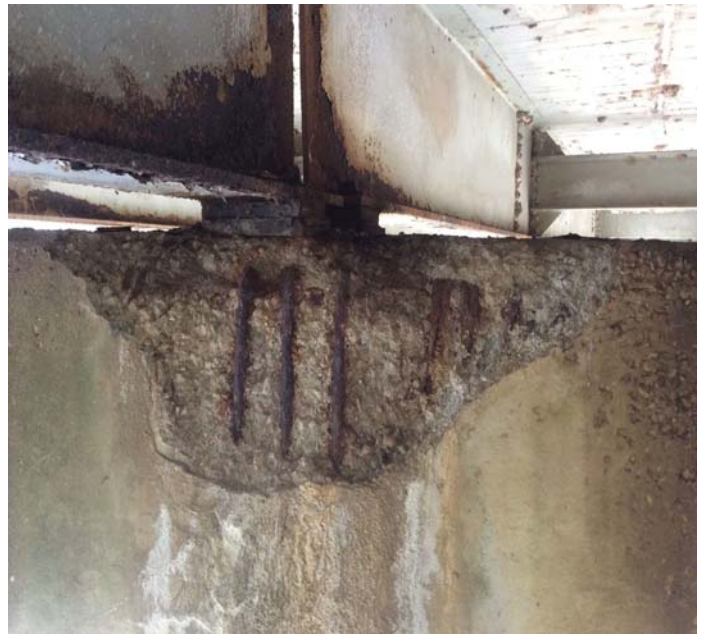
PHOTO 2 Description 02873 09-30-2015 bent 3 cap span 3 side under girder 4.

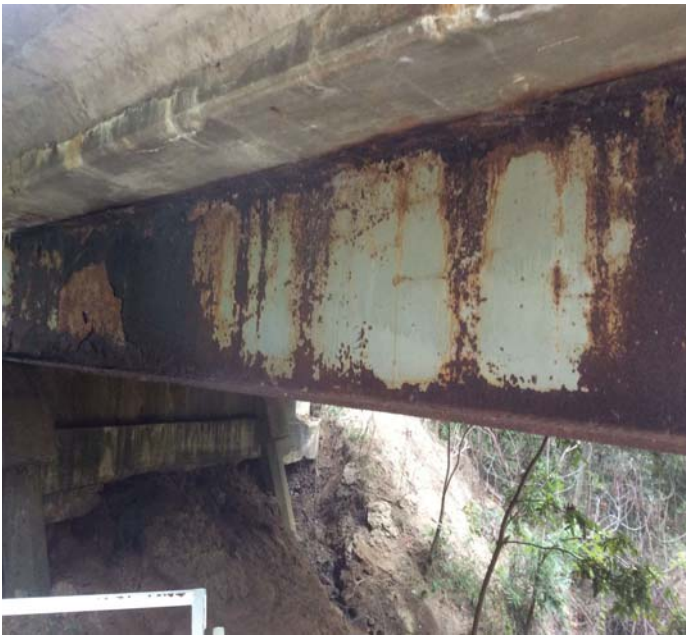
Majority of Span 1 Girders have up to 5/8in. section loss to girders,

PHOTO 1 Description 02873 09-30-2015 Span 1 Girder 5
