Bridge Inspection Report

02881
SH 77-02- LM 6.34
over
LITTLE RIVER

Facility Carried: SH 77-02- LM 6.34

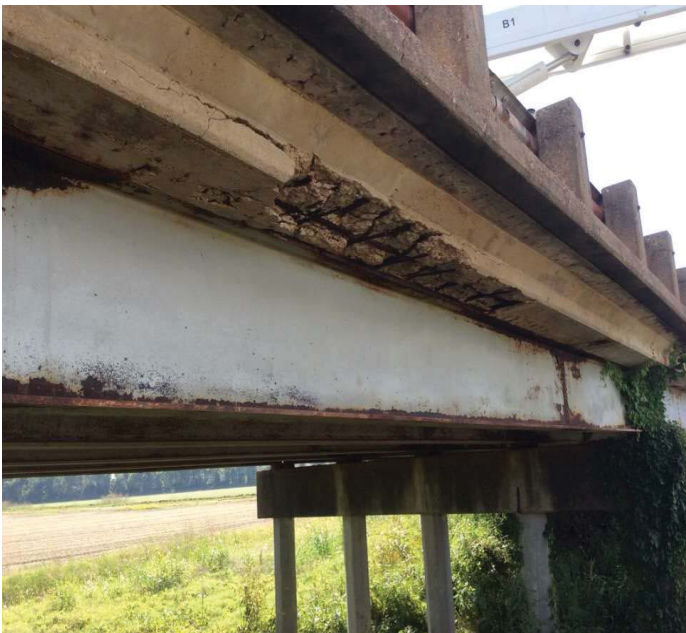
PHOTO 1 Description

Span 8 has a 12ft. X 1ft. X 4in. deep spall with exposed rebar on right Overhang, see 2016 deficiency Photo.

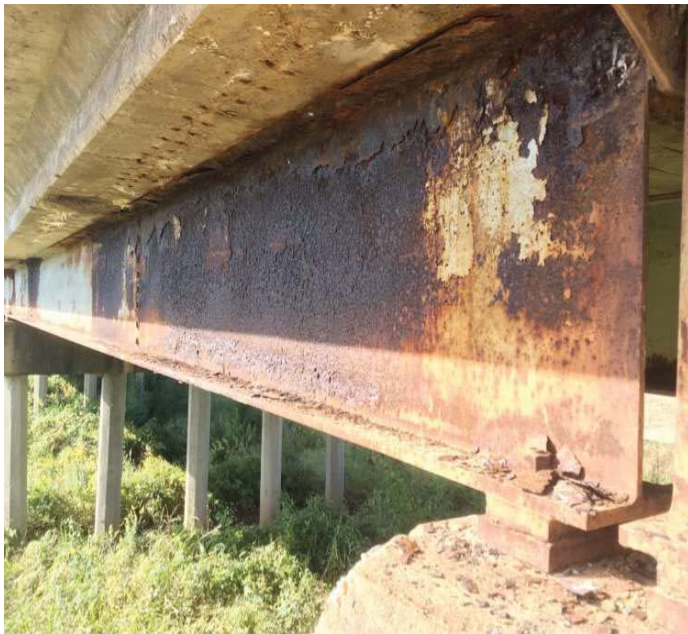
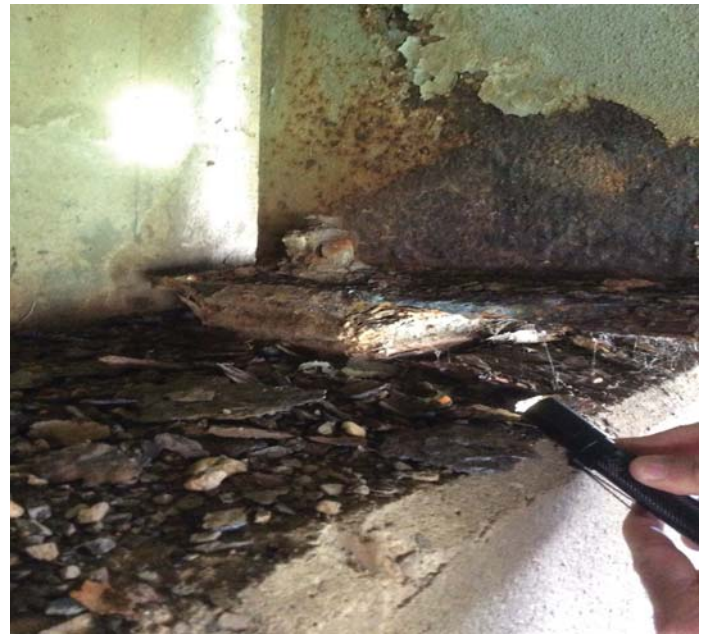
Span 7 Girder 1

Is rusted with 1/8in. loss of section on web and bottom flange, mainly near drains, see 2016 deficiency photo.

Span 9 Girder 4 over Bent 10 has a knife edge in bottom flange near bearing, see 2016 photo.

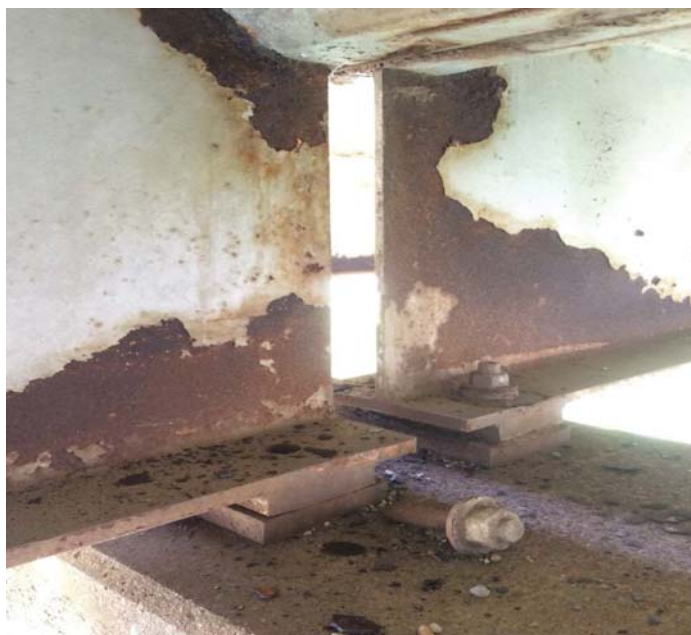
PHOTO 1 Description

Span 3 Girder 2 Bent 4
Has 2 anchor bolts rusted off.

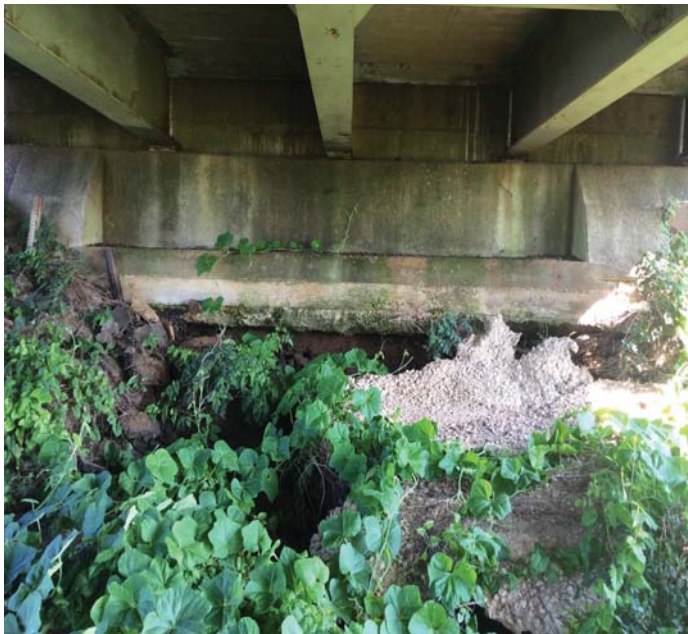
Bent 1 & Bent 10 Abutments have moderate slope erosion from roadway runoff causing undermining of abutments:
Bent 1 Abutment has some embankment erosion near center line
Bent 10 has up to 20ft. length of concrete x 2ft. high and up to 6ft. back under abutment, see 2016 photos.

PHOTO 1 Description Bent 1 erosion.

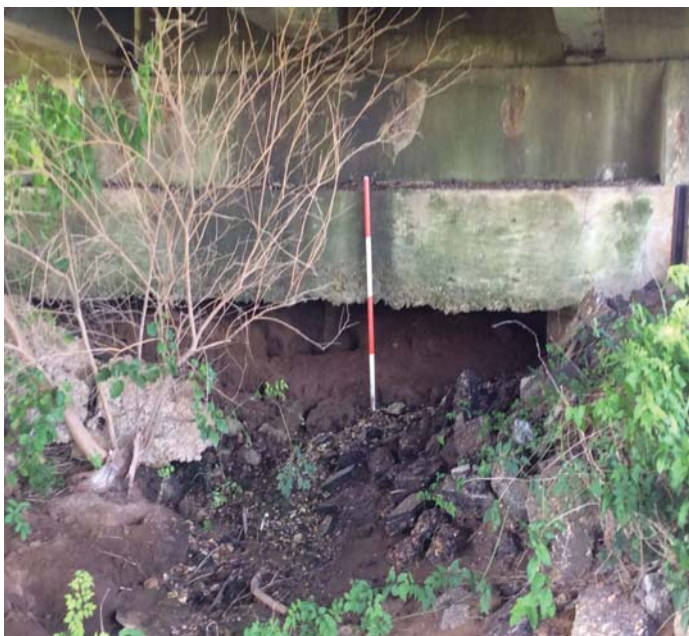
PHOTO 4 Description Bent 10 abutment embankment erosion.

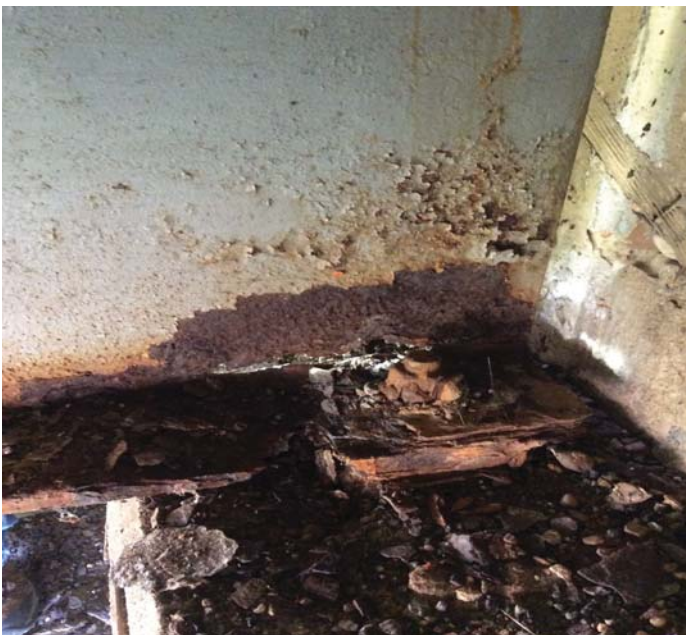
PHOTO 1 Description

Span 9 Girder 2 over Bent 10 has 12in. X 1in. hole rusted thru web near bottom flange and a 2in. x 2in. hole in bottom right and left flange near bearing, see 2016 photo.

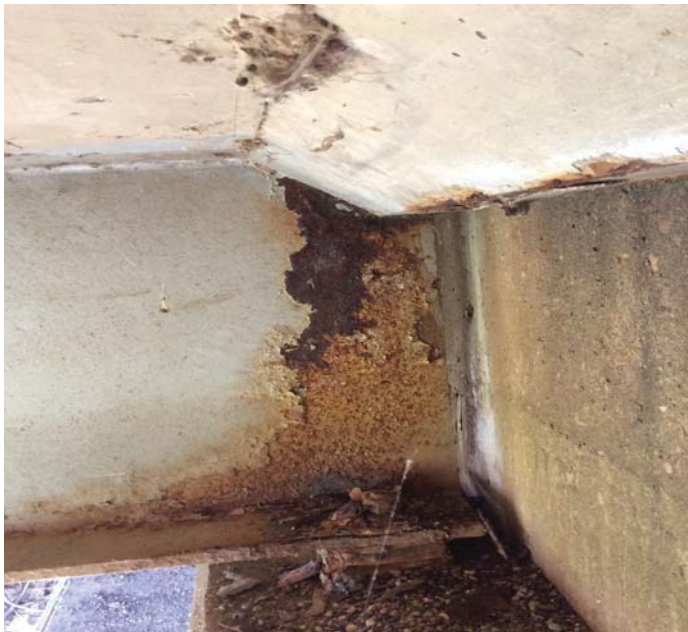
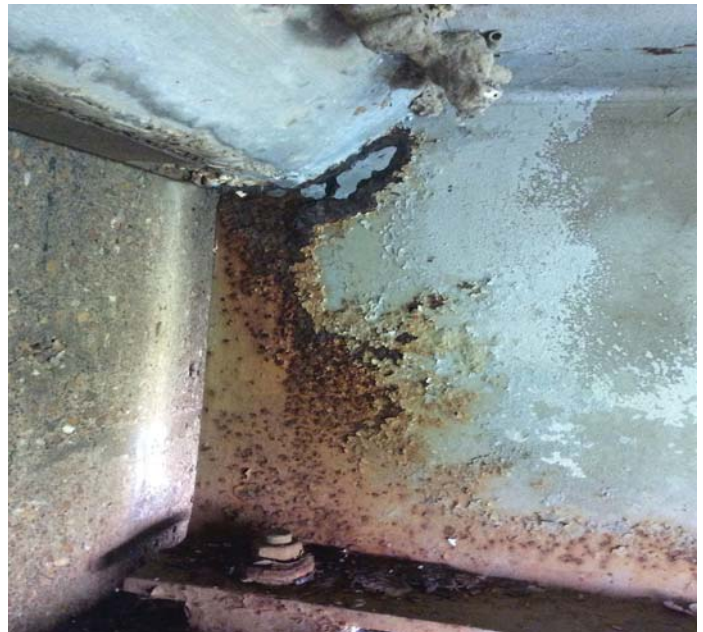
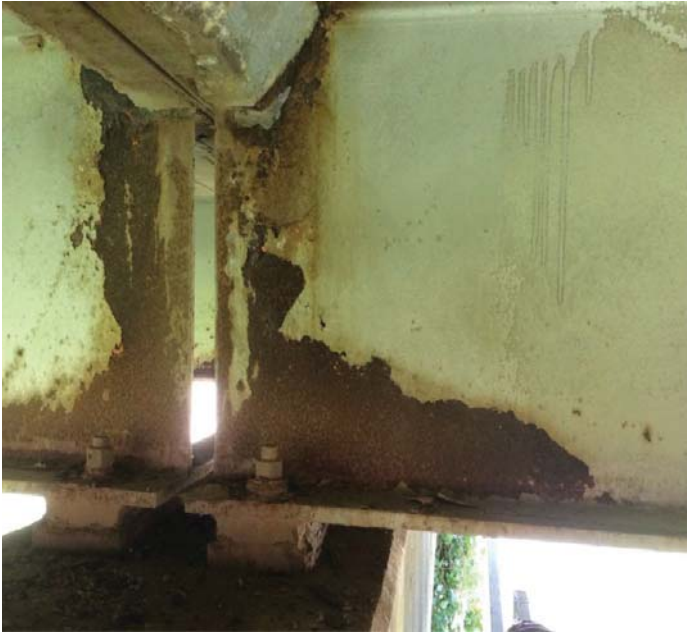
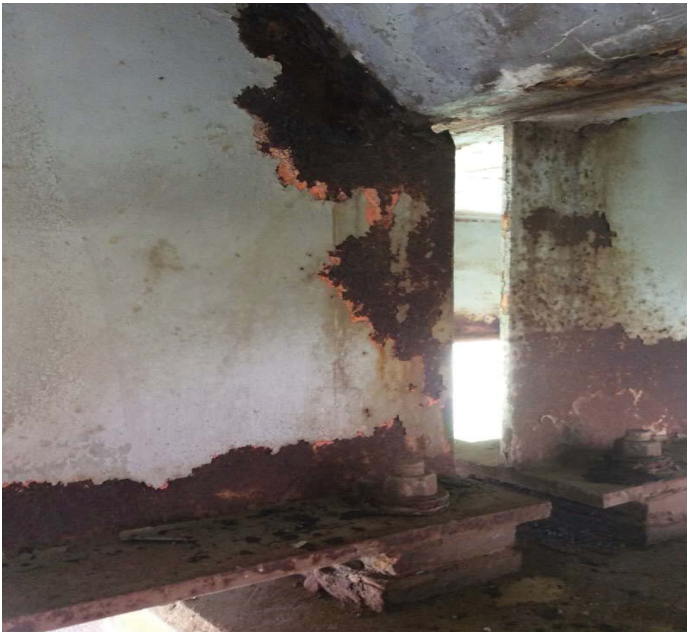
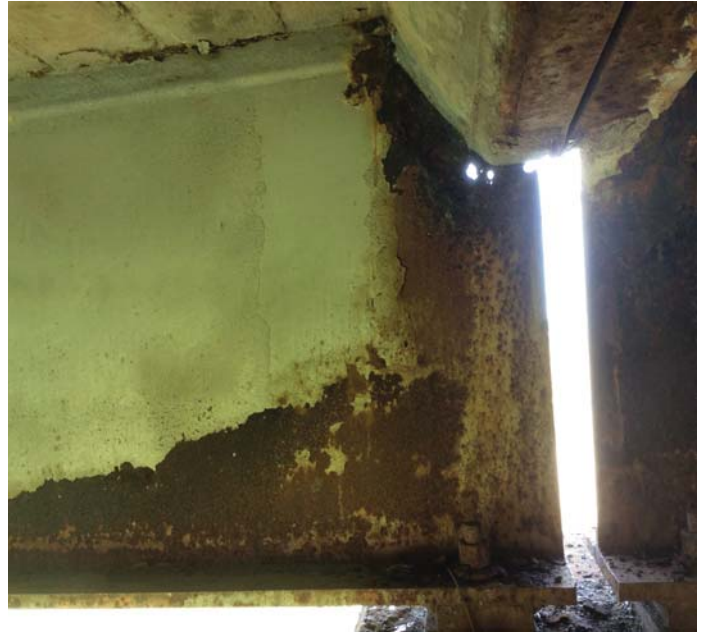
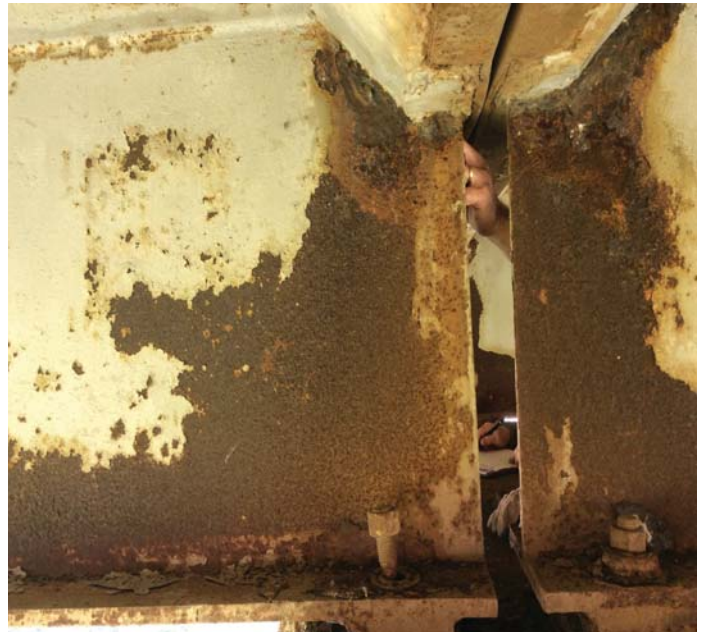
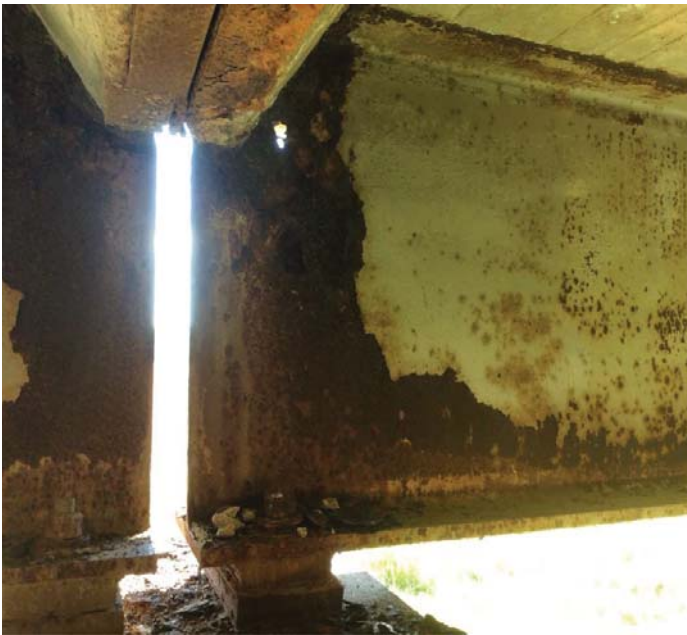
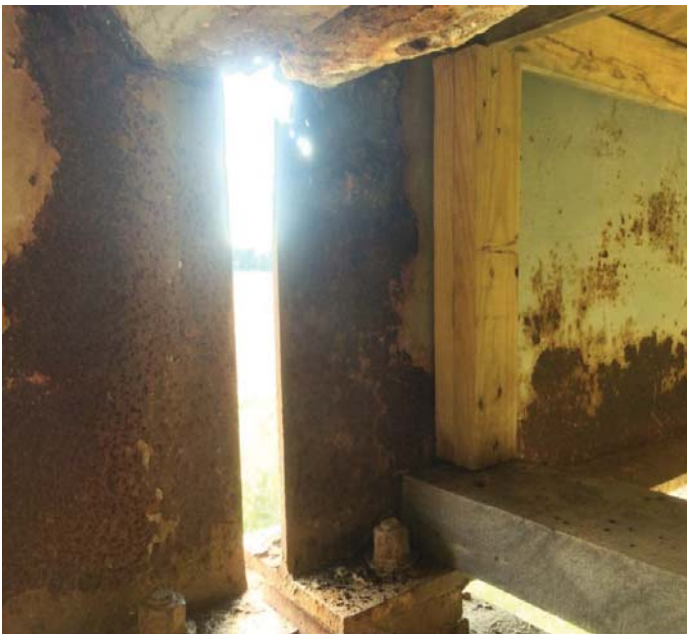
Span 1 Girder 3 over Bent 1 has a 1 1/2in. x 1/2in. hole in web at concrete haunch, see 2016 photo.

Span 3 Girder 3 over Bent 3 has a 2 1/2in. x 3/4in. hole in web at concrete haunch, see 2016 photo.

Span 5 Girder 1 over Bent 5 has a 1 1/2in. x 3in. hole in web at concrete haunch, see 2016 photo.

Span 7 Girder 1 is rusted with 1/8in. loss of section on web and bottom flange, mainly near drains, see 2016 photo.

Span 8 Girder 1 over Bent 8 has a 1in. diameter hole rusted thru web at concrete haunch, see 2016 photo.

Span 8 Girder 3 over Bent 8 has a 1in. x 1/2in. hole rusted thru web at concrete haunch, see 2016 photo.

Span 8 Girder 5 over Bent 8 has several holes making up an area of 4in. x 1in. hole rusted thru web at concrete haunch, see 2016 photo.

Span 8 Girder 2 over Bent 9 has a 3/4in diameter hole rusted thru web at concrete haunch, see 2016 photo.

Span 8 Girder 3 over Bent 9 has a 5in. X 1 1/4in. hole rusted thru web at concrete haunch, see 2016 photo.

Span 9 Girder 3 over Bent 10 has an 8in. X 1 1/4in. hole rusted thru web at concrete haunch, see 2016 photo.

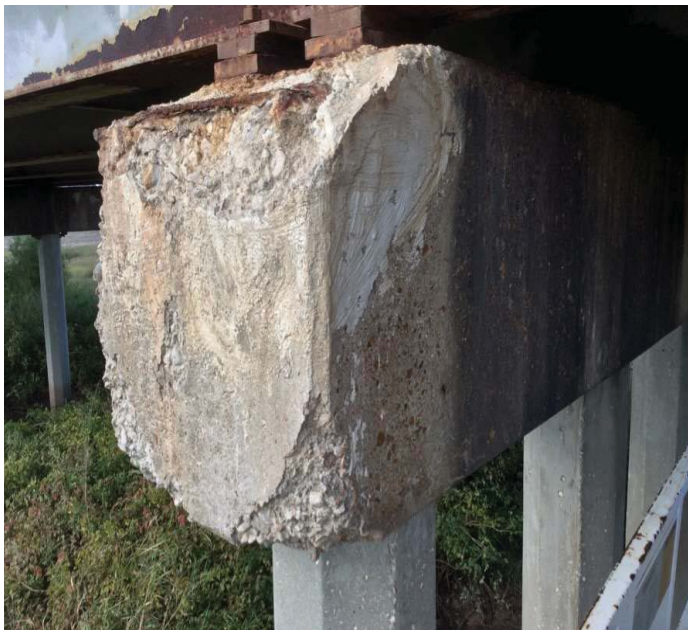
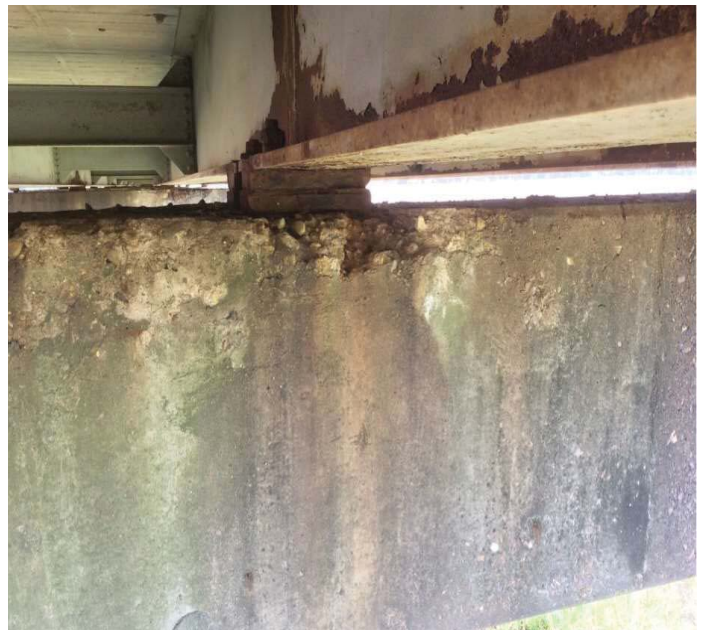
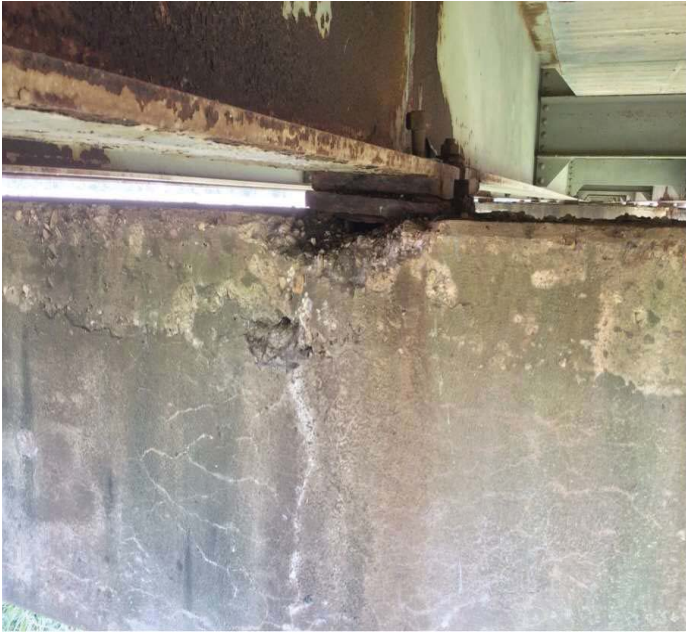
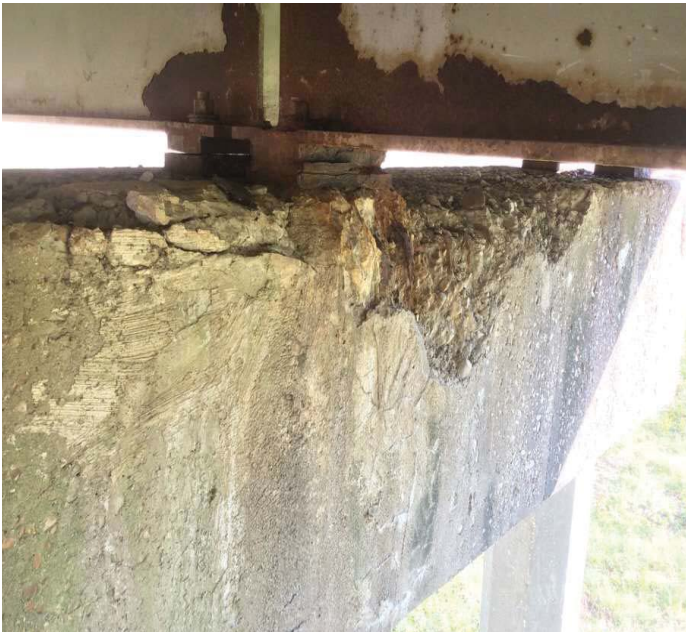
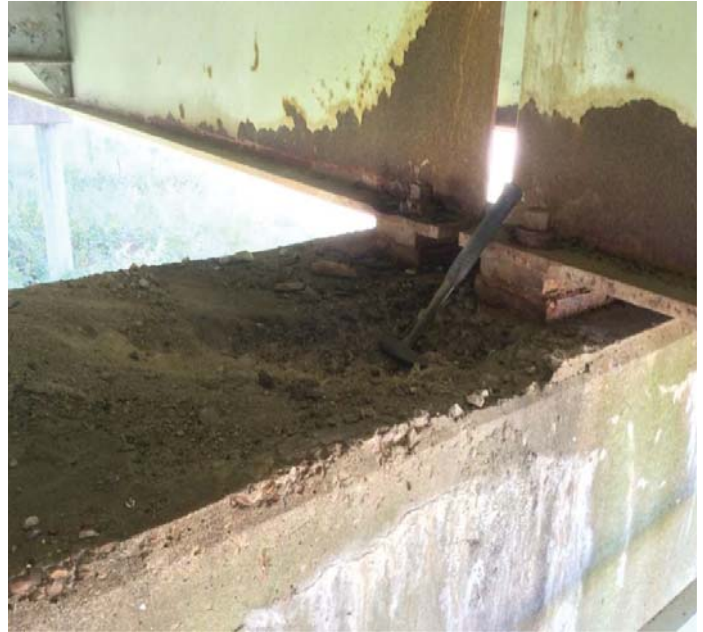
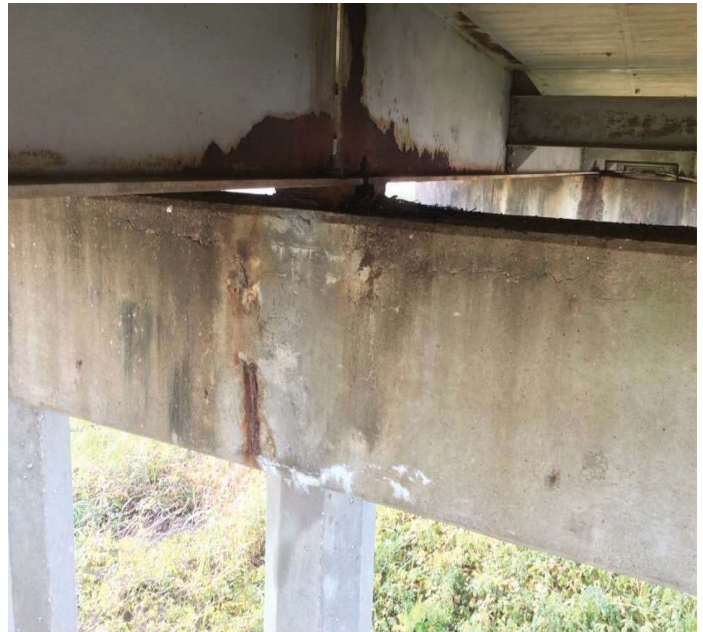
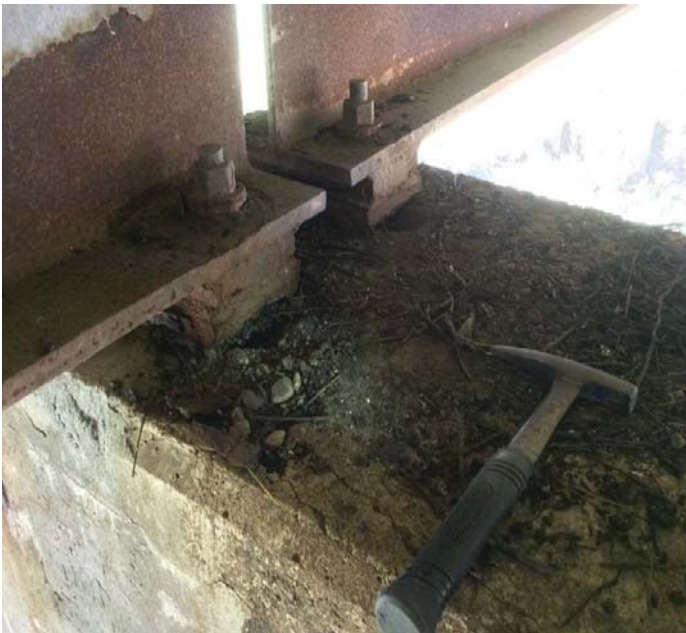
Right End of Bent 2 Concrete Cap has a 1ft. X 1ft. X 2in. deep spall with exposed rebar, see 2015 deficiency photo.
Span 1 side of Bent 2 Concrete Cap over Pile 3 has a 1.5ft. X 2ft. X 1 1/2in. deep spall with exposed rebar, reinforcement has 40% loss of section, see 2015 deficiency photo.
Left end of Bent 2 Concrete Cap has a spall near Girder 1, 12in. x 6in. x 1 1/2in. deep and a spall near Pile 1, 12in. x 6in. x 3in. deep with exposed rebar, see 2015 photo.
Top of Cap Bent 2 Between girders 1&2 is spalled with deterioration and retaining water, up to a 1 1/2in. deep, spall is at the edge of bearing.
Left End of Bent 3 Concrete Cap has a 2ft. X 1ft. X 2in. deep spall with exposed rebar, see 2015 deficiency photo.
Span 4 Between Girders 4&5 Bent 4 Concrete Cap has a 3ft. X 2ft. X 3in. deep spall with exposed rebar, see 2015 deficiency photo.
Bottom of Concrete Cap Bent 4 between Piles 4&5 has a 3ft. X 1ft. X 3in. deep spall with exposed rebar, see 2015 photo.

Left side of Span 6 side of Bent 6 Cap is spalled near bearing with rebar exposed, see 2016 photo.
Span 7 side at Bearing 2 of Concrete Cap Bent 7 has a 3ft X 1ft X 3inch deep spall with exposed rebar; see 2016 photo – Also, Top of Cap has deterioration between Girders 1&2, up to 2in. deep.
Top & Bottom of Concrete Cap Bent 8 has heavy deterioration especially at bearings 2&3, see 2015 photo.

bridge crew is evaluating caps and beams to schedule repairs

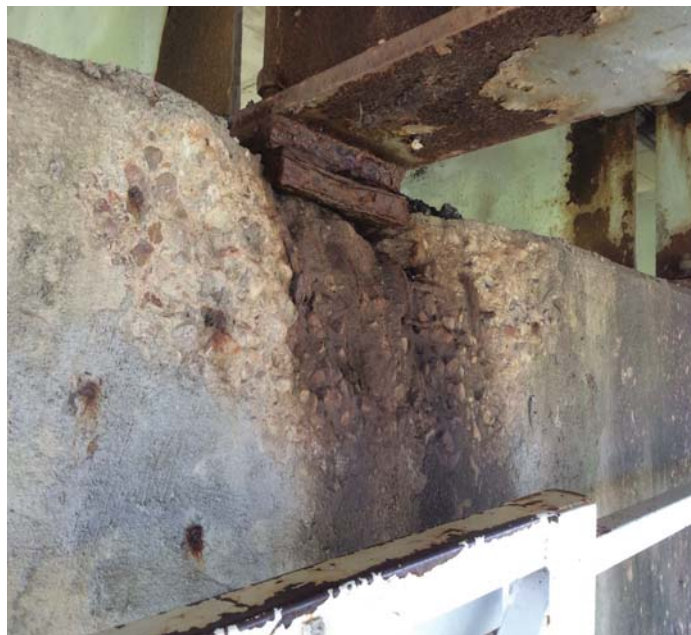
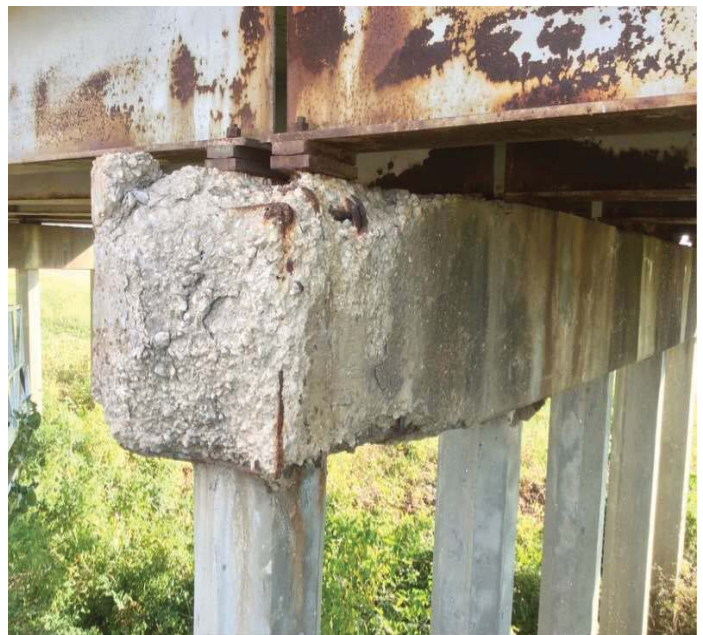
Spans 2&3 side of Bent 3 Concrete Cap under the right side of Bearing 3 has a 3in. deep void on top of cap & under bearing, see 2016 photo.

Span 3 side under Bearing 3 Bent 4 Concrete Cap has a 2.5ft. X 1ft. X 6in. deep spall with 40% loss of bearing area, see 2016 photo.

Right End of Bottom of Concrete Cap Bent 6 at Pile 5 has a 4ft. X 1ft. X 3in. deep spall with exposed rebar, see 2015 photo.

Top of Concrete Cap Bent 6 & between Girders 3&5 has moderate deterioration of up to 3 inches deep with section loss & rebar exposed with 30% of loss of bearing Spans 5&6 Girder 5, (water retention on top of Cap), See 2016 photo.

bridge crew is review caps and beams to schedule repairs
