# Bridge Inspection Report

**M3220**  
**SH 34-04- LM 9.99**  
**over**  
**HURRICANE DITCH**

IDENTIFICATION		INSPECTIONS	
(1) STATE CODE	056 - Arkansas	(90) INSPECTION DATE	05/09/2018
(8) STRUCTURE NUMBER	M3220	(91) DESIGNATED INSPECTION FREQUENCY	24

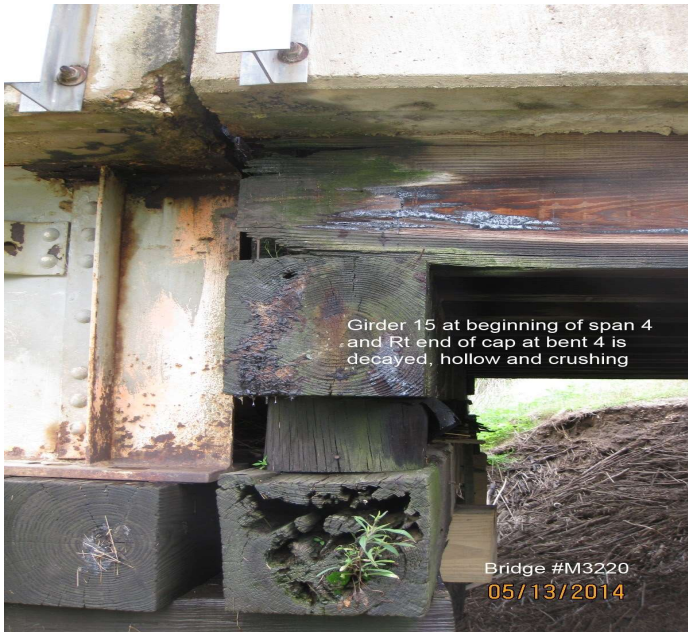
PHOTO 1 Description

Bent 1 cap has 1' on Lt end that is decayed and hollow. Rt end has been spliced in the past. Cap has some outside decay with an edge split over pile 3.

Bent 3A cap has been replaced. A few spacer blocks have decay and checking with up to 40% section loss. Some spacers/sub caps have been replaced.

Bent 3A spacer (sub cap) over pile 6 has core decay and is partially hollow with 20% section loss.

Bent 4B cap is decayed, hollow, and crushing for 4' on Rt end.

Bent 4 spacers/sub caps 1 through 5 have been replaced.

Bent 4 spacer/sub cap over pile 6 is decayed and hollow with 20% section loss 7.5" deep into cap.

Bent 4B spacers/sub caps are decayed and partially hollow.

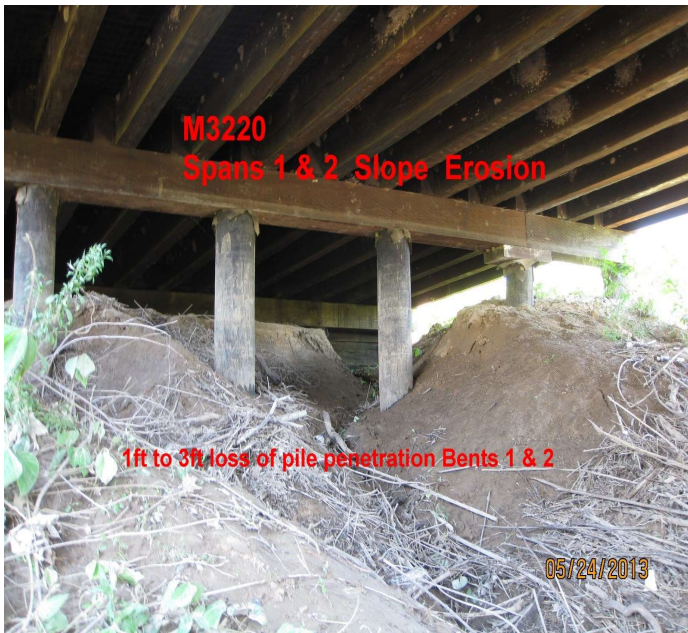
PHOTO 1 Description

Embankment has some erosion under spans 1, 2, 4, & 5. Bent 2 piles have some reduced penetration.

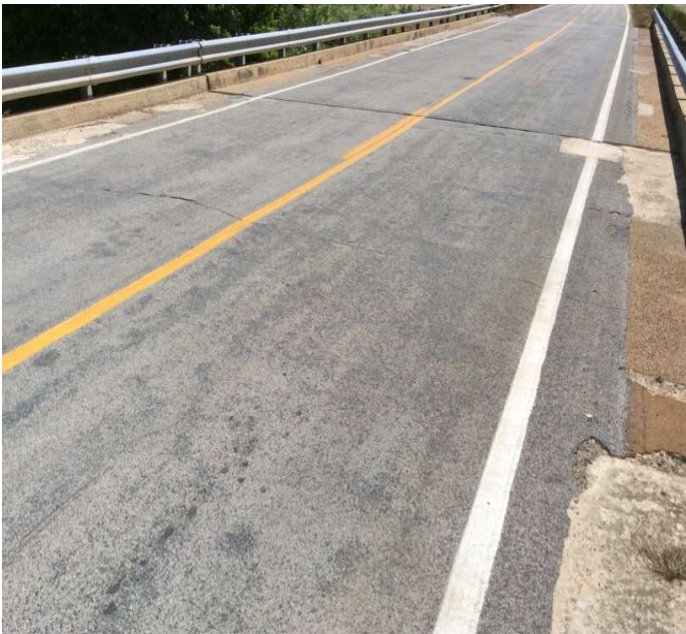
PHOTO 1 Description

Concrete deck with Asphalt Overlay has insignificant size and density cracks.  
Left and Right Gutter Lines have spalled out areas, some up to 1in. deep no rebar exposed at this time.  
Gutter Lines have 150sqft. of patched areas, mainly Spans 1&2.

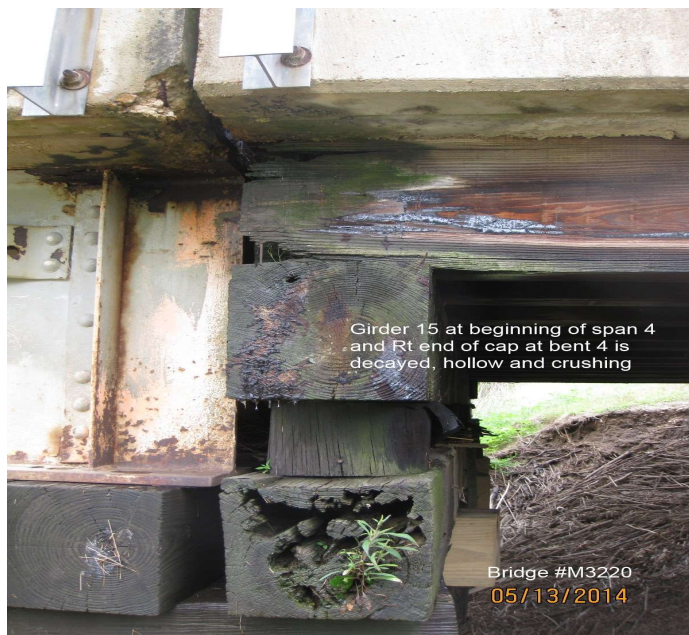
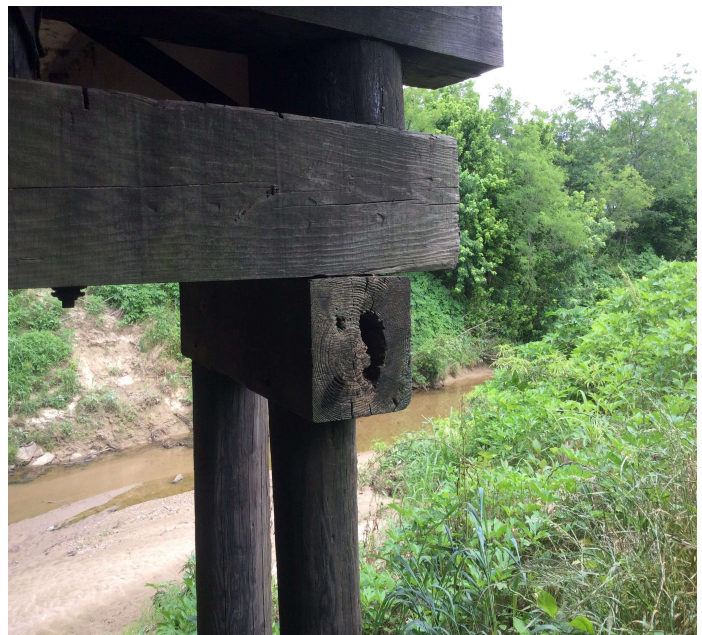
Timber girders

Span 1 bent 1 girders 5 and 6 are decayed and partially hollow at end.

Span 2 girders 1 and 15 have some decay and checking throughout.

Span 2 bent 3 girder 1 is decayed and partially hollow for 2' on end

Span 4 bent 4 girder 4 has some decay and is partially hollow on end.

Span 4 bent 4 girder 15 is decayed and rotted with some crushing.

Span 5 bent 5 girder 6 has some decay on end.

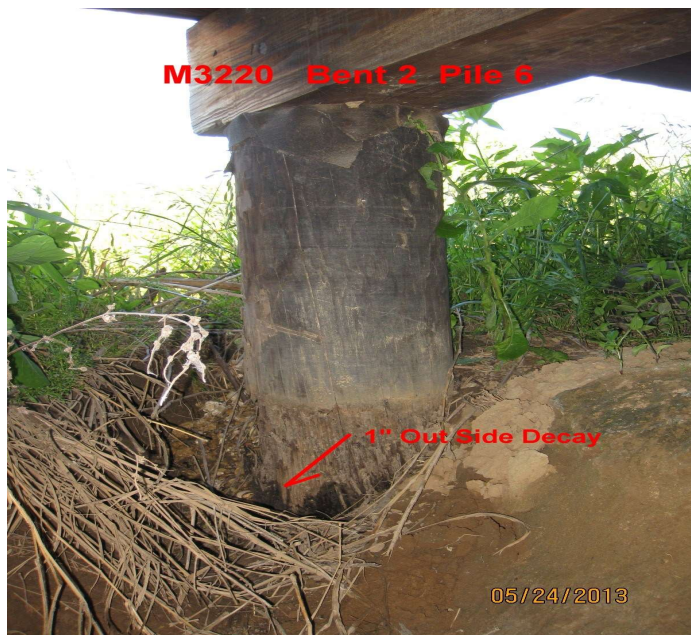
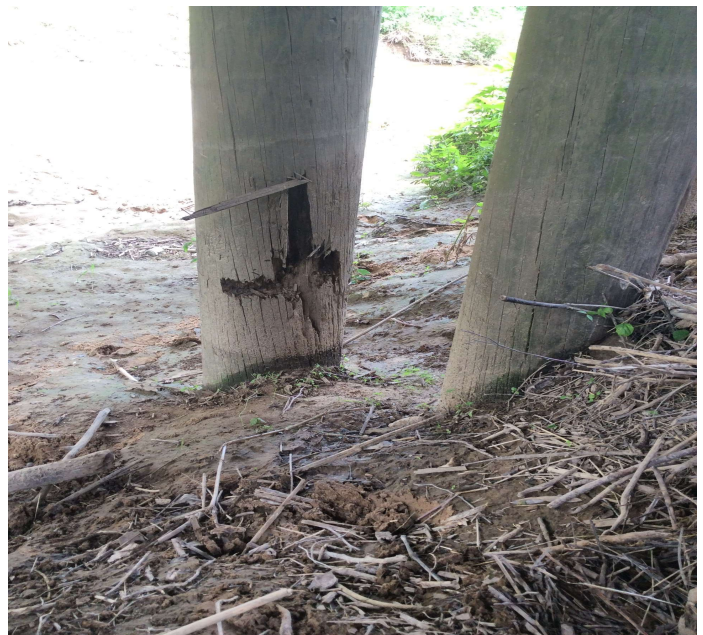
Bent 1 pile 2 has 1/2" of outside decay near ground line.

Bent 1 pile 6 has 3" of outside decay near ground line.

Bent 2 pile 1 has 1/2" of outside decay near ground line.

Bent 2 pile 6 has 1" of outside decay near ground line.

Bent 3 pile 4B has 2" of outside decay and is partially hollow near ground line.

Bent 3 pile 4A has some outside decay and is partially hollow

Bent 4 pile 5B has 1" of outside decay at ground line.

Bent 4 pile 6B has outside decay and checking.

Bent 6 piles 1 – 4, and 6 have up to 1" of outside decay near groundline.

Bent 6 pile 2 has up to 2" of outside decay near groundline.
