Bridge Inspection Report

M3818

SH 34-04- LM 12.09

BIG SLOUGH DITCH

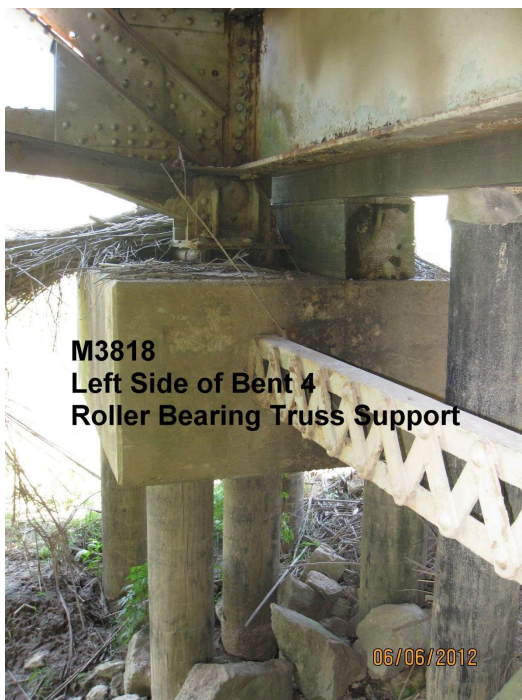
PHOTO 1

**M3818
Left Side of Bent 4
Roller Bearing Truss Support**

Description M3818 Left Side of Bent 4 Roller Bearing Truss Support 6-6-2012

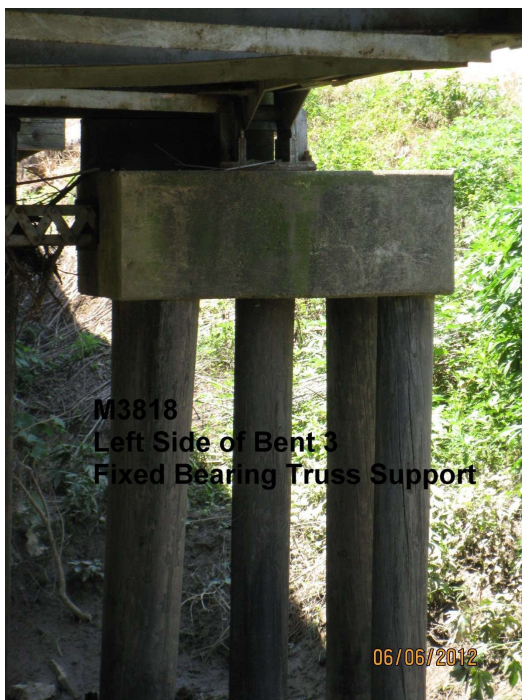
PHOTO 3

Description M3818 Left Side of Bent 3 Fixed Bearing Truss Support 6-6-2012

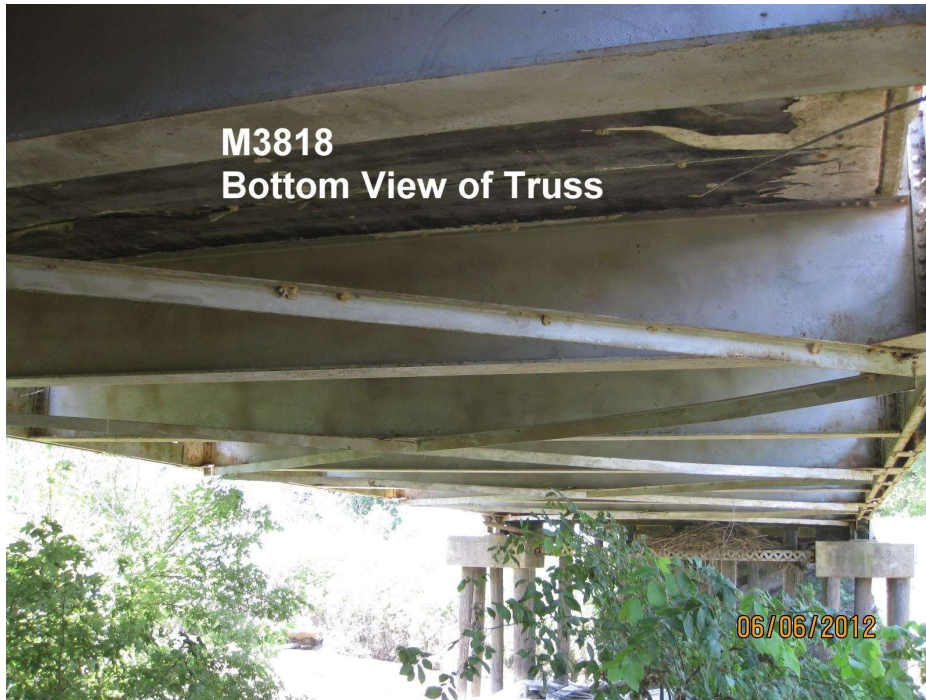
PHOTO 4

Description M3818 Bottom View of Truss 6-6-2012

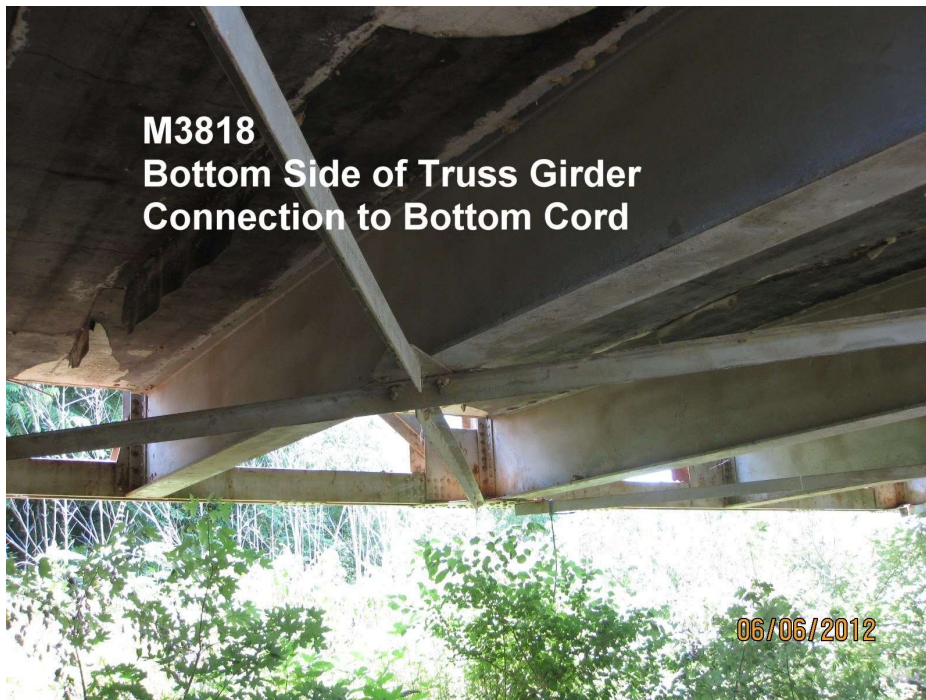
PHOTO 5

Description M3818 Bottom side of Truss Gr connection to bottom cord 6-6-2012

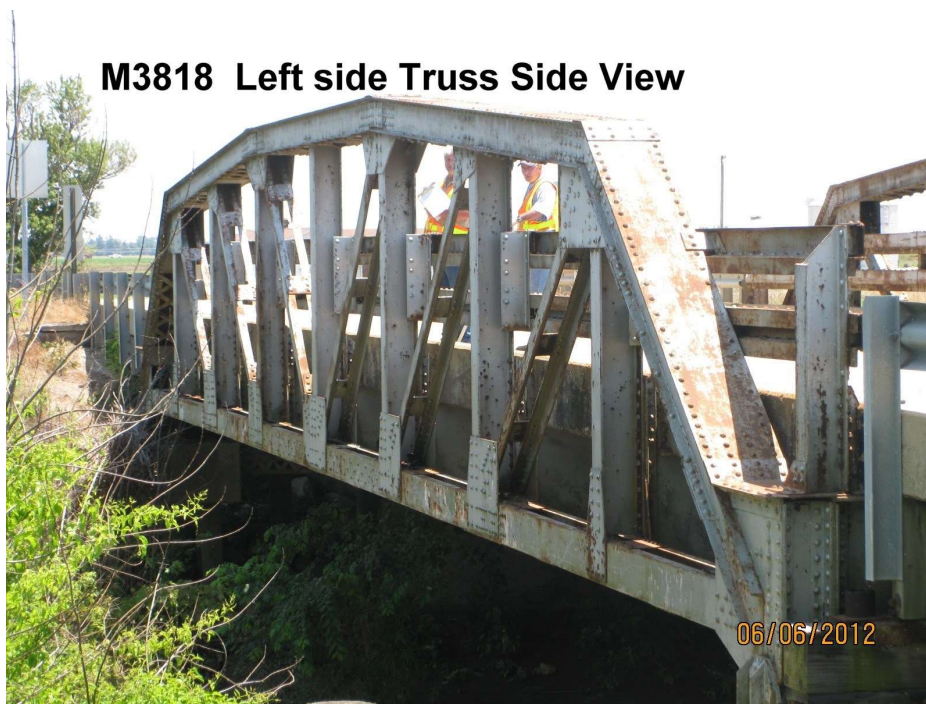
PHOTO 6

Description M3818 Lt side truss side view 6-6-2012

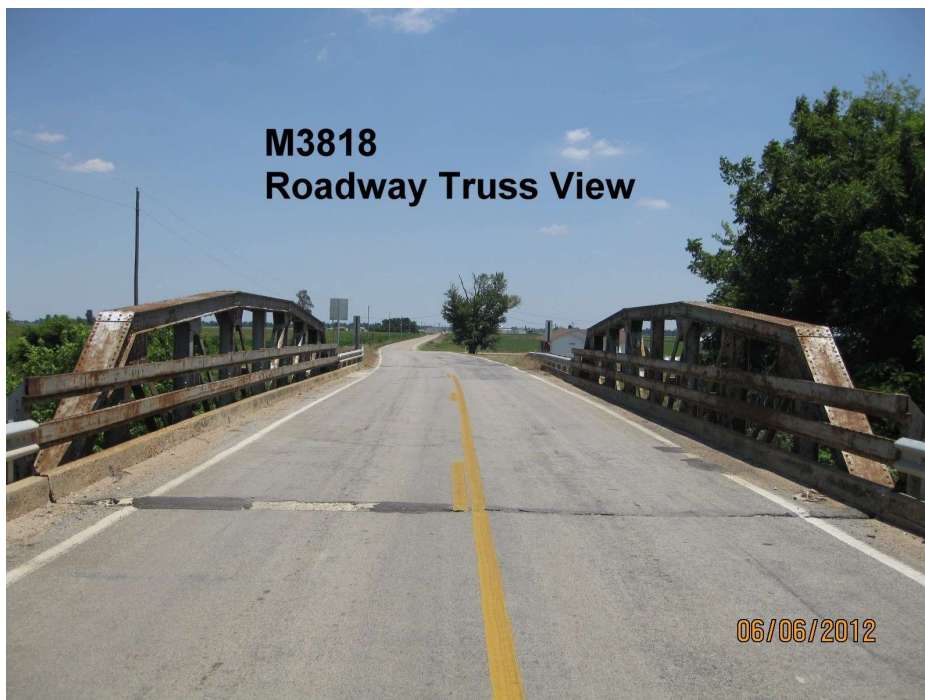
PHOTO 8

Description M3818 Roadway view of truss 6-6-2012

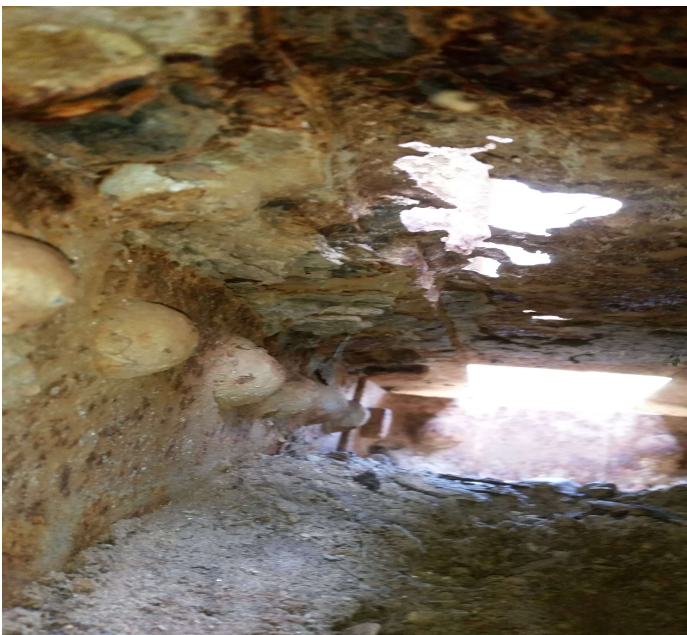
PHOTO 1 Description

L6 Lt - lower chord batten plate has section loss with several holes rusted through. Lower chord has debris buildup inside. Top flange of interior channel of lower chord has section loss

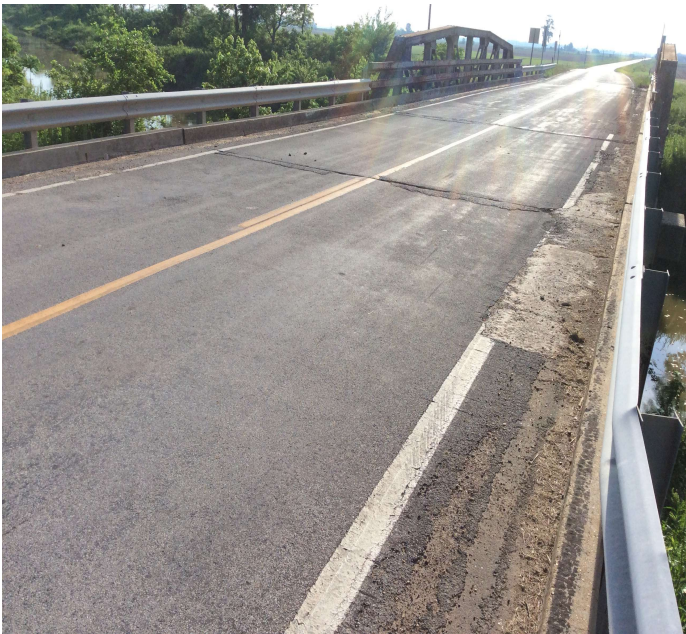
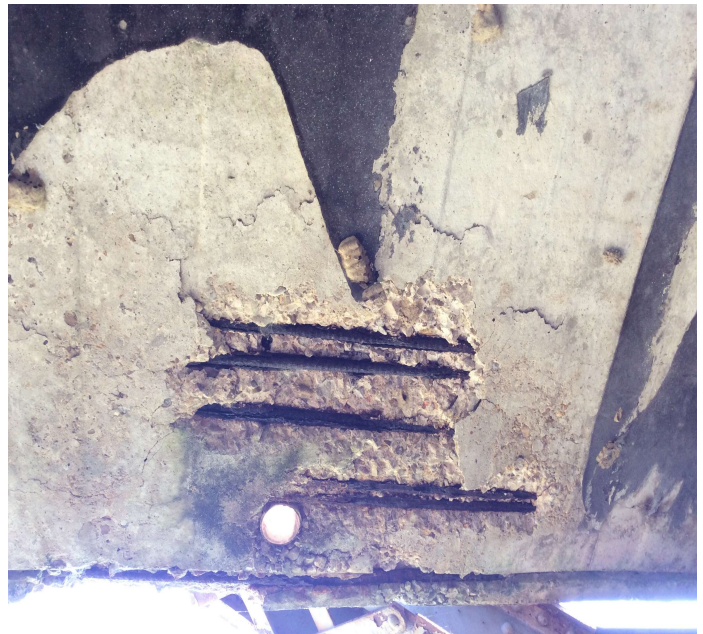
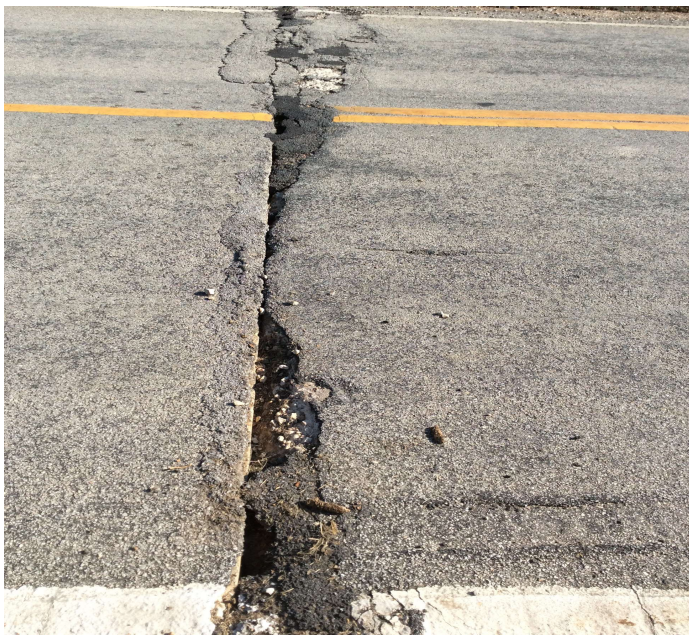
Deck and wearing surface have delaminated areas and/or spalls along joints.
Gutter lines have areas of abrasion, patches, and some spalled areas.
Soffit has a few spalls with exposed rebar, especially at drain openings.

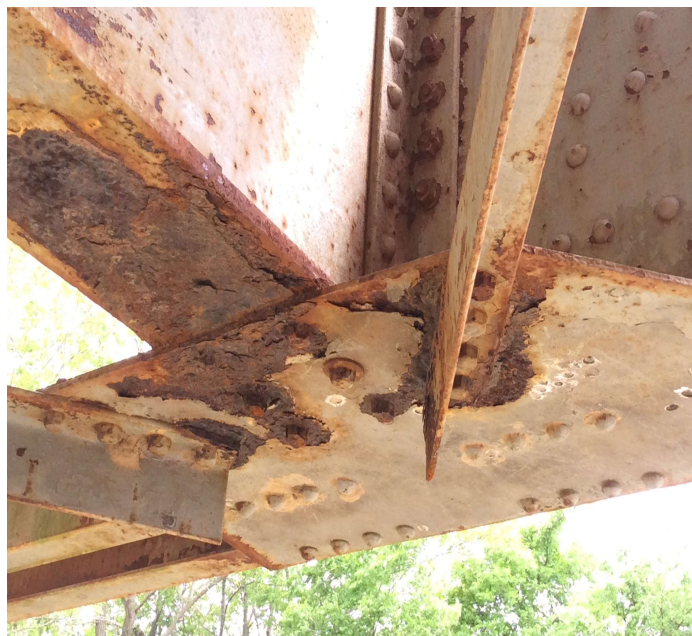
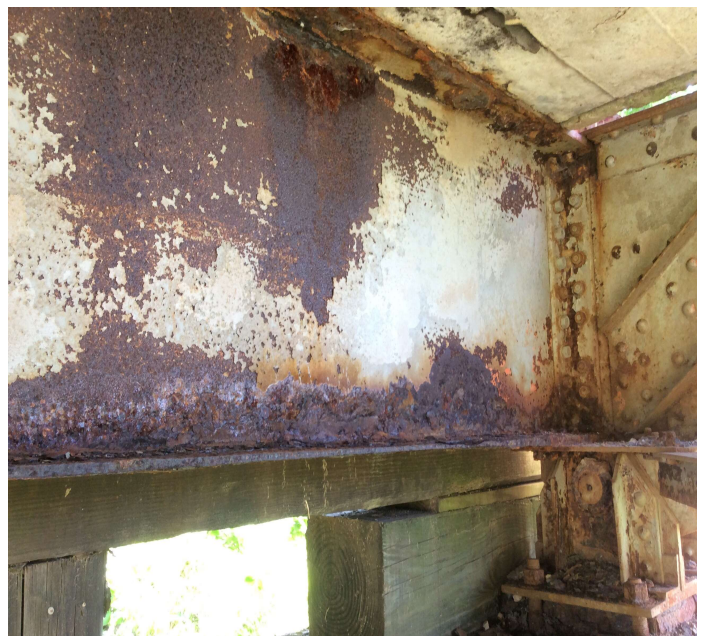
Floorbeam and lower lateral connections have pack rust and section loss around bottom flange. Several bolts and/or rivet heads have heavy section loss at these locations.

L8 floor beam has 3.5' of moderate section loss along bottom of web and bottom flange on Rt end. Bottom flange is knife edged for 1'.

replacement project fall 2018 KAW 6/15/18

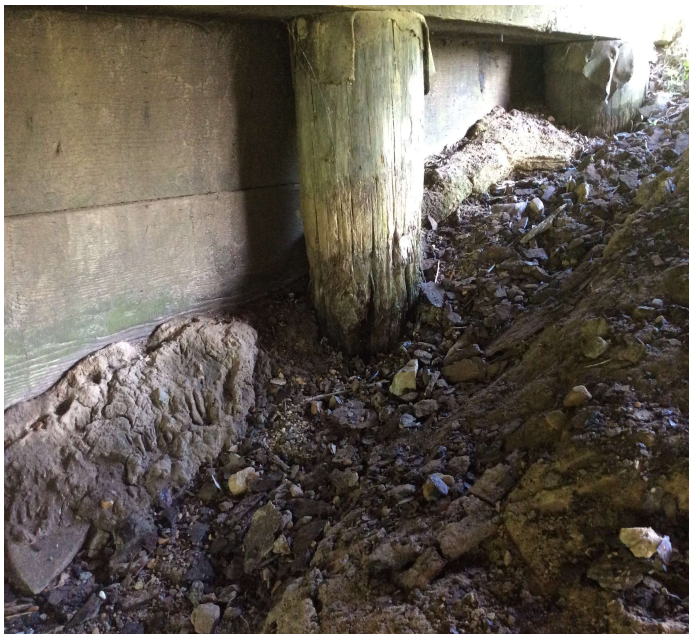
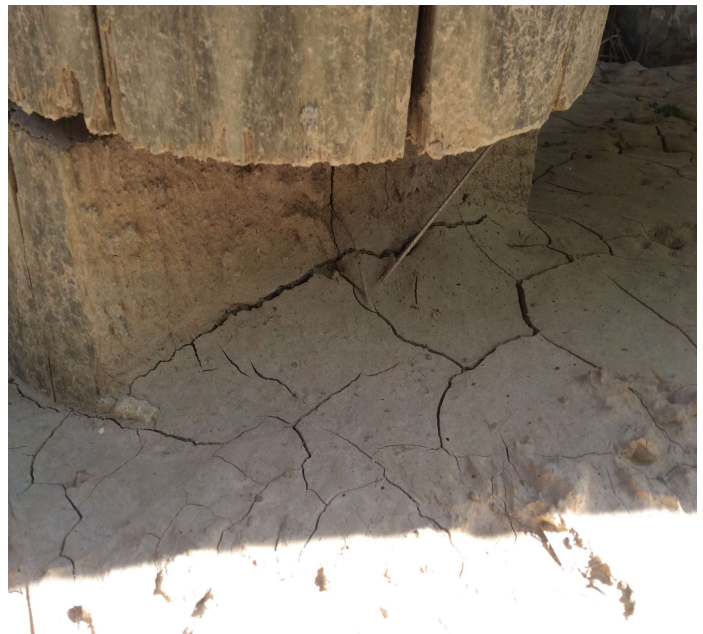
Bent 1 piles 1, 2, and 5 have moderate outside decay near groundline. (up to 1")

Bent 4 piles 9B and pile 10 under right concrete cap has been replaced with new pile splice, 1" – 3" outside decayed below splice still exist, see 2017 photo of pile 9B.

Bent 4 pile 11A has been spliced, but has a 2" section cut out on Rt side.

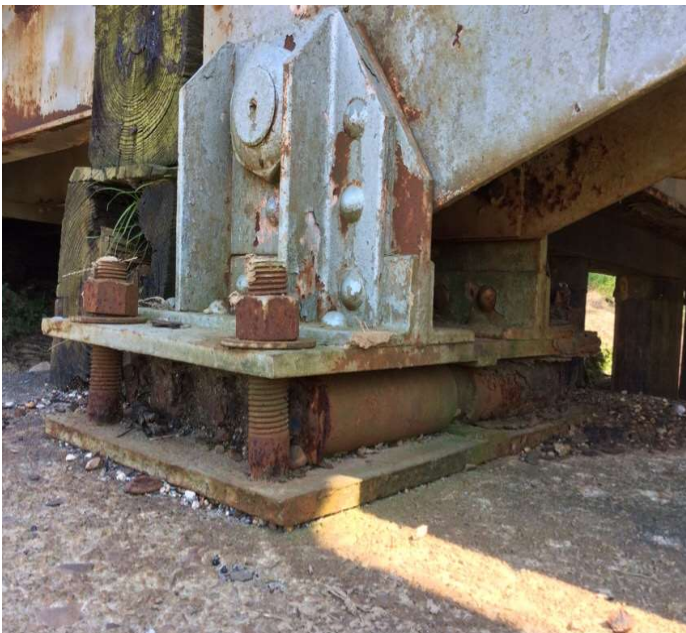
PHOTO 1 Description

Truss Bearings have heavy pack rust and are frozen from corrosion.

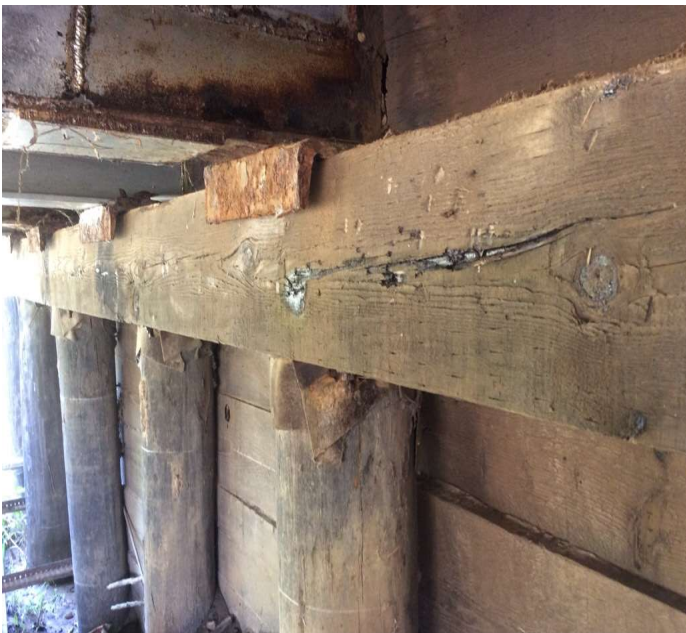
PHOTO 1 Description

Bent 1 cap is decayed and partially hollow; beginning to show some crushing from pile 3 to pile 7.

will continue to monitor - replacement project in fall 2018 KAW 6/15/18

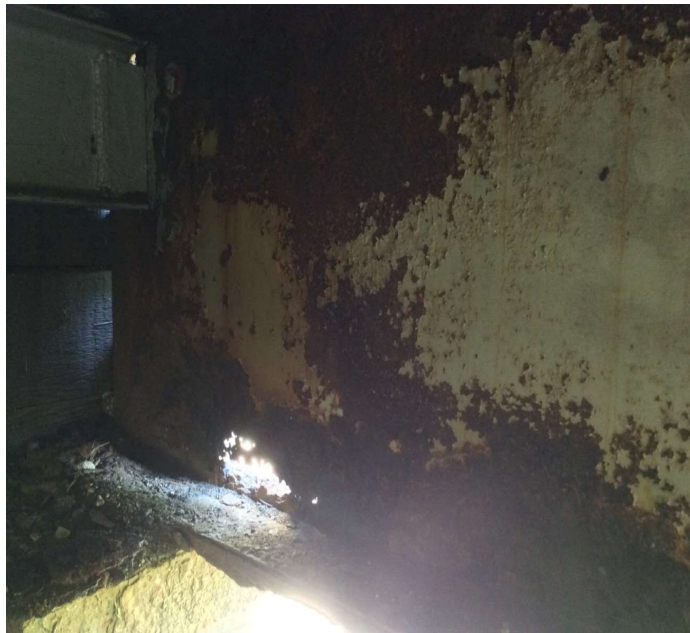
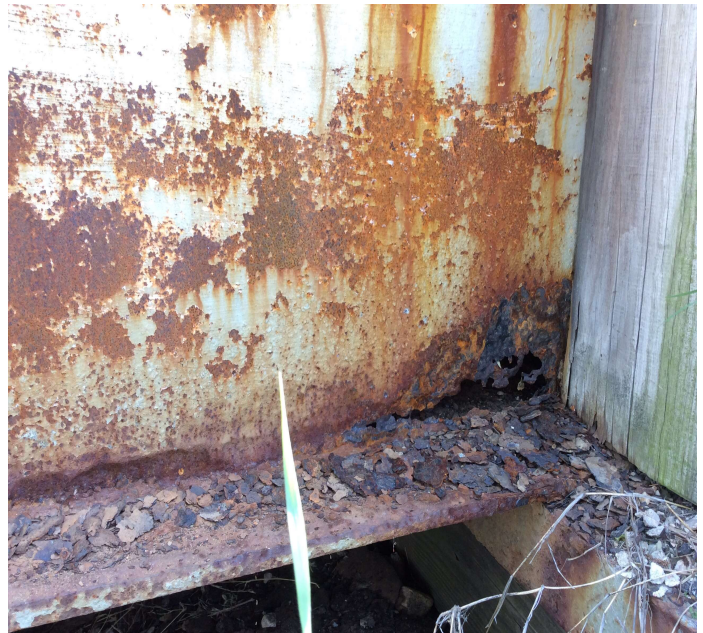
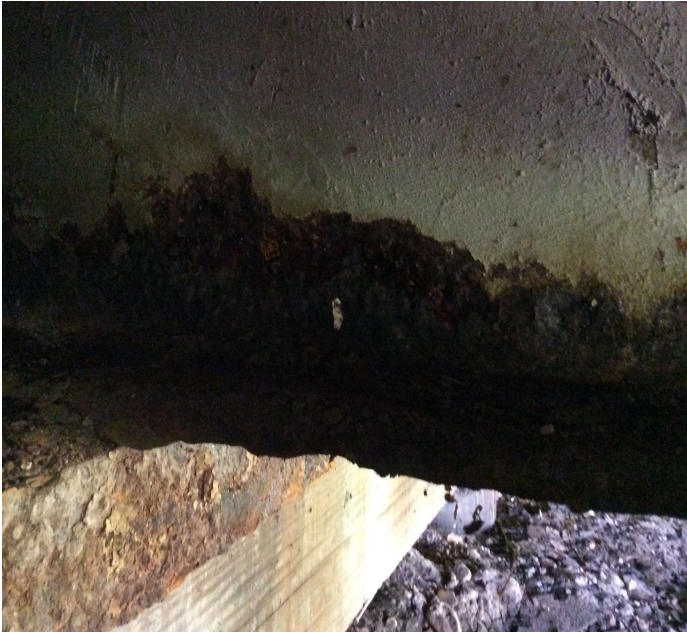
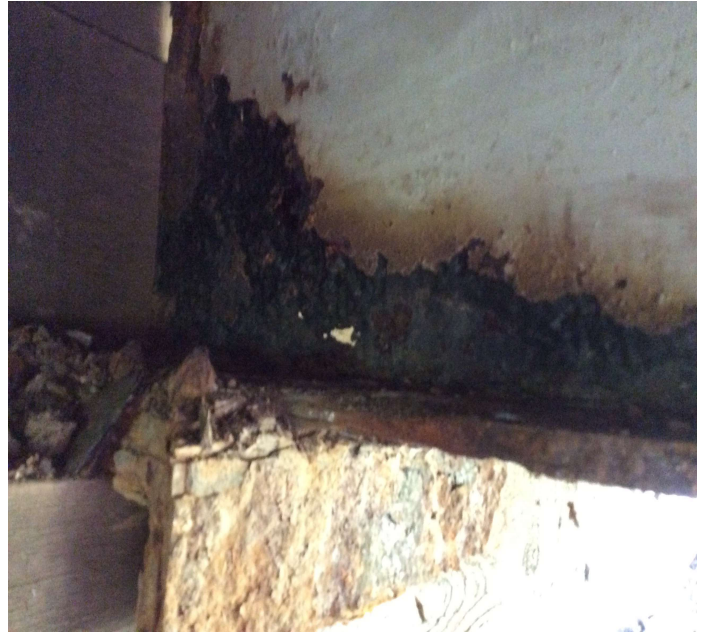
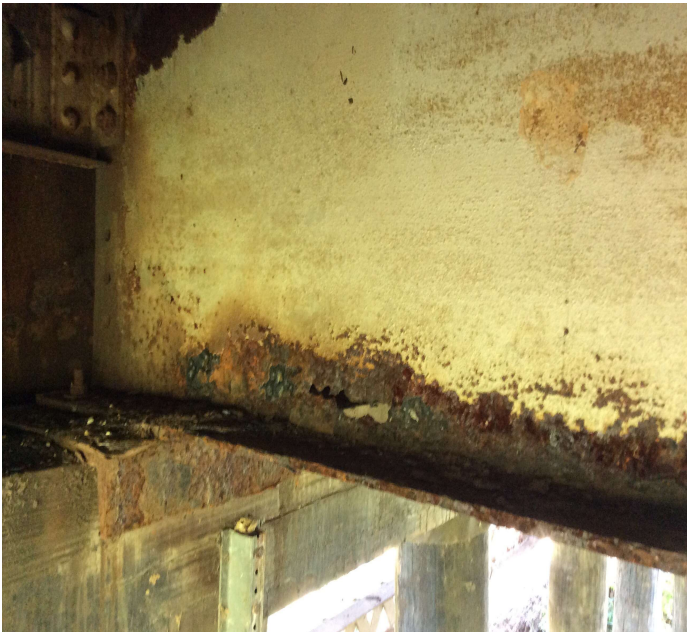
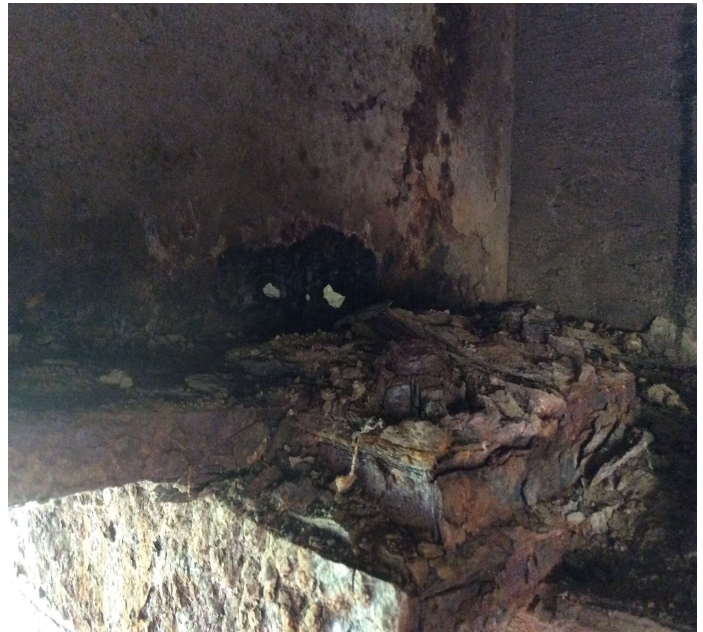
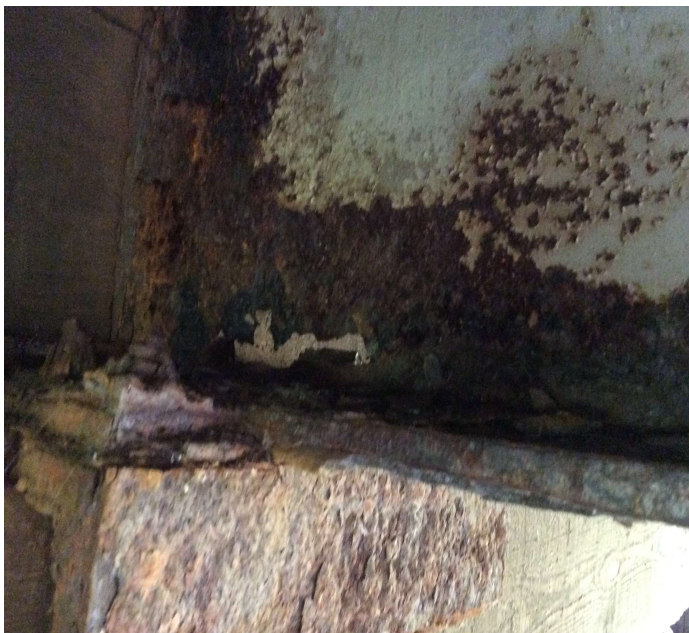
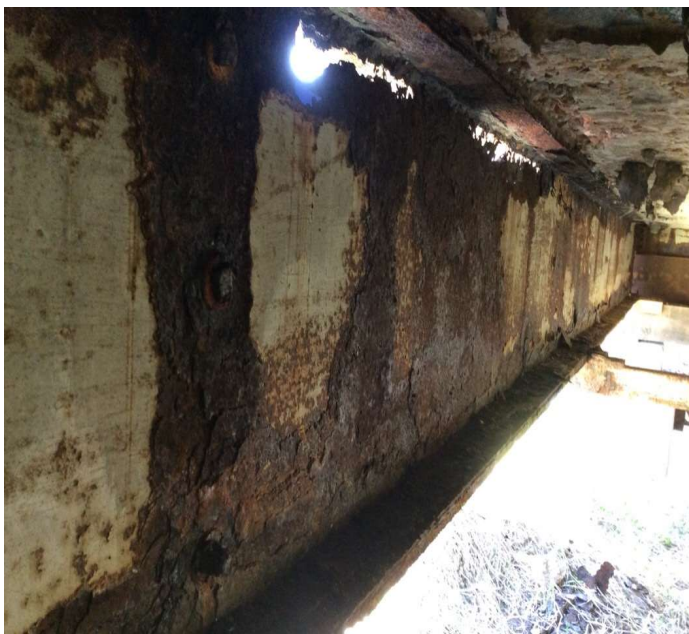
Span 1 bent 1 girder 2 has a 3.5' x by up to 8" area of moderate to heavy section loss along bottom of web with a 3" x 1" hole 9" from end of girder.

Span 1 bent 1 girder 3 has a 3' x up to 4" area of section loss along bottom of web with a 9" x 1.5" hole 4" from end of girder.

Span 1 bent 1 girder 6 has a 4" x 1" hole in bottom of web.

Span 4 bent 4 girder 5 has 2' of heavy section loss along bottom of web with a 9" x 1" hole 20" from end of girder.

Span 4 bent 5 girder 2 has 1.5' of heavy section loss with a 1" diameter hole 18" from end of girder.

Span 4 bent 5 girder 7 has a 10" x up to 3" hole in bottom of web 10" from end of girder.

bridge crew busy on other projects at this time, will continue to monitor and schedule repairs later

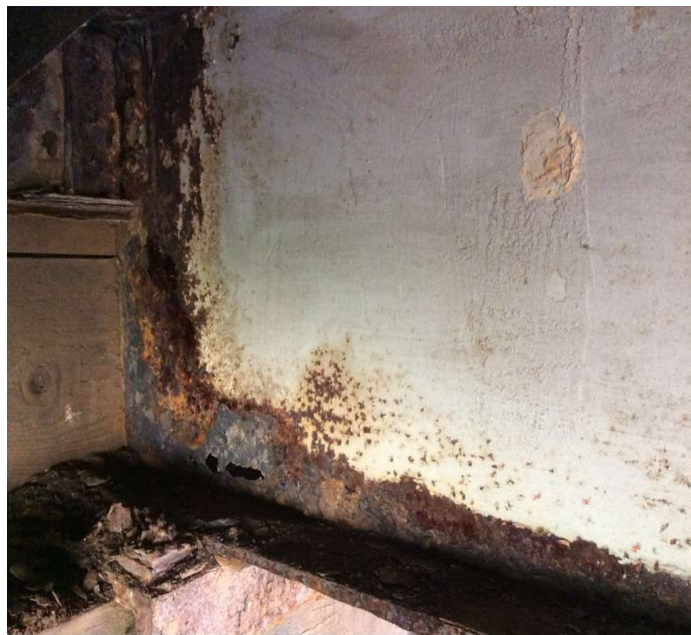
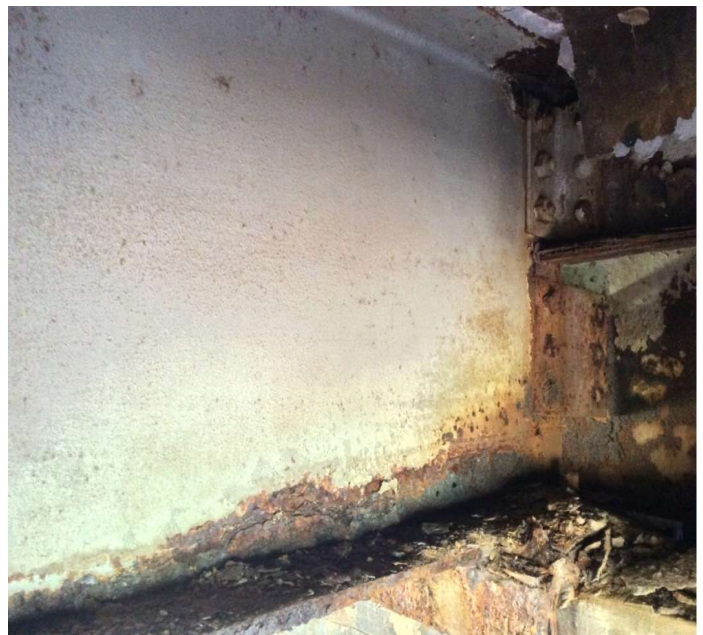
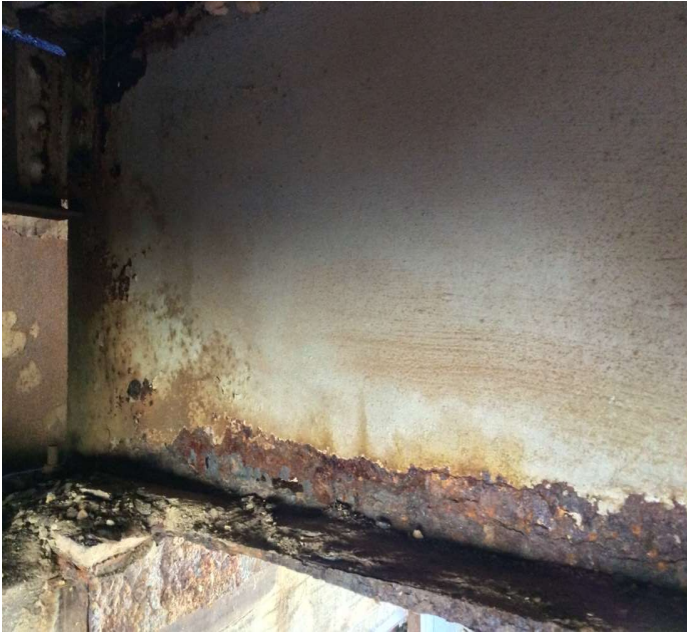
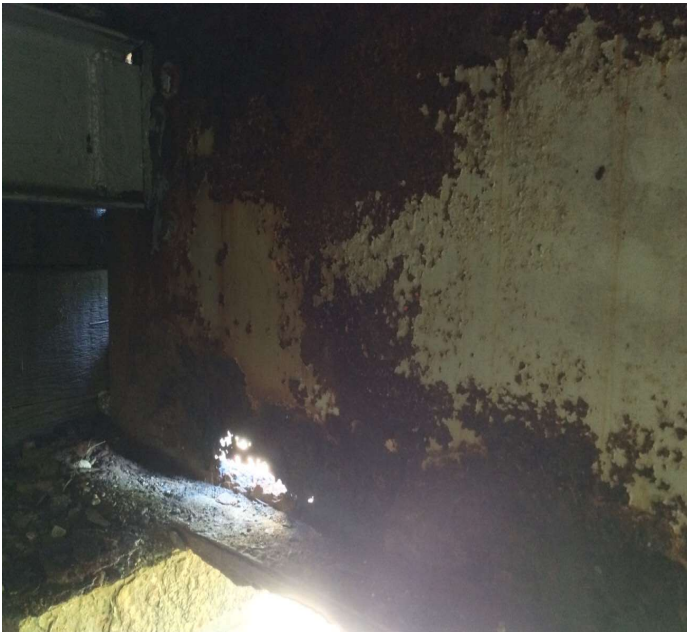
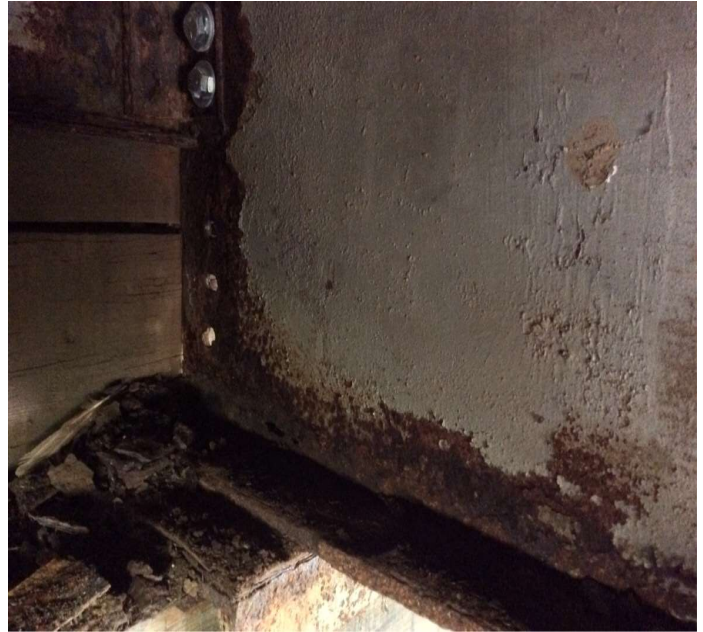
Span 1 bent 2 girder 1 has 4' of flaking rust with initial section loss.

Span 1 bent 2 girder 6 has 6' of moderate section loss along bottom flange.

Span 4 bent 4 girder 1 has 4' of moderate section loss along bottom of web and bottom flange. Bottom flange is beginning to knife edge.

Span 4 bent 4 girder 6 has 2' of moderate section loss along bottom of web and bottom flange.

Span 4 bent 5 girder 1 has 3' of moderate to heavy section loss along bottom of web and bottom flange. Bottom flange is knife edged.

Span 4 bent 5 girder 3 has 4' of moderate section loss along bottom of web.

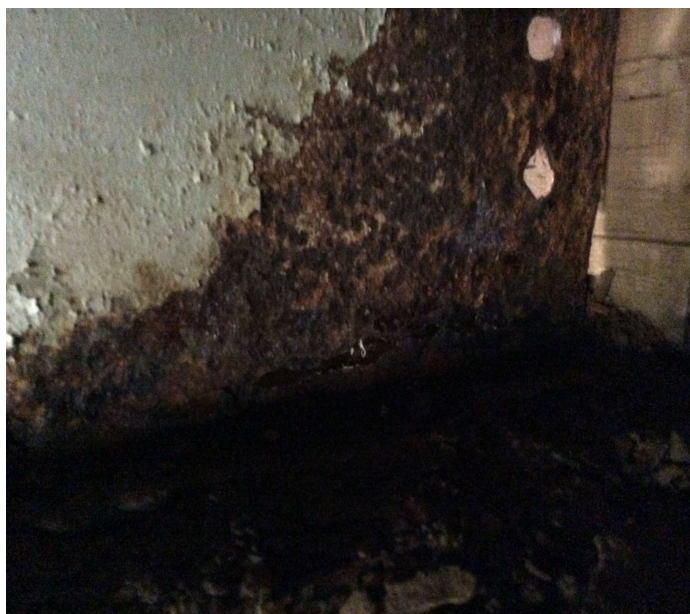
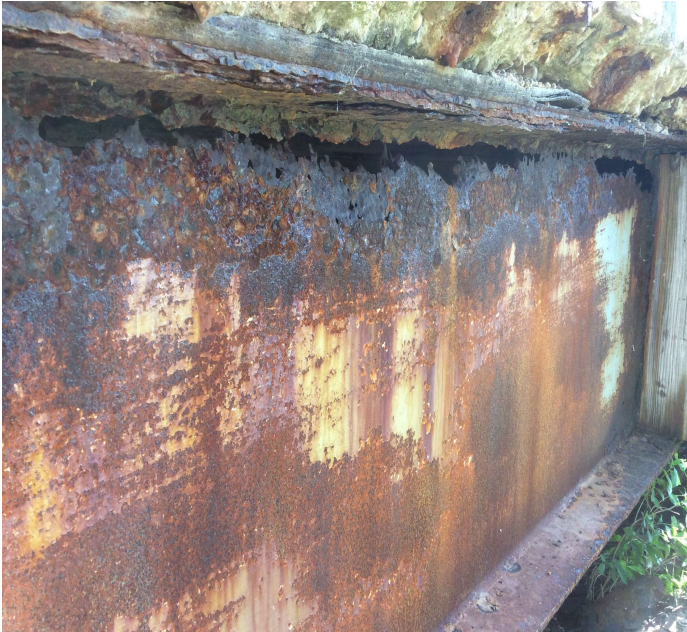
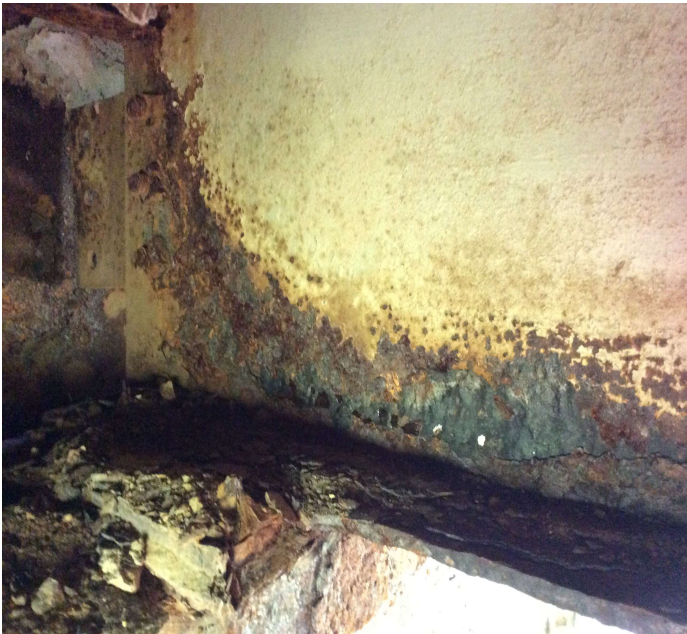
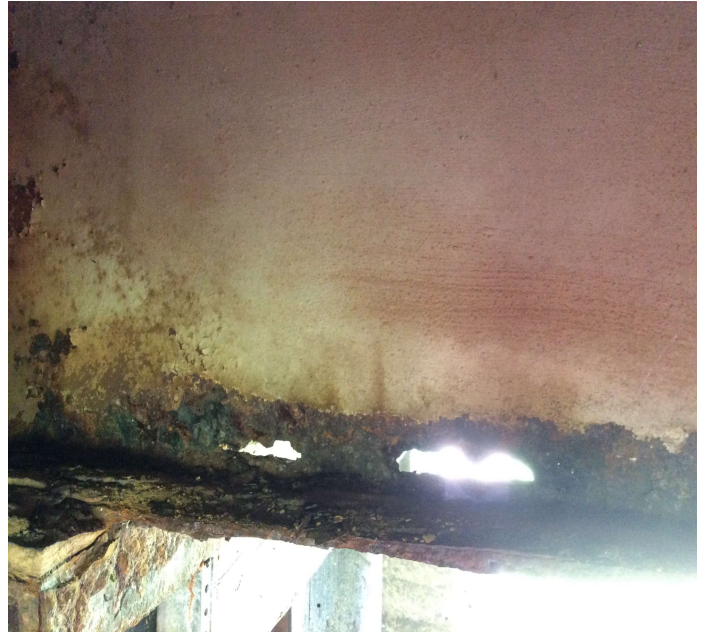
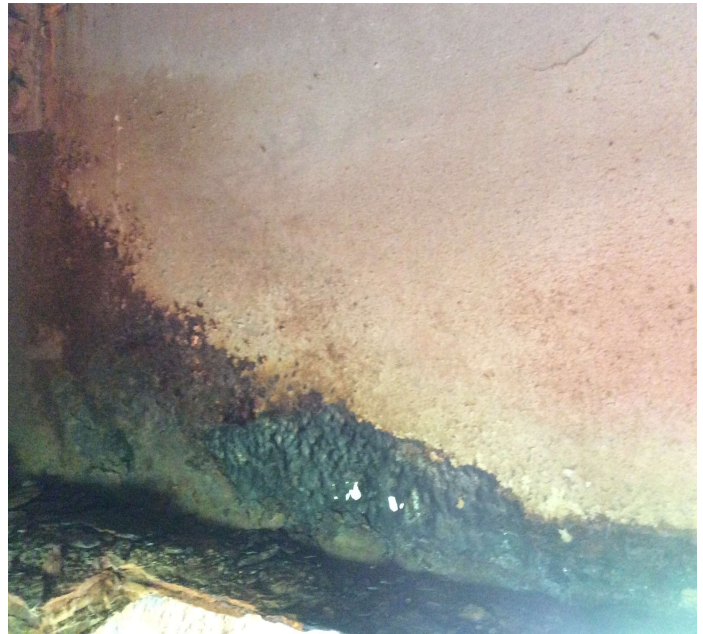
Span 4 bent 4 girder 2 has 2.5' x up to 4" of heavy section loss with a 1.5" x 1" hole 32" from end of girder, and a few small pin holes 20" from end. Web has some crushing ahead of bearing.

Span 4 bent 4 girder 3 has a 3' area of heavy section loss to bottom of web with a 18" x 1" hole 11" from end of girder with some possible crushing. Top of web near diaphragm connection has a pin hole rusted through web. Bottom flange has some knife edge.

Span 4 bent 4 girder 4 has 2' of heavy section loss along bottom of web with a 10" x 1" hole 9" from end of girder.

Span 4 bent 4 girder 7 has 5.5' moderate to heavy section loss along bottom of web and bottom flange. Bottom flange is knife edged. Web has heavy section loss with some possible crushing. Top of web near diaphragm connection has a 3" x 2" hole.

Top of web near midspan has a 14" x up to 4" hole through web.

Top of web near ¾ point has a 15" x 9" tall area of heavy section loss with several small holes rusted through.

Span 4 bent 5 girder 4 has a 7.5" x 1" hole in bottom of web 3" from end of girder. Web is beginning to crush.

Priority moved from CF to A based on bridge rated on 6/11/2018 considering current condition. Bridge scheduled for replacement 9/2018.

Will continue to monitor, but not able to schedule repairs at this time due to other priorities. KAW 6-15-18
