Bridge Inspection Report

03813
SH 53 S-0 LM 16.36
over
I 30Sec14 Log62.84

Structure Number: 03813

Facility Carried: SH 53 S-0 LM 16.36

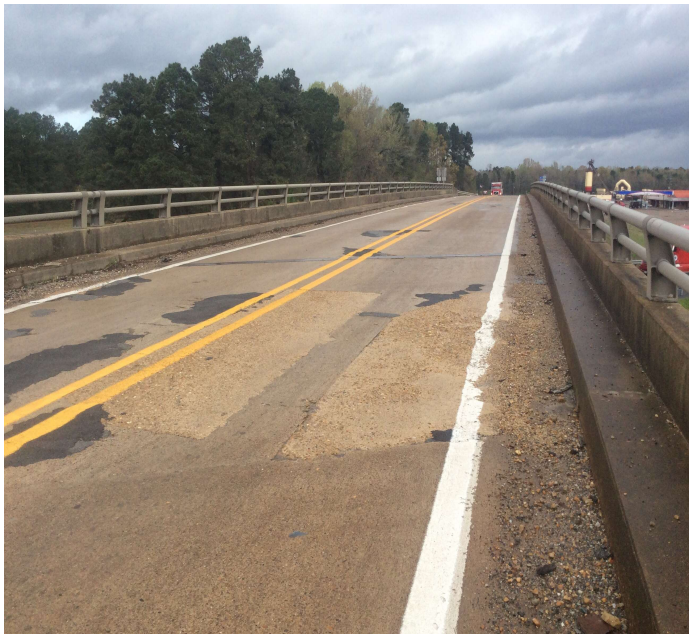
Deck - All spans

Numerous shelled and pitted areas. Several patched potholes are losing bond, also numerous sealable cracks
03/29/2018 JPR -- Span 1 has numerous potholes that have been patched with cold mix.

PHOTO 1 Description Deck, span 4 both lanes, with the worst being in the south bound Rt. lane.

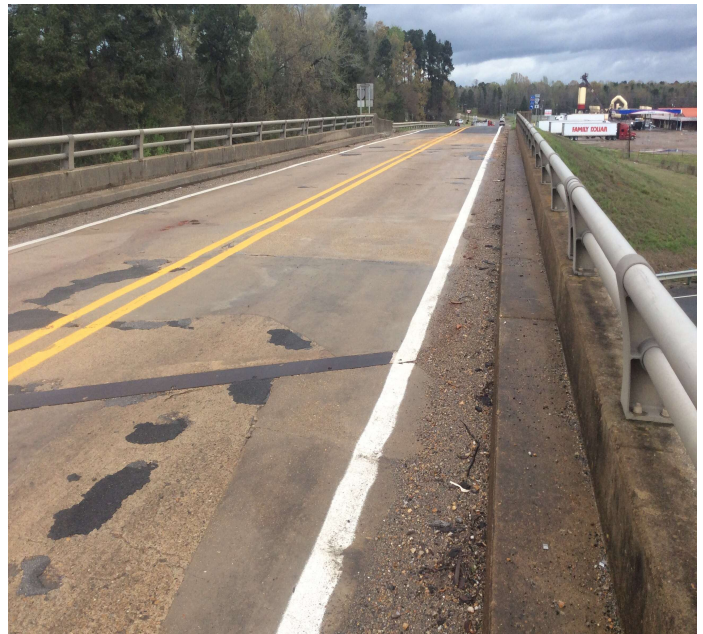
PHOTO 2 Description Deck, Spans 1 & 2, looking north against log, have numerous pot holes that are patched with cold mix both lanes.

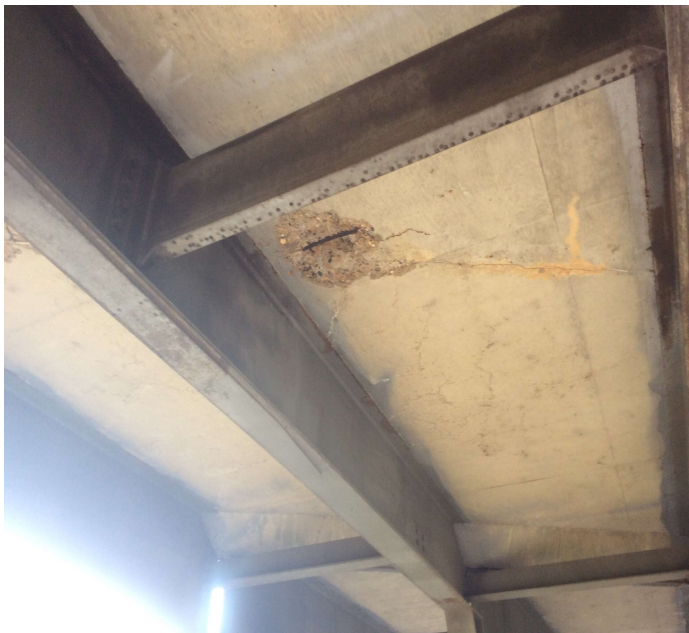
Spalls in deck soffit @ construction joints of Spans 1 & 4, with exposed steel.

PHOTO 1 Description Spall in Soffit span 1 @ construction joint.

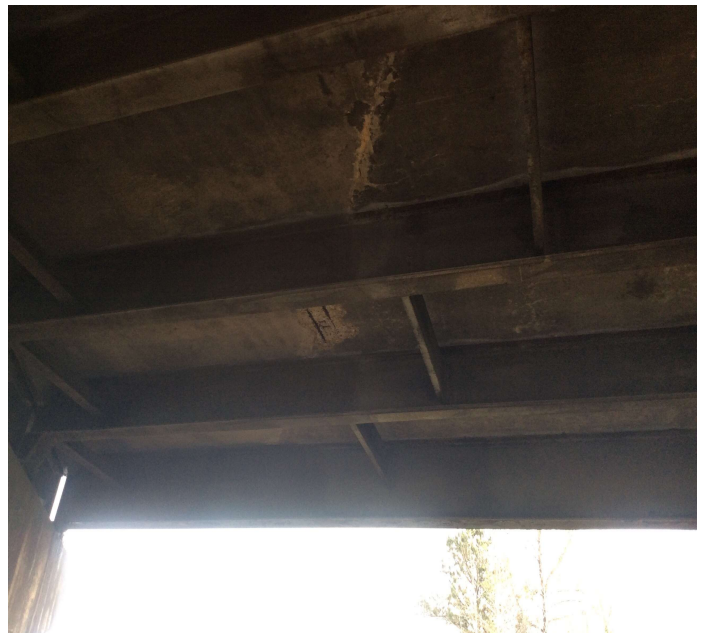
PHOTO 2 Description Spall in Soffit span 4, @ construction joint
