Bridge Inspection Report

06021

US 67SB-18-LM 7.37

BLACK RIVER

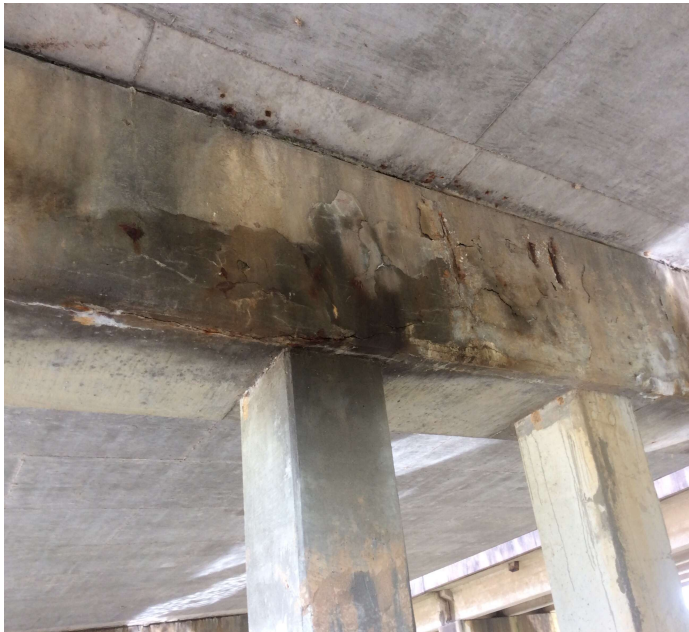
PHOTO 1 Description

Majority of caps at slab spans have rust stained cracks, delaminated areas and/or spalls with rebar exposed. See 2016 photos.

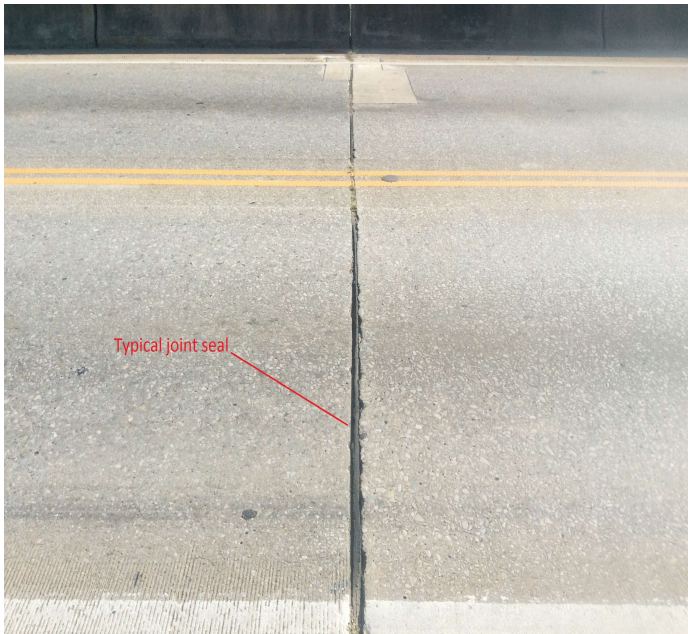
PHOTO 1 Description

Poured joint seals are deteriorated, separated from slabs and leak with some sections missing at bents 1 – 17, and 23 – 28.

Compression seals are torn and split at bents 18 – 22.

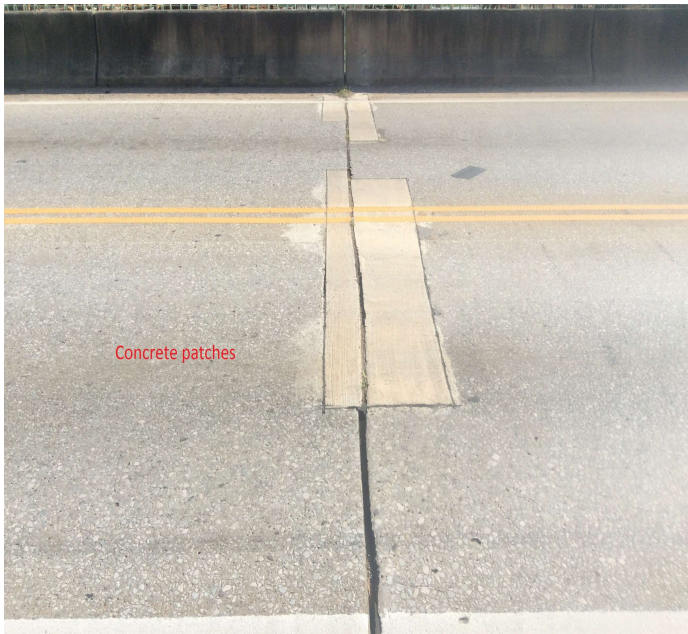
PHOTO 1 Description

Deck has several spalls and concrete and asphalt patches along joints at several spans: 1, 2, 3, 5, 6, 9, 11, 12, 13, 14, 22, 24, 25 & 26. (patches are in good condition with insignificant cracks) Repairs made as part of job # 100759, repairs began 06-21-2016.
