# Bridge Inspection Report

06022

US 67SB-18-LM 7.23

BLACK RIVER RELIEF

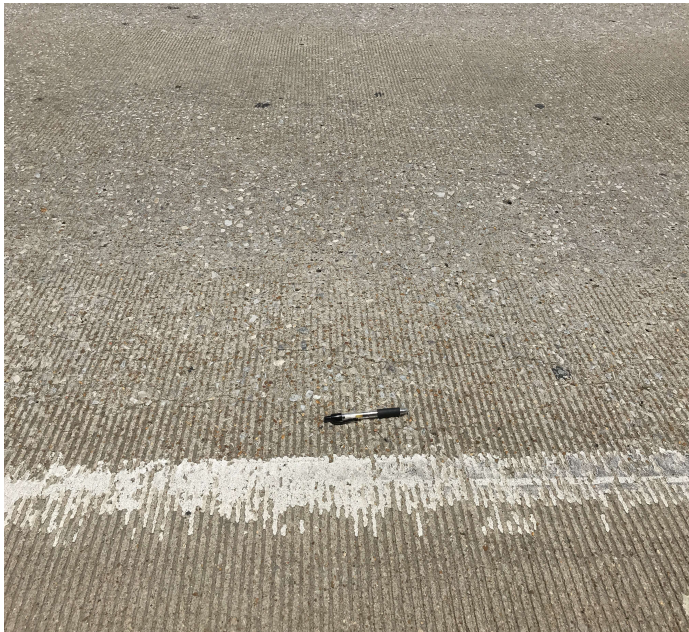
Top of slab has unsealed longitudinal and map cracks in wheel path at all spans.  
Top of slab has abrasion throughout.

PHOTO 1      Description      Deck cracks

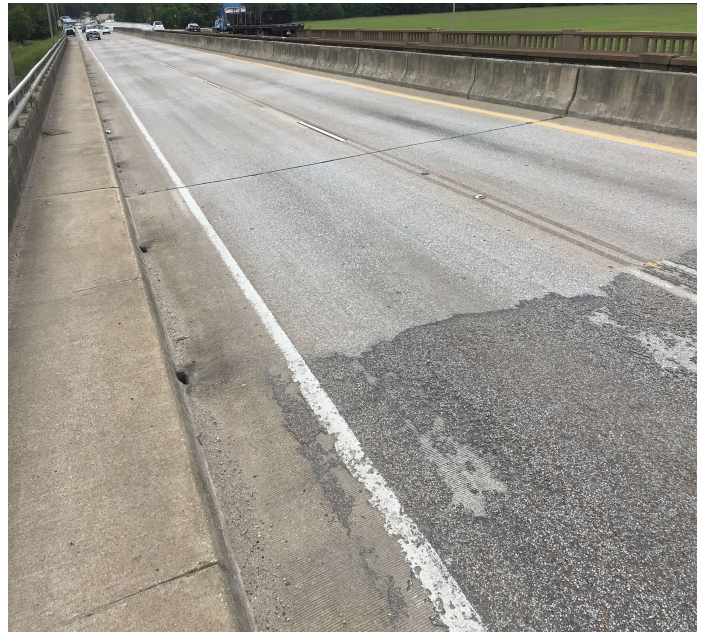
PHOTO 2      Description      Overall view of deck

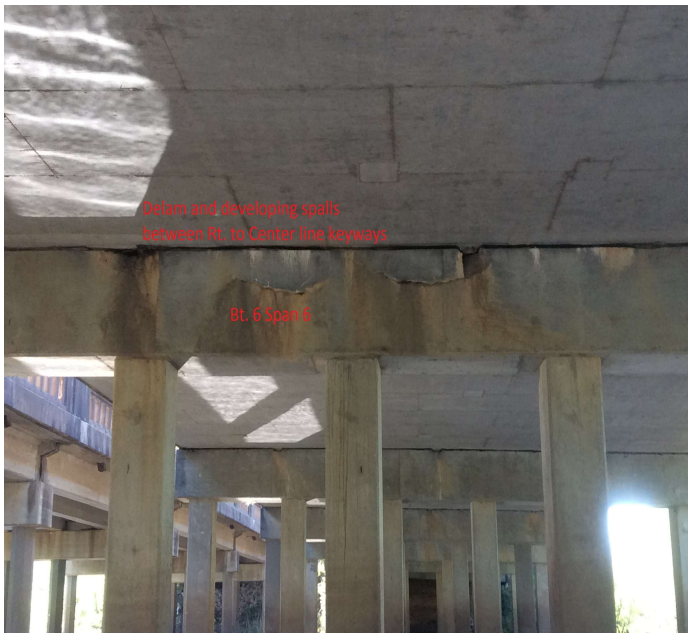
PHOTO 1 Description

Caps have several cracks with efflorescence and/or rust stains, delaminated areas, and spalls with some rebar exposed.

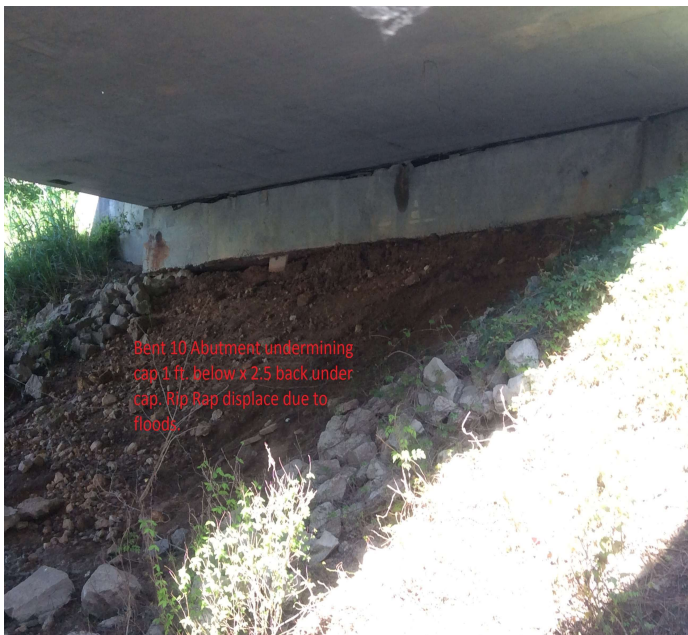
PHOTO 1 Description

Bent 10 abutment has 15' undermined with 2 piles exposed on Lt end. Abutment is undermined up to 1' below and 2.5' back under. Some rip rap displaced on slopes.

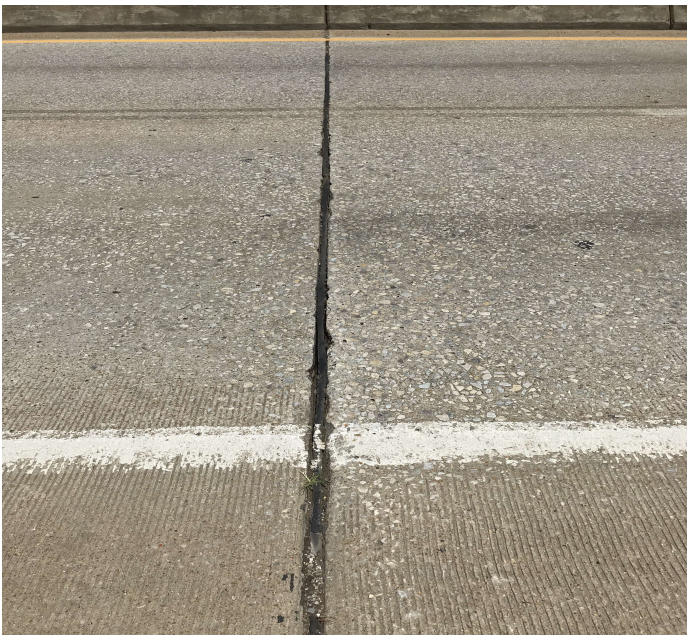
Poured joints are torn, deteriorated, and leak.

PHOTO 1    Description    Typical joint

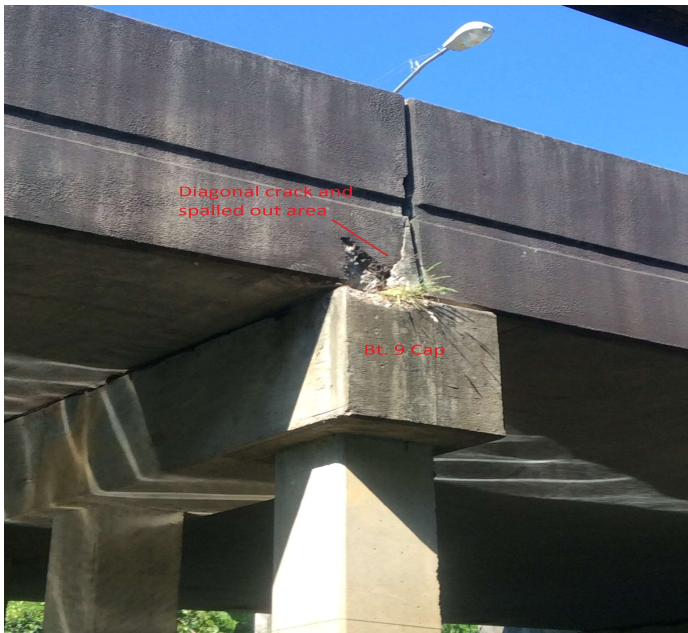
PHOTO 1 Description

Span 8 Rt edge of slab has diagonal crack and spall out area , See photo 2017
