# Bridge Inspection Report

**03164**  
**SH 239-01- LM 2.76**  
**over**  
**I 55-SEC 12**

IDENTIFICATION		INSPECTIONS	
(1) STATE CODE	056 - Arkansas	(90) INSPECTION DATE	10/16/2018
(8) STRUCTURE NUMBER	03164	(91) DESIGNATED INSPECTION FREQUENCY	24

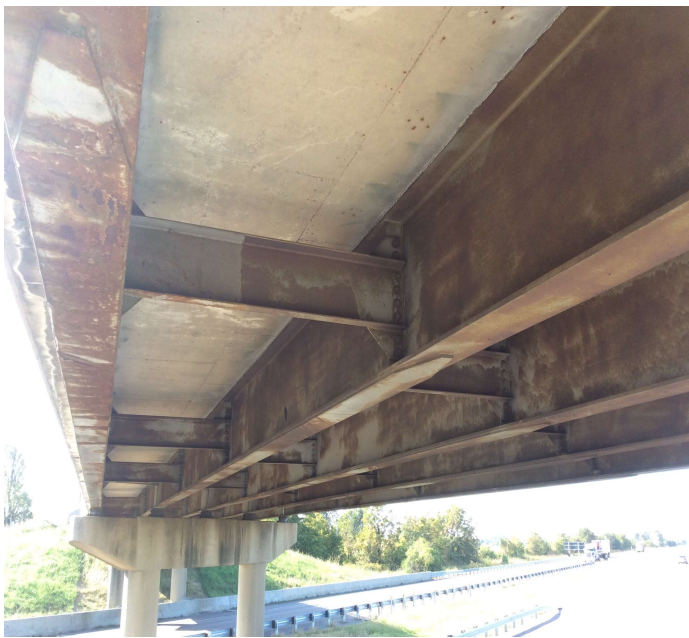
PHOTO 1      Description

Steel Girders have 70% paint deterioration and rust with pitting, see 2016 photo.  
Ends of Girders near concrete haunch has initial section loss.

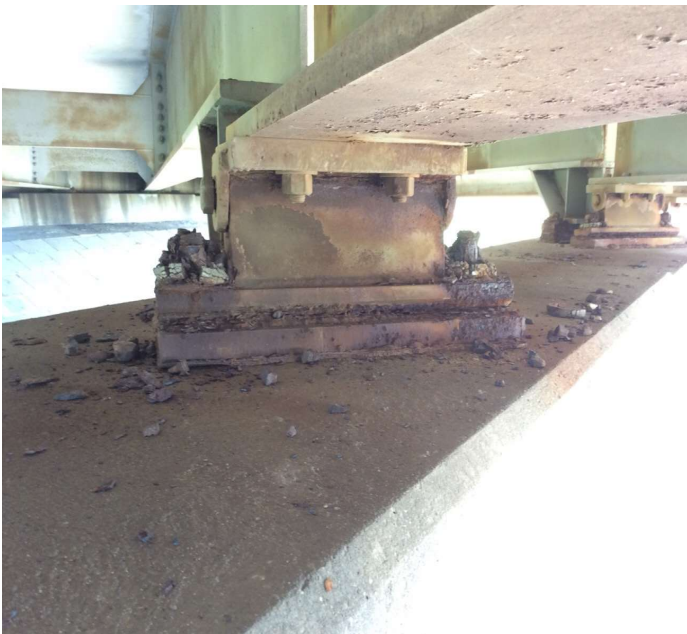
PHOTO 1 Description

Majority of Bearings are rusted with initial loss of section and some pack rust, see 2016 photo.  
Majority of Anchor Bolt Nuts are rusted with up to 100% loss of section, see 2016 photo.

Span 1 Bearing 3 Bent 1 has one anchor bolt nut missing.

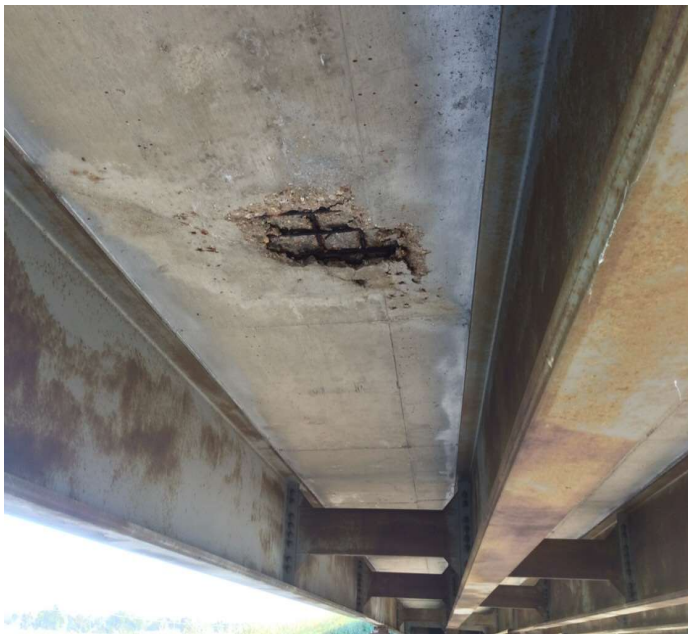
PHOTO 1      Description

Top of Concrete Deck has several minor to moderate unsealed cracks, spalls with exposed rebar and patches, see 2018 photo of span 4.

Bottom of Deck has some cracks with efflorescence, delamination and some spalls with rebar exposed, see 2016 & 2018 photo Span 3 Bay 1.

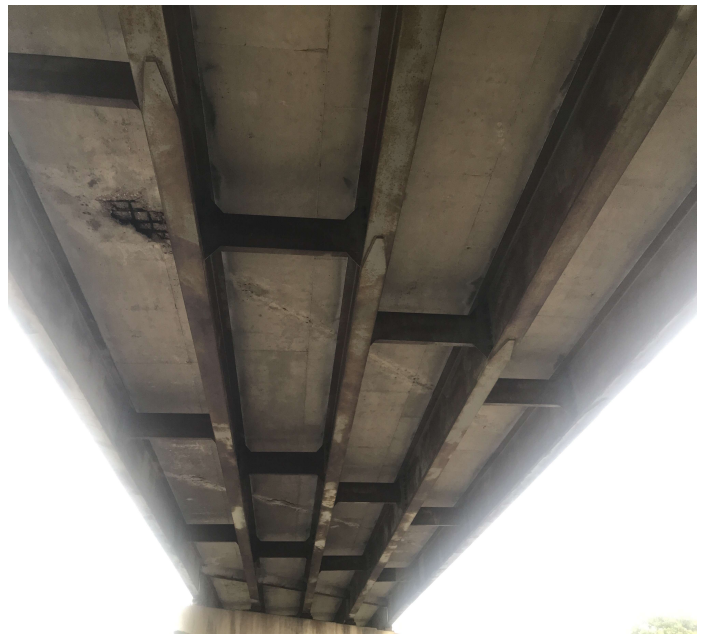
PHOTO 2      Description      Span 3 soffit

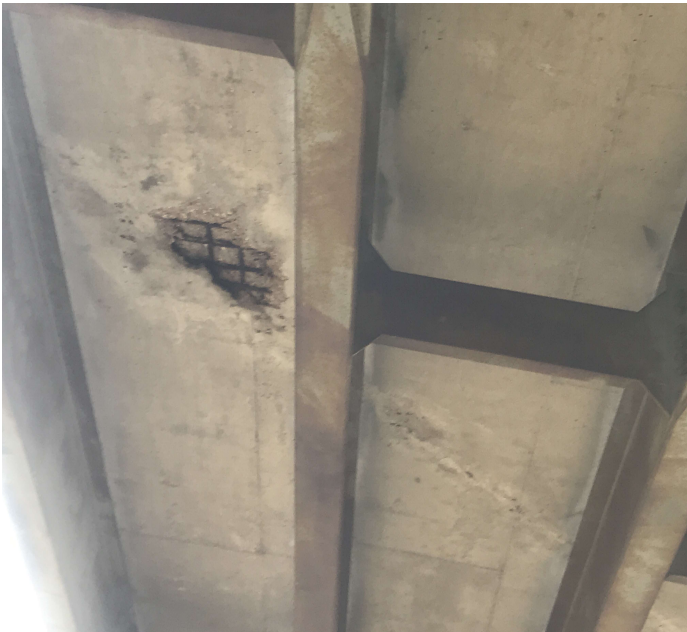
PHOTO 4 Description Span 3 bay 1

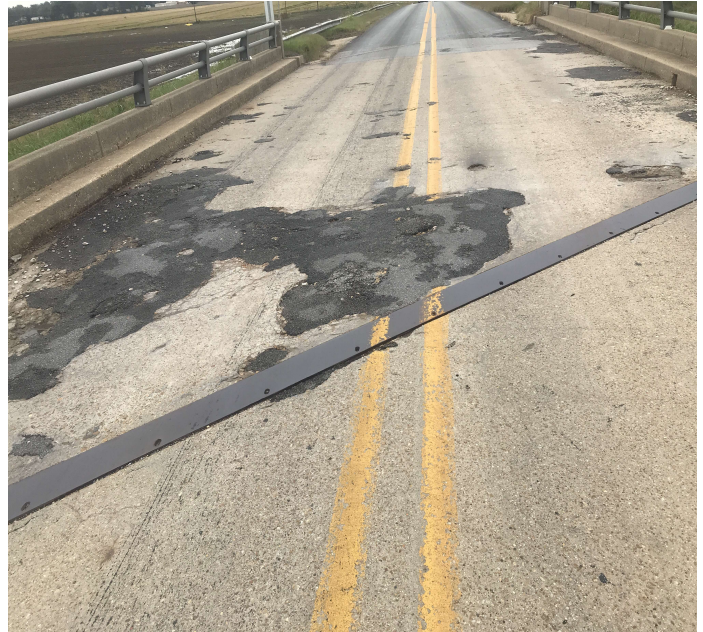
PHOTO 5 Description Span 4 deck

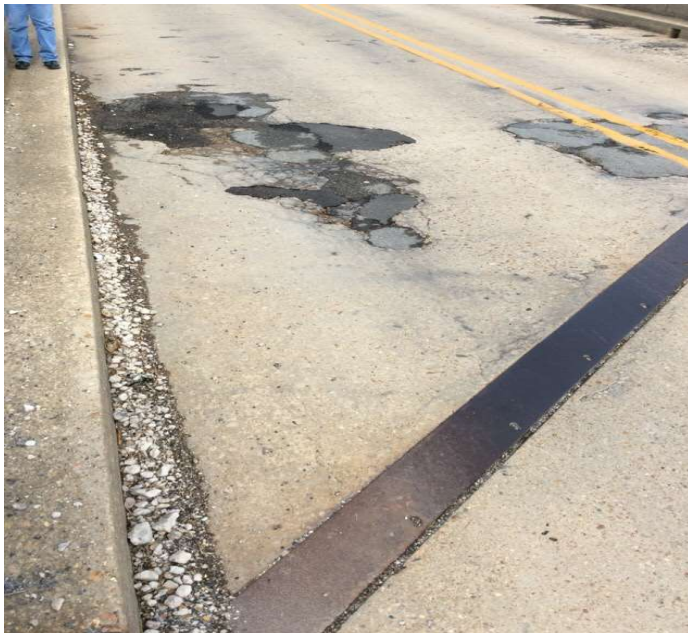
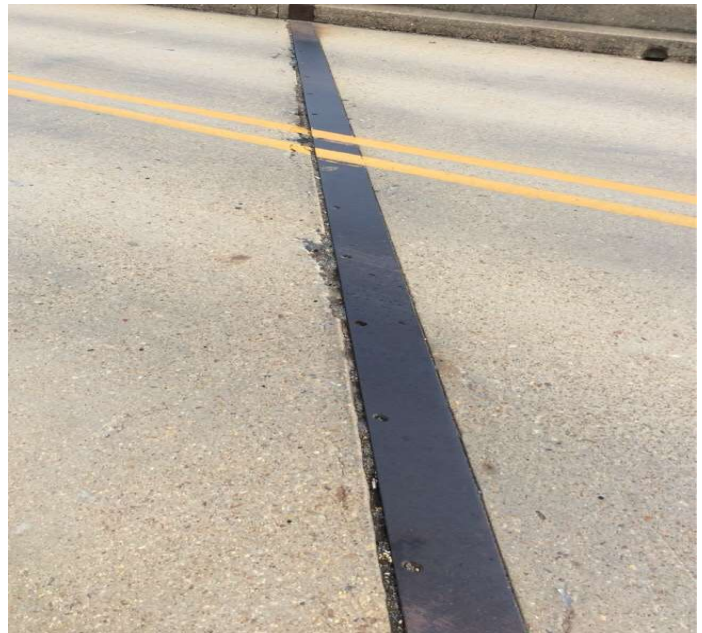
Assembly Joint Bent 2 has 38LF of delamination.

Assembly Joint Bent 3 has 5LF of rebar exposed due to lack of steel coverage.

Assembly Joint Span 3 Bent 3 in left lane, has a 2ft. X 4in. X 1 1/2in. deep spall with exposed rebar and it has been repaired with asphalt.

Assembly Joint Span 3 Bent 3 in right lane, has a 5ft. X 6in. X 1 1/2in. deep spall with exposed rebar and it has been repaired with asphalt.

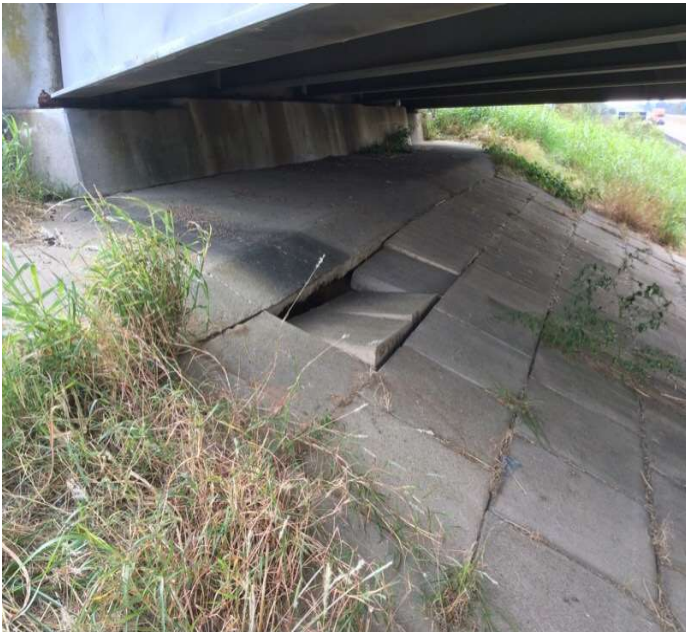
PHOTO 1 Description

Concrete Embankment Protection under Span 1 has some settlement with a void 8in. deep and up to 2ft. back under concrete, see 2016 photo.
