# Bridge Inspection Report

**05266**

**US 412-09- LM 0.83**

**EIGHT MILE CREEK**

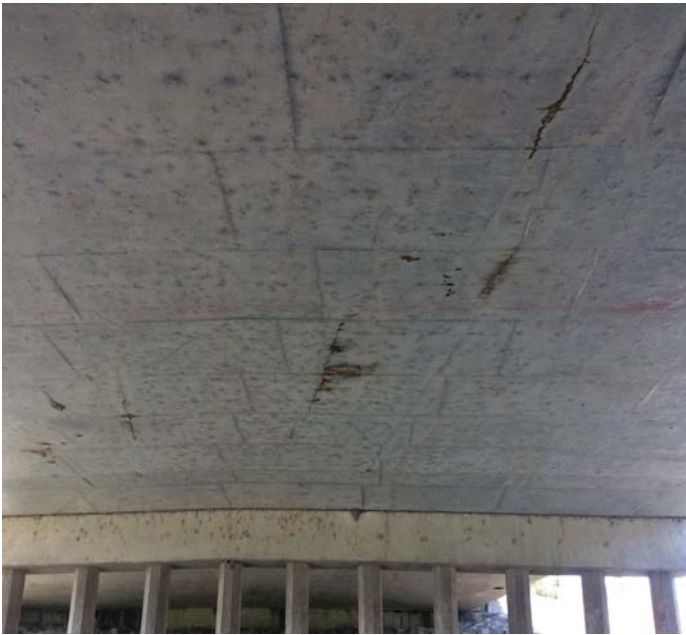
PHOTO 1      Description

Bottom of Deck

has insignificant size and moderate density cracks in bottom of deck with some efflorescence and rust stains visible.

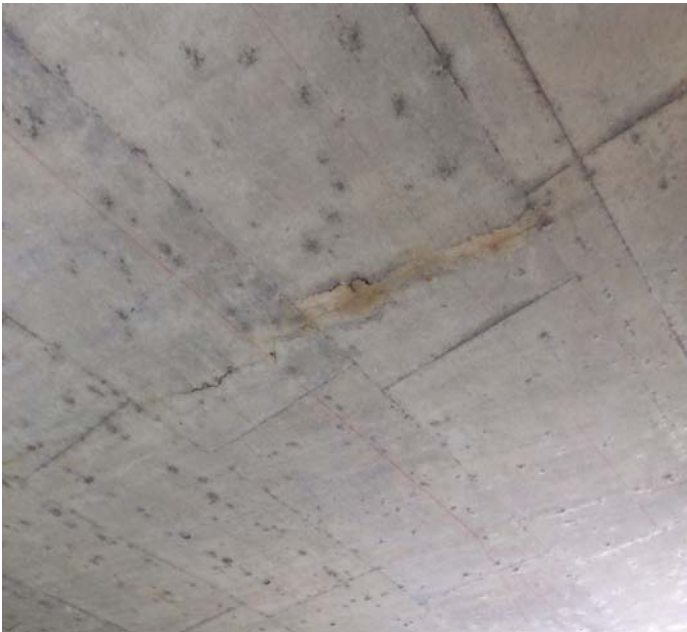
PHOTO 1      Description

Span 3  
impending spall 6 ft. x 4 ft. Bottom of deck.
