Bridge Inspection Report

01924
SH 115-01- LM 0.93
over
SPENCER CREEK

Structure Number: 01924

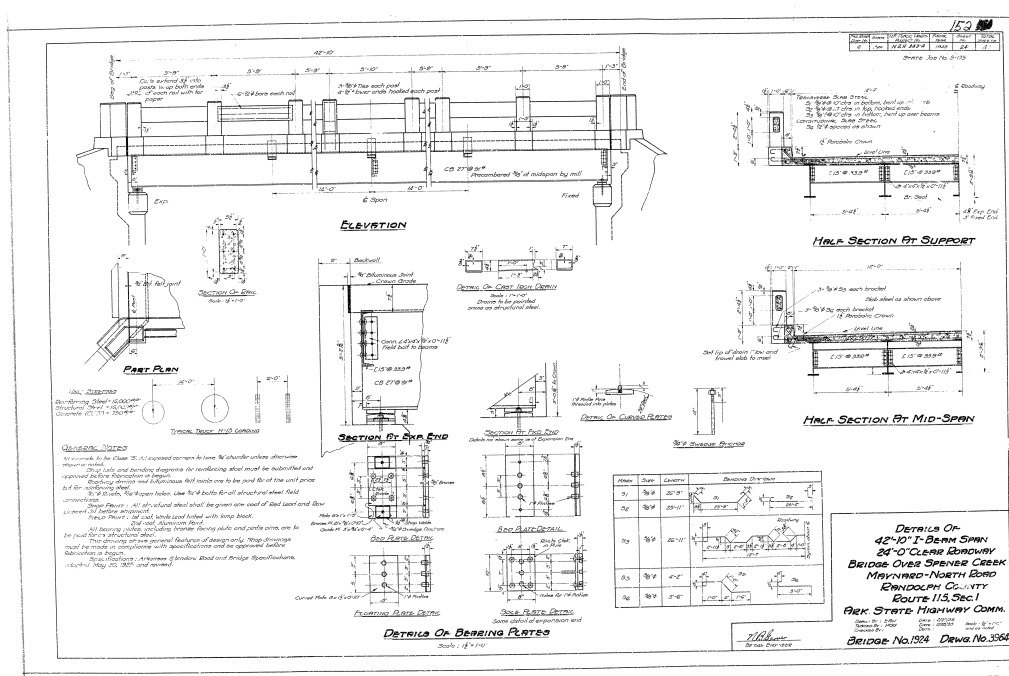
PHOTO 1

Description	Cross Section View
-------------	--------------------

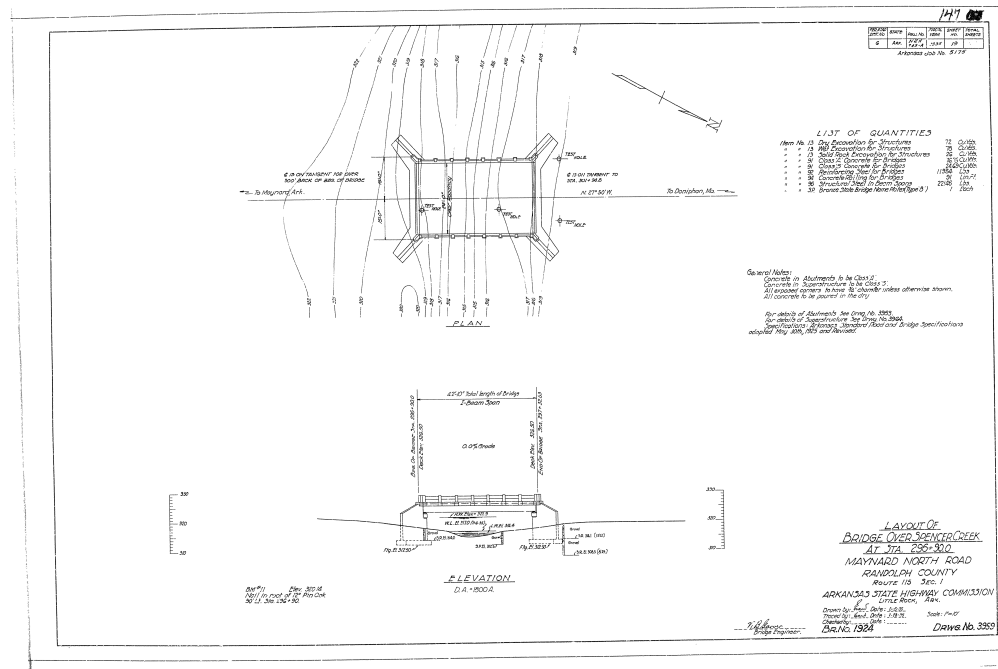
PHOTO 2

Description Layout View

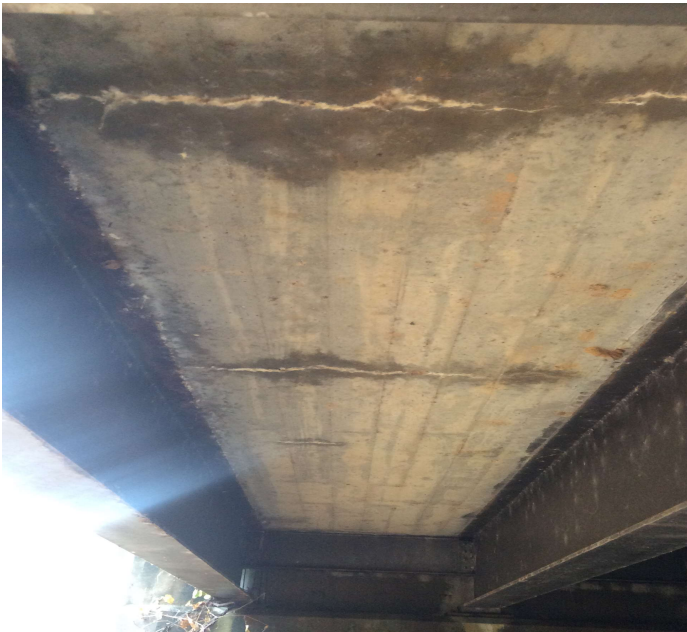
PHOTO 1 Description

Soffit has transverse cracks with efflorescence and rust stains, a few delaminated areas, and a few spalls with rebar exposed.

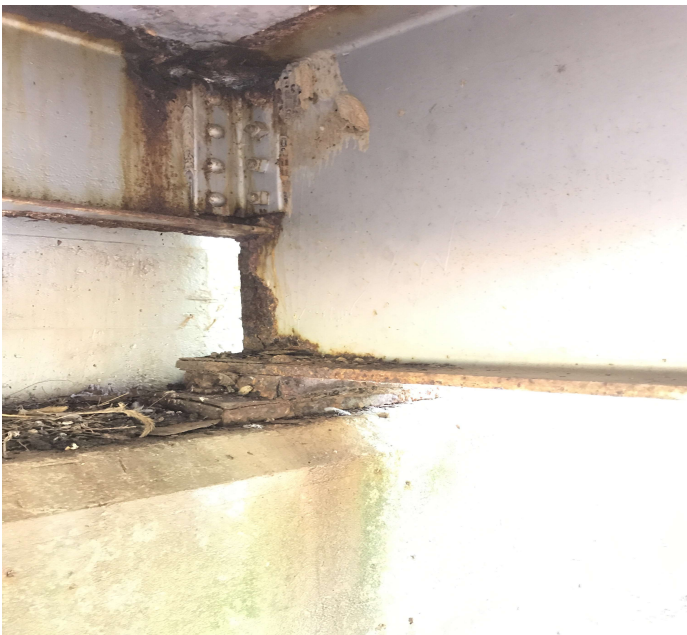
Steel girders have areas of minor measurable section loss on ends over caps. A few girder ends have flaking rust.

PHOTO 1 Description Girder 1 at bent 1
