Bridge Inspection Report

02719

SH 115-01-LM 12.81

FOURCHE CRK

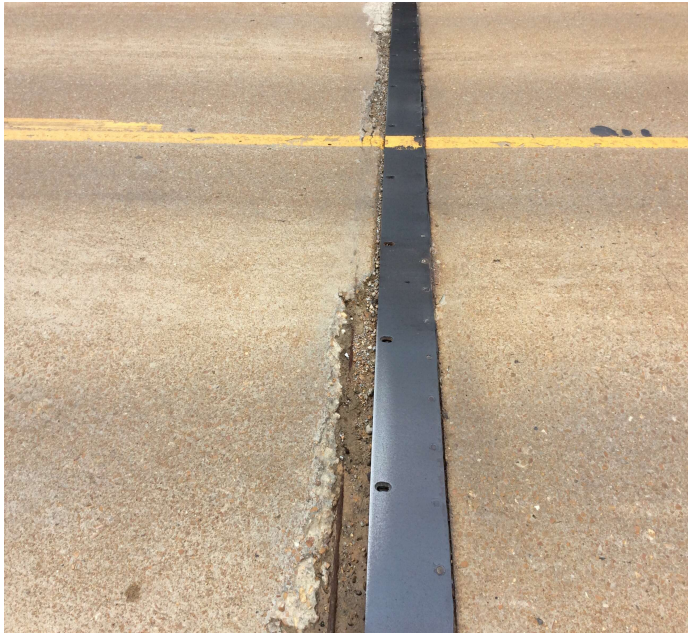
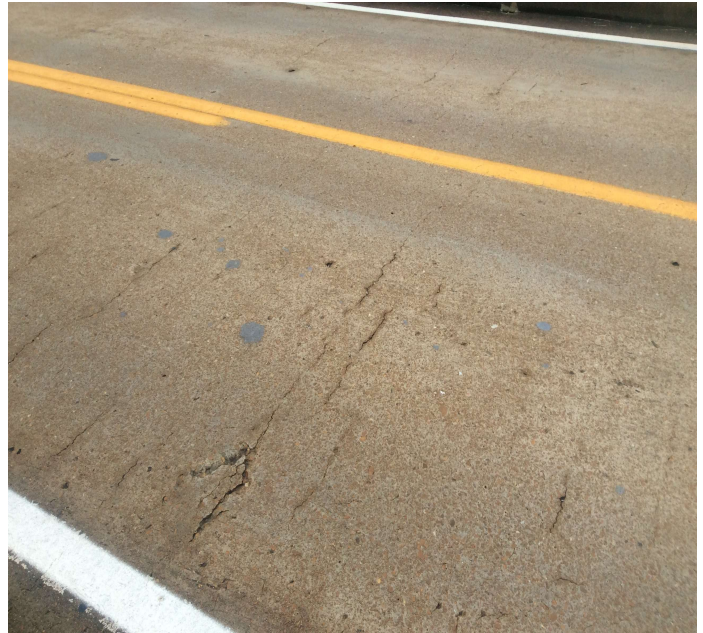
Concrete deck has several unsealed moderate width transverse cracks.

Lt and Rt curbs have several spalls with rebar exposed.

Deck has delaminated areas and spalls with up to 2' of rebar exposed along joints over bents 2 – 8.

Span 6 has a few small spalled areas with some rebar exposed in Rt gutter.

Bent 8 slide plate is loose and moving under traffic.

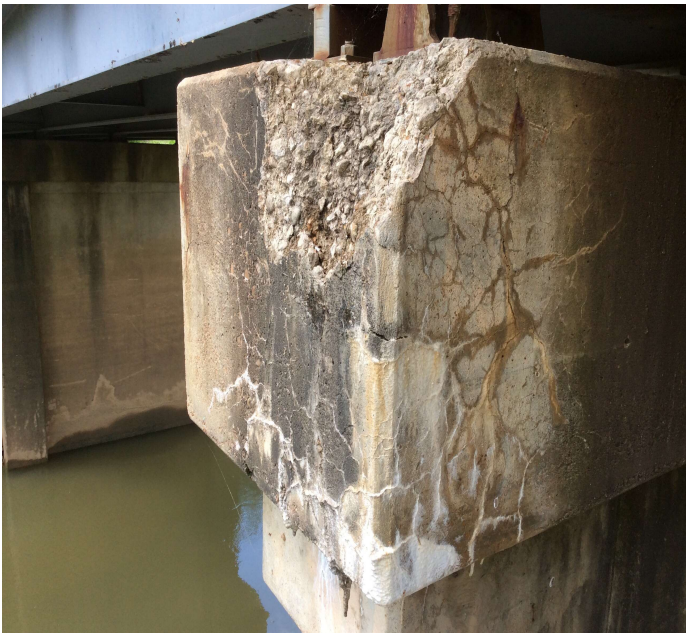
Bent 4 cap has efflorescent map cracking on Lt end on ahead side.

Bent 5 cap has a spall with rebar exposed on Rt end.

Bent 7 – Lt end of cap has efflorescent map cracking, deterioration, and is spalled with rebar exposed.

Bent 7 – Concrete haunches under Lt and Rt ends of cap and web wall portion of pier have a few small spalls with rebar exposed. (1' typical) Web wall portion of pier also has minor size horizontal cracks with efflorescence.

Bent 8 – Lt. concrete haunch under cap has a small spall with 6 inches of rebar exposed on back face.

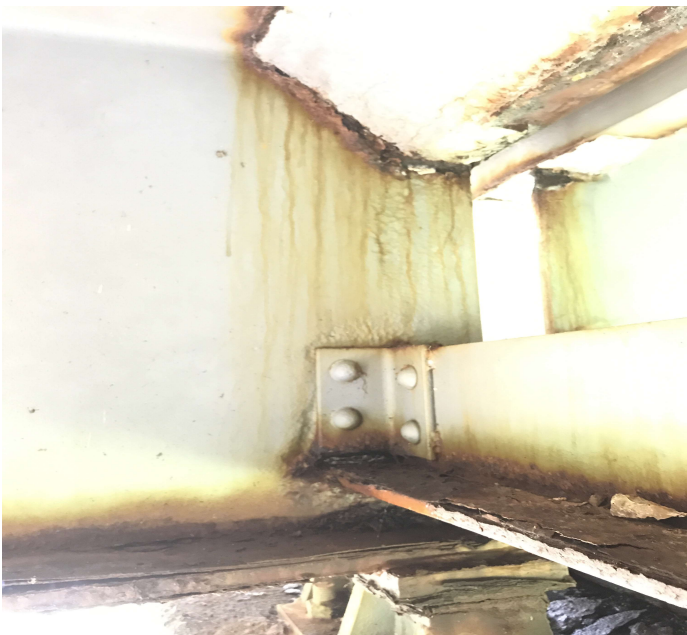
PHOTO 1 Description Span 2 bent 3 girder 2

Ends of girders are rusted with up to 1/4" section loss at web below haunch, and around diaphragm connections. A few have holes rusted through web at haunch and/or diaphragm connection. See notes for specific locations.

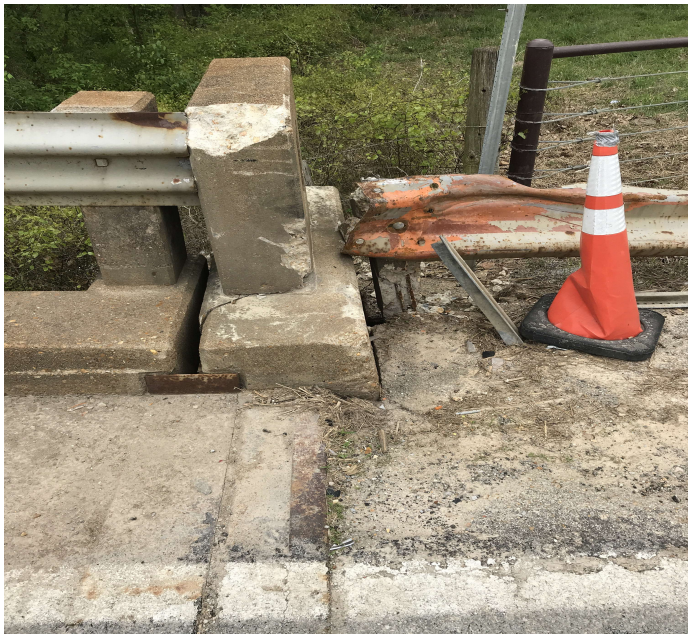
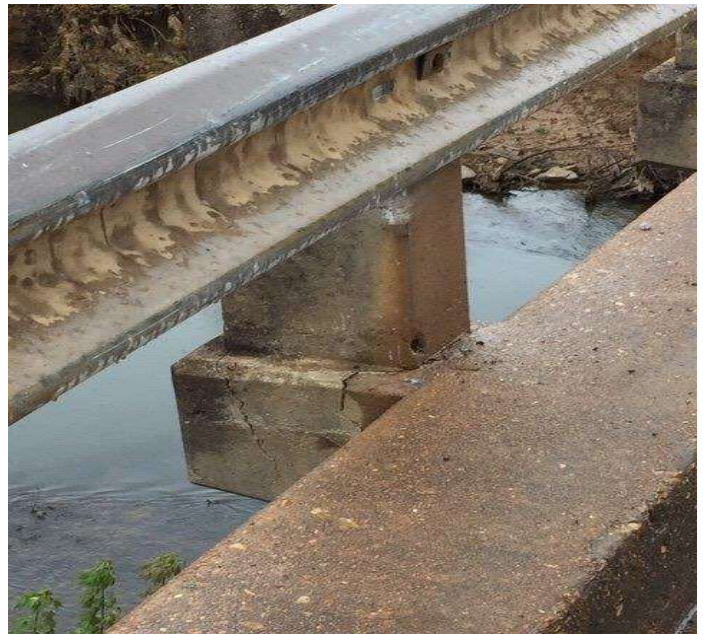
On 4/13/19 an accident occurred when a vehicle hit bent 9 Lt approach rail and was slung into Rt bridge rail at span 8. Approach rail and endpost was damaged. Endpost was rotated toward bridge. Rt bridge rail posts at span 8 were damaged/cracked at base of posts.

Bridge rail posts have been patched since accident inspection.
