Bridge Inspection Report

02882

SH 115-01-LM 3.80

BRANCH HAYGOOD CRK

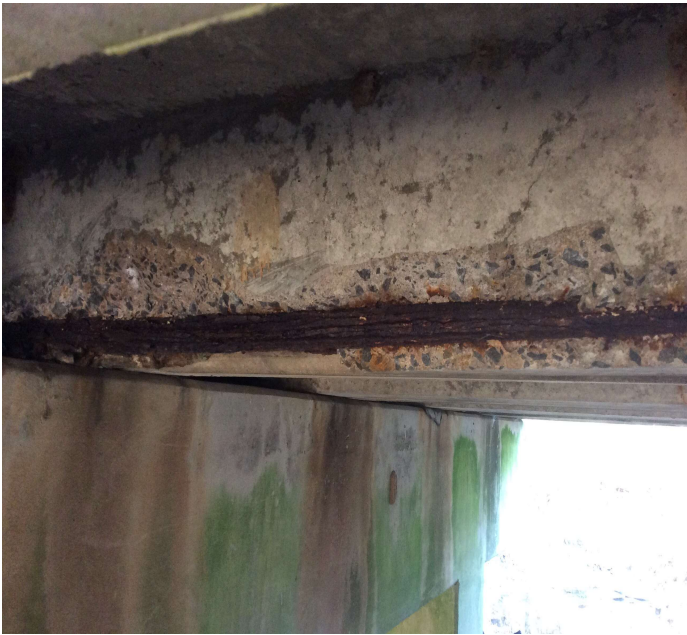
PHOTO 1 Description

Span 3 concrete channel beam 5 has a 4 ft. x 8 in. x 3 in. deep spall with exposed rebar at bent 3 with heavy section loss to rebar, see photo.

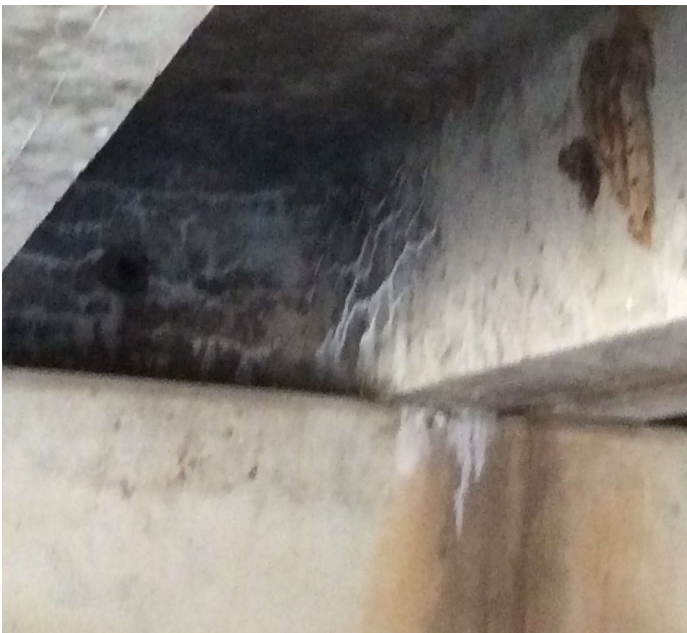
PHOTO 1 Description

Span 1 unit 5 over bent 1 has map cracking with efflorescence, see photo.
