Bridge Inspection Report

02883
SH 115-01-LM 3.34
over
HAYGOOD CR

Structure Number: 02883

Facility Carried: SH 115-01-LM 3.34

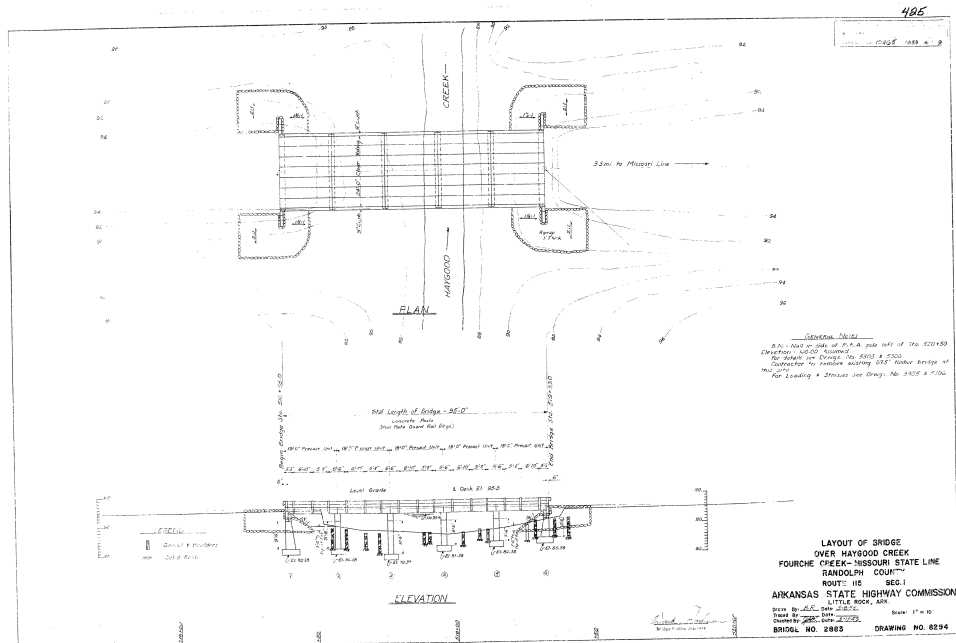
PHOTO 1

Description layout

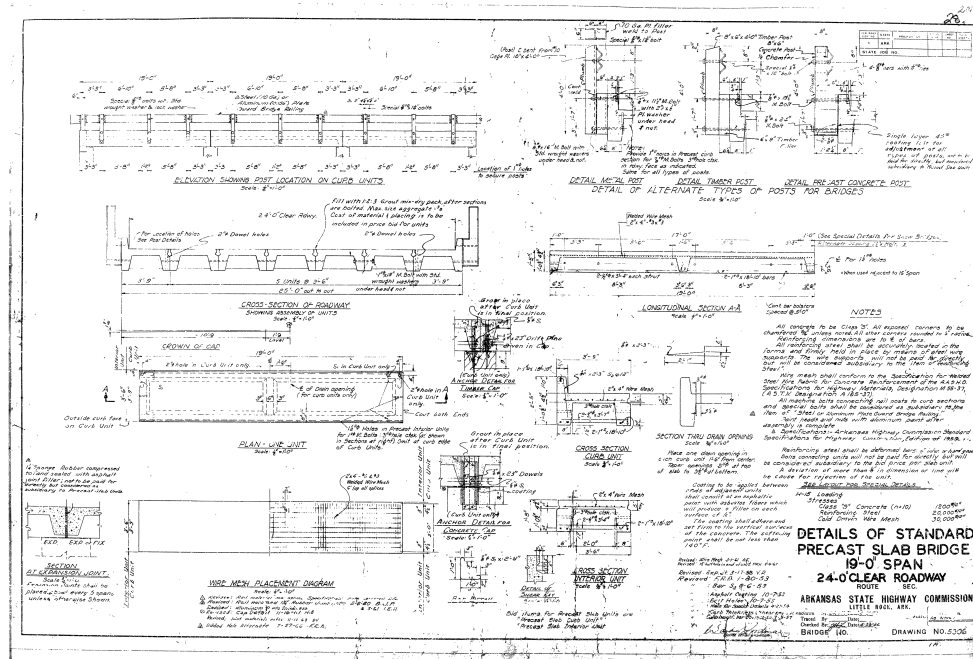
PHOTO 3

Description precast units

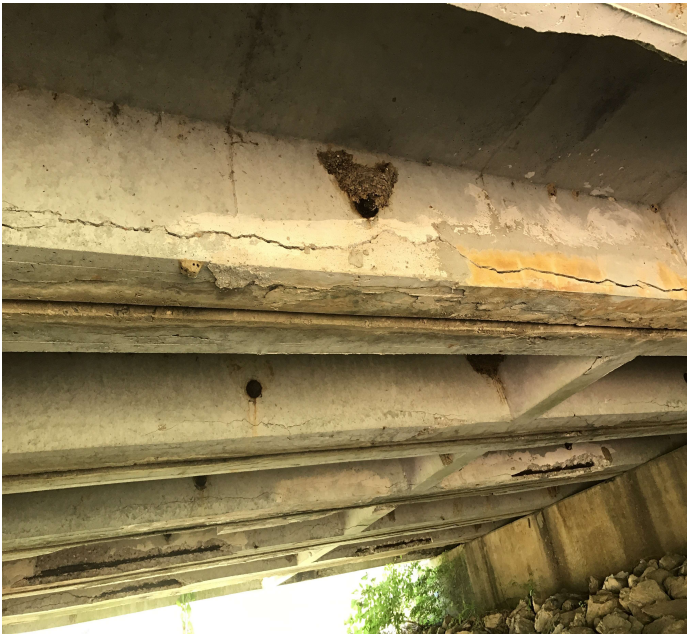
PHOTO 1 Description Span 5

Span 5 unit 2 has spalls with 19' of exposed rebar.

Span 5 unit 3 has spalls with 16' of exposed rebar.

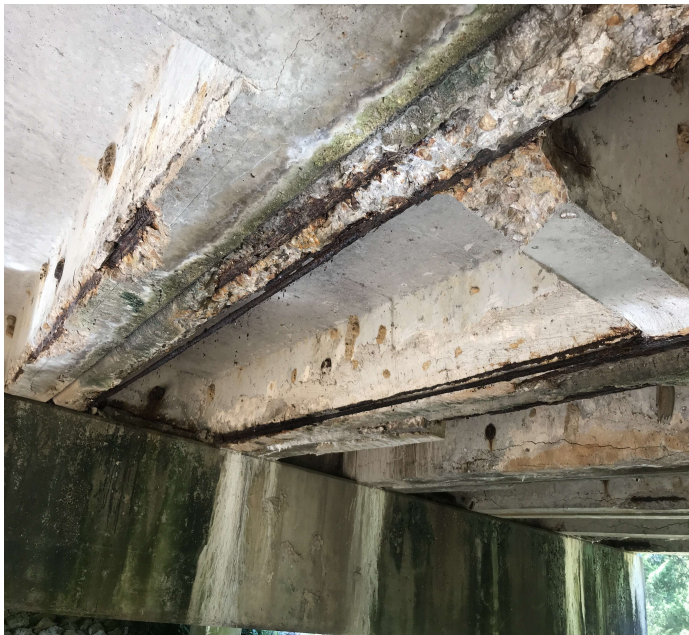
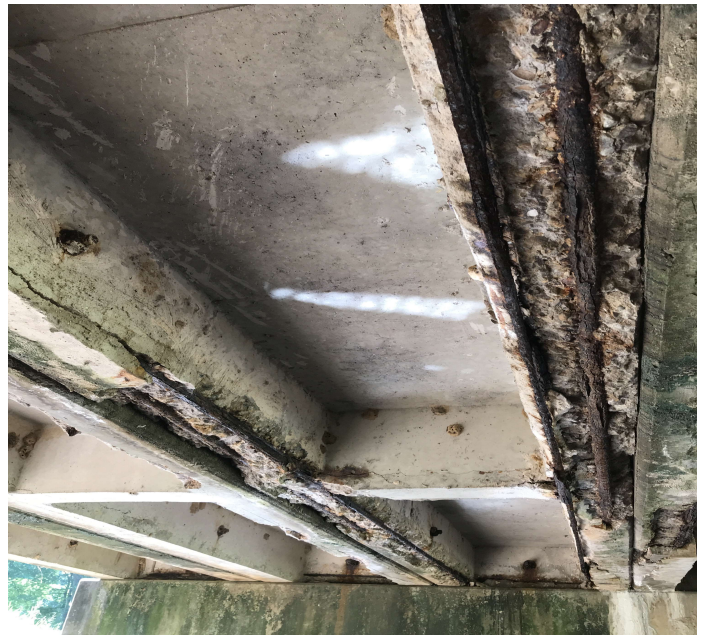
Span 3 unit 3 has spalls with 19' of exposed rebar. Concrete has spalled completely away from rebar for 10' on both legs. Exposed rebar has section loss. 5/8" diameter remain on Lt leg, 3/8" remain on Rt leg.

PHOTO 1 Description Span 3 unit 3

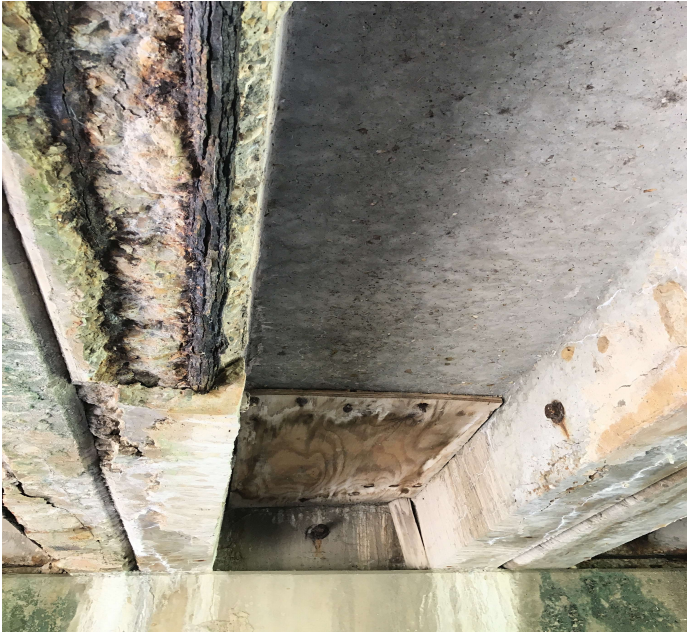
PHOTO 3 Description Span 3 unit 4

Span 3 unit 4 has spalls with 19' of exposed rebar and excessive efflorescent cracking.

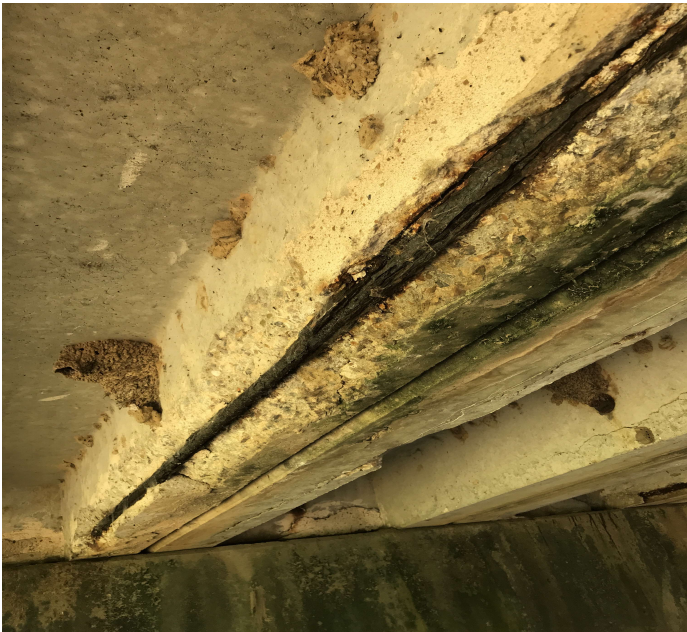
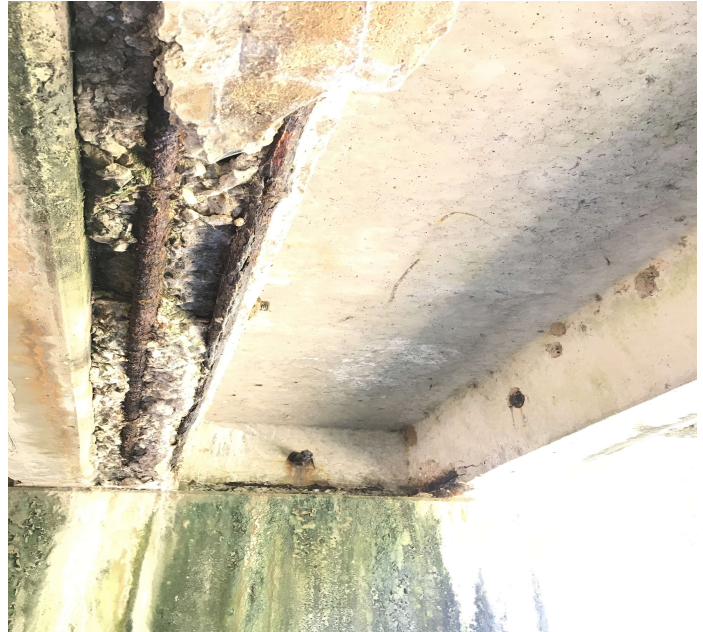
Span 3 unit 7 has spalls with 19' of exposed rebar. 5' is spalled completely away from rebar on Lt leg.

PHOTO 4 Description Span 3 unit 7

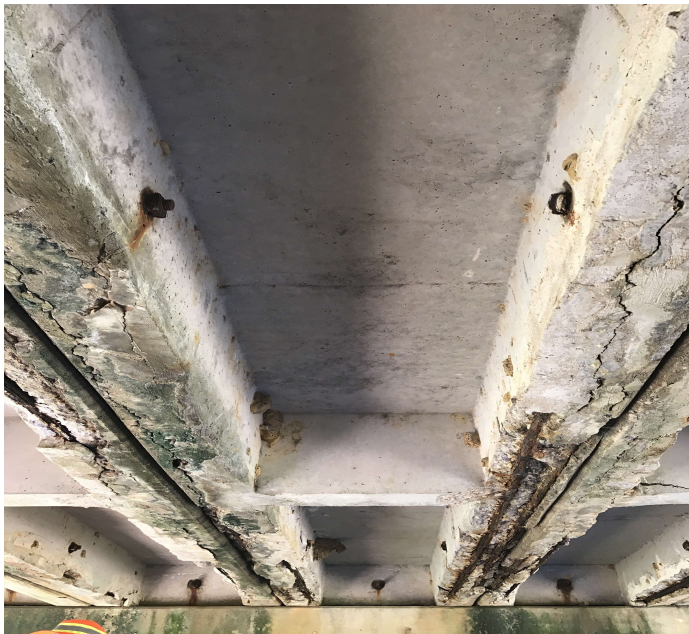
PHOTO 1 Description Span 4 unit 4

Span 4 unit 4 has spalls with 19' of exposed rebar.

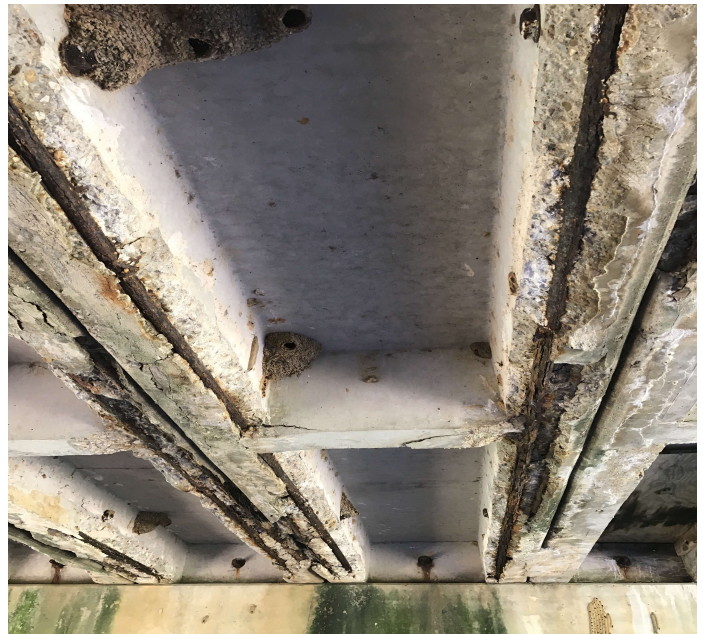
PHOTO 2 Description Span 4 unit 5

Span 4 unit 5 has spalls with 19' of exposed rebar.

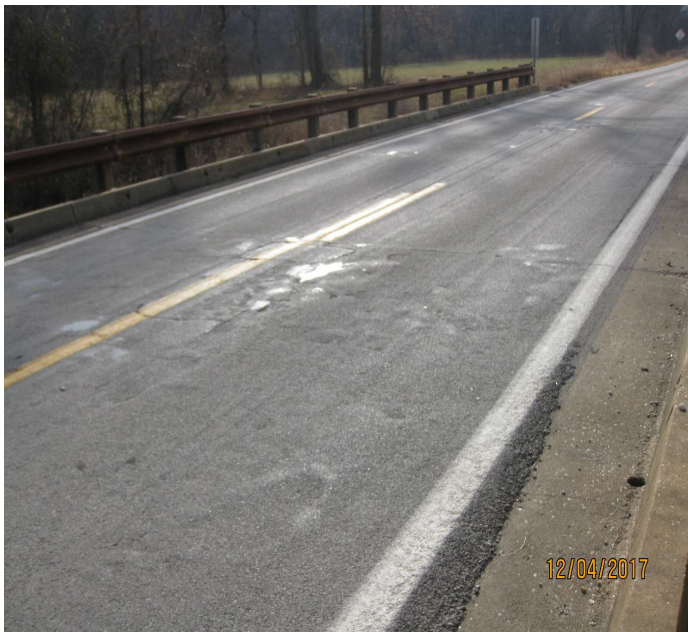
PHOTO 1 Description

Asphalt overlay top of deck.

Several small spalls and delaminated areas to deck especially at span 1, mostly patched with asphalt see 2014 photos.

Asphalt wearing surface received a chip seal in 2016

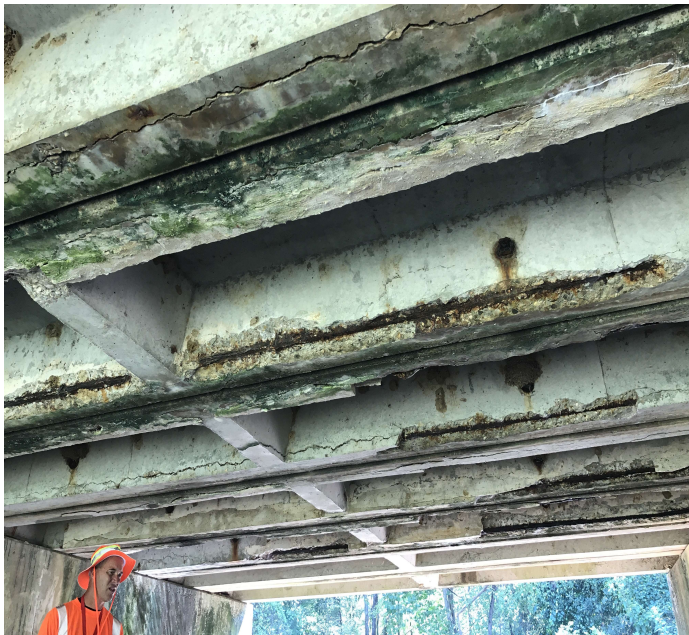
PHOTO 1 Description Span 2

Span 2 unit 3 has spalls with 15' of exposed rebar. Lt and Rt legs have approx. 4' where concrete has spalled completely away from rebar. Exposed rebar has section loss. ($\frac{3}{4}$ " remains).

Span 2 unit 5 has spalls with 9' of exposed rebar and 9' delaminated.

Span 2 unit 6 has spalls with 19' of exposed rebar and excessive efflorescent cracking.

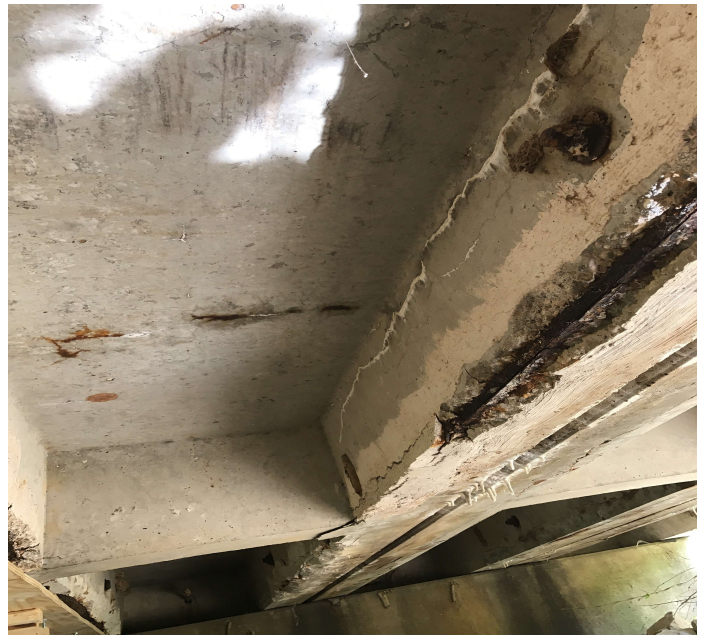
PHOTO 2 Description Span 1 unit 3

Span 1 unit 3 has spalls with 19' of exposed rebar.

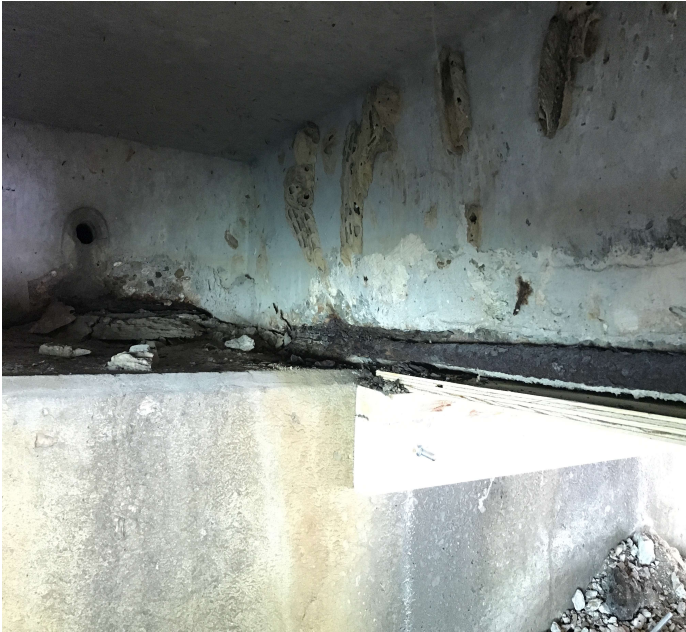
PHOTO 3 Description Span 1 unit 5

Span 1 unit 5 has spalls with 18' of exposed rebar. Lt leg has 13' where concrete has completely spalled away from rebar. Exposed rebar has section loss. ($\frac{3}{4}$ " remains near bent 1)

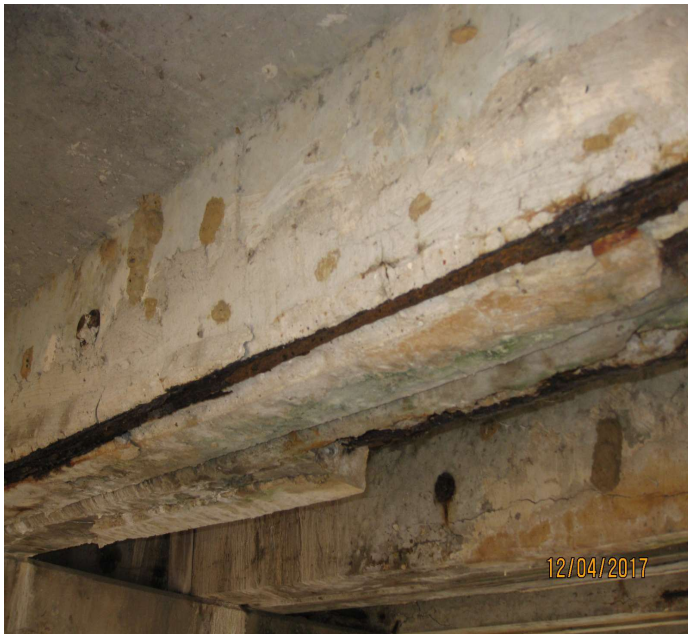
PHOTO 1 Description

All units have longitudinal cracks and delaminated areas to girder portion of units. Most have rebar exposed. Several units have spalls with exposed rebar in girder portion. Some rebar has been hand patched with grout in the past. Exposed rebar has rust with section loss.

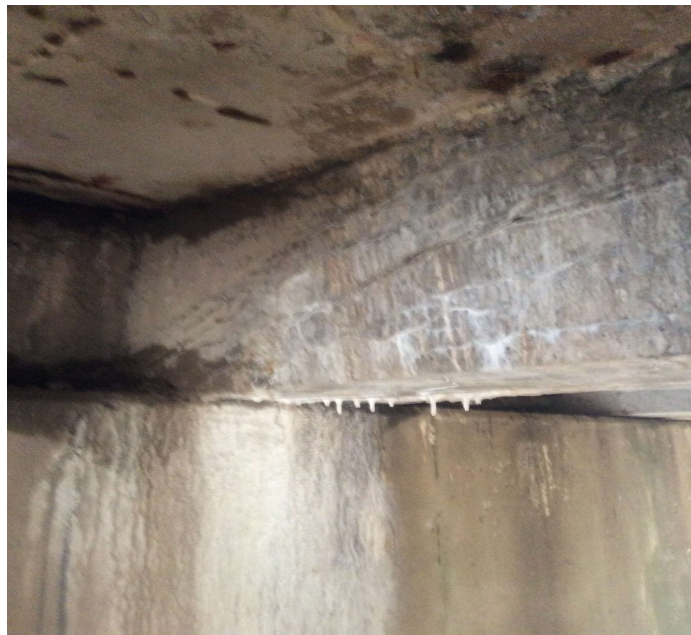
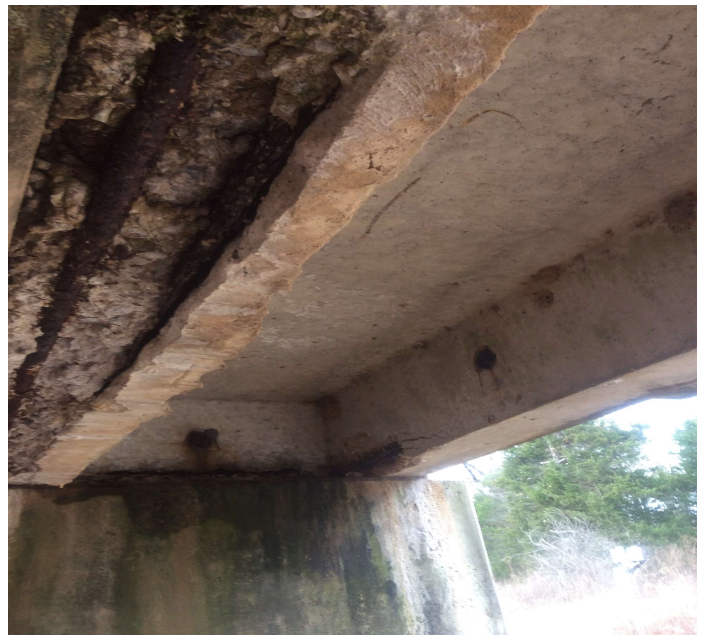
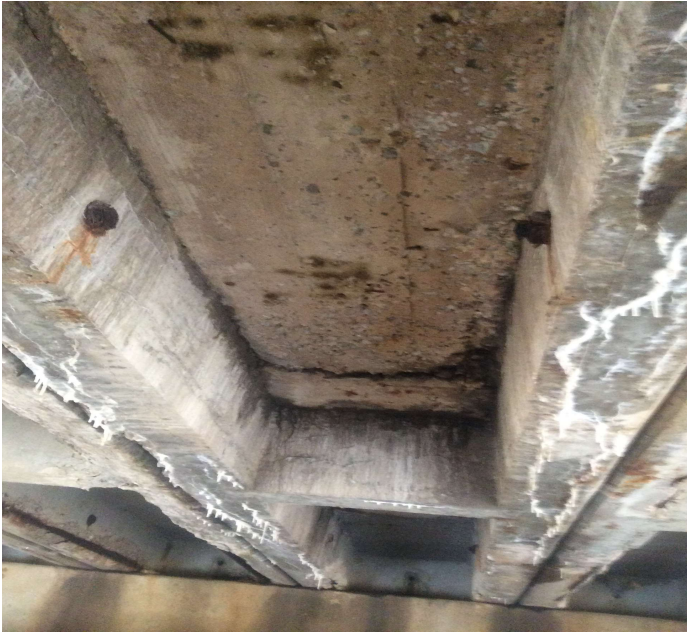
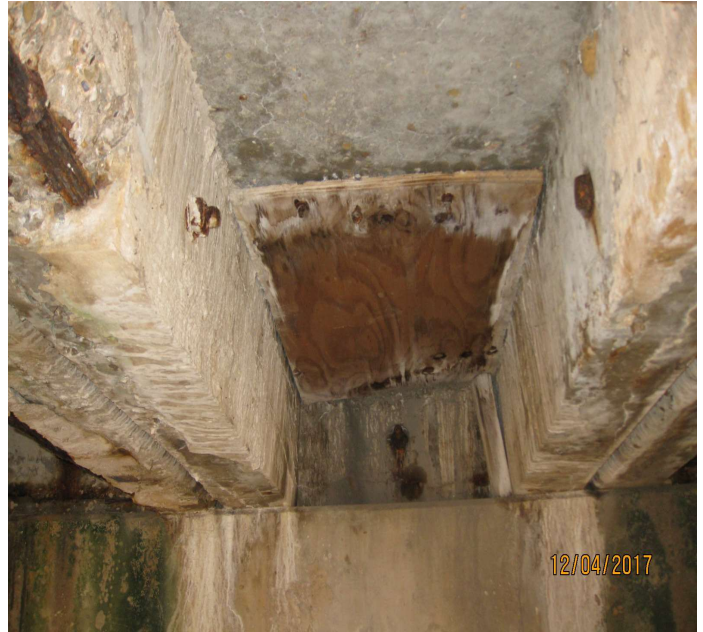
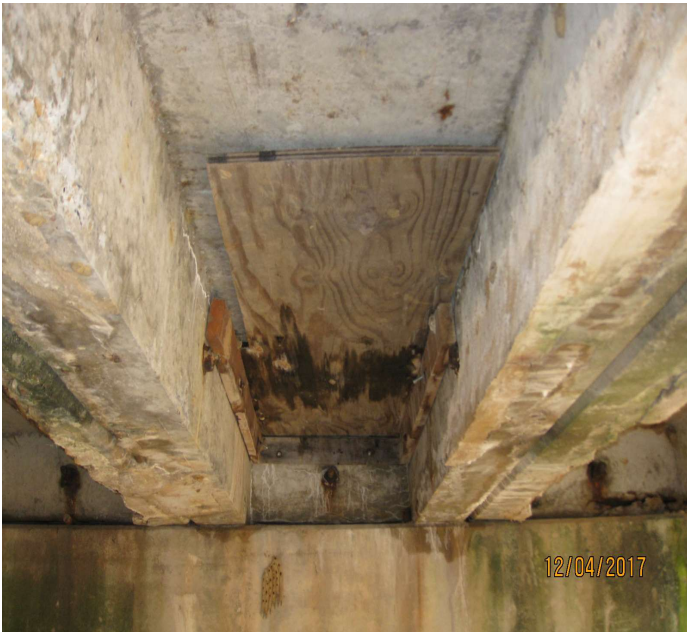
Deck portion on channel beam has been full depth patched on Unit 4 Span 1, Unit 4 Span 3, and Unit 6 Span 4. (48ft. total) ends of Units also have excessive cracking and efflorescent, Unit 7 Span 3 is beginning to shell out with rebar exposed.

Span 1 unit unit 4 has been replaced with a cast in place unit.
Span 3 unit 4 has a 3' x 3' full depth concrete patch.
Span 4 unit 6 has a 3' x 5' full depth concrete patch.
Span 3 unit 7 is covered in other maintenance need.

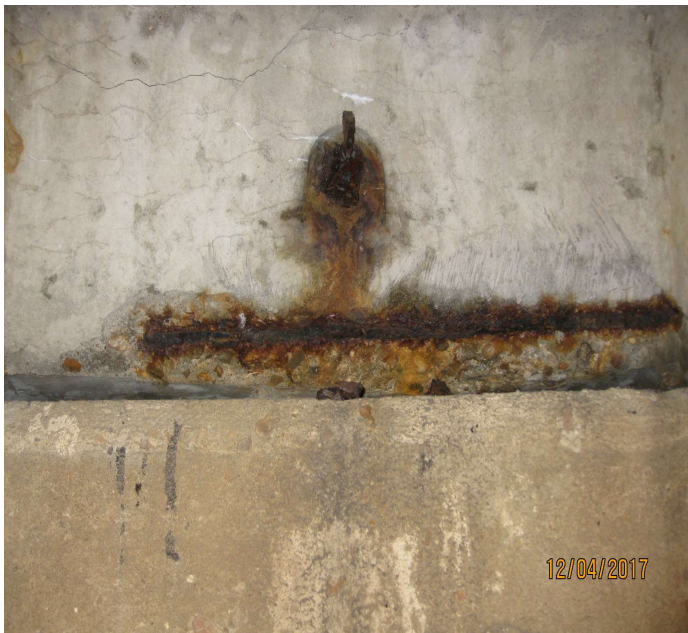
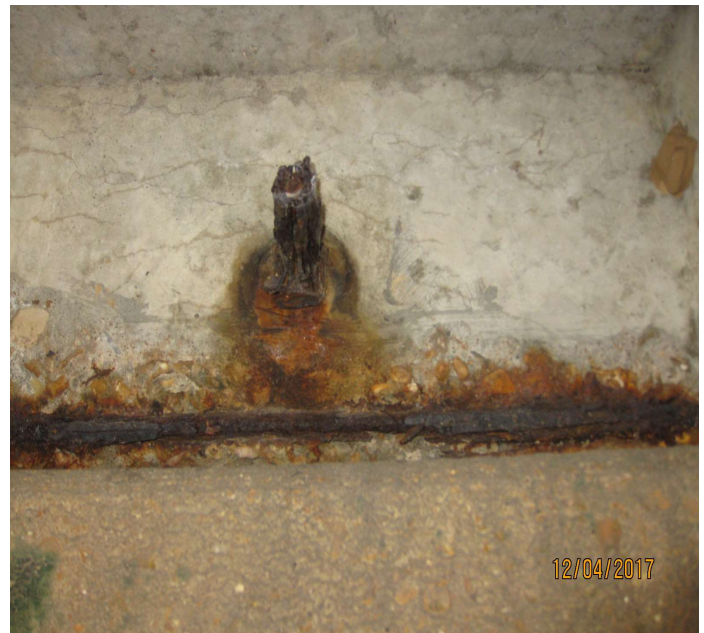
Several units have spalls with exposed rebar at ends of units over bents and diaphragms at beginning and end of spans.
