Bridge Inspection Report

02717

SH 135-05- LM 3.08

JACKS CREEK

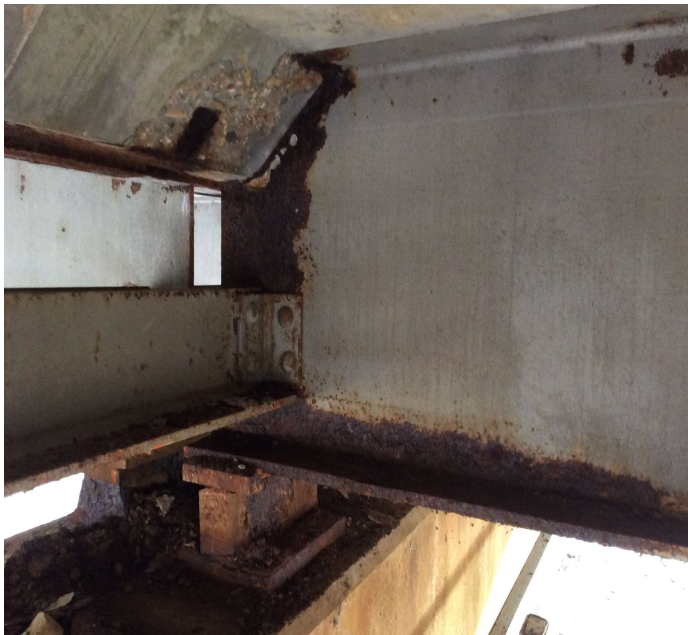
PHOTO 1 Description

Span 1 bent 2 girder 3 has a 6" x 1" hole in web below haunch. Bottom of web and bottom flange has 2' of up to 1/8" section loss.

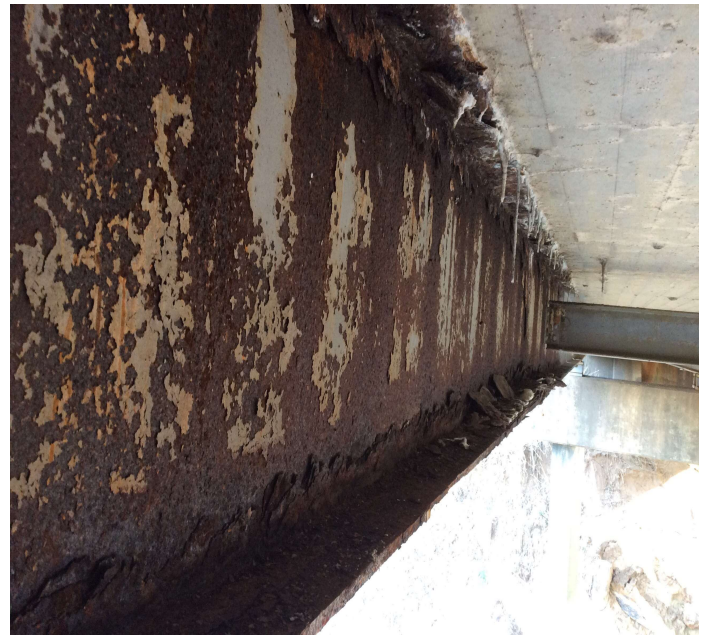
PHOTO 2 Description

Span 1 bent 2 girder 4 has a 3" x 1" hole in web below haunch. Bottom of web and bottom flange has 3' of up to 1/8" section loss

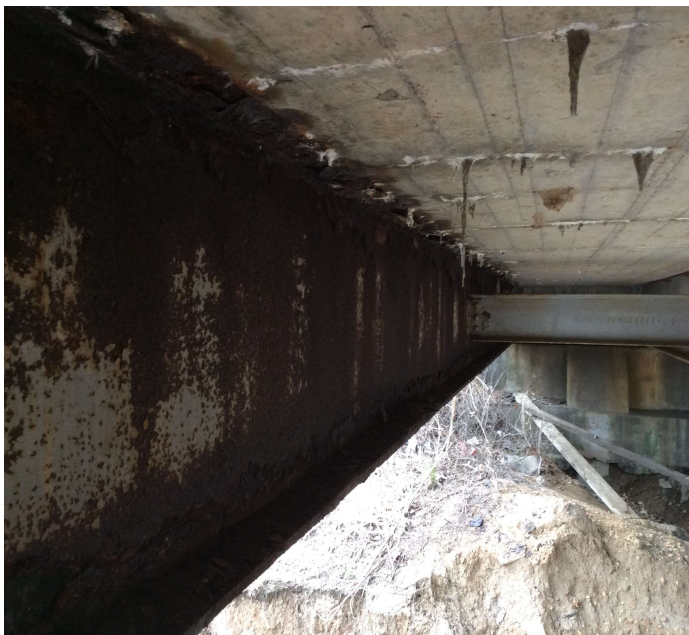
PHOTO 3 Description

Girders 1 and 5 have flaking rust and section loss along top and bottom flanges at all spans.

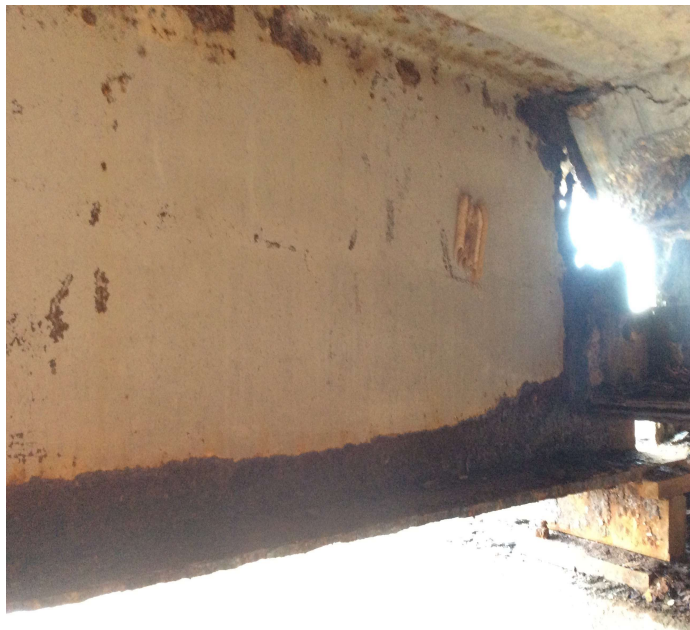
PHOTO 1 Description

Span 1 bent 1 girder 1 has 5' of section loss along bottom of web (up to 1/4"). Bottom flange has 2.5' of heavy section loss beginning to knife edge. Edge of flange has 3/16" remaining. Web below haunch has a 7" x 6" area of heavy section loss with a 3" x 3" hole rusted through.

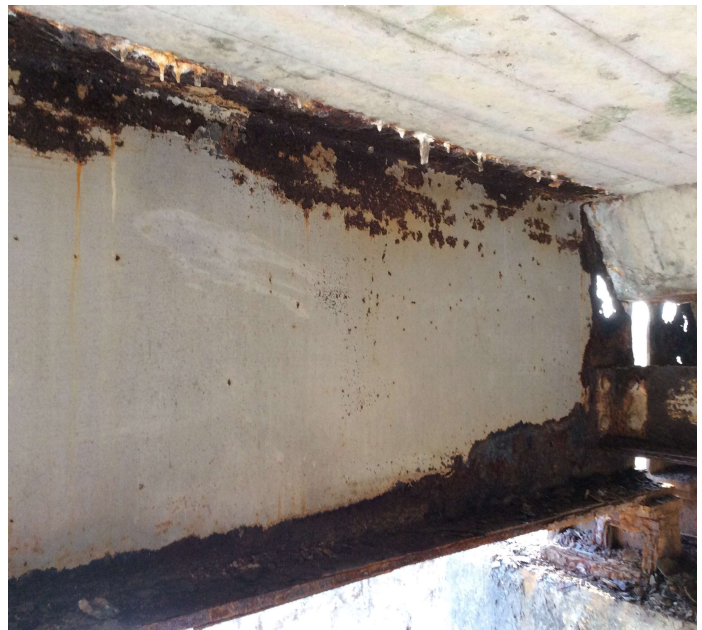
PHOTO 2 Description

Span 1 bent 1 girder 5 has 3' of section loss along bottom of web (up to 1/4"). Bottom flange has 2' near bearing that is beginning to knife edge. Bottom flange has 1/8" remaining at edge. Web below haunch has a 9" x 8" area of heavy section loss.

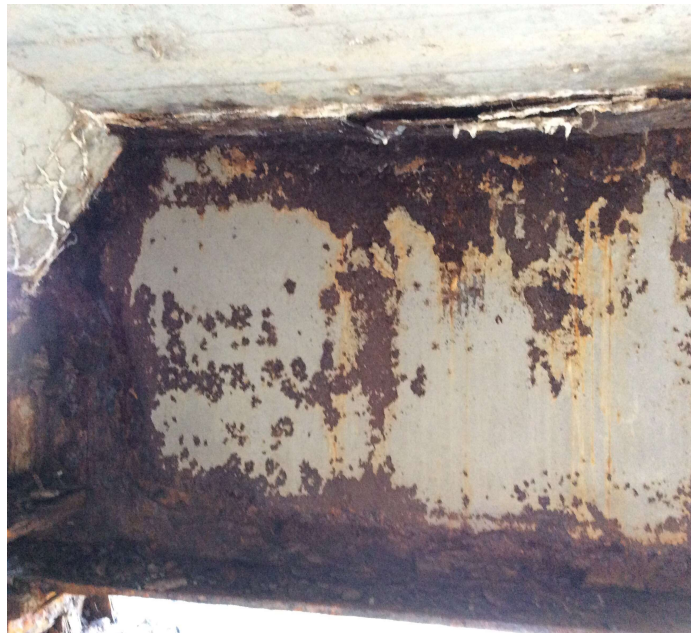
PHOTO 3 Description

Span 1 bent 2 girder 1 has 5.5' of section loss along bottom of web and bottom flange. Bottom flange has 5/16" remaining on edge. Web below haunch has a 11" x 8" hole rusted through.

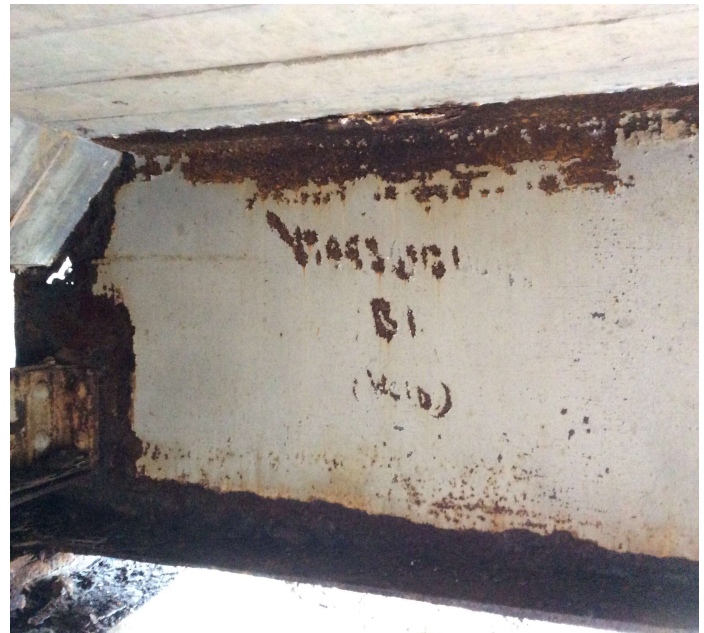
PHOTO 5 Description

Span 2 bent 2 girder 1 has 1' on end with heavy section loss at web below haunch, diaphragm connection, and along bottom flange. 3/4 of span has section loss along top and bottom flanges.

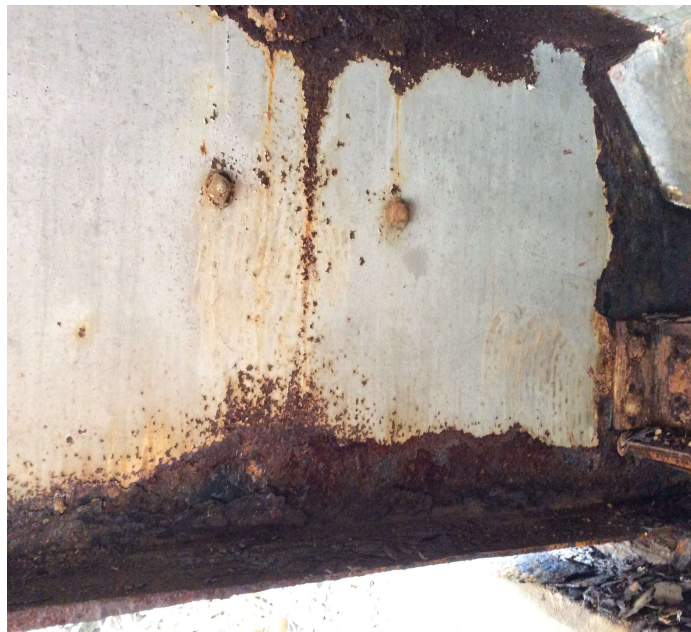
PHOTO 4 Description

Span 1 bent 2 girder 5 has 5' of heavy section loss along bottom of web and bottom flange. Interior bottom flange is beginning to knife edge with 1/8" remaining on edge. Web below haunch has 6" x 9" area of heavy section loss/hole in web.

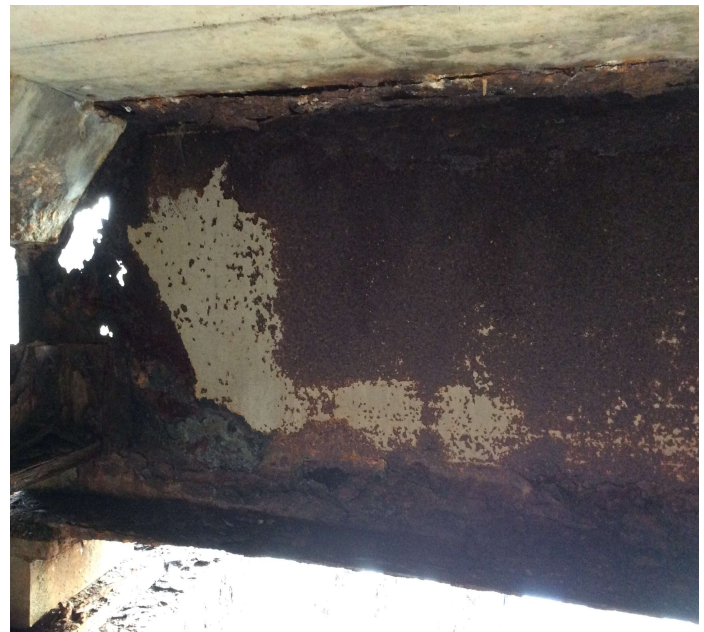
PHOTO 6 Description

Span 2 bent 2 girder 5 has 4' of 1/8" section loss along bottom of web and bottom flange. Web below haunch has an 8" x 7" area of heavy section loss with a 4" x 4" hole rusted through.
