Bridge Inspection Report

02718

SH 135-05- LM 4.45

LOCUST CREEK RELIEF

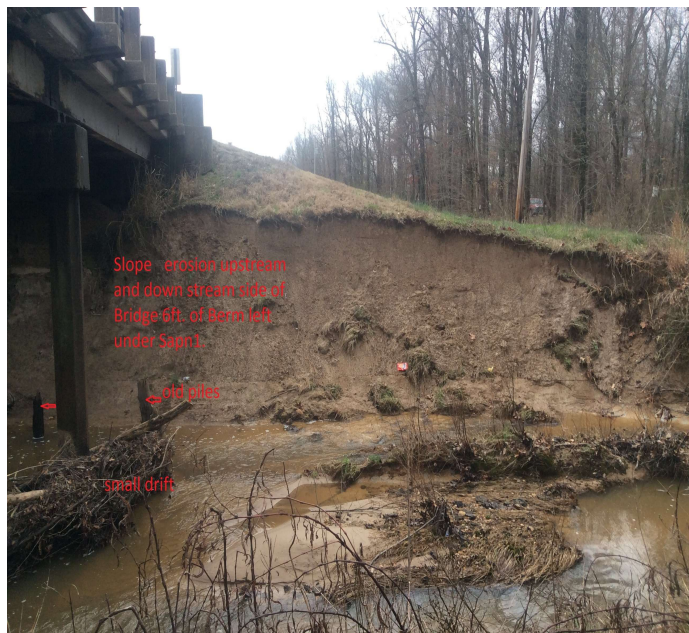
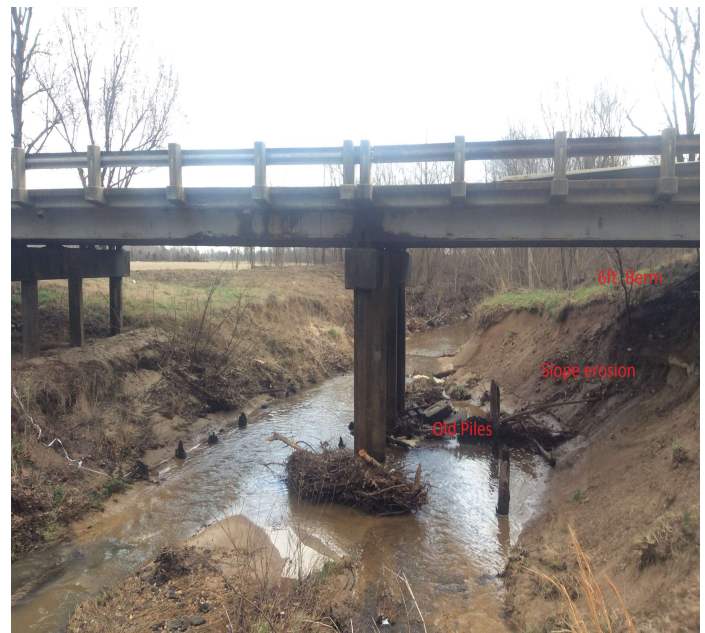
Channel has heavy embankment erosion under and adjacent to span 1.

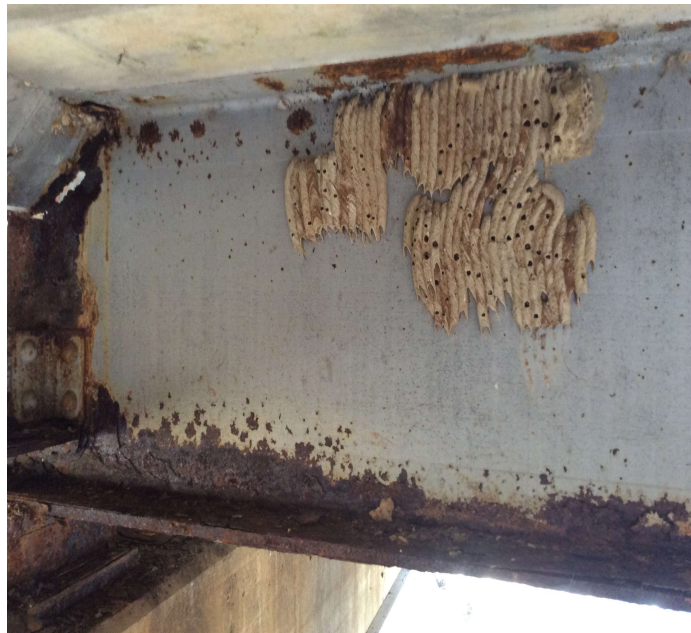
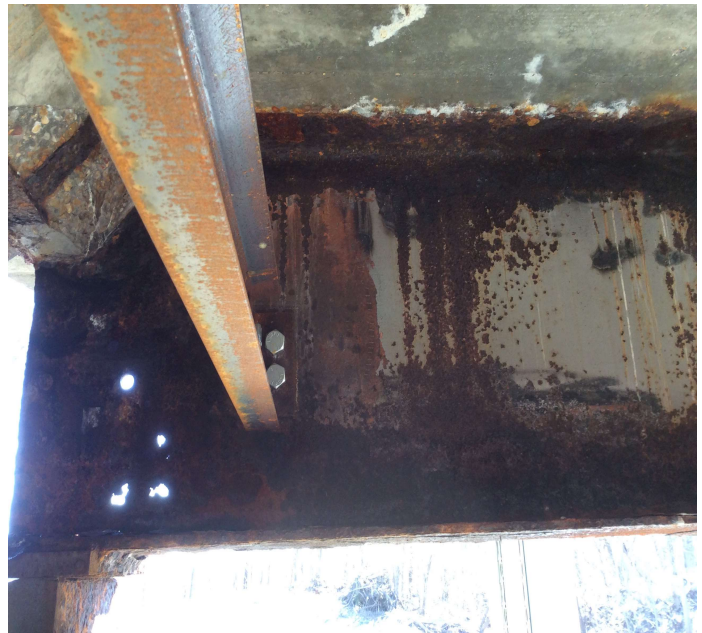
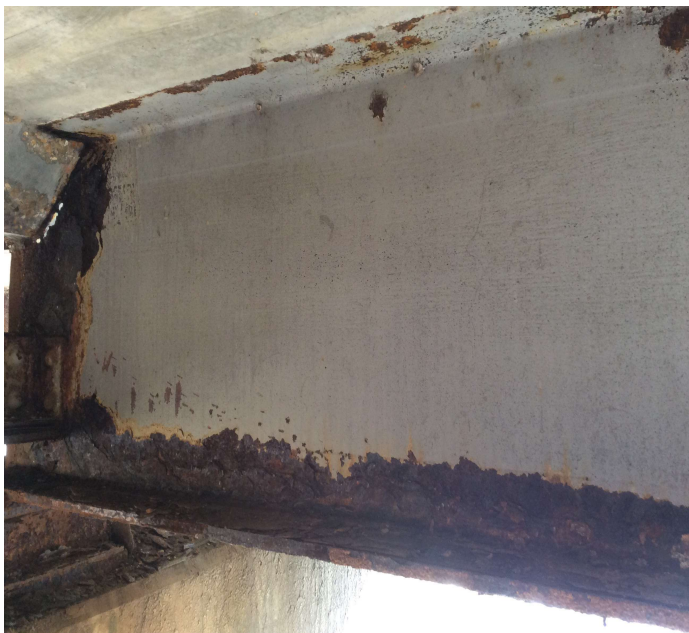
Span 1 bent 2 girder 3 has a 9" x 1" hole rusted thru web below haunch.

Span 1 bent 2 girder 4 has 4.5' of section loss (1/8" – 3/16") along bottom of web, and a 6" x 1" hole rusted thru web below haunch.

Span 2 bent 3 girder 1 has 2' of 1/8" section loss along end of web and bottom flange.

Span 2 bent 3 girder 5 has 15" of section loss along bottom of web with three 1.5" holes rusted through at old diaphragm connection.

Span 3 bent 4 girder 1 has 1/8" section loss at web below haunch and at diaphragm connection.

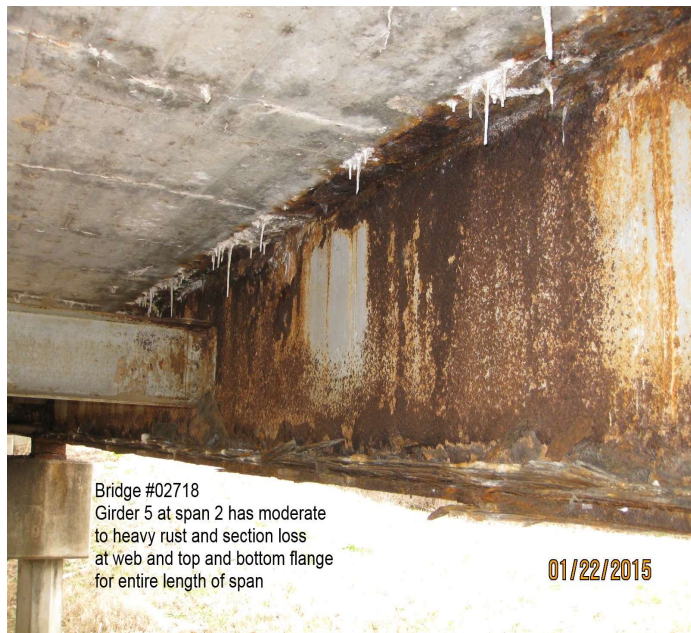
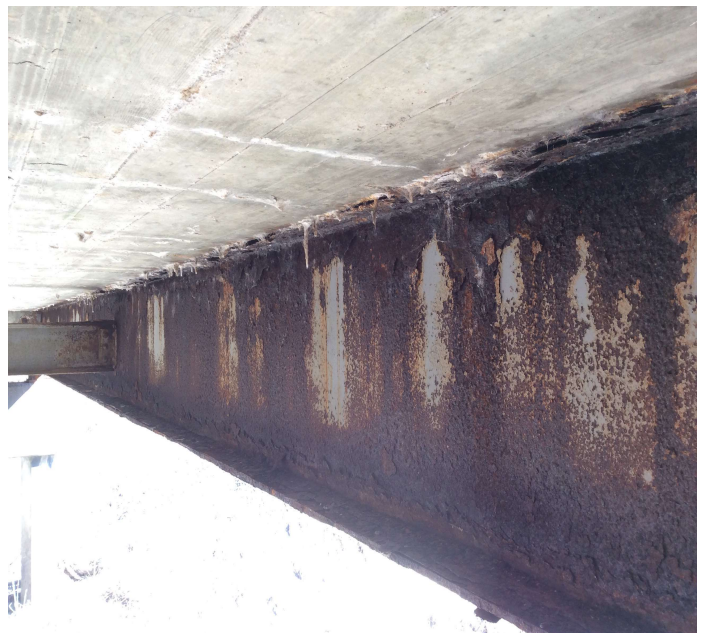
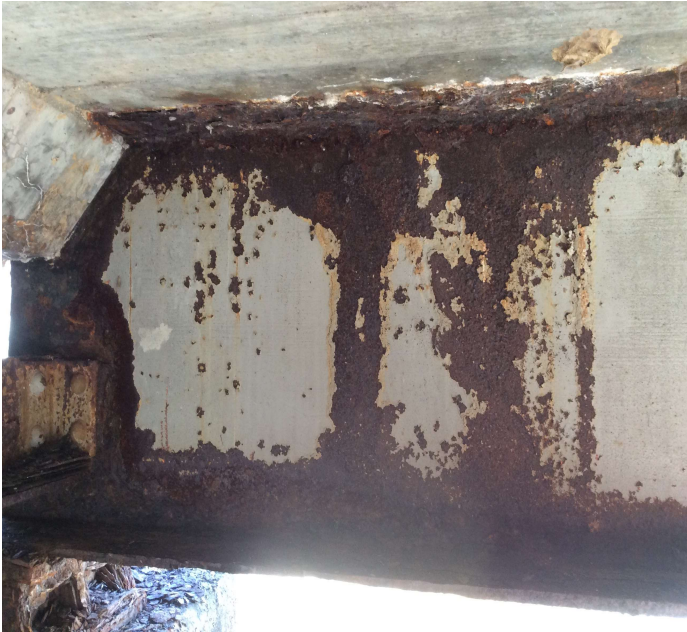
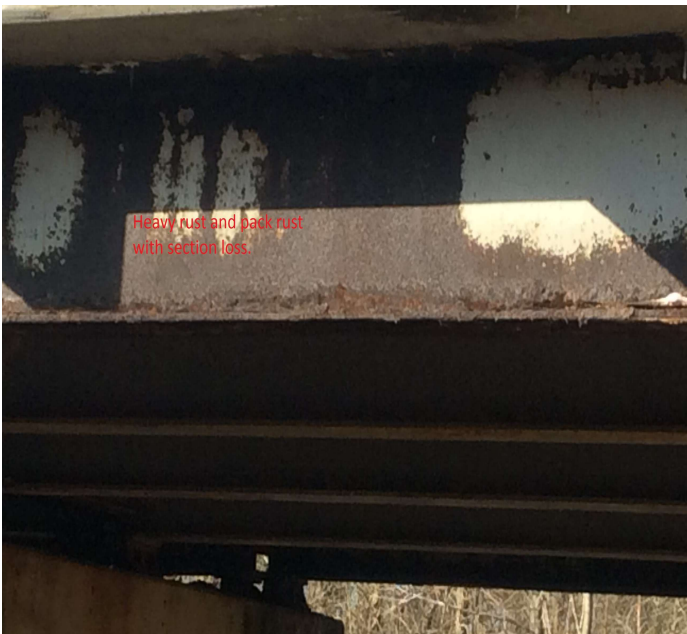
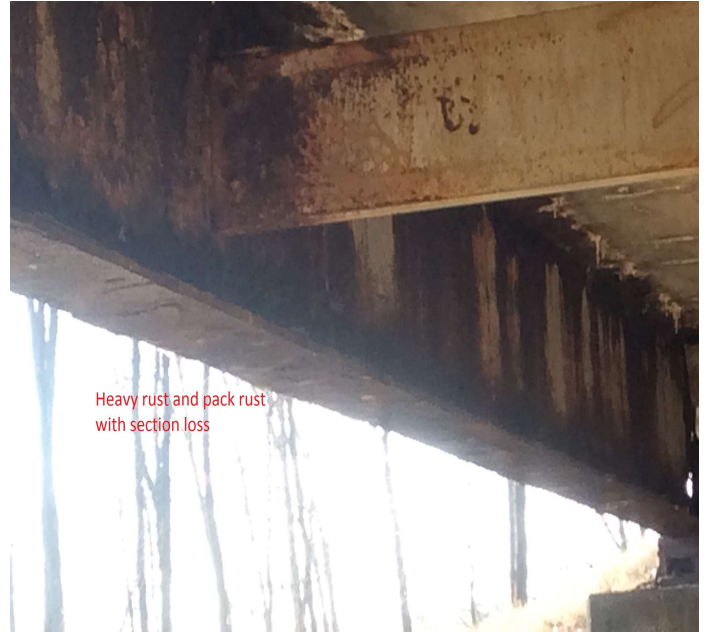
Span 1 bent 1 girder 5 has 3.5' of heavy section loss at web below haunch, at diaphragm connection, and along bottom of web.

Span 2 bent 2 girder 1 has 3' of 1/8" section loss along bottom of web and bottom flange. 1' on end has heavy section loss at web below haunch and diaphragm connection. Web has a slight bow below haunch. Approx. 15' of girder has section loss along top and bottom flange.

Span 2 girder 5 has areas of heavy section loss along top and bottom flange and bottom of web throughout span.

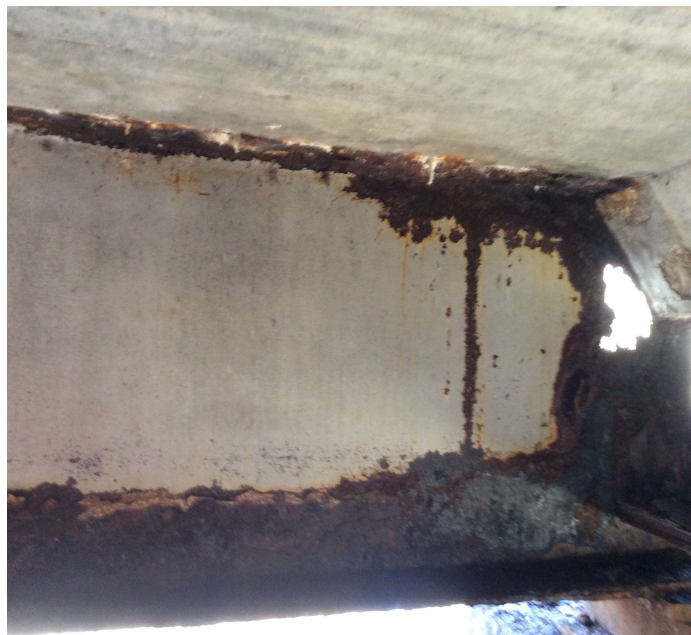
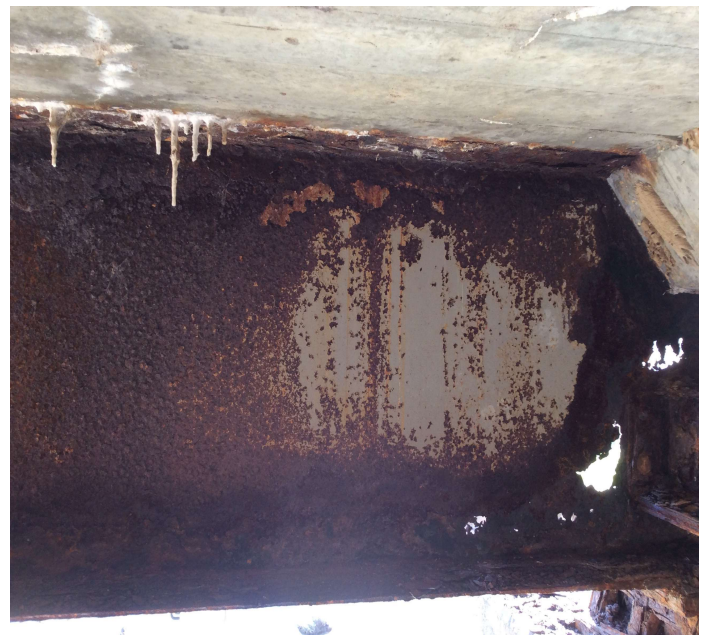
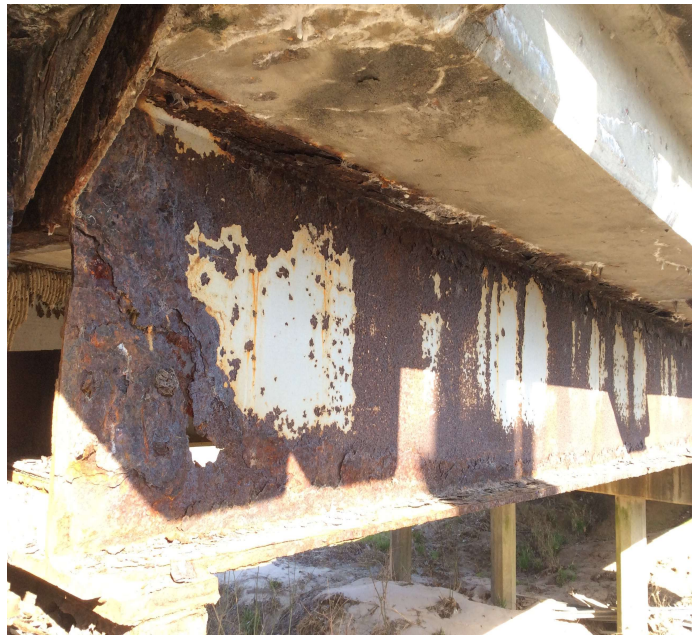
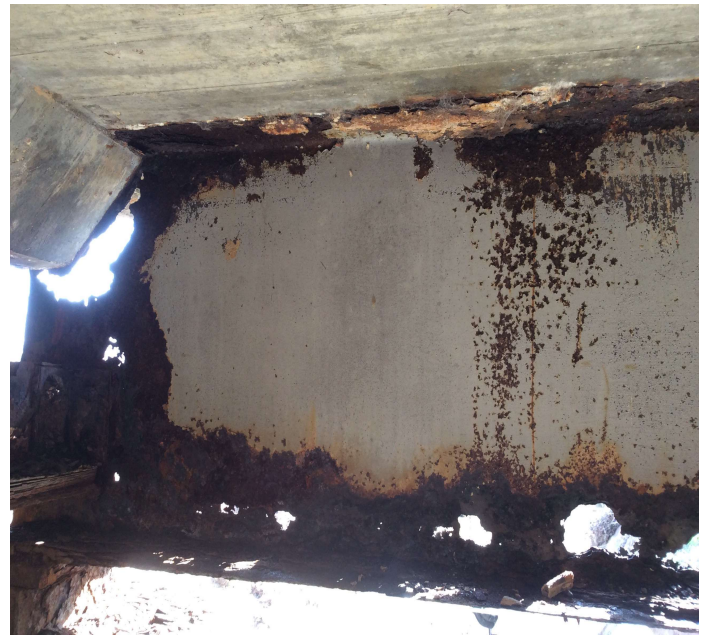
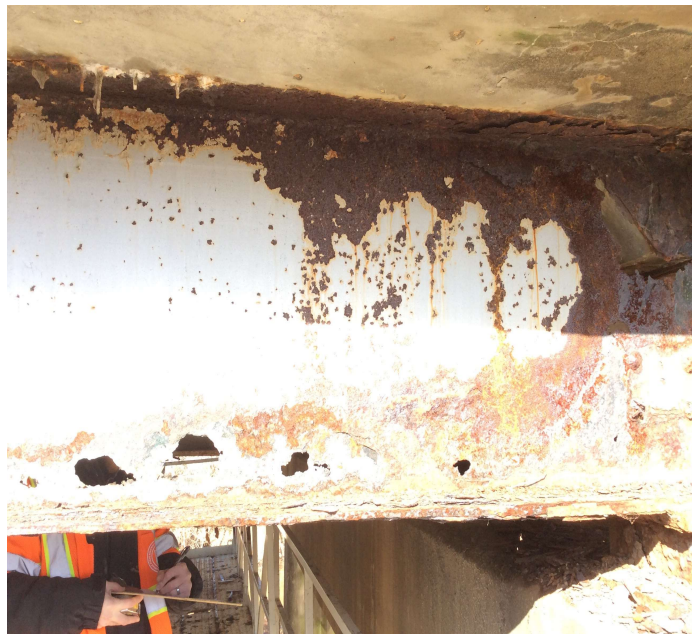
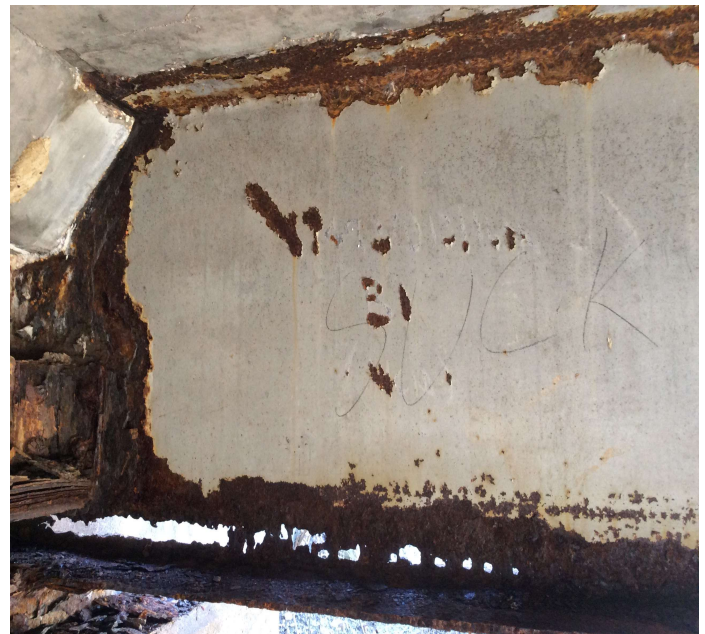
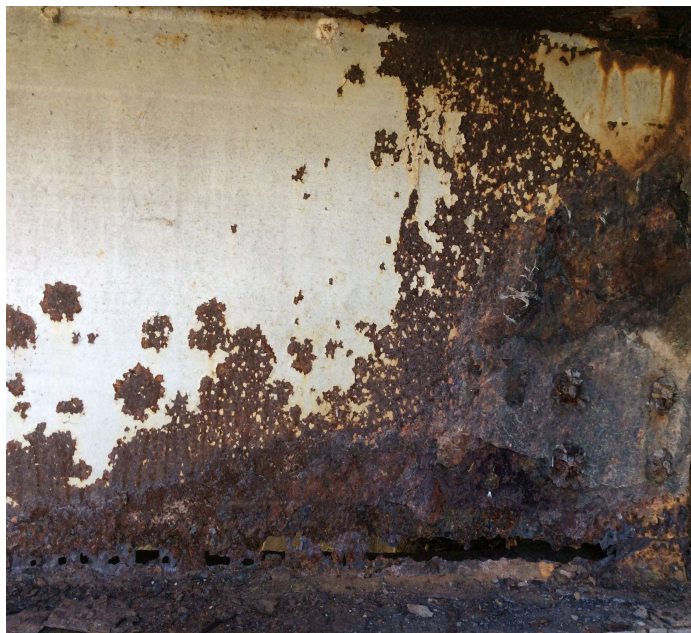
Span 1 bent 1 girder 1 has 4' of heavy section loss and holes rusted through bottom of web with a 3" crack at end of girder. Girder has 1' on end with heavy section loss at web below haunch and at diaphragm connection. Web is beginning to buckle.

Span 1 bent 2 girder 1 has 7' of heavy section loss along bottom of web and bottom flange. Interior bottom flange is beginning to knife edge with 3/16" remaining on edge. End of girder has 1' of heavy section loss with a 6" diameter hole rusted thru web below haunch.

Span 1 bent 2 girder 5 has 5' of heavy section loss with holes rusted thru bottom of web. Interior bottom flange is knife edged with holes rusted thru. Web below haunch has a 14" x 3" hole rusted thru. Web has holes rusted thru at diaphragm connection. Web is buckling.

Span 2 bent 2 girder 5 has 4' of heavy section loss at end with holes rusted through web below haunch, at diaphragm connection, and along bottom of web. Web is buckled at end.
