Bridge Inspection Report

06104
SH 135-05-LM 6.34
over
GAINESVILLE CREEK

Structure Number: 06104

Facility Carried: SH 135-05-LM 6.34

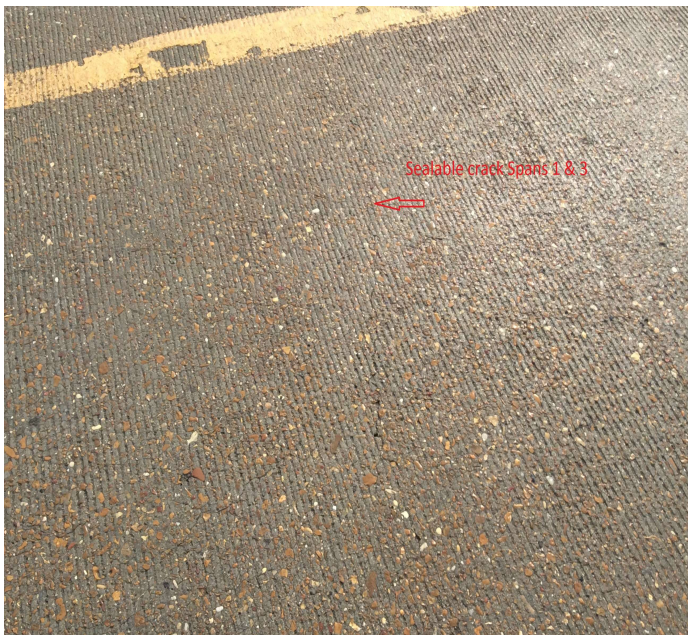
PHOTO 1 Description

Deck

A few sealable cracks top of deck.

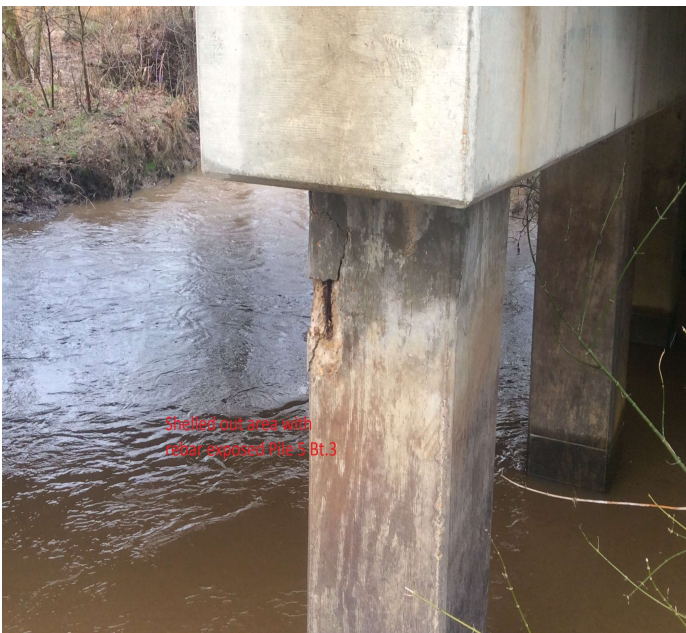
PHOTO 1 Description

Channel Bent 3.

Some minor erosion Bent 3 at Piles 3, 4 & 5 due to past drift problems, 1 ft.- 3 ft. typical. Pile encasement on Pile 5 Bent 3 beginning to undermine, see photo.

Pile encasement on Pile 5 Bent 3,

beginning to undermine, see 2012 photo.

Pile encasements on Bt's 2 & 3, have some cracking and/ or spalled areas with exposed rebar. See photo Pile 5 Bt.3

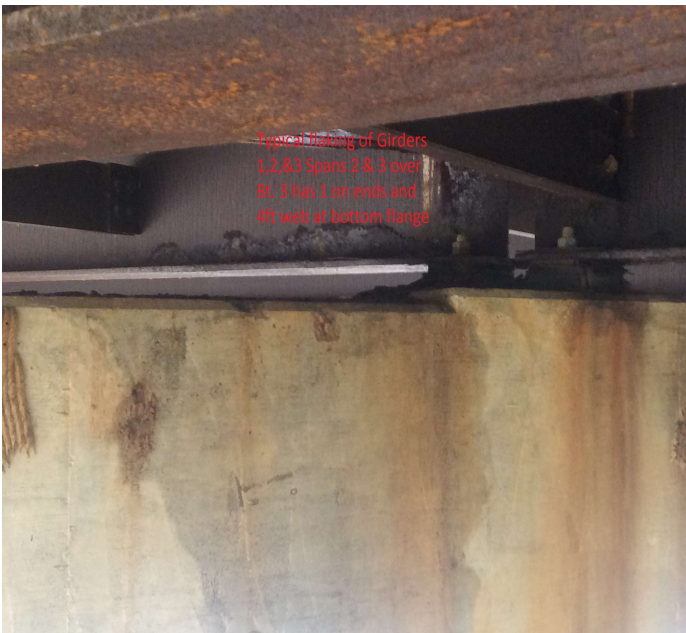
PHOTO 1 Description

Environment	Total Quantity	Units	Condition State 1	Condition State 2	Condition State 3	Condition State 4
12 - Reinforced Concrete Deck	1- Ben.	3724	sq. ft.	3724			
107 - Steel Open Girder/Beam	1- Ben.	525	ft.	501	0	24	0
	2ft. on Ends of steel girders have flaking with initial section loss to web and bottom flange, especially Bt's 2 & 3.						
1000 - Corrosion		24				24	
515 - Steel Protective Coating		3733	sq. ft.	3393	0	340	0
3430 - Oxide Film Degradation Color/Texture Adherence(Steel Protective Coatings)		340				340	
215 - Reinforced Concrete Abutment	1- Ben.	212	ft.	212			
225 - Steel Pile	1- Ben.	10	each	10			
234 - Reinforced Concrete Pier Cap	1- Ben.	76	ft.	76			
302 - Compression Joint Seal	1- Ben.	148	ft.	124	0	24	0
2330 - Seal Damage		24				24	
311 - Movable Bearing	1- Ben.	15	each	0	15	0	0
	Bearings are rusted with pitting and pack rust forming between masonry plate and bearing.						
1000 - Corrosion		15			15

End of several girders are flaking , Girders 1,2,&3 of Spans 2 & 3 (4ft. typical) see photo

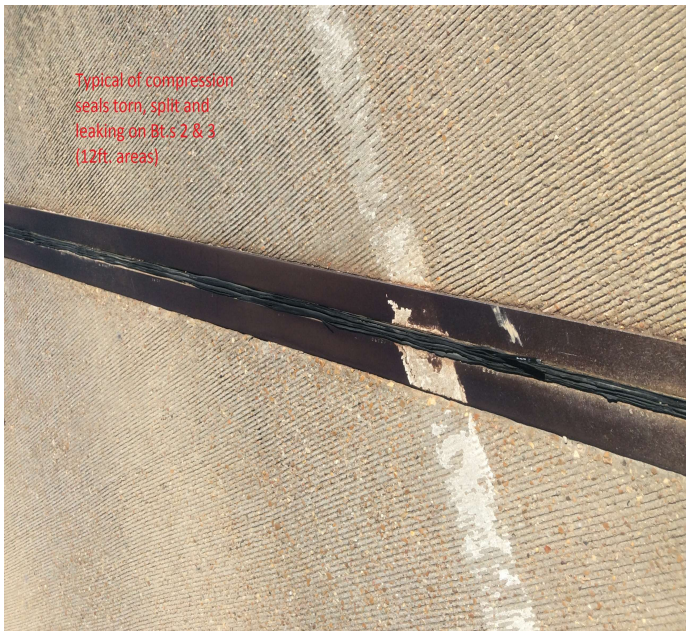
PHOTO 1 Description

Compression seal Bents 2&3 torn, split and leaking (12ft.typical)
