Bridge Inspection Report

06105
SH 135-05- LM 6.71
over
GAINESVILLE CREEK

Structure Number: 06105

Facility Carried: SH 135-05- LM 6.71

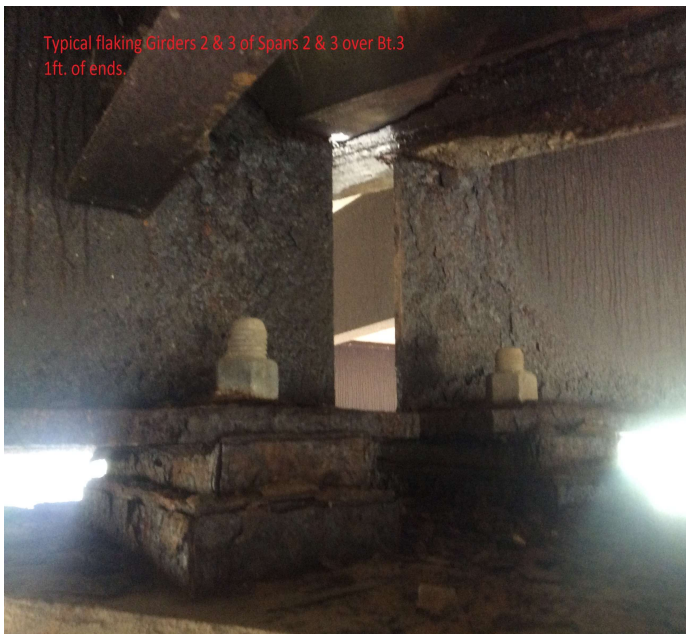
PHOTO 1 Description

Ends of several of steel girders,

have some flaking, 1 ft. typical, especially Bent 3. Girders 3 & 4 Spans 2 & 3 over Bt.3 (4ft. total)

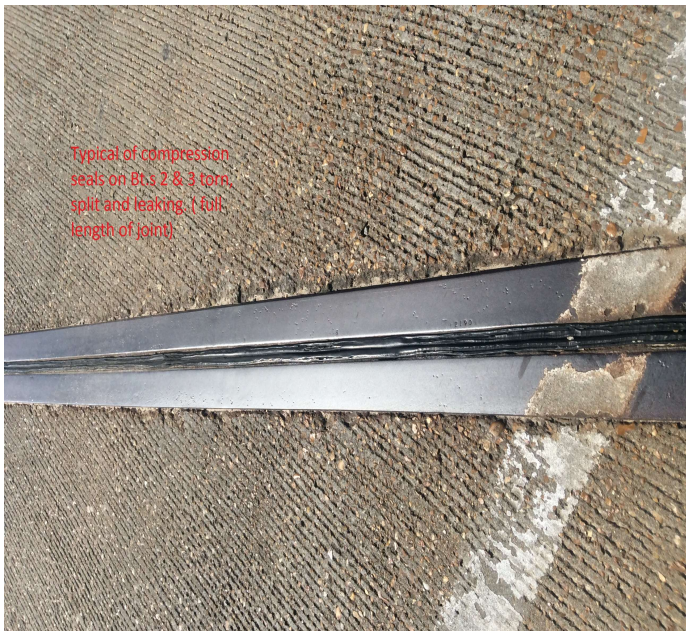
PHOTO 1 Description

Compression seals Bents 2&3 have torn split and leaking
