Bridge Inspection Report

06603

US 67-17- LM 19.17

BIG RUNNING WATER CREEK

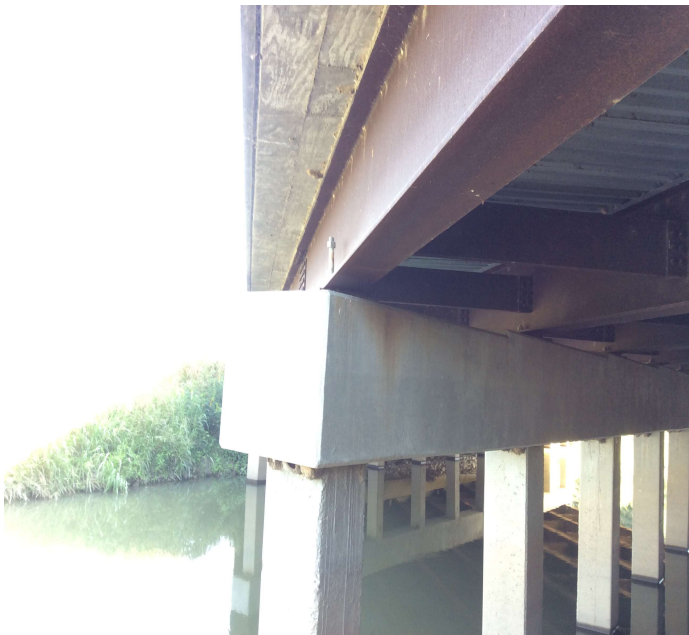
PHOTO 1 Description

Bent 2 bearing 1 anchor bolt is sticking out of cap approximately 1'

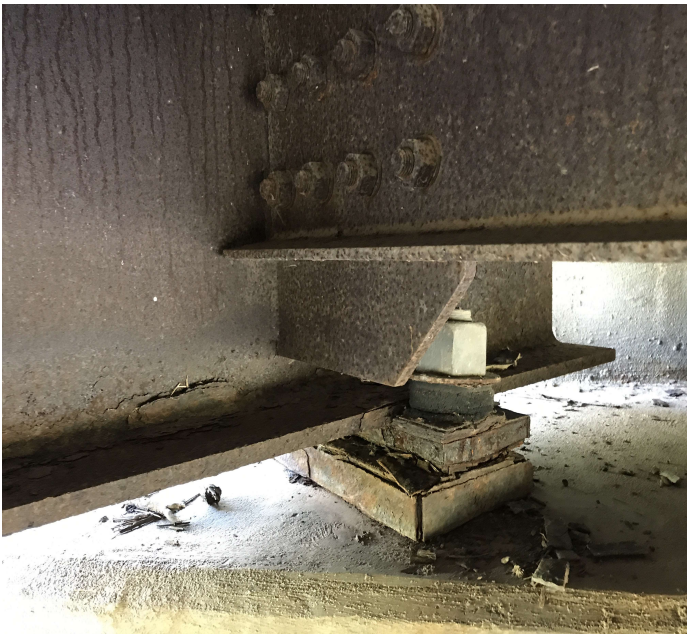
Span 1 bent 1 girder 10 has 5' of flaking rust with initial section loss along bottom of web and bottom flange near bearing.

PHOTO 1 Description Span 1 bent 1 girder 10
