Bridge Inspection Report

02015
SH 463-01-LM 6.71
over
LITTLE BAY

Structure Number: 02015

Facility Carried: SH 463-01-LM 6.71

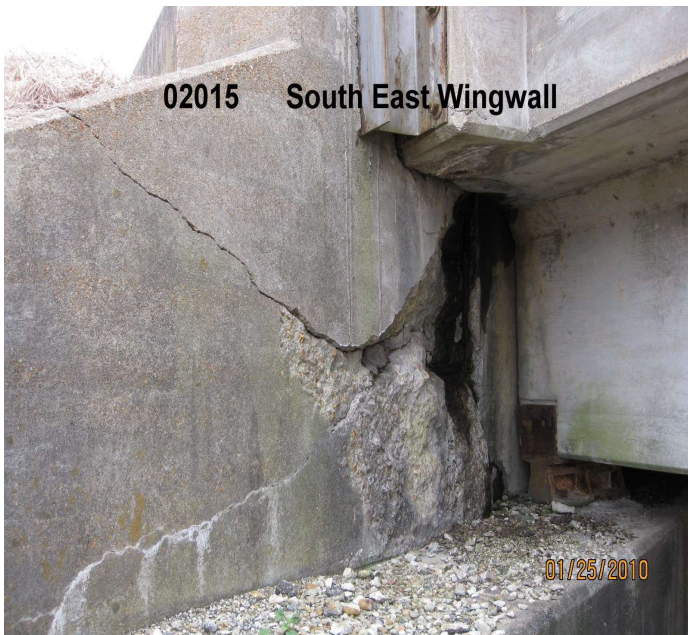
PHOTO 1 Description

All wing wall are cracked and broken away from back walls, South East wing wall in broken and shelled off with exposed rebar, see 2010 photo.

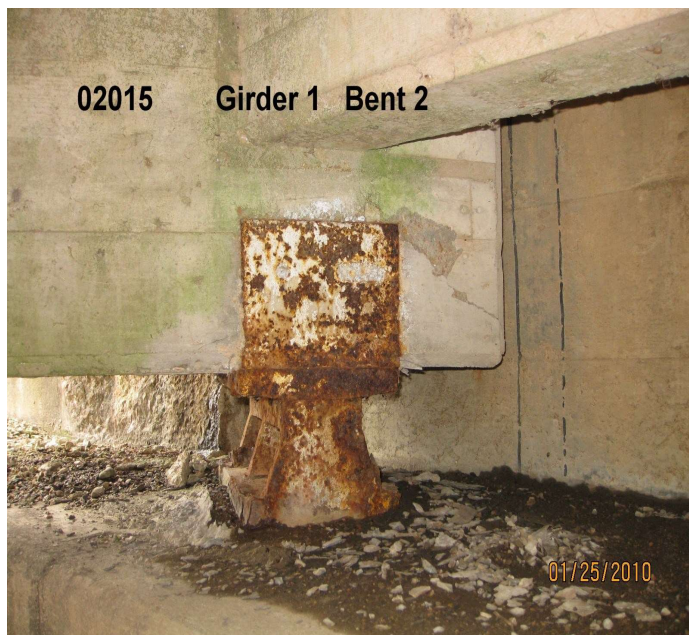
PHOTO 1 Description

Concrete Girders have butted up against concrete abutments on Bents 1 and 2 abutments causing some minor cracking to ends of concrete girders with a few spall on ends of girders, see 2010 photo.
