Bridge Inspection Report

03685

SH 139-05- LM 1.01

DRAINAGE DITCH NUMBER 3

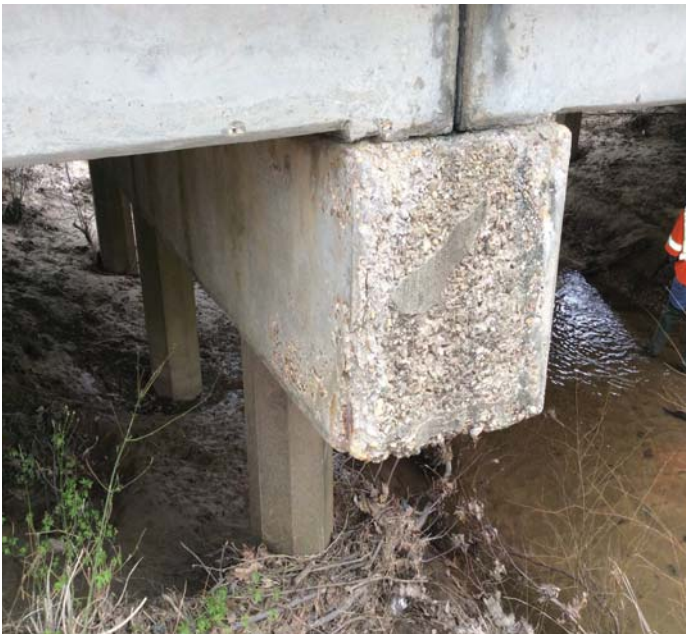
PHOTO 1 Description

Majority of Concrete Members have some deterioration.

Right and left end of Cap Bent 2 has some deterioration and shelled out area with rebar exposed.

Bents 2&3 Cap has some rebar exposed on the bottom of cap due to lack of steel coverage.

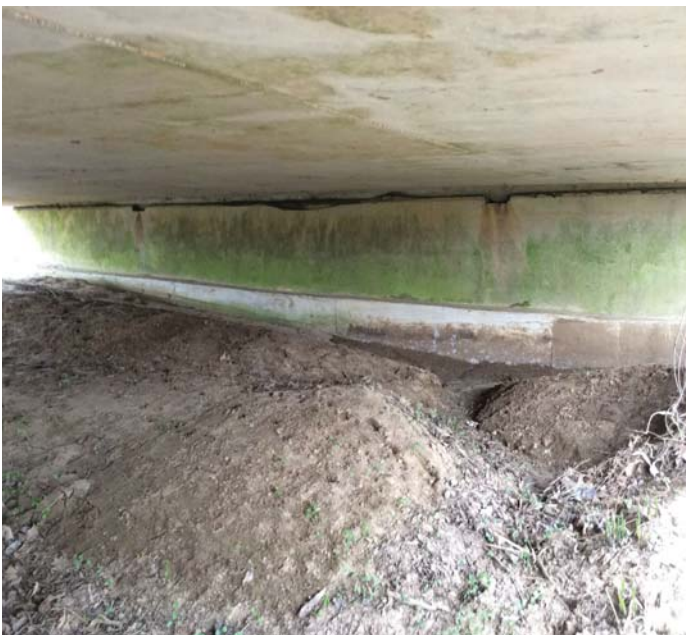
PHOTO 1 Description

Spans 1 near Bent 1 has some minor embankment erosion due to roadway runoff, some repairs have been made in the past, see 2016 photo.
