Bridge Inspection Report

03687

SH 139-05- LM 3.52

DRAINAGE DITCH NUMBER 1

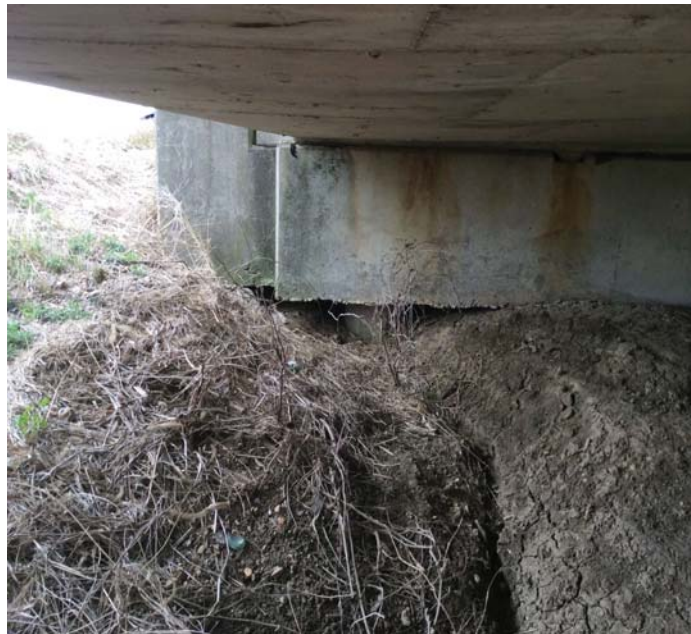
PHOTO 1 Description

Embankment Erosion

4 ft. Rt. end Bt. 1 cap is undermined 1 ft. deep and 3 ft. back under cap from road way runoff, one pile is exposed.

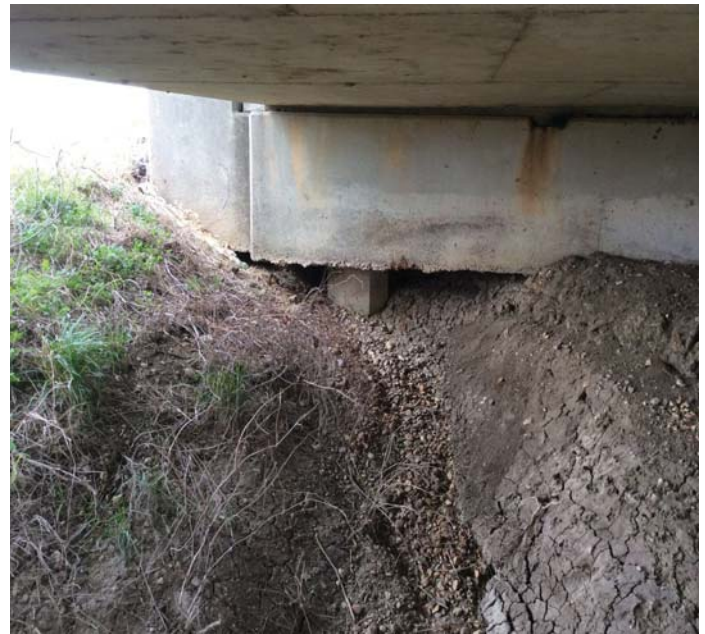
PHOTO 2 Description

6 ft. Lt. end Bt. 4 cap is undermined 1 ft. deep and 3 ft. back under cap from roadway runoff, one pile exposed.
