Bridge Inspection Report

02503

SH 140-01- LM 9.11

LITTLE RIVER

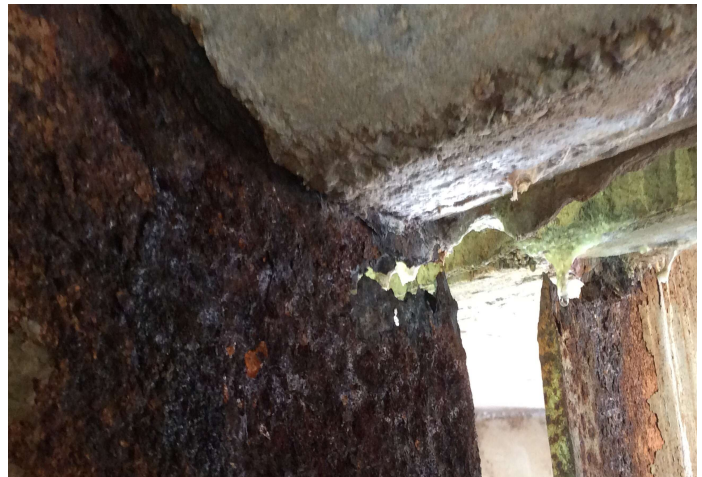
PHOTO 1 Description

Ends of several Girders have cracks and holes rusted thru web near concrete haunch (See 2012 & 2014 Photos):

Span 1 Girder 4 Bent 1 has a 1 1/4in. x 1/4in. hole at haunch with a 1 1/2in. crack at end of hole, see 2014 photo
