Bridge Inspection Report

M2853
SH 312-01- LM 0.82
over
NATL DITCH

Structure Number: M2853

Facility Carried: SH 312-01- LM 0.82

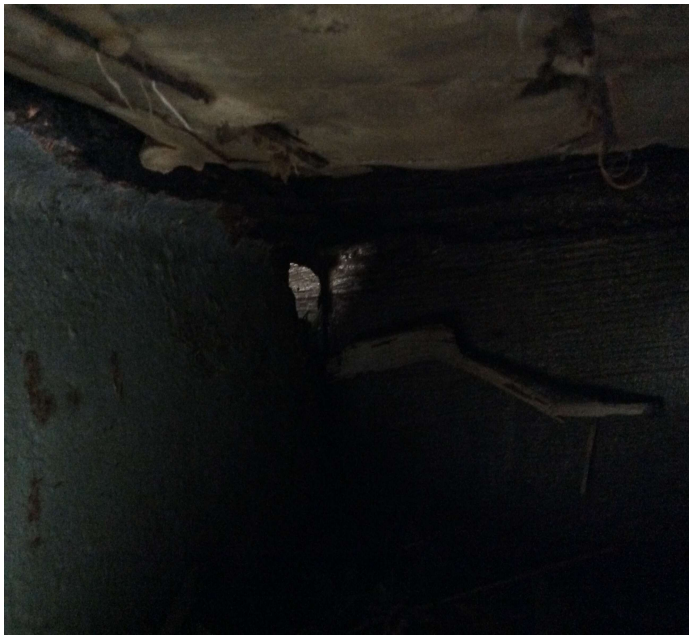
Span 1 Girder 3 over Bent 1 has a 2in. x 2 1/2in. hole rusted thru web near Top Flange.

PHOTO 1 Description Span 1 girder 3 over bent 1.

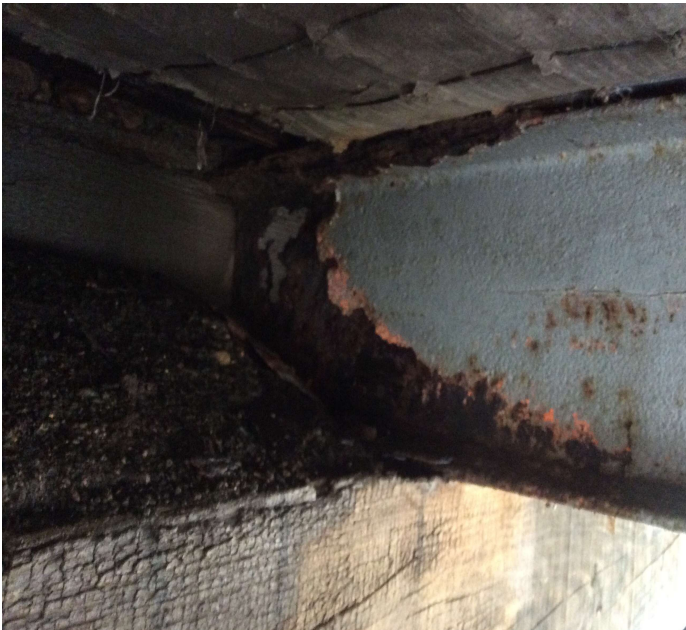
PHOTO 4 Description Span 1 girder 5 over bent 1.

Span 1 Girder 5 over Bent 1 has a 2 1/2in. x 5in. hole rusted thru web near top flange near end of Girder and a 6in. x 2 1/2in. hole near bottom flange.

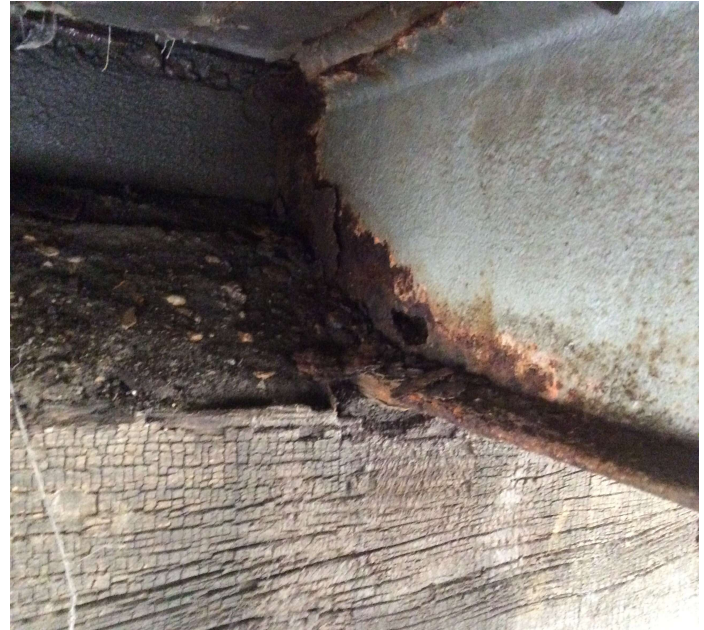
PHOTO 5 Description Span 1 girder 6 over bent 1.

Span 1 Girder 6 over Bent 1 has a 4in. x 1 1/2in. hole rusted thru web near bottom flange 12in. from end of Girder.

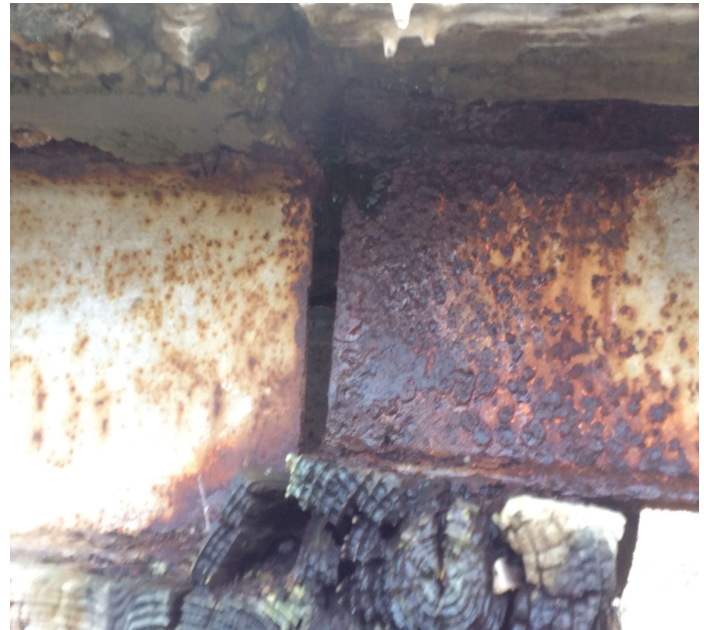
PHOTO 6 Description Span 1 girder 1 over bent 2.

Span 1 Girder 1 over Bent 2 has a 13in. x up to 2in. area of holes rusted thru web near Top Flange and a area 3in. x up to 1in. area of holes in web at end of girder.

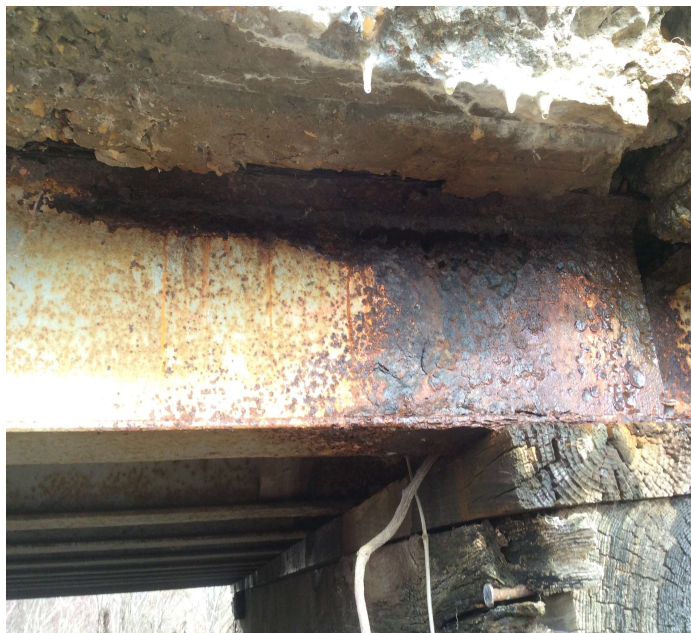
PHOTO 7 Description Span 1 girder 13 over bent 2.

Span 1 Girder 13 over Bent 2 has an 8in. x 3/4in. hole rusted thru web near top flange 7in. from end of Girder.

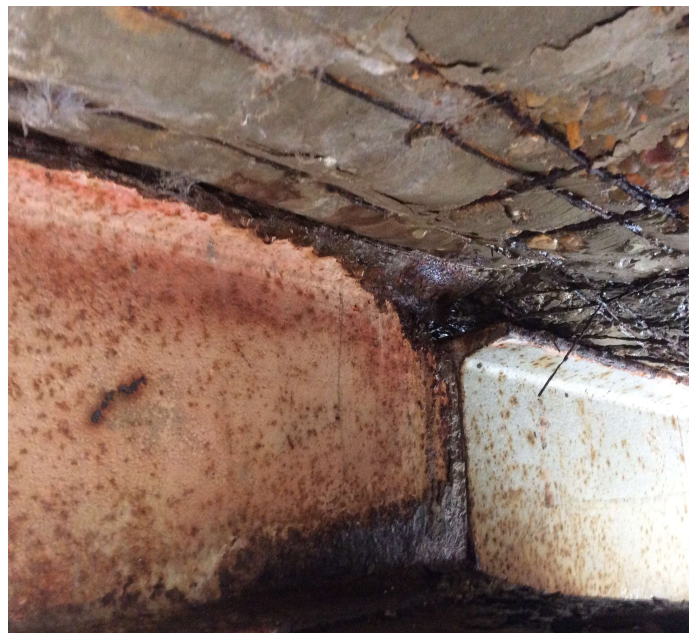
Span 3 Girder 2 over Bent 3 has a 1 1/2in. x 1in. hole rusted thru web near Top Flange and the end of web has section loss with several small holes rusted thru web, 1/4in. typical.

PHOTO 9 Description Span 3 girder 2 over bent 3.

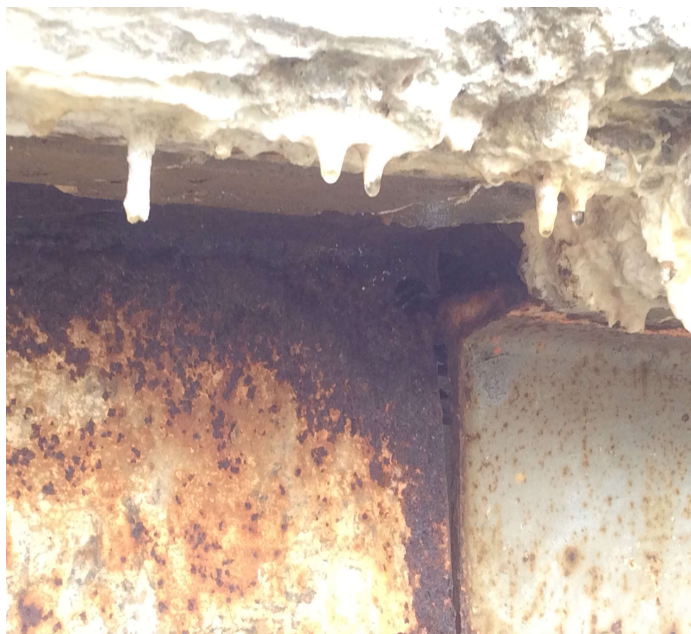
Span 3 Girder 1 over Bent 3 has a 1 1/2in. x 1in. hole rusted thru web near Top Flange.

PHOTO 8 Description Span 3 girder 1 over bent 3.

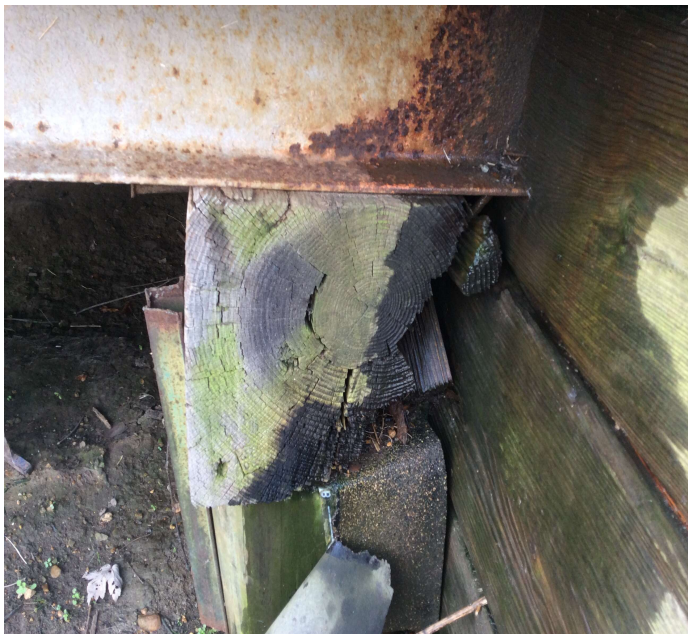
Bents 1&4 Timber Caps

have 4ft. on each end decayed with 30% section loss, see deficiency sketch 2010.

PHOTO 1 Description Left end bent 1 cap.

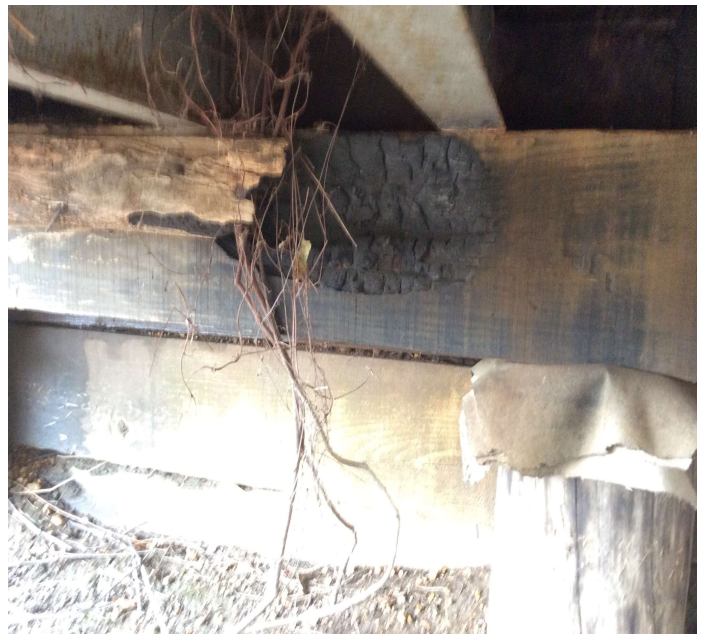
Bent 1 Cap between Piles 4&5 has a 24in. x 9in. area burnt with up to 2in. section loss, see 2015 photo.

PHOTO 2 Description Bent 1 cap between pile 4 & 5.

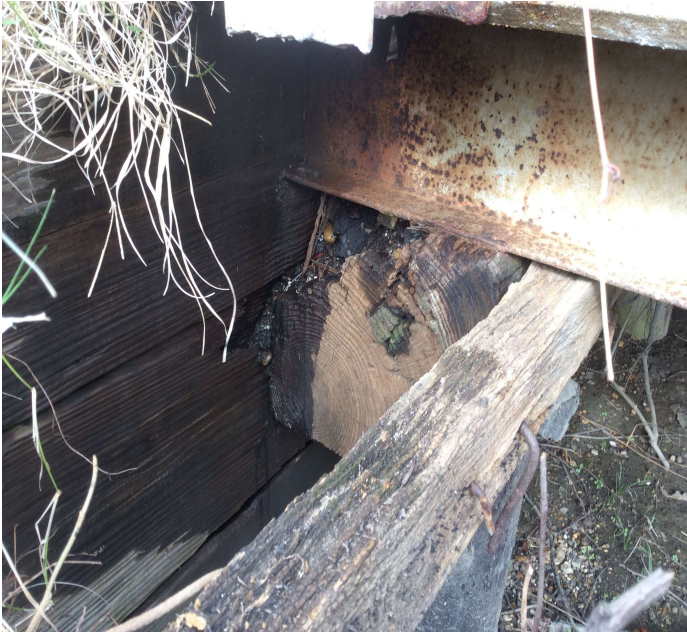
PHOTO 3 Description Right end bent 1 cap.

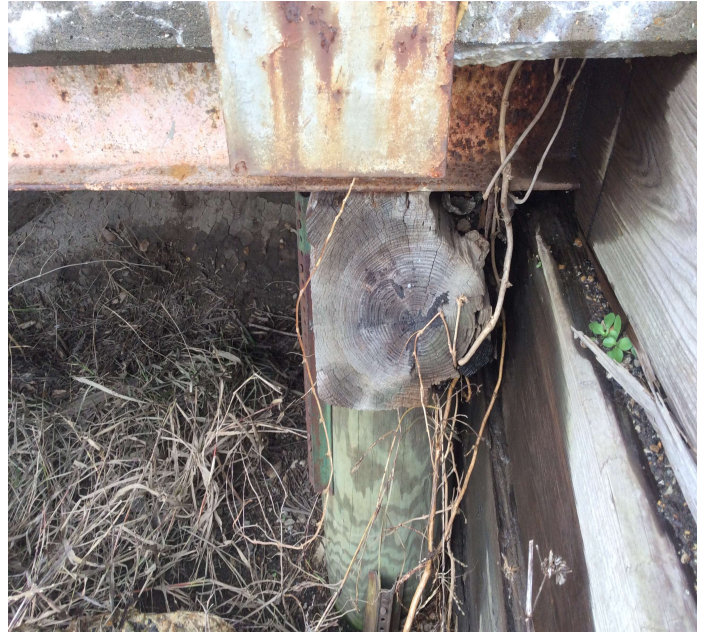
PHOTO 5 Description Right end bent 4 cap.

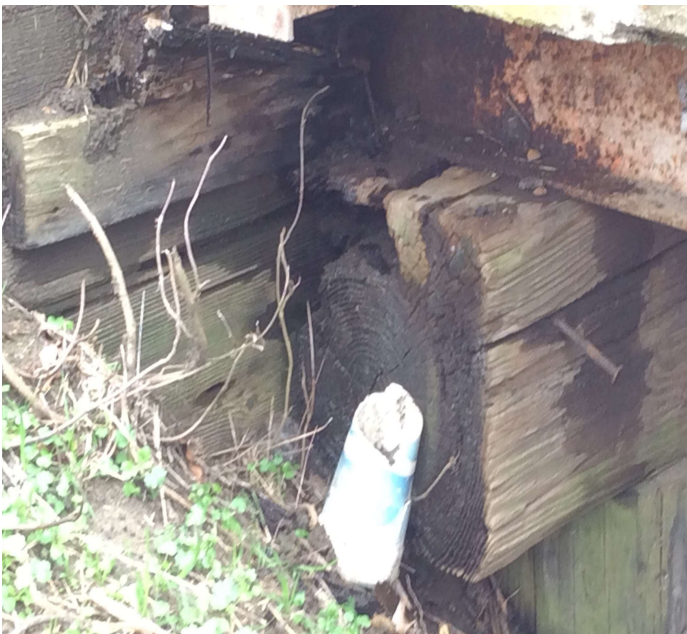
PHOTO 4 Description Bent 4 cap left end.

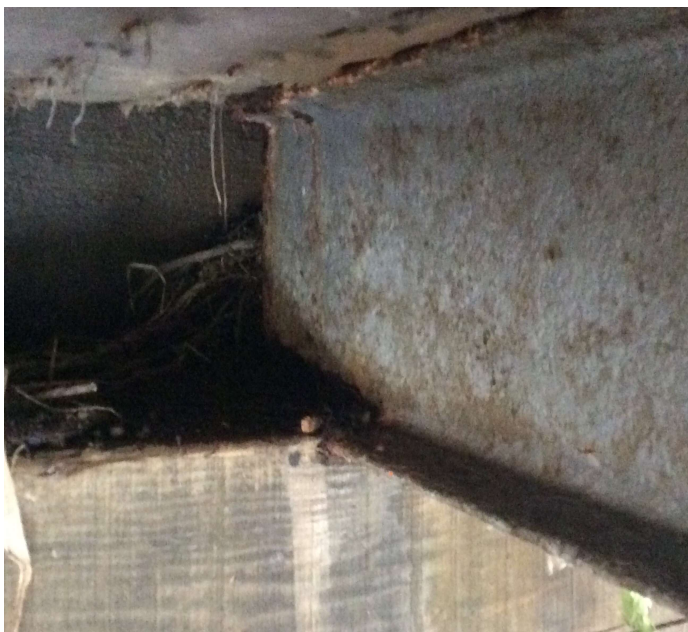
Span 1 Girder 4 over Bent 1 has a 6in. x 3/4in. hole rusted thru web near Bottom Flange.

PHOTO 1 Description Span 1 girder 4 over bent 1.

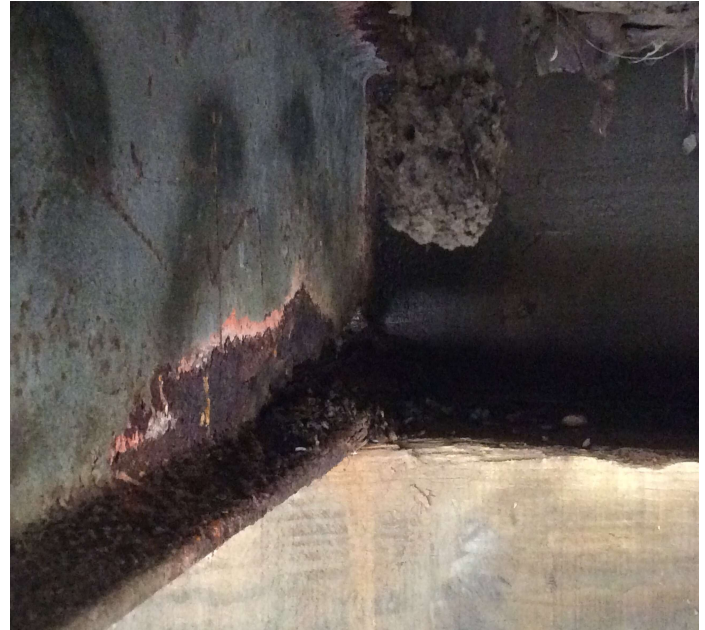
Span 1 Girder 9 over Bent 1 has a 13in. x 2in. hole rusted thru web near bottom flange with some crushing.

PHOTO 12 Description Span 1 girder 9 over bent 1.

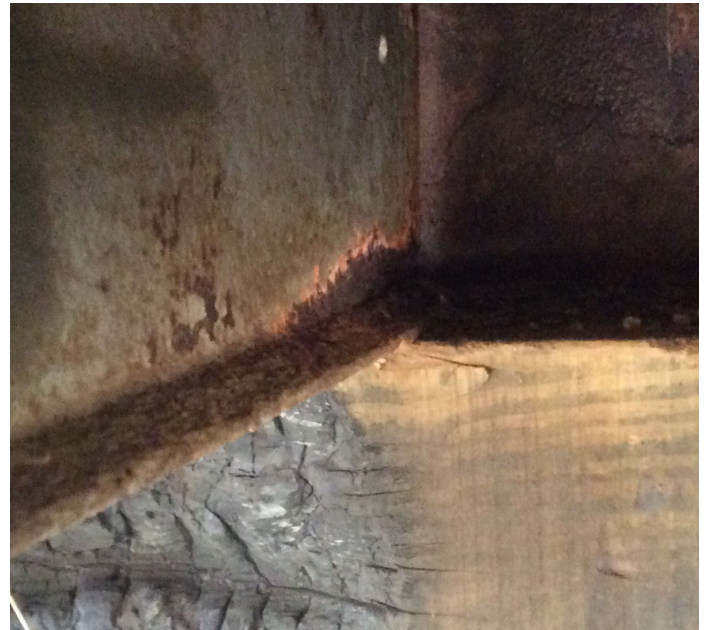
Span 1 Girder 10 over Bent 1 has a 4in. x 1/2in. hole rusted thru web near bottom flange near end of Girder.

PHOTO 13 Description Span 1 girder 10 over bent 1.

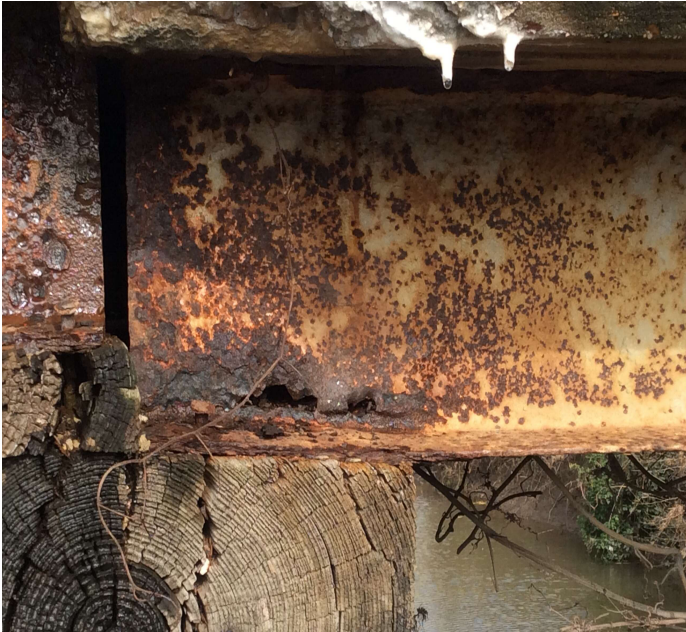
Span 2 Girder 13 over Bent 2 has a 9 1/2in. x up to 1in. hole rusted thru web near bottom flange with up to 1in. crushing.

PHOTO 14 Description Span 2 girder 13 over bent 2.

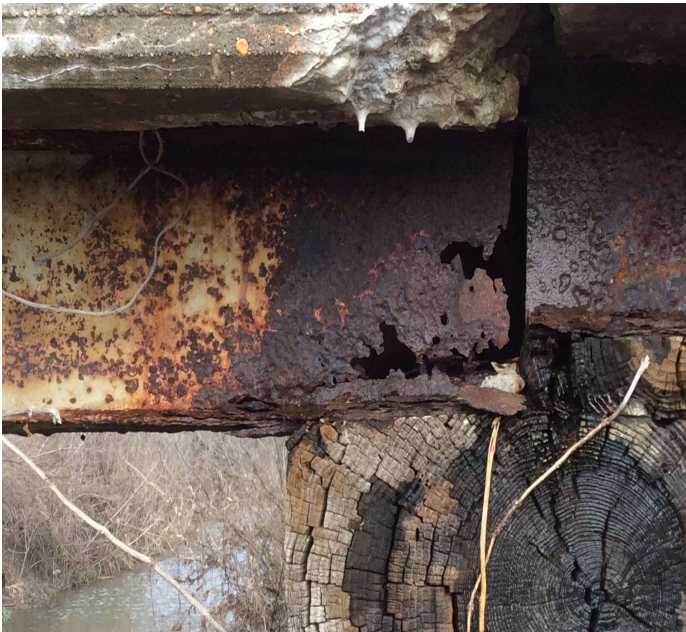
Span 2 Girder 13 over Bent 3 has a 9in. x 3in. hole rusted thru web near bottom flange with up to 1in. crushing and the end of girder has the web paper thin with several small holes.

PHOTO 15 Description Span 2 girder 13 over bent 3.

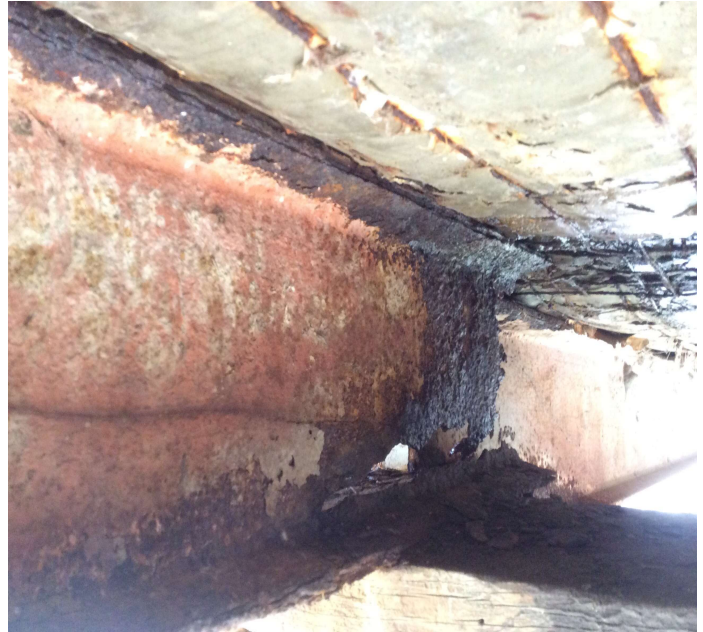
Span 3 Girder 12 over Bent 3 has a 16in. x 2in. hole rusted thru web near bottom flange with some crushing and several holes at end of girder; Girder has no support at this time.

PHOTO 16 Description Span 3 girder 12 over bent 3.

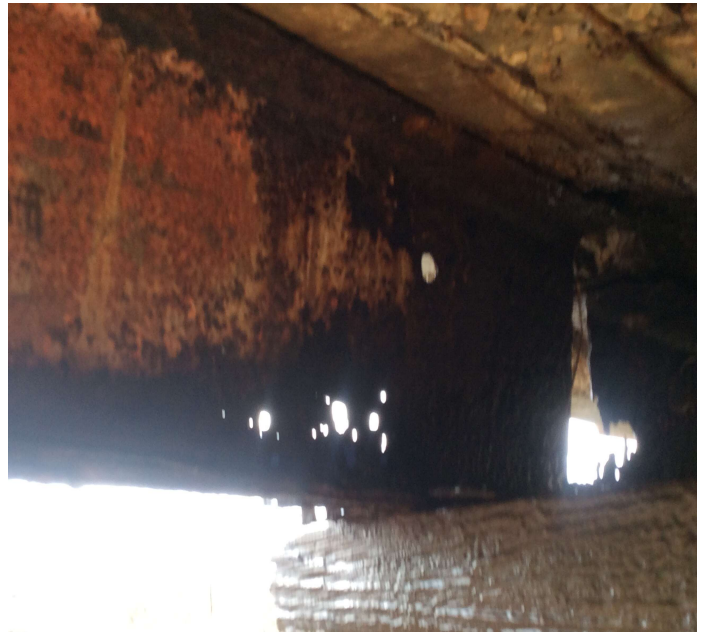
Span 3 Girder 13 over Bent 3 has a 9in. x 2in. area with holes rusted thru web near bottom flange.

PHOTO 17 Description Span 3 girder 13 over bent 3.

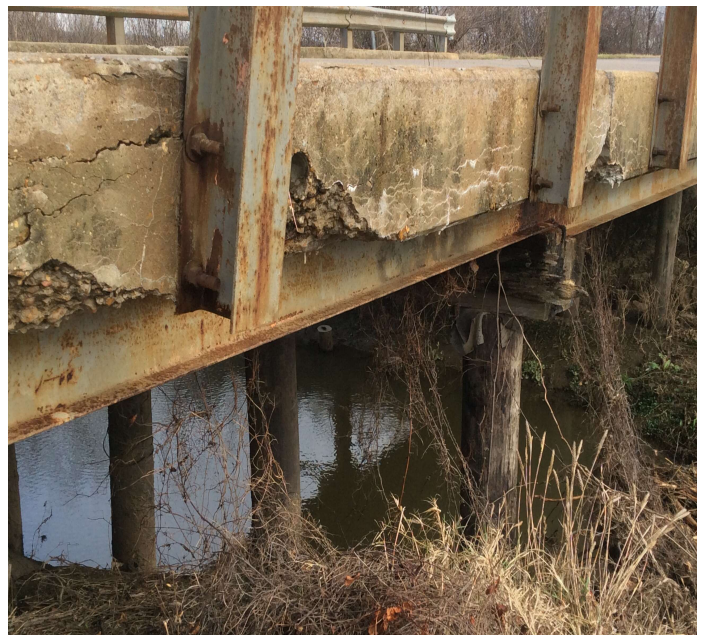
20LF of Concrete Curb & Right Side of Deck is deteriorated with section loss with rebar exposed on the right side of Span 1, see 2015 photo.

PHOTO 2 Description Span 1 right overhang.

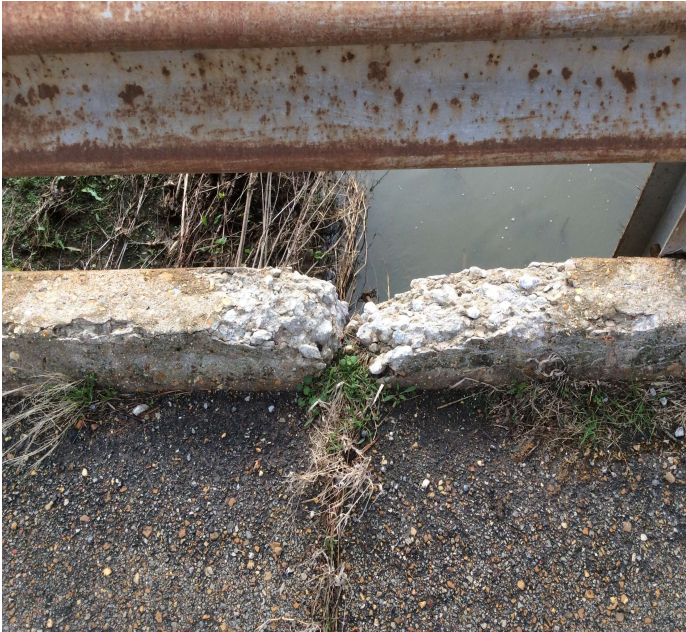
PHOTO 3 Description Right curb over bent 3.
